ILLUMINATED SIGNAGE, OLD WINDSOR ROAD, BELLA VISTA

SIGNAGE SAFETY ASSESSMENT

PREPARED FOR MULPHA NORWEST PTY LTD | 12 SEPTEMBER 2022
300303960

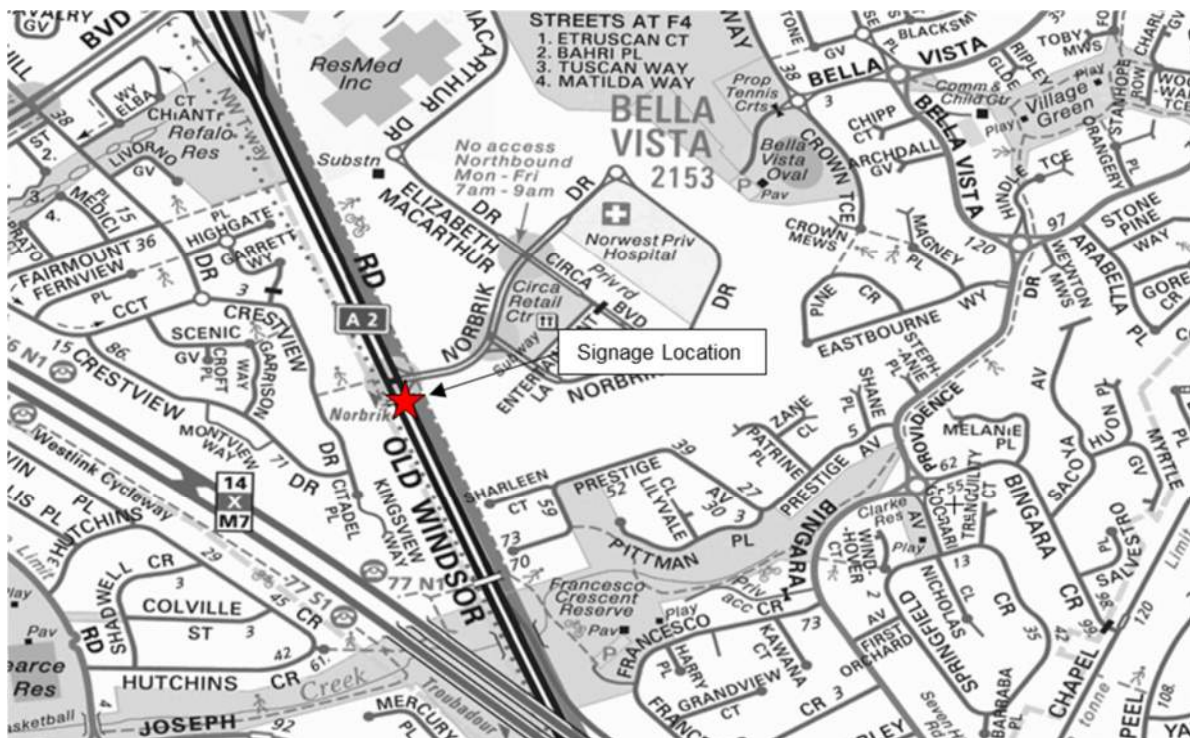
Figure 1: Existing signage location and surrounds

The location of the subject site and its surrounding environs are shown in Figure 1.

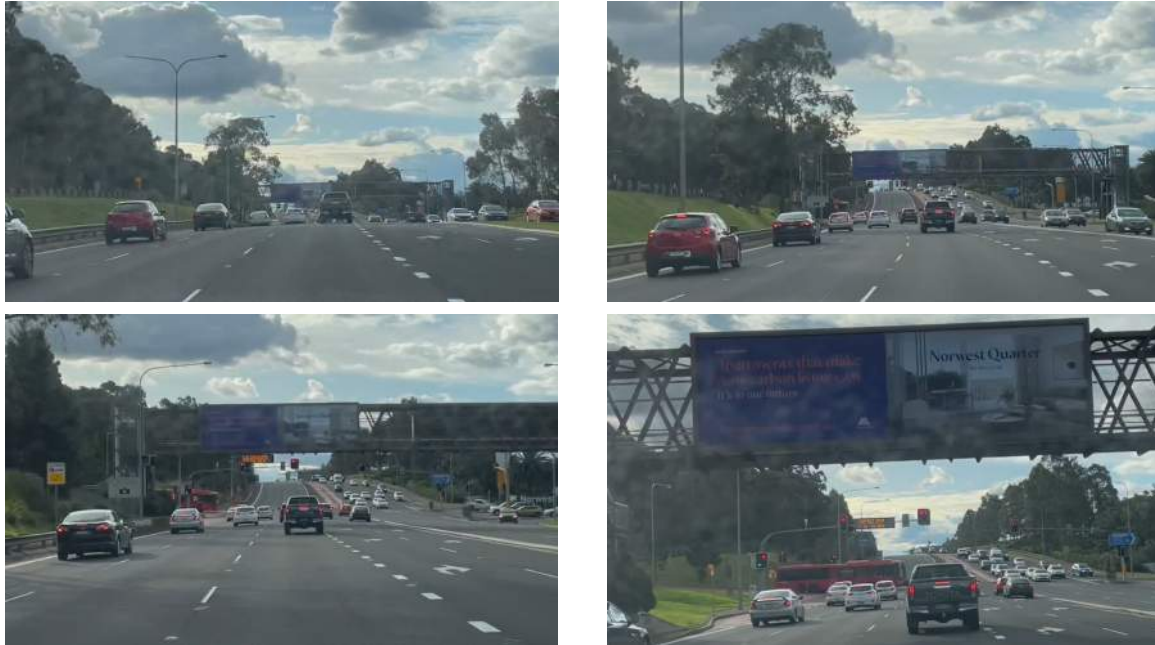
Figure 2: Photomontage of the existing south facing sign (northbound traffic)

A photo montage of the existing northbound and southbound signs is shown in Figure 2 and Figure 3 respectively.

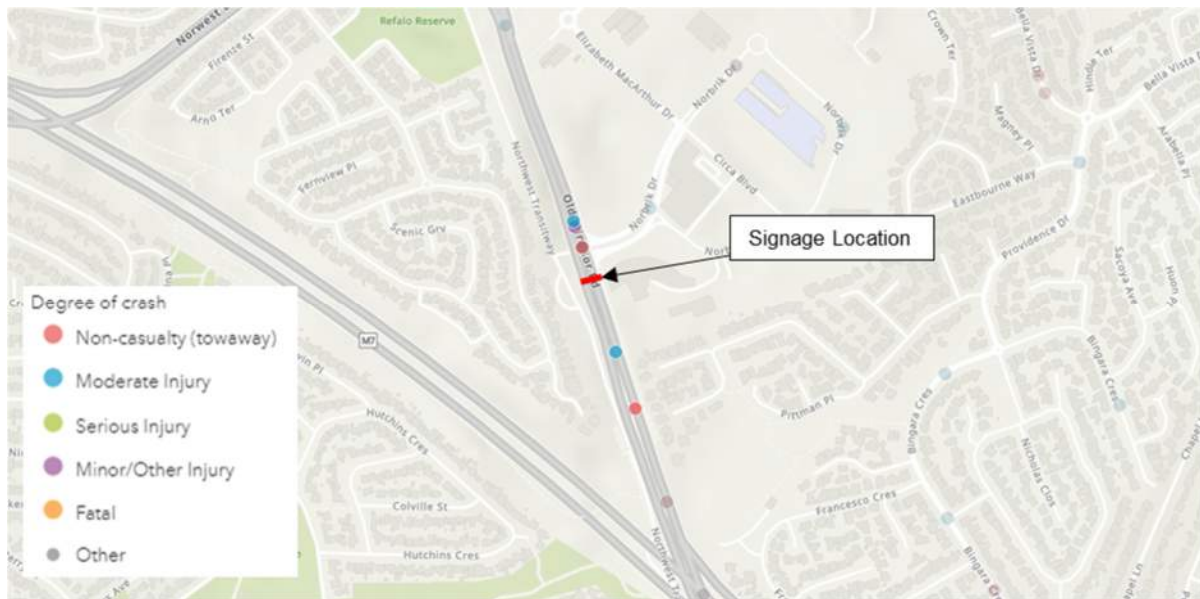
Figure 8: Crash map from 1 January 2016 to 31 December 2020

The data indicates that a total of nine collisions occurred on Old Windsor Road within the visible distances of the existing signs during the five-year study period. Six of these were north of the existing signs and the remaining three were south of the existing signs. These collisions are shown in Figure 8. It is noted that the data provided on the TfNSW Centre for Road Safety site is limited and the above crashes may have occurred downstream of the existing signs, i.e., where the sign would not have been visible.

Figure 8 indicates that within the exposure distance of the north facing sign there is a small cluster of crashes at or on approach to the Norbrik Drive and Old Windsor Road Intersection. Of the six crashes recorded at this intersection, four (67%) were classified as rear-end crashes, which are typical in busy urban environments where congestion is common. The grades through the area likely contributed to the moderate severity of two of the recorded rear end crashes.

There have been an additional three crashes reported within the exposure distance of the south facing sign. Two of these were classified as rear-end crashes, which as indicated above is typical for the road environment.

Considering that a significant proportion of the recorded crashes were rear-end crashes (which are typical at major road intersections that are prone to congestion) and there were no other relevant observable trends in terms of crash types or influences, the location of the existing advertising signs does not present a safety concern.

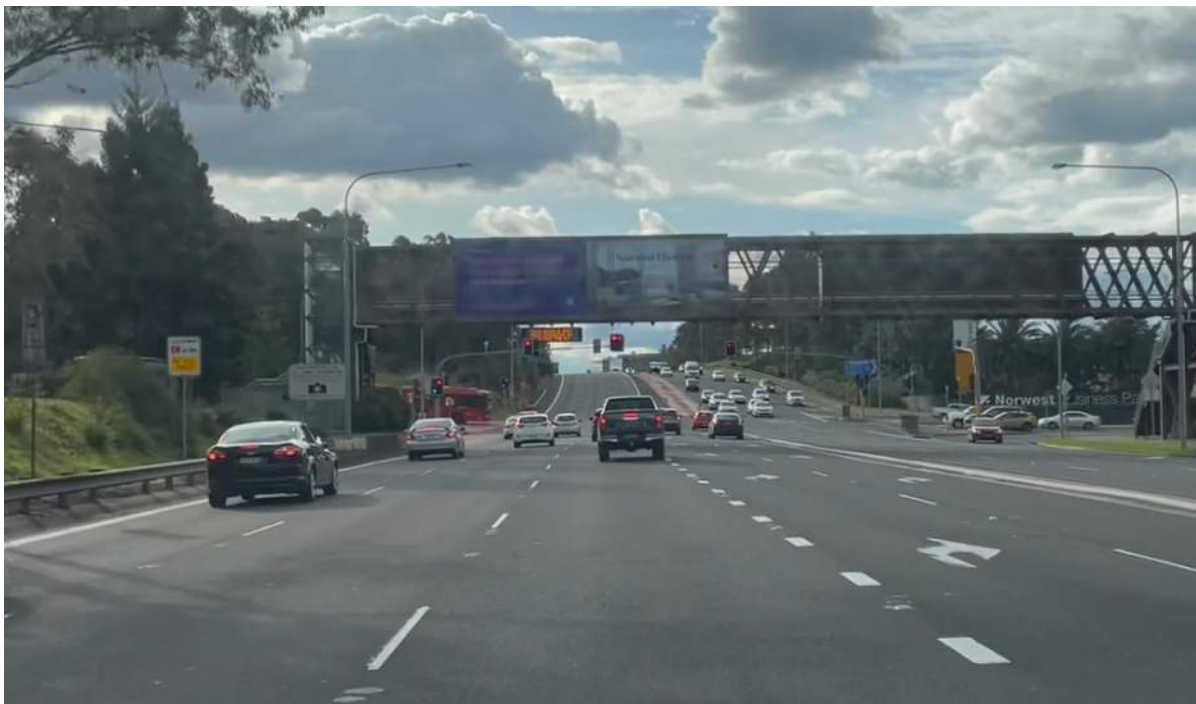
Figure 9: Southbound drivers' view at SSD from Norbrik Drive intersection

TfNSW clarified that application of Criteria 3.2.3 requires SSD to be measured horizontally in the direction of travel back from the stop line. As such, the first two points of Criteria 3.2.3 apply to the south facing sign given it is located approximately 50 metres from the relevant stop line. The view of the south facing sign at the SSD from the stop line is shown in Figure 9.

Although the south facing sign is within the SSD from the intersection, given the static nature of the sign and straight alignment of the road, it is not anticipated that the sign compromises road safety at this location.

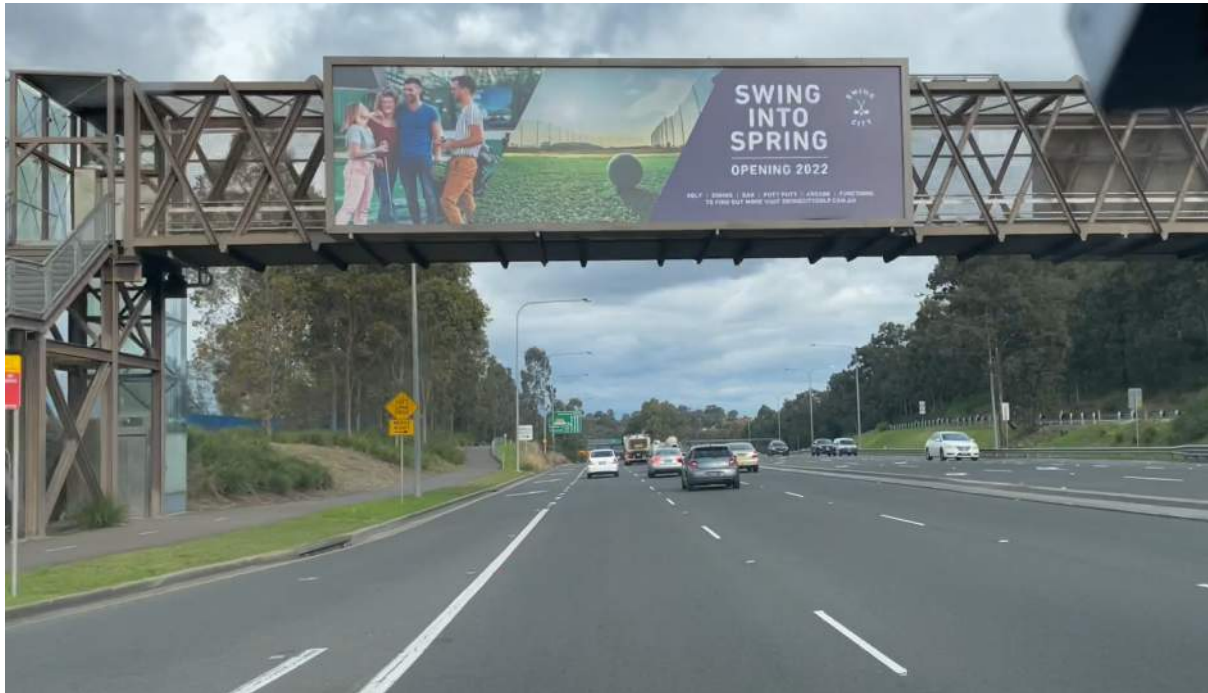
Figure 10: Southbound drivers' view at SSD from southbound merge point

The north facing sign is within the SSD for the merge point between southbound vehicles on Old Windsor Road and vehicles turning left out of Norbrik Drive. The sign is located approximately 100 metres up stream of the merge point and therefore the first two points of Criteria 3.2.3 also apply to the north facing sign. The view of the north facing sign at the SSD from the merge point is shown in Figure 10.

Although the north facing sign is within the SSD from the intersection, given the static nature of the sign and straight alignment of the road, it is not anticipated that the sign compromises road safety at this location. Furthermore, the north facing sign is only visible for the 20 metres of the SSD before it is out of sight.

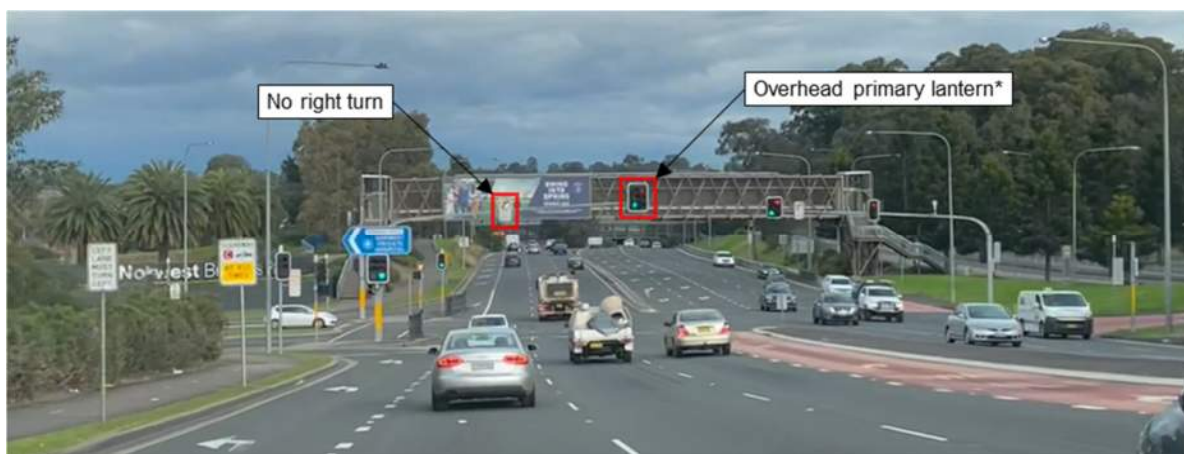
Figure 11: Southbound overhead primary lantern backdropped by north facing sign

The north facing advertising sign backdrops the overhead primary traffic signal lantern and no right turn sign on the Old Windsor Road southbound approach to the Norbrik Drive intersection as shown in Figure 11. It should be noted that the traffic signal lantern and no right turn sign are only backdropped by the sign briefly.

* The overhead lantern is backdropped by the advertising sign when travelling in the central and right-hand lanes

Given the static nature of the sign, the traffic signals would remain more prominent than the advertising sign. It is important to note that there are also other primary, secondary and tertiary

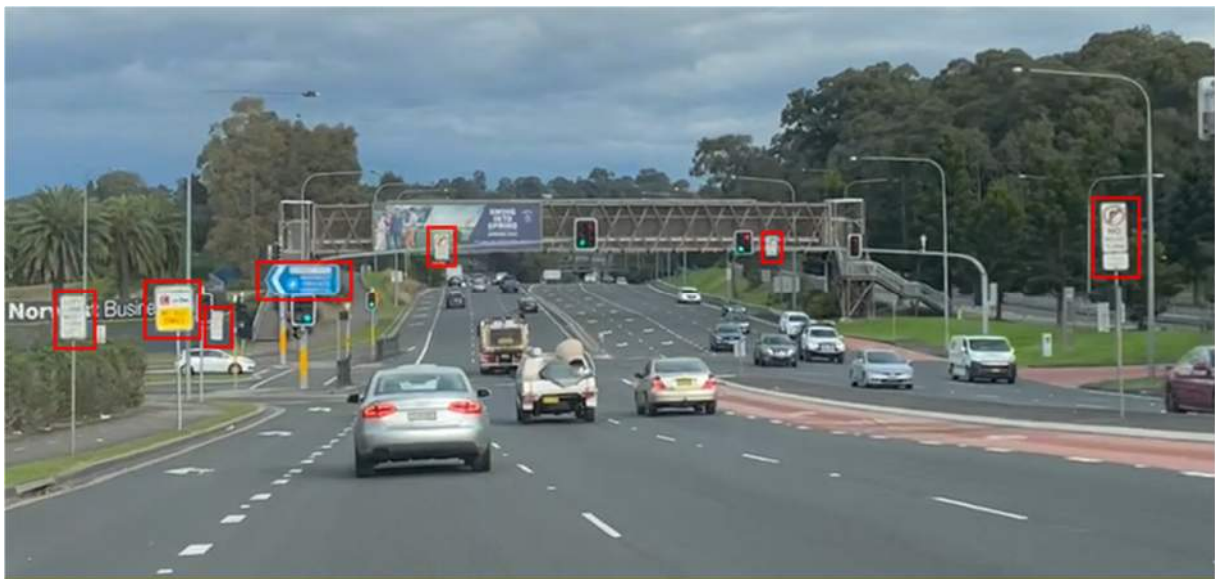
Figure 12: Existing road signs on approach to north facing advertising sign

It is noted that there are various signs on approach to both advertising signs along Old Windsor Road, as shown in Figure 12 and Figure 13. These include clearway signage, intersection direction signs, turning restrictions onto the Transitway and camera enforcement for unauthorised access to the Transitway. Although these are within the readable distance of the advertising signs, it is not expected that the advertising sign reduces the effectiveness of these signs.
