**Broadcrest Consulting Pty Ltd**

Geotechnical Investigation

December 2022

Project 2465-GEO

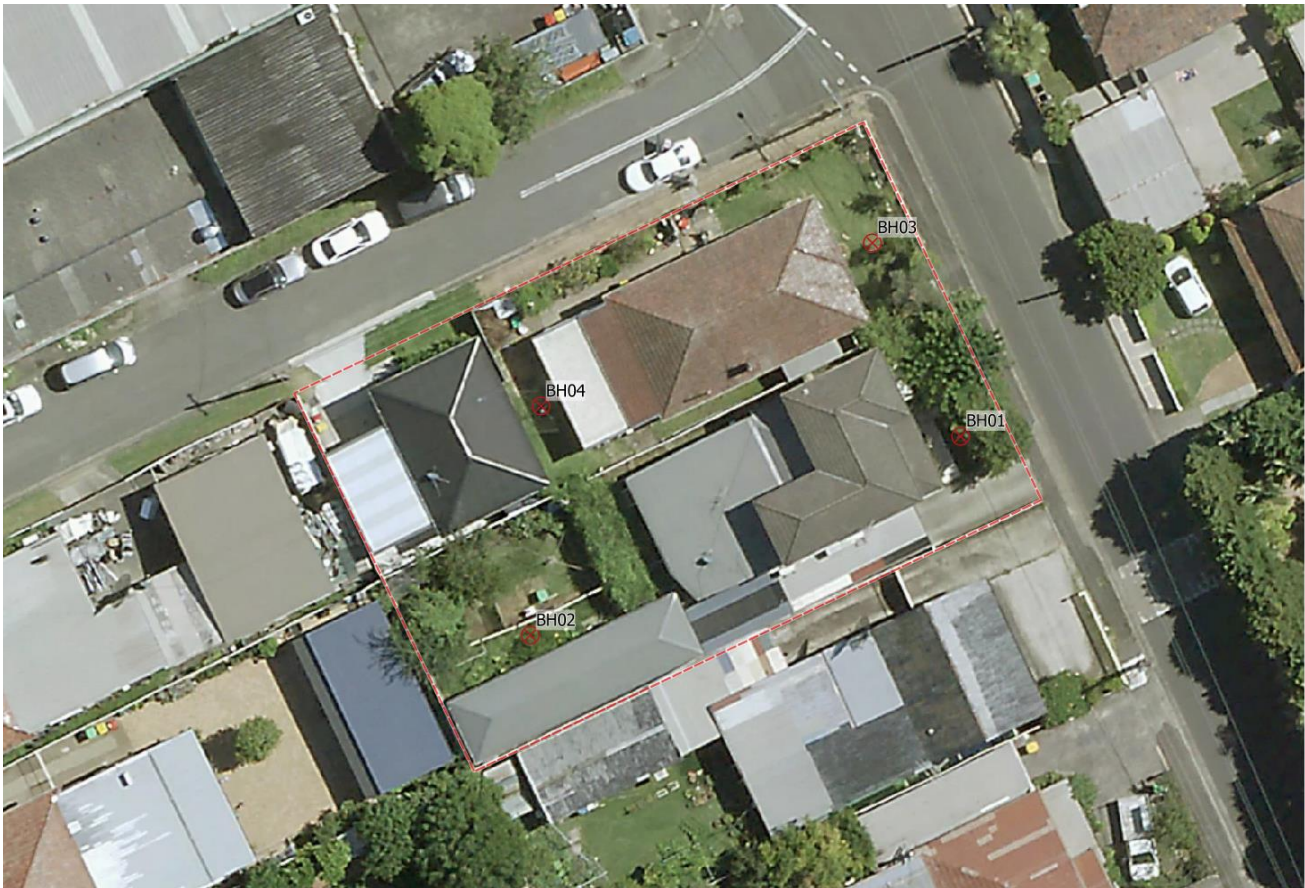
Figure 3.1: Site aerial photo with boreholes

The site is surrounded by residential dwellings on the southern and western boundaries, and road ways on the northern and eastern boundaries (see figure 3.1 and Appendix A).

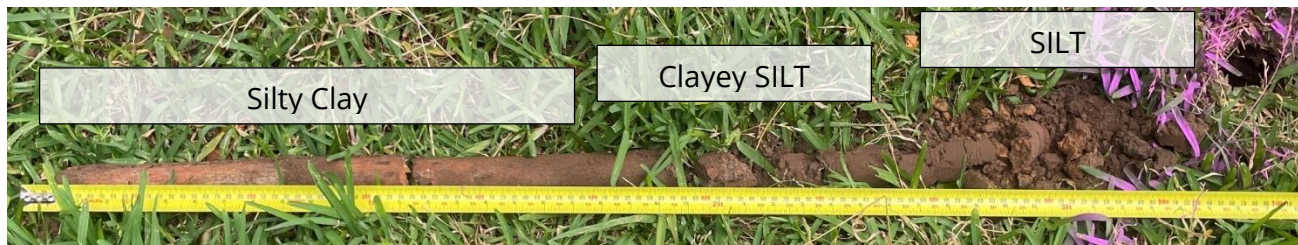
Figure 5.1: Borehole 1

- See bore logs for location specific subsurface conditions (variable)
- Proposed development to be founded within the Shale layer (estimated to be between 1.3 and 2.0m BEGL)

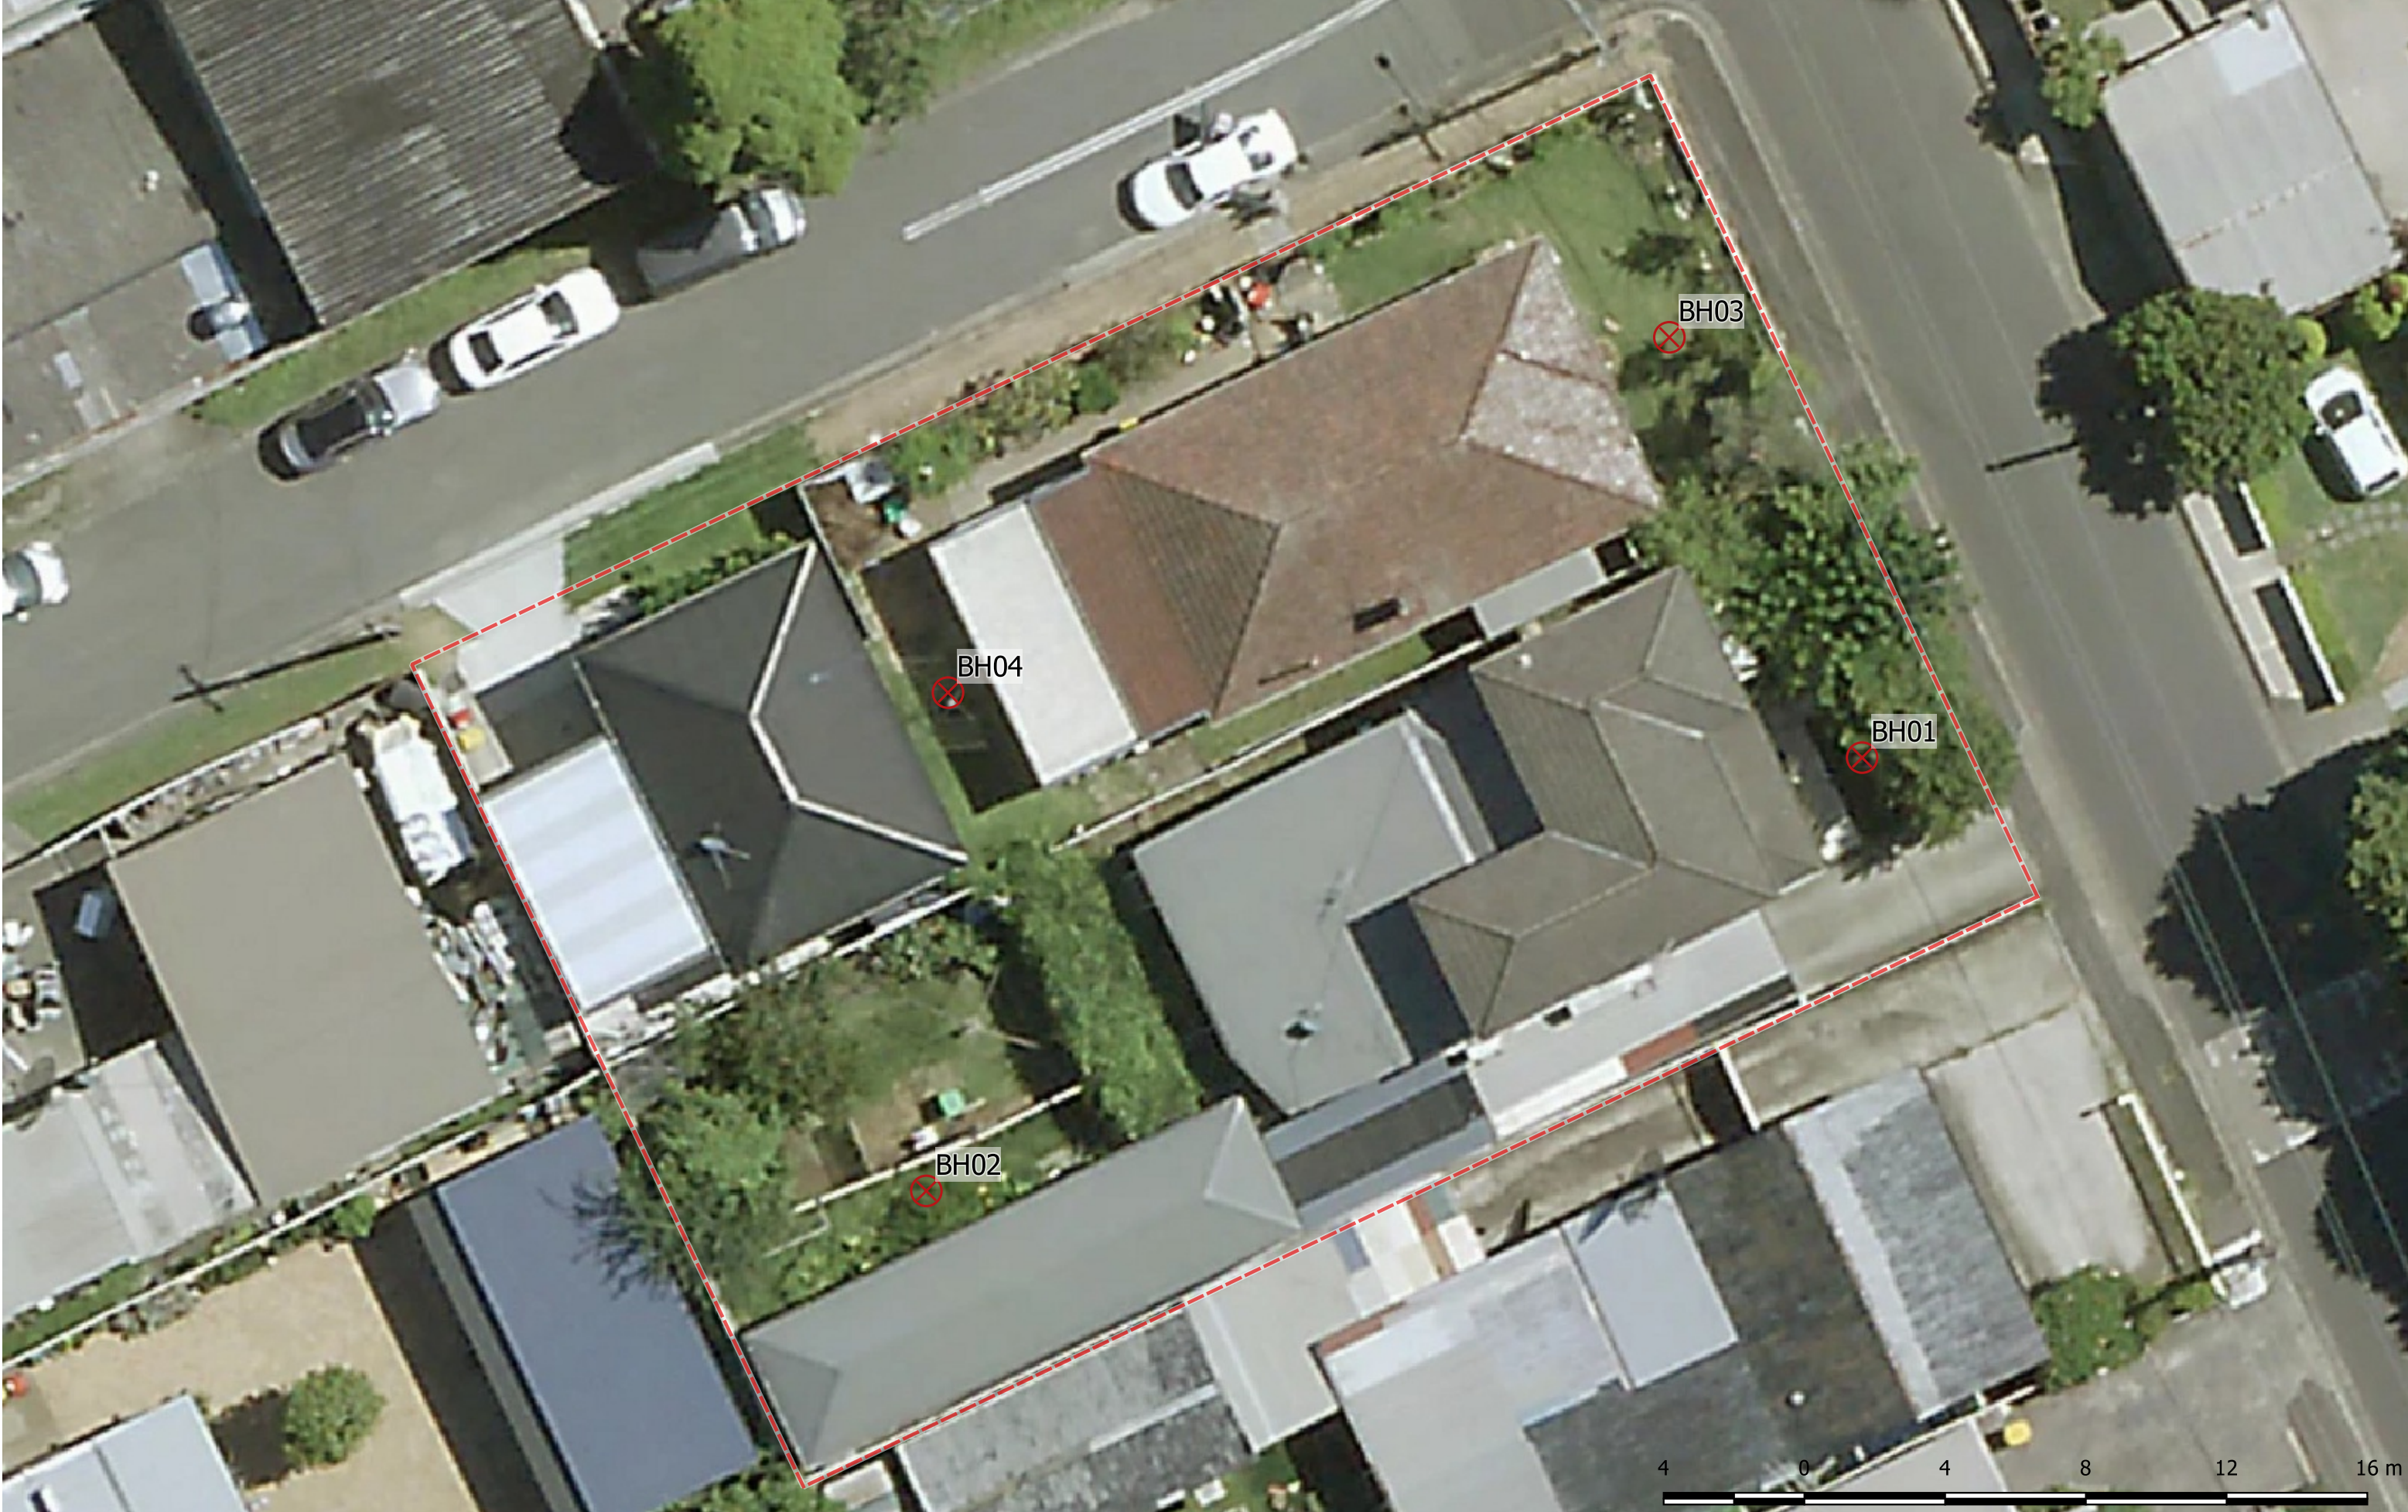
Appendix A: Bore log

Depth (m)	SPT B/100mm	Samples	Graphic Log	Moisture	Consistency	Material Description

M	L	<p>TOPSOIL: PT Dark brown, moist. High Organic content.</p> <p>Silty CLAY: Light Brown with Red Mottles, Low Plasticity</p>

M	F	TOPSOIL: PT Dark brown, moist. High Organic content.

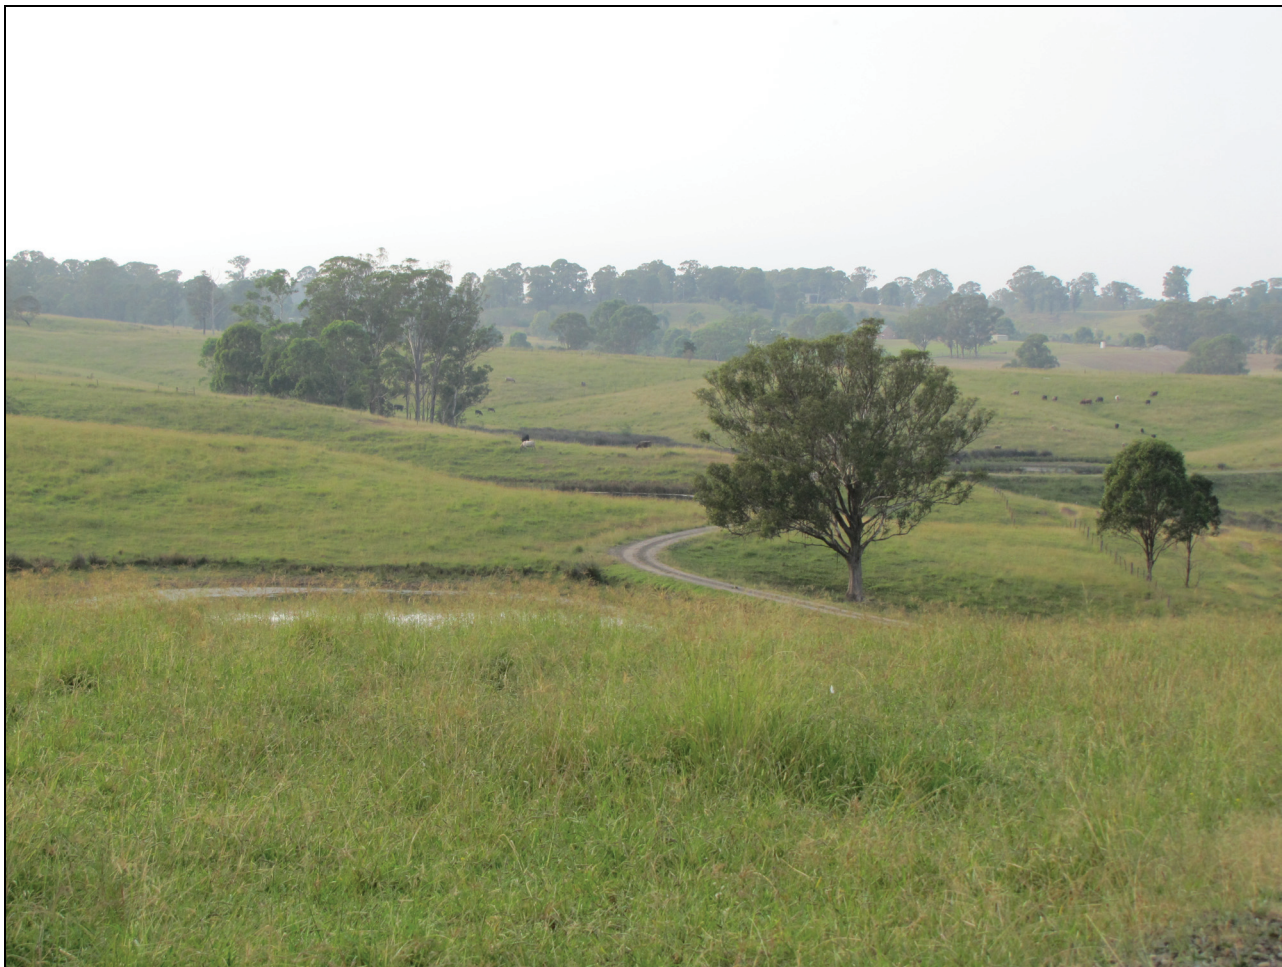
Landscape—gently undulating rises on Wianamatta Group shales. Local relief to 30 m, slopes usually >5%. Broad rounded crests and ridges with gently inclined slopes. Cleared Eucalypt woodland and tall open-forest (dry sclerophyll forest).

Soils—shallow to moderately deep (>100 cm) hardsetting mottled texture contrast soils, red and brown podzolic soils (Dr3.21, Dr3.31, Db2.11, Db2.21) on crests grading to yellow podzolic soils (Dy2.11, Dy3.11) on lower slopes and in drainage lines.

Limitations—localised seasonal waterlogging, localised water erosion hazard, moderately reactive highly plastic subsoil, localised surface movement potential.
