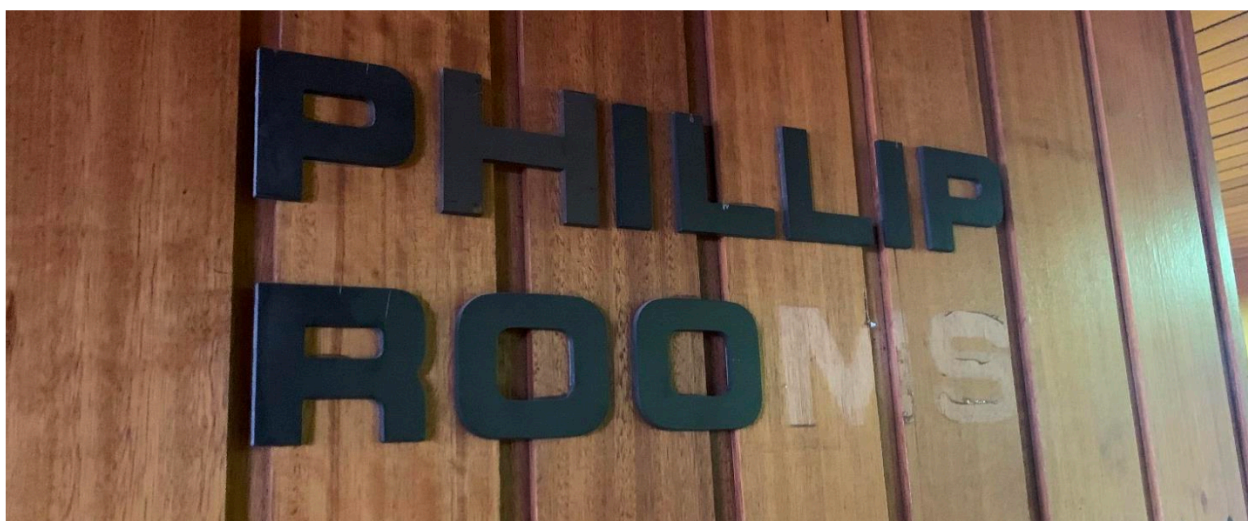
Figure 25 – Original 'Phillip Rooms' signage mounted to northern side of core.

Check the condition of the existing wall-mounted 'Phillip Rooms' signage at the northern wall of the core (located outside of the Phillip Room itself). If found to be in good condition, allow for careful removal and reinstatement in an appropriate, visible location (noting that the M & S letters will need to be reproduced).

If found to be in poor condition, or if removal is not feasible, allow to reproduce like-for-like (with regard to dimensions, typeface, and colour finish) and install in a publicly visible location.
