Report on  
Geotechnical Investigation

Proposed Mixed-Use Development  
469-483 Balmain Road, Lilyfield

Prepared for  
Roche Group Pty Ltd

Project 72046.03  
June 2023

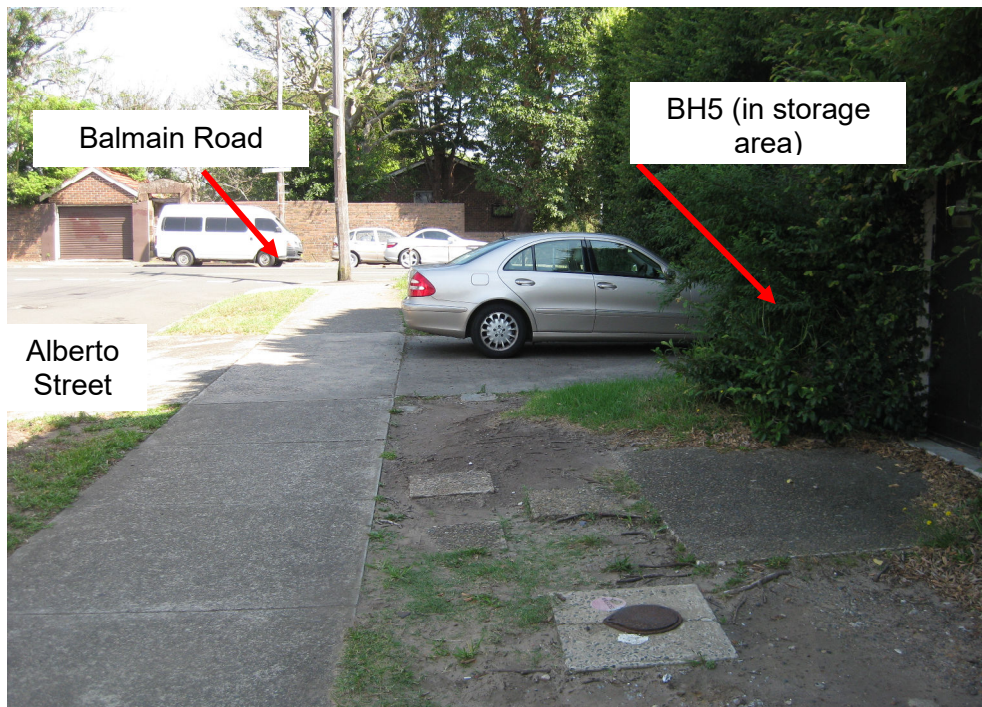
Photo 3 – View north-west towards Alberto Street and Balmain Road. The position of Borehole BH5 is indicated as shown.

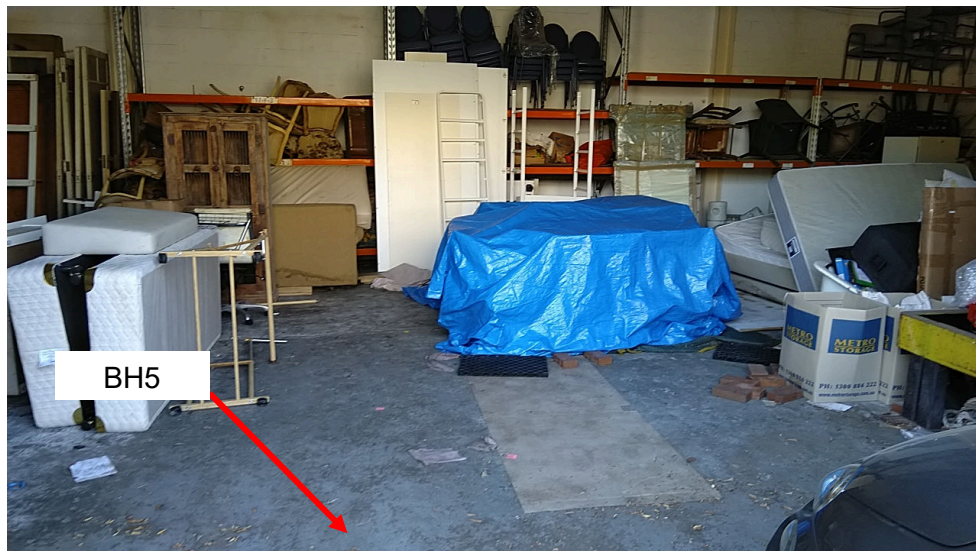
Photo 4 – View to north-east from an entrance from Alberto Street, within a storage area. The position of Borehole BH5 is indicated as shown.

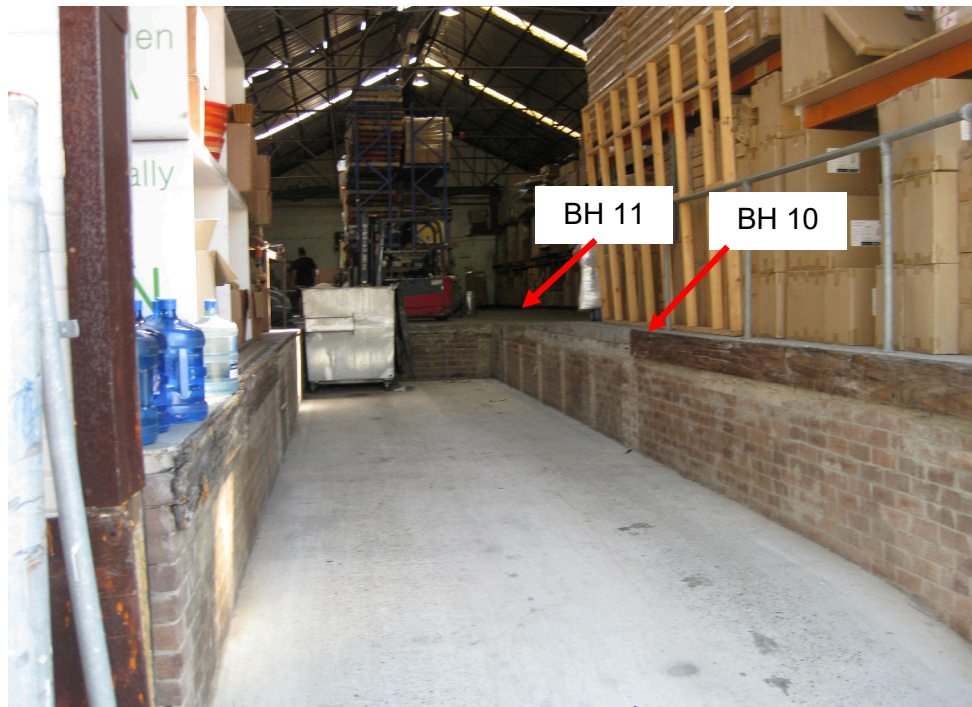
Photo 9 – View north-east into loading dock, with the approximate positions of Boreholes BH10 and BH11 indicated as shown.

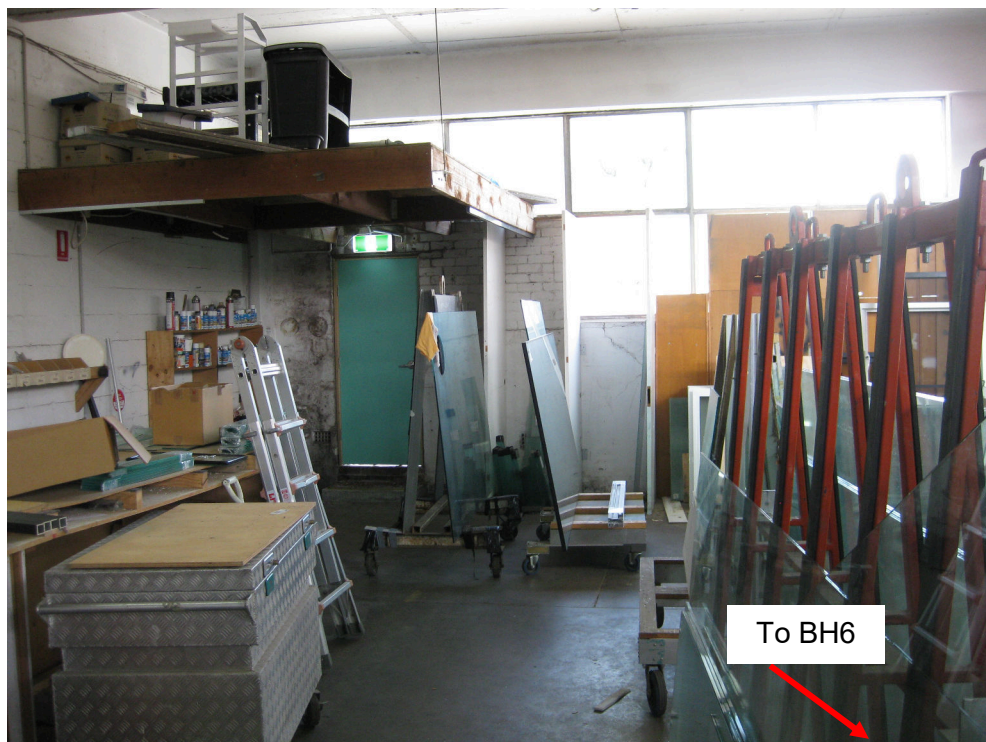
Photo 10 – View to north-west within a factory unit, indicative of the general area near borehole BH6, which is indicated as shown.

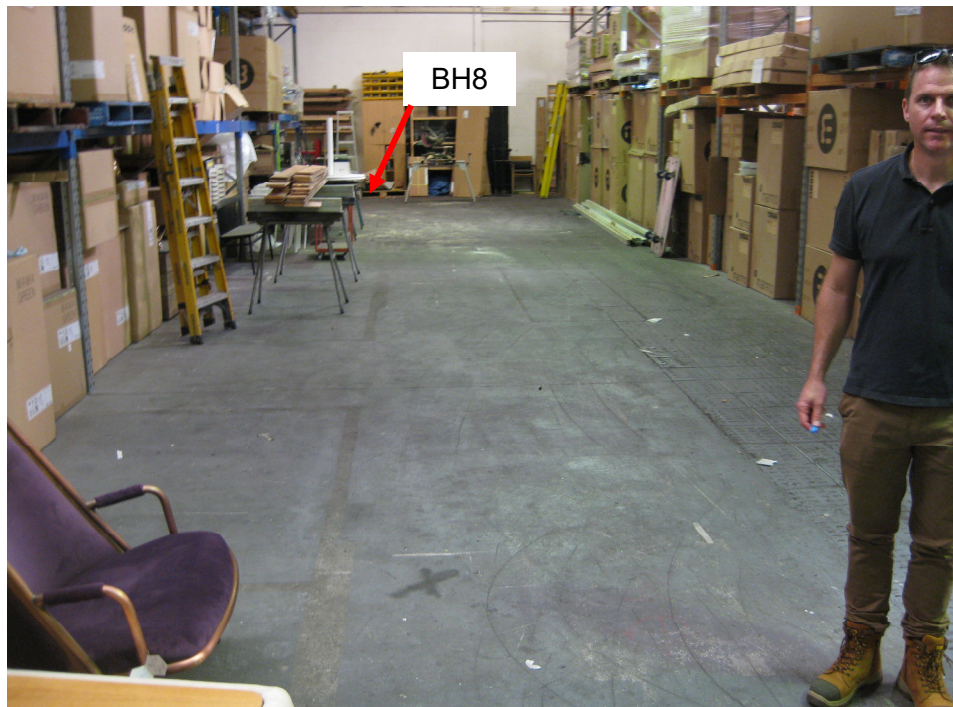
Photo 11 – View north-east along forklift passageway towards mini-workshop and the approximate position of Borehole BH8, which is indicated as shown.

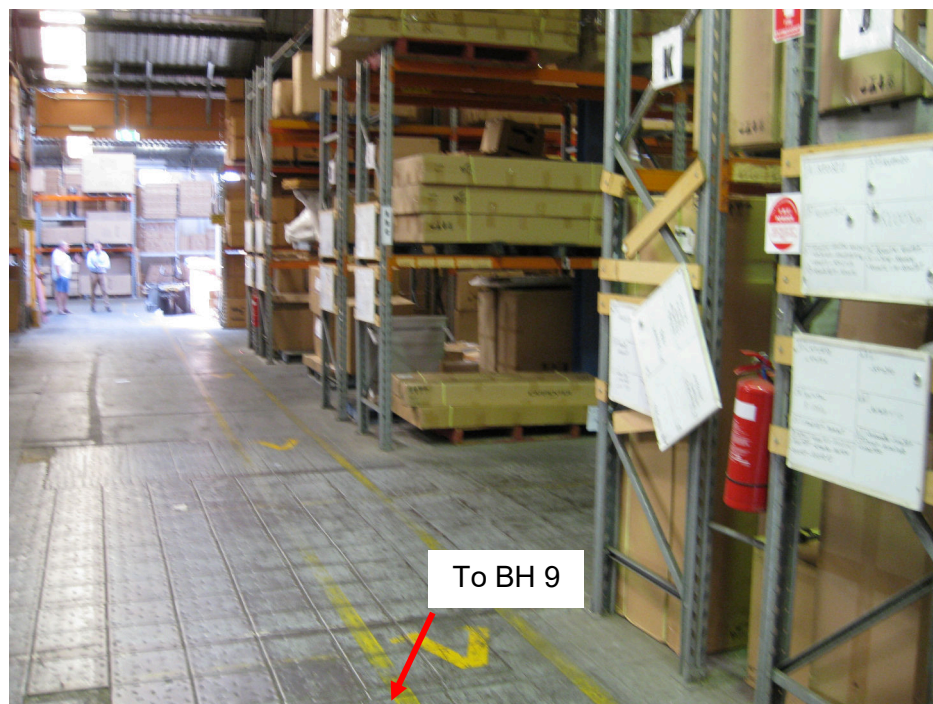
Photo 12 – View south-east along forklift passageway towards loading dock, with the approximate position of Borehole BH9 indicated as shown.

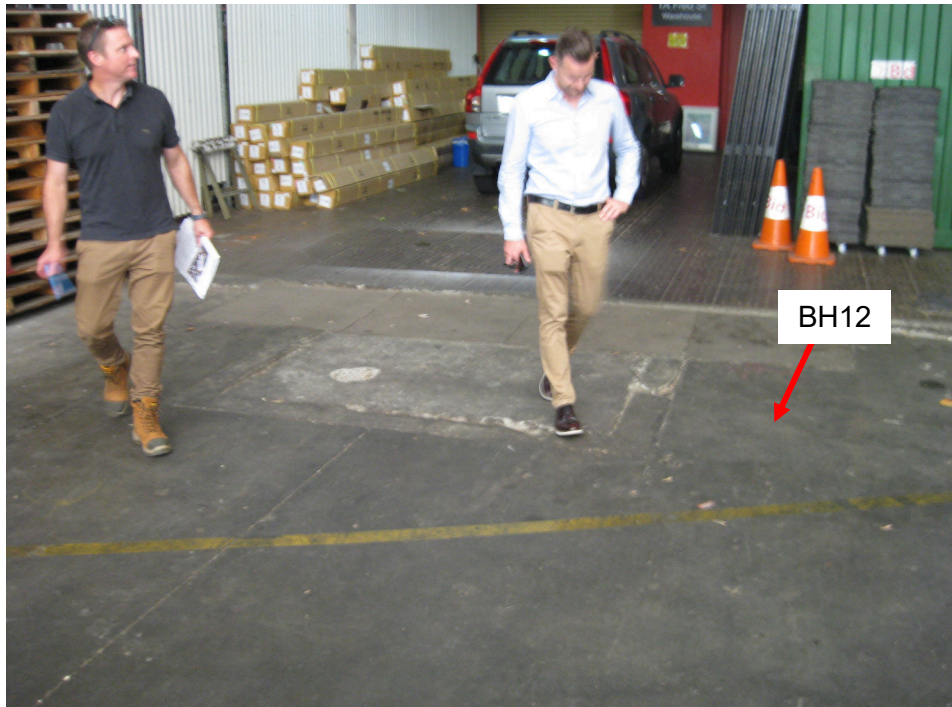
Photo 13 – View north-west within Fred Street loading dock, with the position of Borehole BH12 indicated as shown.

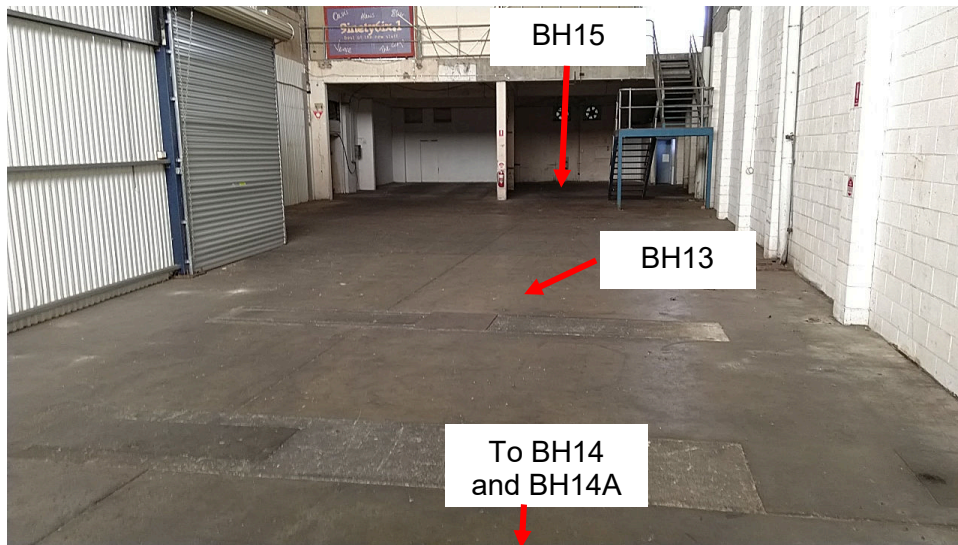
Photo 14 – View north-west within vacant warehouse towards a two-level section of the building, with the approximate positions of Boreholes BH13 and BH15 indicated as shown.

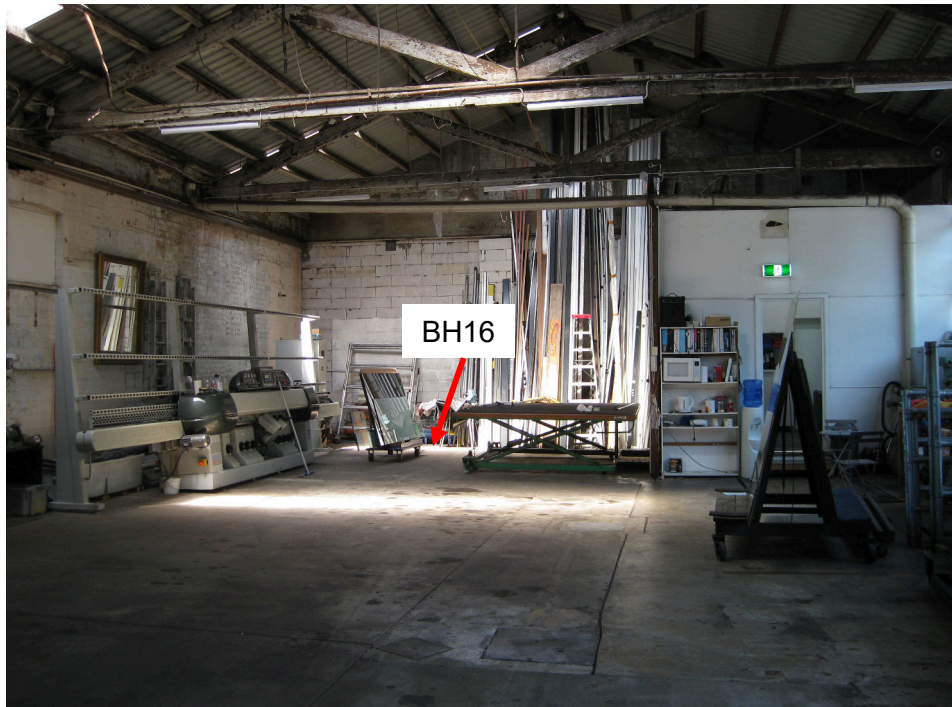
Photo 15 – View south-west within factory unit and the approximate position of Borehole BH16, which is indicated as shown.

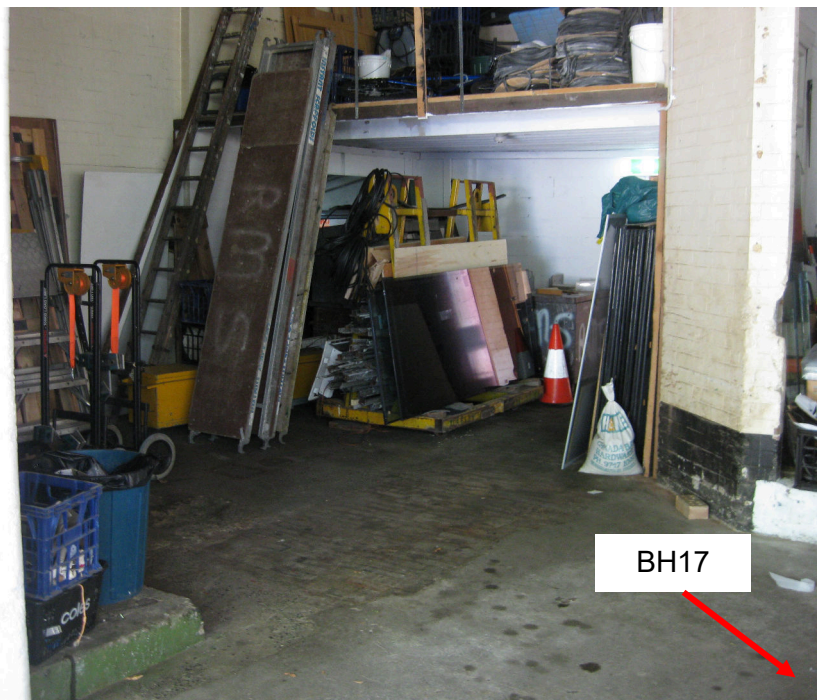
Photo 16 – View south-east within factory unit, with the approximate position of Borehole BH17 indicated as shown.

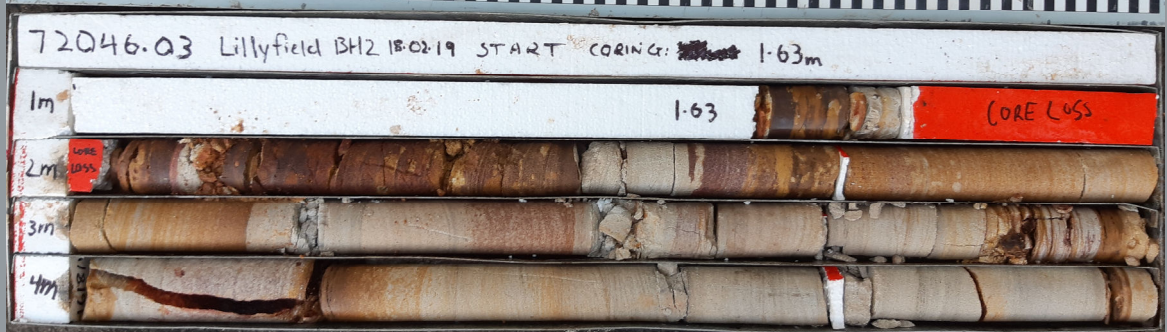
1.63m - 5.0m

Test ID: BH2  
Depth: 1.63 - 5.0  
Core Box No.: 1/2  
Date: 19.2.19

Chalk marks denote handling or drilling breaks

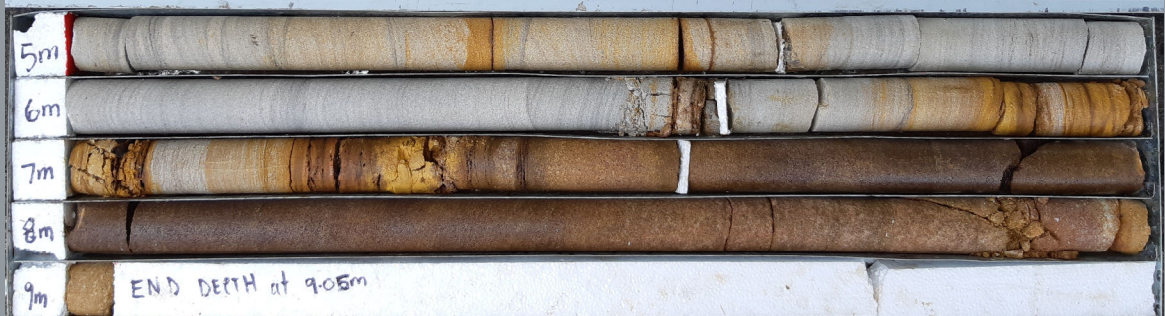
5.0m - 9.05m

Test ID: BH2  
Depth: 5 - 9.05m  
Core Box No.: Box 2/2  
Date: 19.2.19

Chalk marks denote handling or drilling breaks

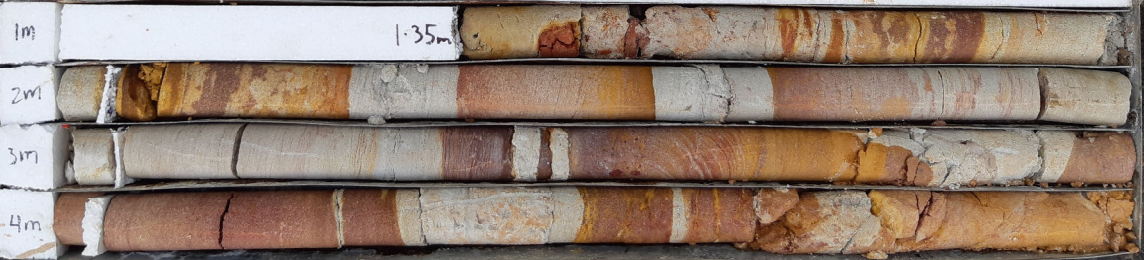
1.35m – 5.0m

X Chalk marks denote handling or drilling breaks

72046.03 Lilyfield Starting 1.35m  
BH3

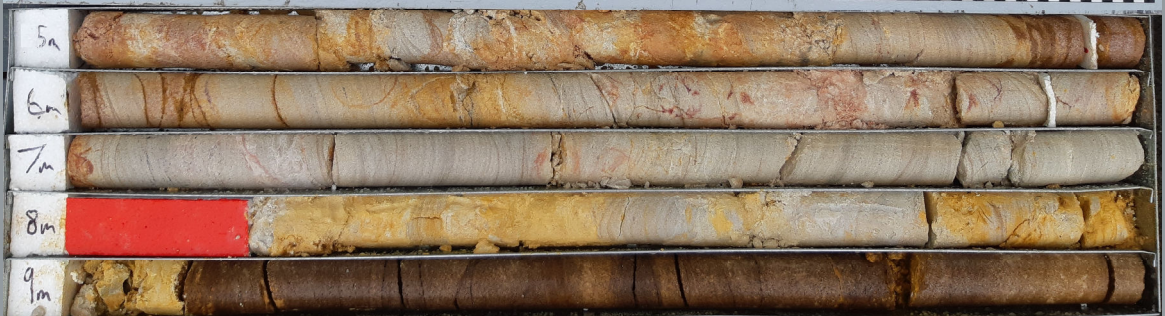
5.0m – 10.0m

X Chalk marks denote handling or drilling breaks

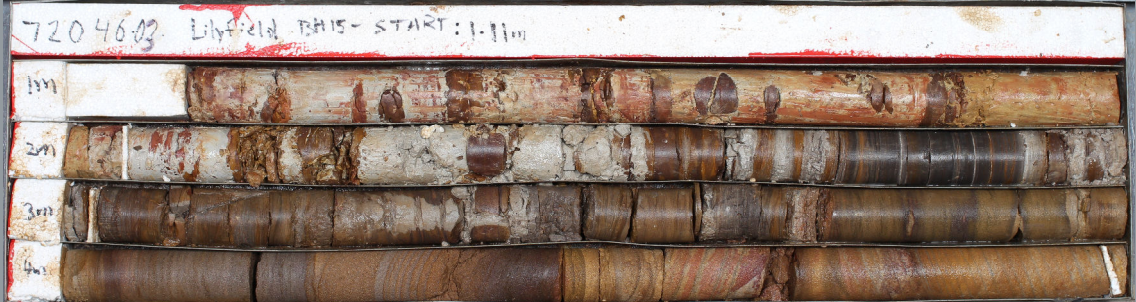
1.11m – 5.0m

Project No: 72046-03  
BH ID: BM15  
Depth: 1.11-5m  
Core Box No.: BOX 1/2

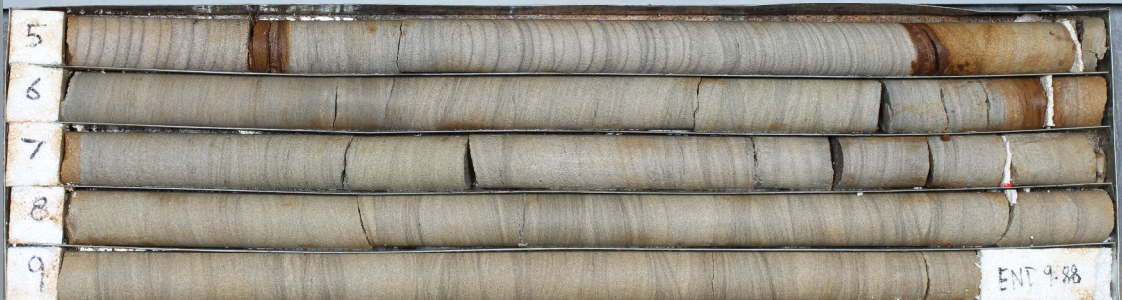
5.0m – 9.88m

Project No: 72046-03  
BH ID: BM15  
Depth: 5-9.88m  
Core Box No.: BOX 2/2
