Concord High School

Statement of Heritage Impact

Prepared for School Infrastructure NSW

June 2023 – Final Update

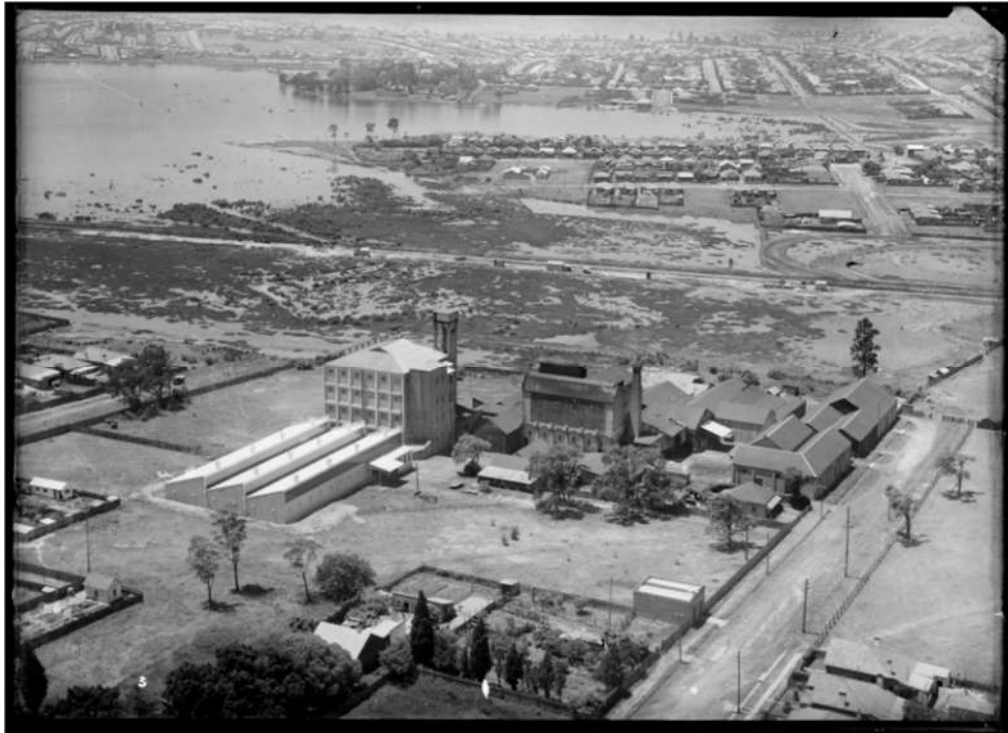
Figure 10. 1938 aerial photograph of the Farleigh Nettheim & Co. tannery. *Source:* Mitchell Library, State Library of New South Wales. File number FL8810356, Call number ON 447/Box 130.

(Dodds n.d.). By 1938 the tannery consisted of an extensive complex of gable and sawtooth roof masonry warehouses, timber sheds, and a five-storey masonry structure with a water tower extending from a Dutch gable roof (refer Figure 10 through to Figure 12). Between 1930 and 1938 an additional sawtooth building was added to the site.

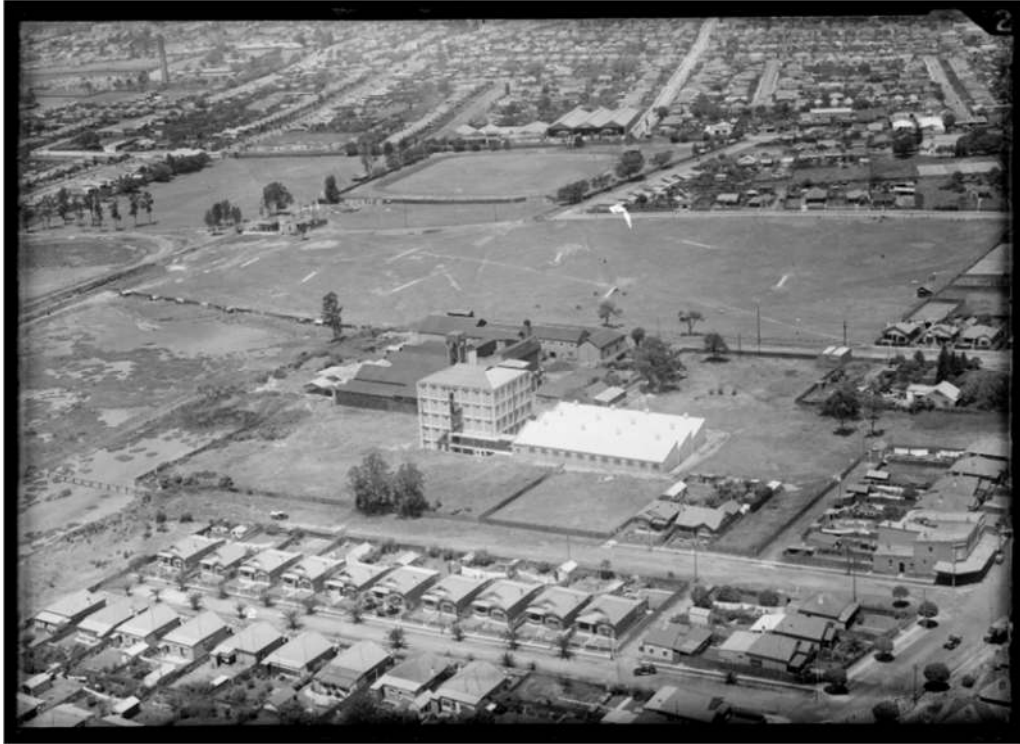
Figure 11. 1938 aerial photograph of the Farleigh Nettheim & Co. tannery *Source:* Mitchell Library, State Library of New South Wales. File number FL8810358, Call number ON 447/Box 130.

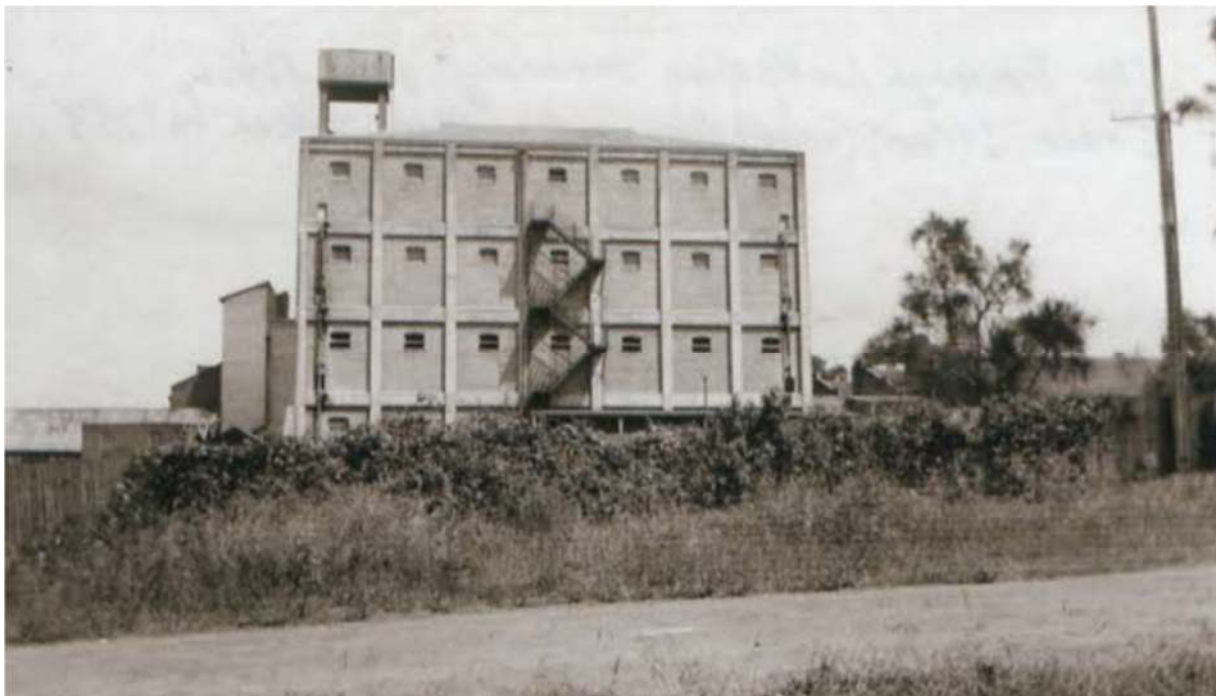
Figure 12. Photograph of the five-storey structure with water tank, undated. *Source:* Peter Bryant in Canada Bay Heritage Society.

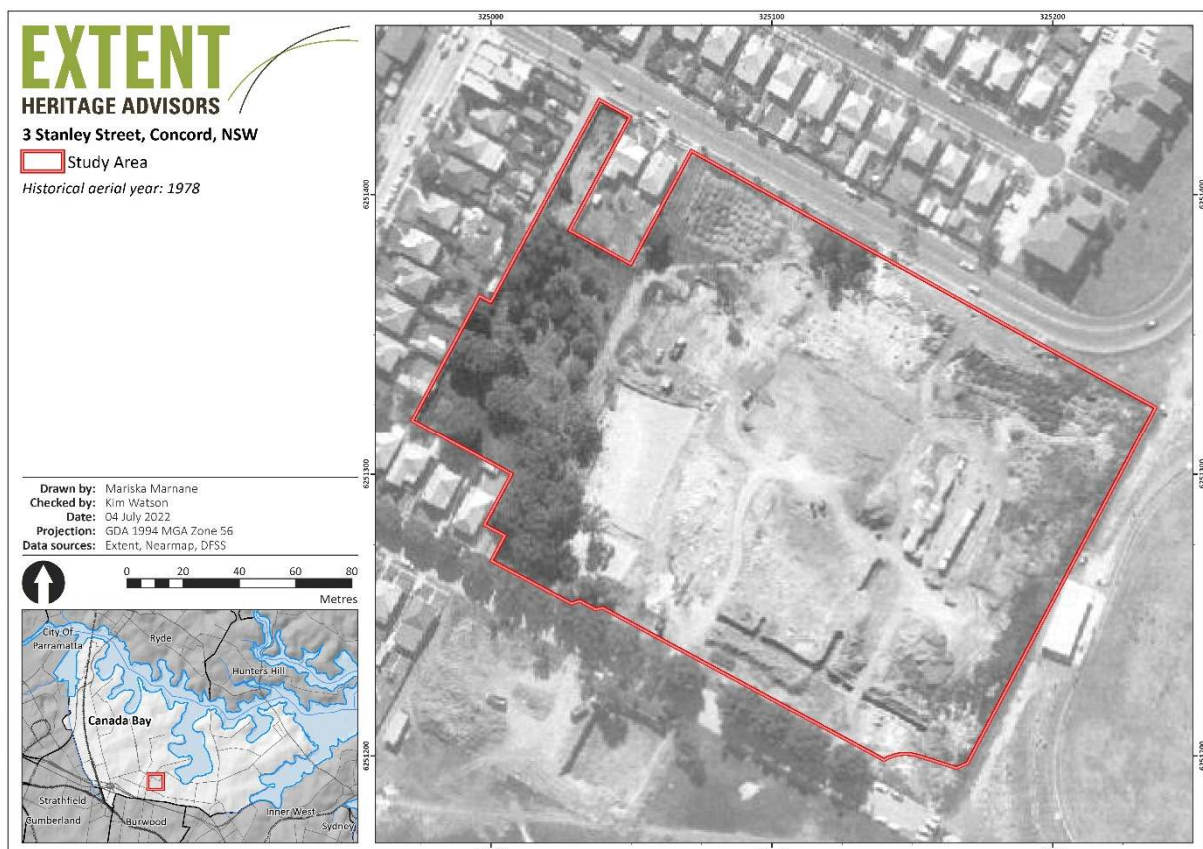
Figure 15. Historical aerial of the study area showing the beginning of the school construction, 1978.
Source: NSW Historical Imagery.

Tenders for the construction of the school was called in October 1977 and won by C.H. Webb Brothers Pty Ltd (Concord High School n.d.). The study area remained cleared until the commencement of construction in between 1978 and 1979 (refer to Figure 15) (Concord High School n.d.).

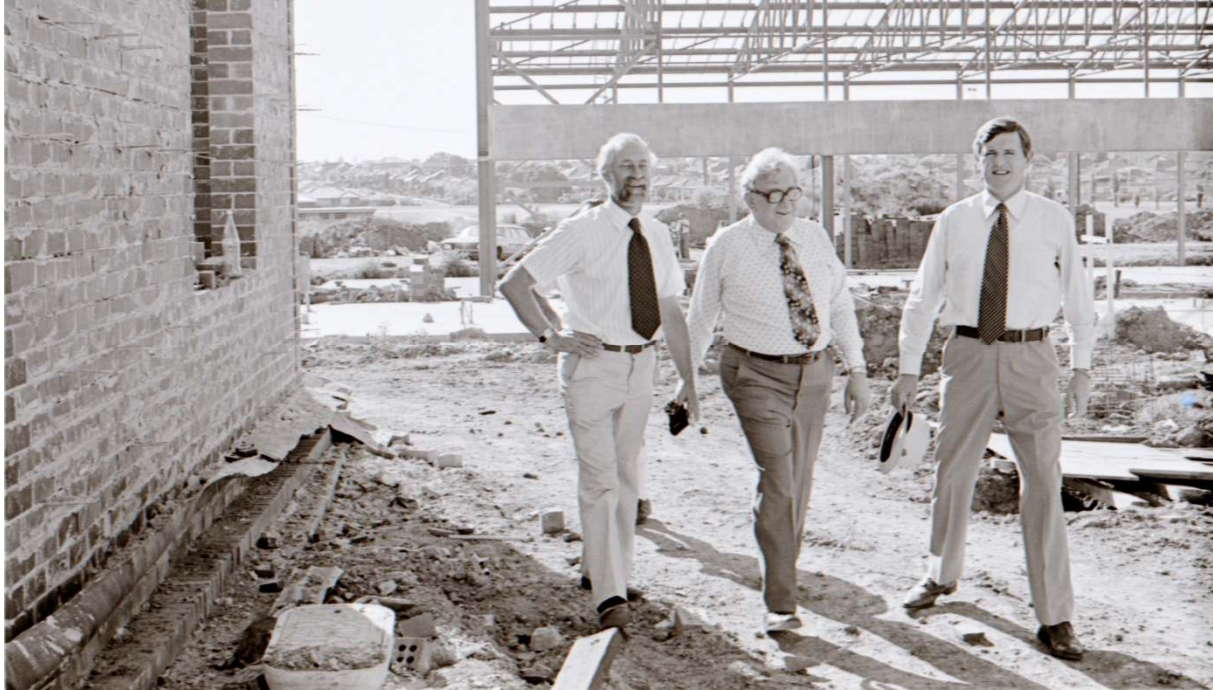
Figure 16. Photograph of the construction of the school campus, 1979. *Source:* State Library of New South Wales, File number: FL2734187, Call number: Government Printing Office 3 – 51274, IE number: IE2734174.

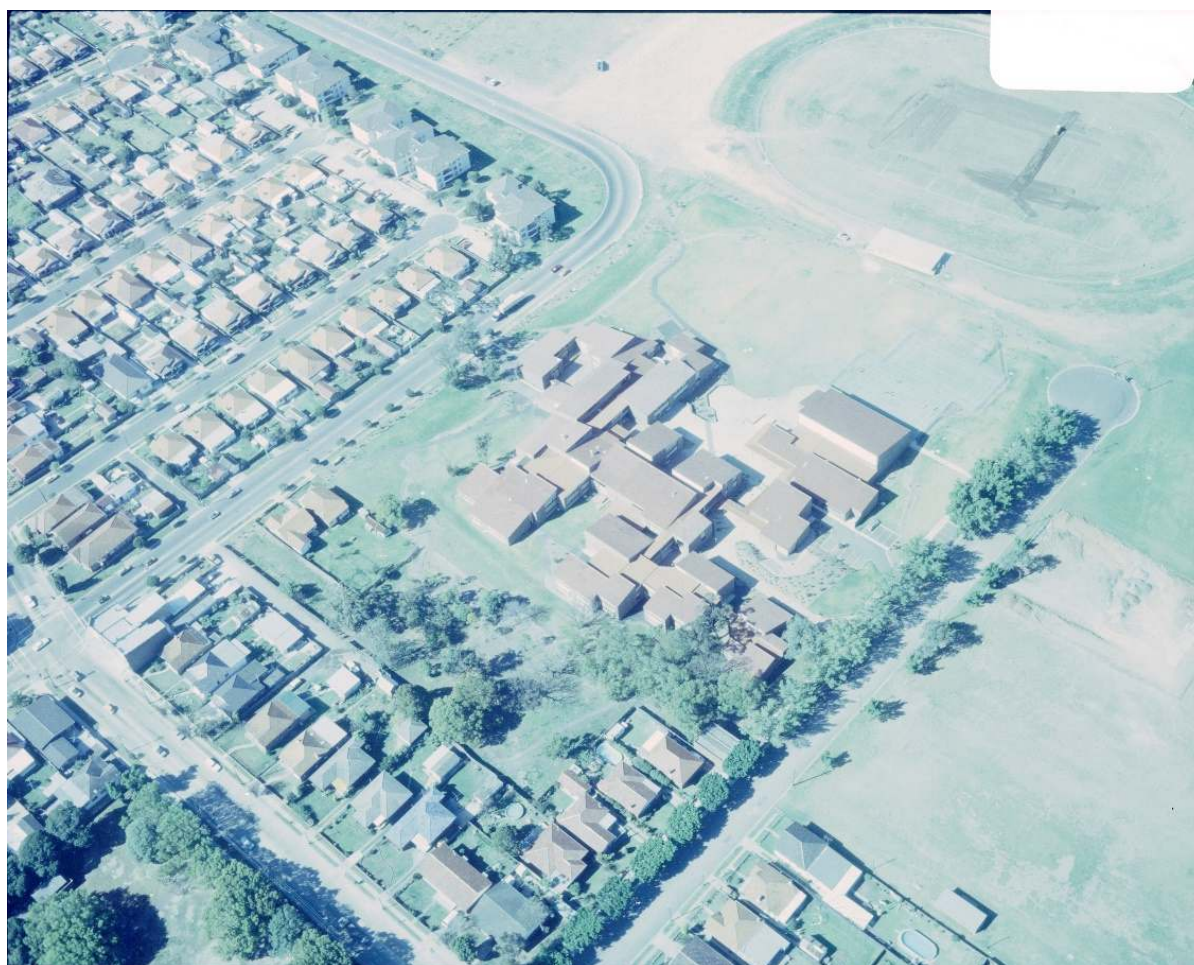
Figure 19. Aerial photograph of the study area showing the completed Concord High School campus, 1981. *Source:* State Library of New South Wales, File number: FL2618176, Call number: Government Printing Office 3 – 36794, IE number: IE2618167.

The Concord High School campus consisted of a closely spaced complex of interconnected single and double storey masonry structures presenting a distinct form featuring mono-pitched roofs surrounding internal open courtyards. A larger paved central courtyard overlooks the sports fields and courts occupying the east extent of the study area (refer to Figure 19 to Figure 24).

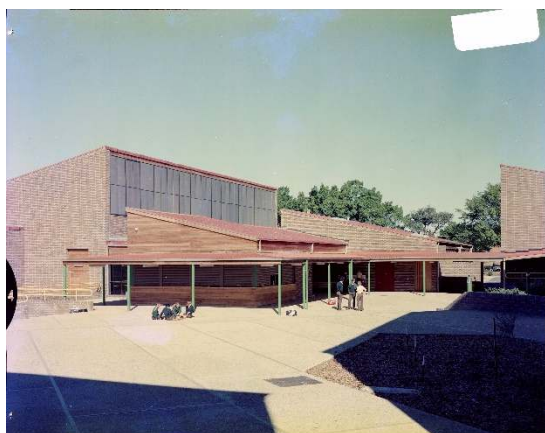
Figure 23. Photograph of the central courtyard at Concord High School, c.1980. *Source:* State Library of New South Wales, File number: FL2659676, Call number: Government Printing Office 3 – 36908, IE number: IE2659669.

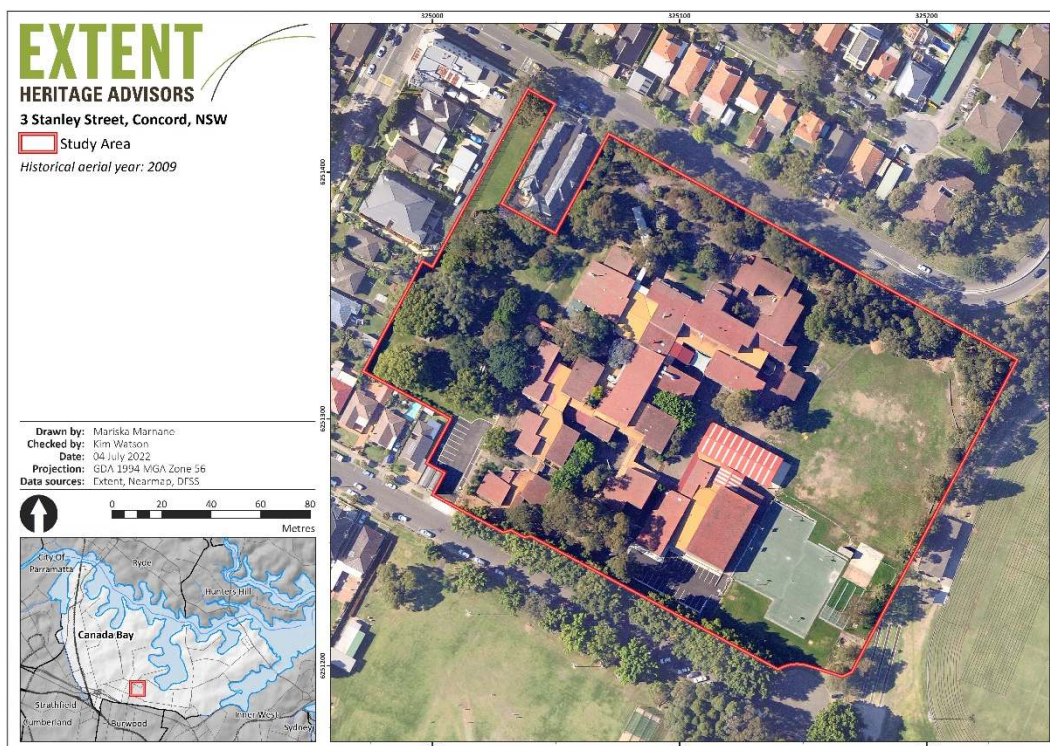
Figure 25. Historical aerial of study area showing the school campus prior to major addition. The single addition is visible at the former courtyard adjacent to the sports field and courts, 2009. *Source: Nearmap*

The campus at Concord High School remained relatively unchanged until c.2010 with only one minor structural addition to the former central courtyard structure constructed between 2005 and 2009 (refer to Figure 25). By 2016, school enrolment surpassed 1000 students (Concord High School 2016). This further increased to over 1250 students by 2018 (Concord High School 2018). This saw the introduction of demountable classroom structures located along the northern side of the campus fronting Crane Street between 2016 and 2018 (refer to Figure 26).

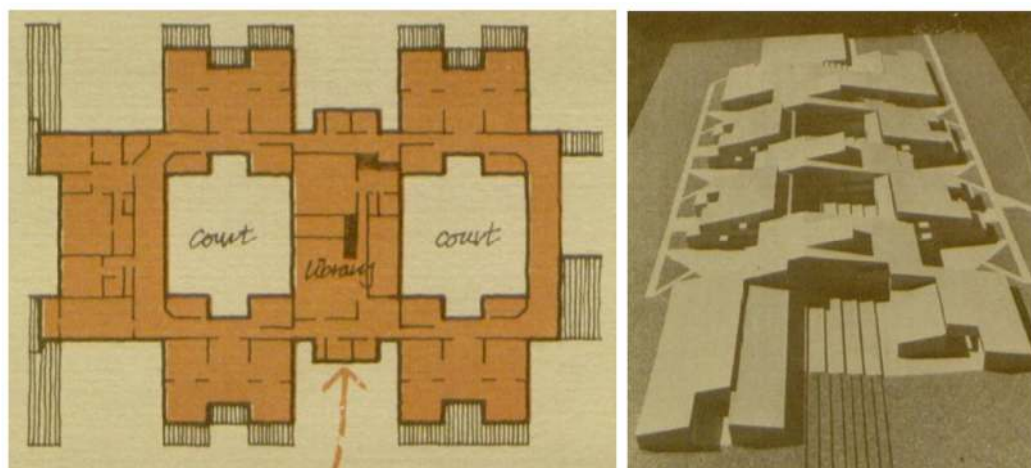
Figure 31. Diagrammatic plan and model of Kelso High School, representative of the school design influenced by the 1975 Secondary School Brief, 1976. *Source:* Tanner Denton Kibble 2018, 138.

Further change was implemented to the Study 3 scheme with the introduction of the 1975 Secondary School Brief which developed on the notion of subject base spaces and flexibility in school planning. Secondary schools were considered as ‘complete entities’ with school facilities that were ‘shared for all’. The usage of school facilities came into focus as shared spaces. A ‘core’ consisting of the library and administration spaces was aligned with a close and priority relationship with ‘flexible learning units’. The flexible learning units were then surrounded by specialised areas housing the Arts, Music, Home Science and Industrial Arts spaces. The arrangement was then complemented with a large multi-purpose centre. Under the 1975 Secondary School Brief, flexible learning units consisting of four learning spaces that could take groups of up to 120 students, attached to a common area, resources unit, outdoor courts and a staff study were developed (Tanner Denton Kibble Architects 136-137).

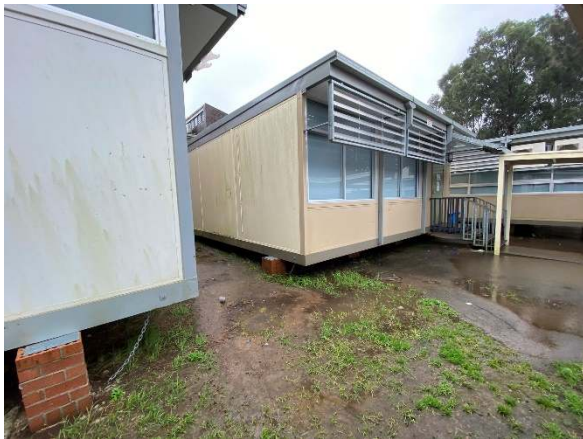
The collection of demountable buildings, located to the north and northeast of the study area, date to c.2016. They are simple, prefabricated metal structures built atop brick piers. They are accessed via an external metal stairway and are connected by concrete paths.

Figure 46. View to demountable buildings located in the northeast of the study area.

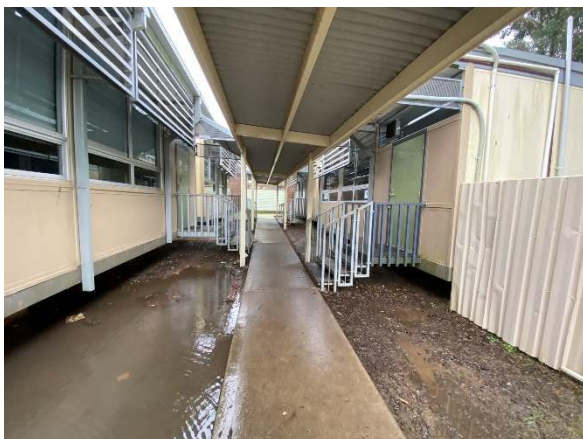
Figure 48. Overview of demountable buildings connected by sheltered concrete foot path.

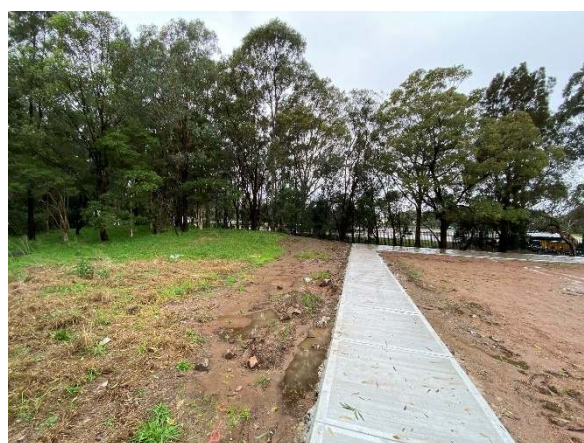
Figure 61. Plantings located in the northeast corner of the study area, fronting Crane Street.

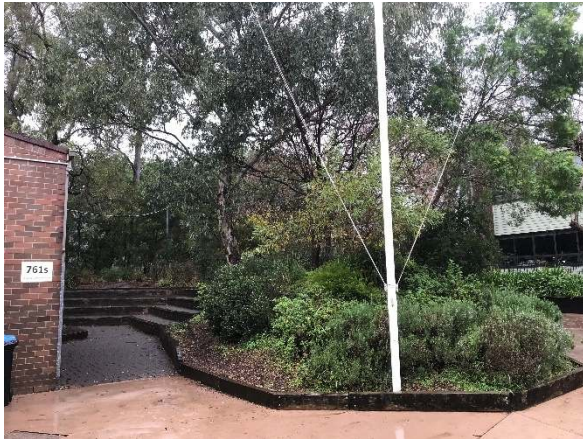
Figure 62. Landscaped mound framing entrance and Block F.

There are several planned gardens located throughout the school campus, framing buildings, pathways, courtyards, and carparks. The plantings contained within the garden beds feature a mix of exotic and native plants with timber edging. Of particular note is the landscape surrounding Block F including a small amphitheatre surrounding an open stage. The amphitheatre comprises four stepped platforms constructed of brick pavers and timber edging.

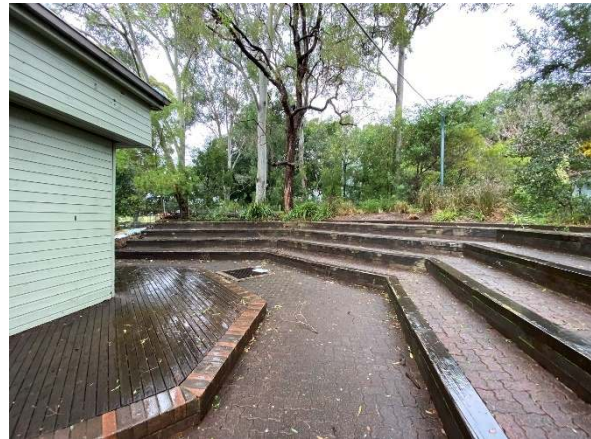
Figure 63. Detail of landscaped amphitheatre fronting Block F.

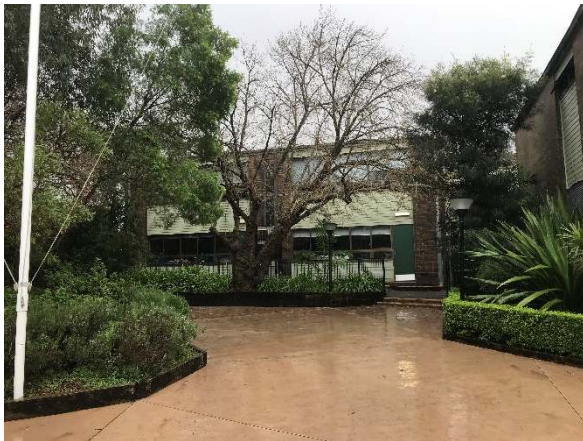
Figure 64. Overview of gardens framing Block B and Block A.

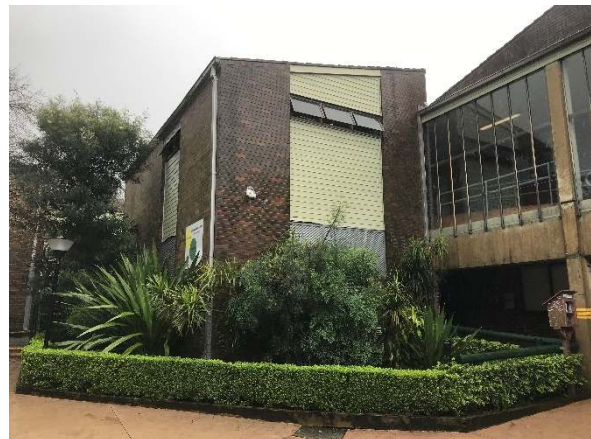
Figure 65. View to gardens adjoining Block A.

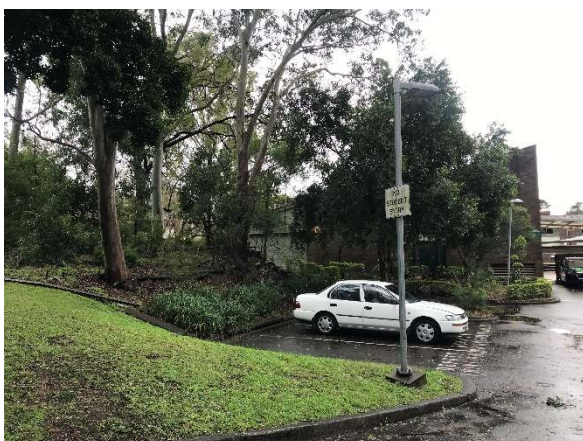
Figure 66. View to landscaped mound and garden framing the southeast carpark.

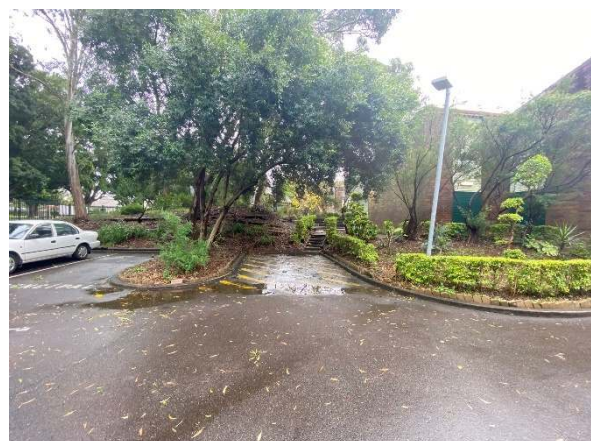
Figure 67. Overview of landscape garden framing the southeast carpark.

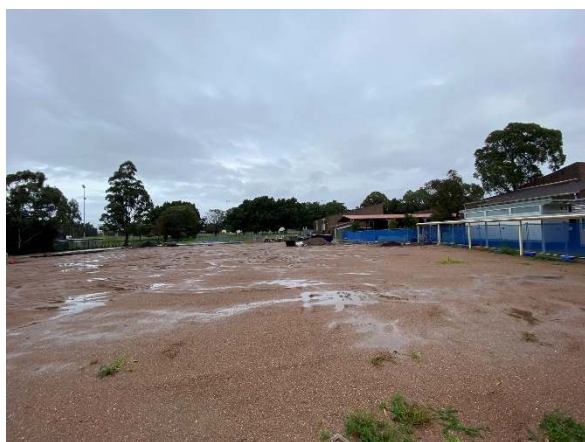
Figure 68. Turfed sporting field under construction.

Contemporary landscape features within the study area include a newly landscaped concrete plaza with associated seating and a new sporting field, under construction. The new plaza includes seating for spectators atop landscaped concrete platforms. The seating will front the turfed sporting field, at present under construction. Elements constructed to date include concrete slab paths and contemporary plantings on the eastern boundary.

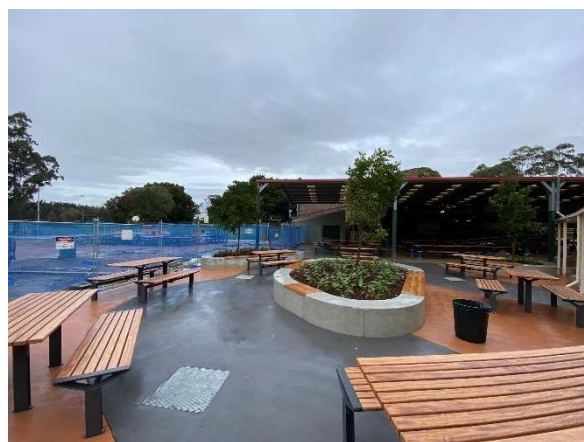
Figure 69. Overview of new plaza fronting the sporting fields.

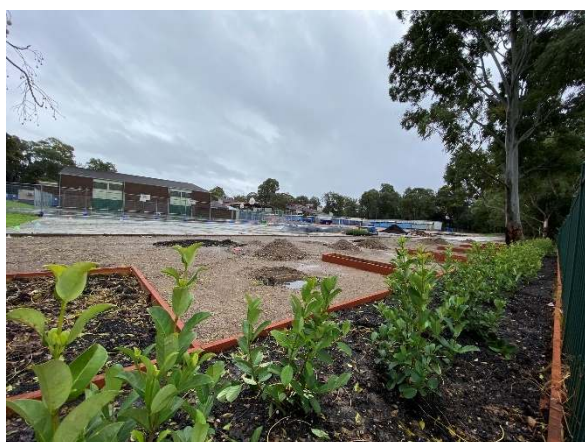
Figure 70. View of contemporary plantings along the eastern boundary of the study area.

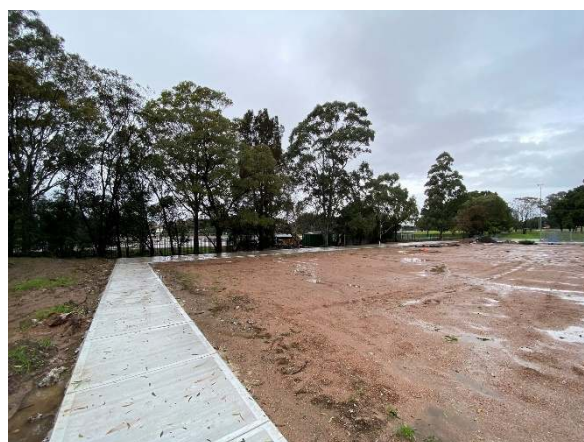
Figure 71. View to concrete slabs framing the turfed area.

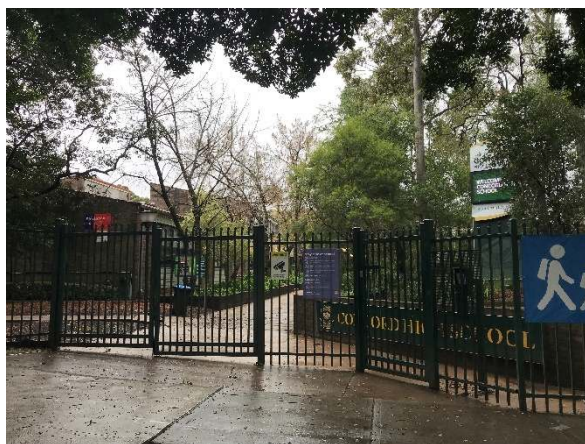
Figure 72. View through tall palisade fence and gardens.

along Stanley and Crane Streets. The mature *Ficus microcarpa*'s along Stanley Street are particularly notable landscape features that obscure views from the public domain. Views are further shielded by the tall palisade fence surrounding the study area.

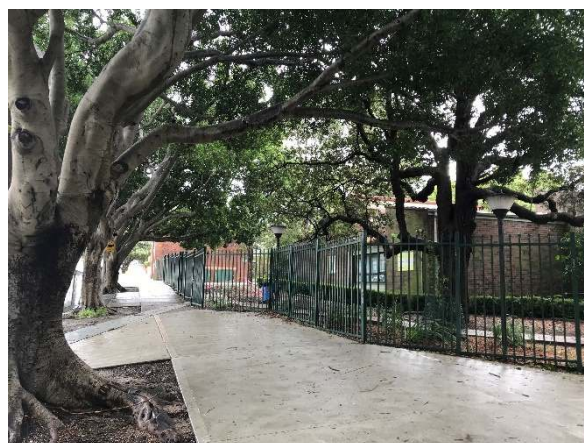
Figure 73. View west along Stanley Street showing mature *Ficus microcarpa*'s obscuring views to the study area from the public domain.

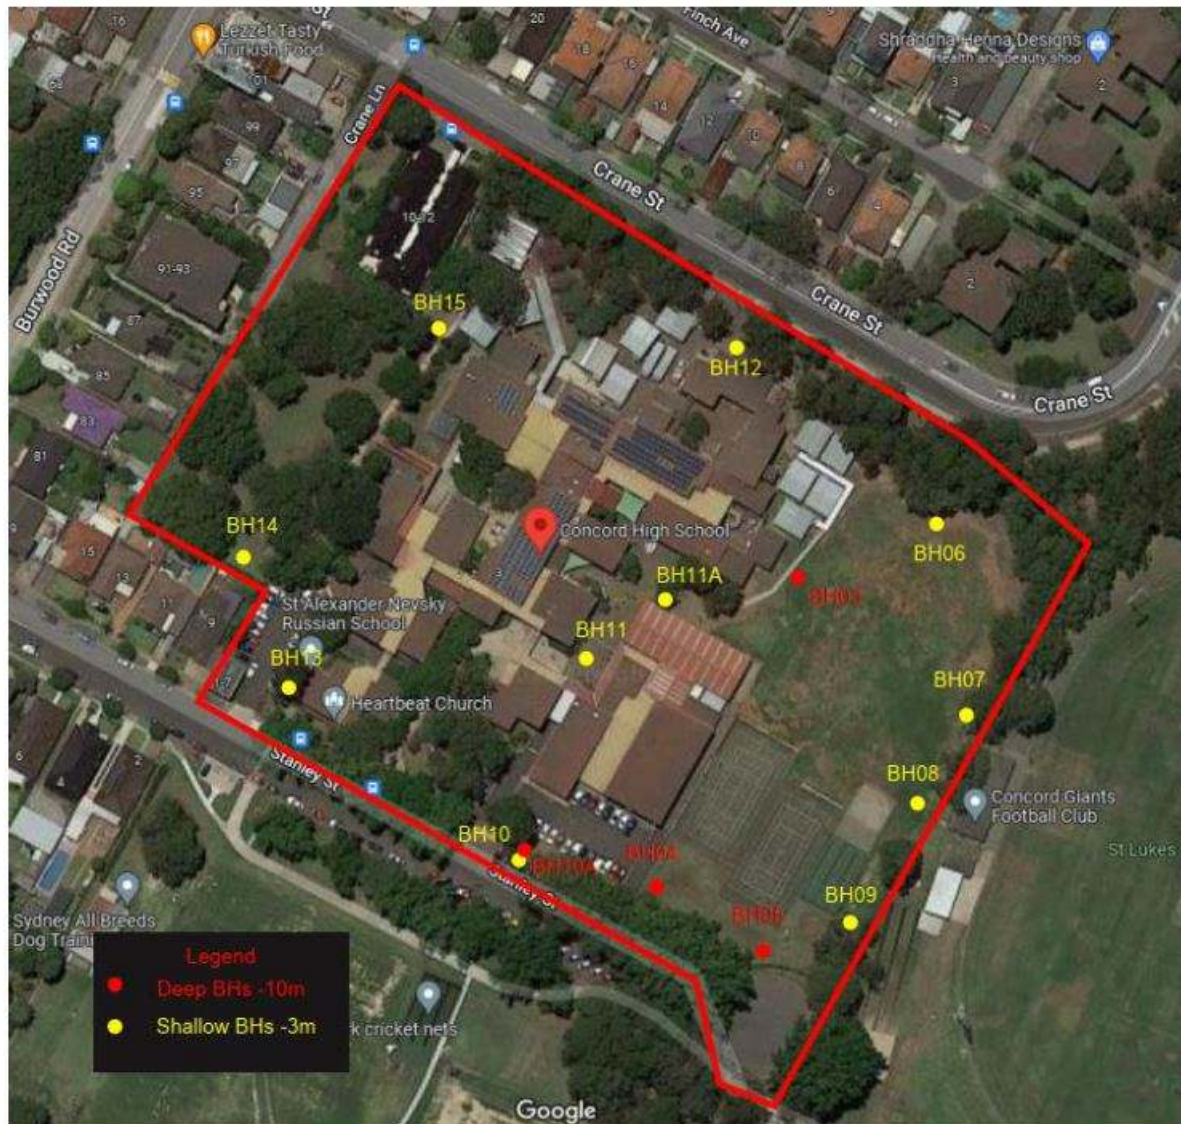
Figure 74. Site investigation plan with borehole locations. *Source:* CMW Geosciences.

The August 2022 report summarised the subsurface conditions encountered during the borehole testing. Generally fills and residual soils consisting of sandy clay, crushed rock, gravelly sand and sandy clay soils were encountered between ground surface and depths of 3m. Beneath these fills and residual soils, sandstone bedrock was observed at a depth of 4.5m to 7.5m. BH11 and BH11A both refused at 250mm, with CMW Geosciences suggesting the possible presence of concrete slabs or obstructions at this location.

Of importance to this impact assessment, the geotechnical report stated that any fill encountered on the site is considered uncontrolled and recommended that any fill encountered on site to a depth of between 0.1m and 4.5m should be removed. On the eastern side of the study area, fills were observed between ground level and a maximum of 4.5m depth in the south-east corner of the study area and 2.7m in the north-east corner. On the western side of the study area fills were observed between 0.1m and 1.5m below ground level.

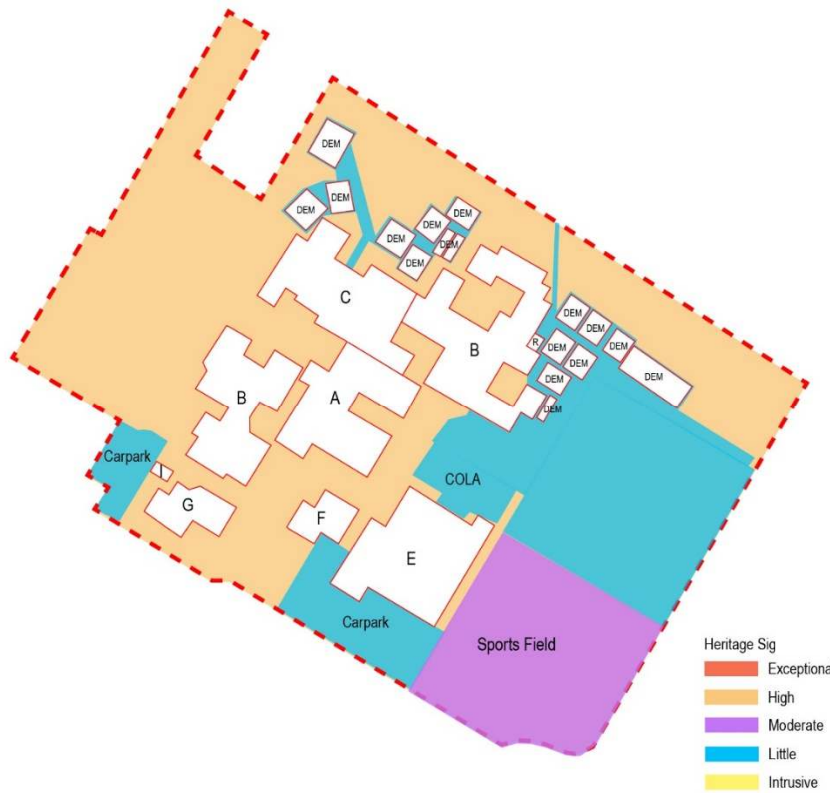
Figure 76. Plan showing contribution of landscape elements. *Source:* Extent Heritage.

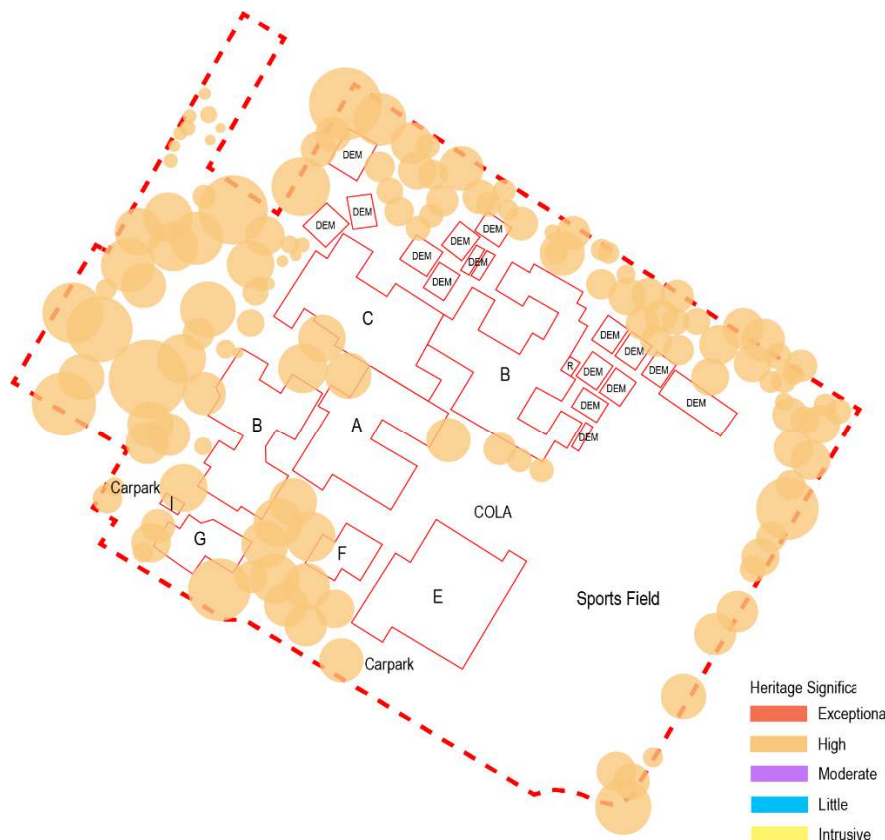
Figure 77. Plan showing significant cultural trees within the study area. *Source:* Extent Heritage.

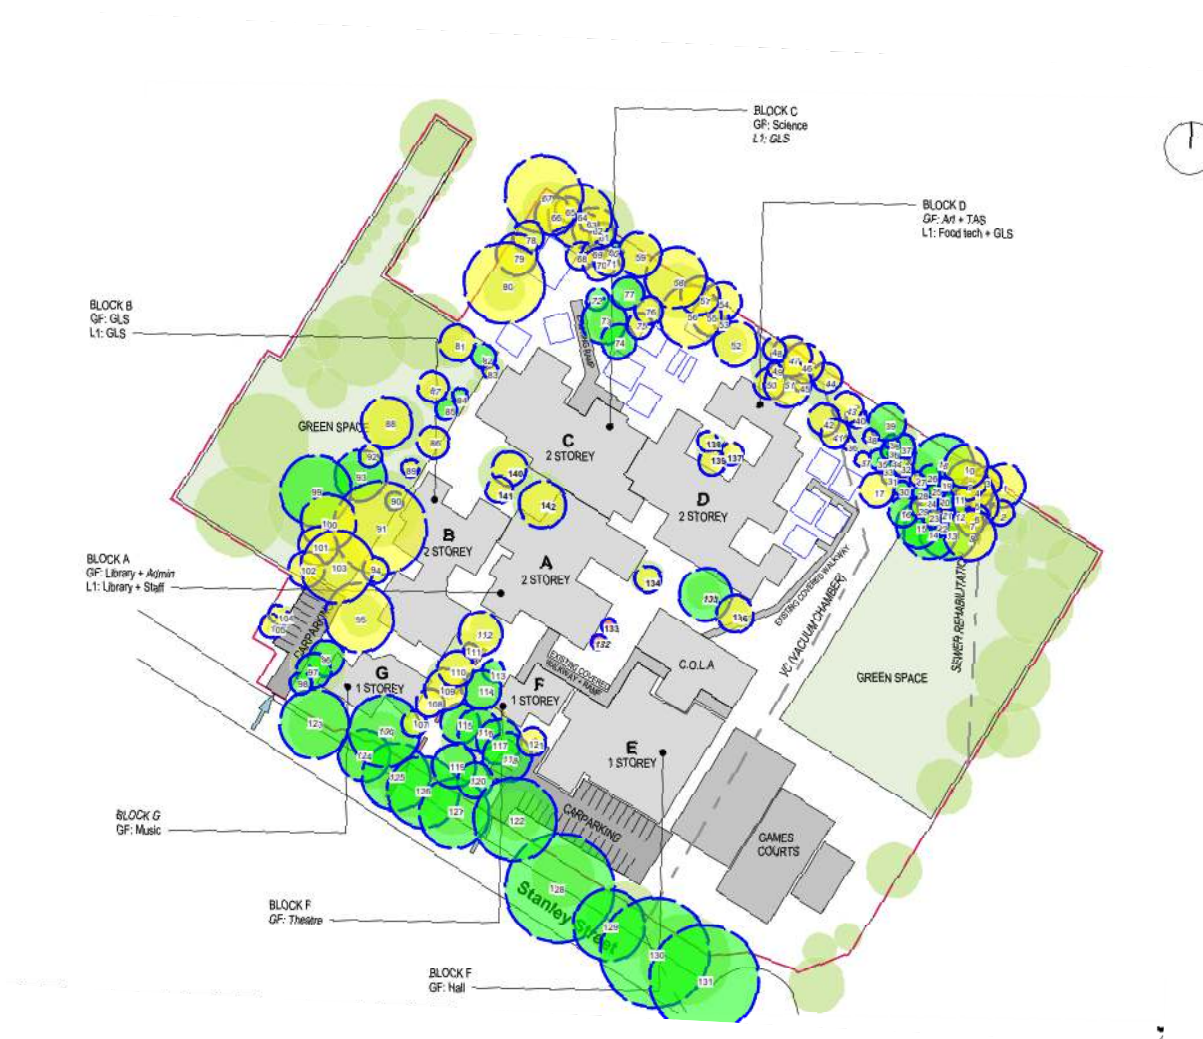
Figure 78. Tree plan showing trees with high retention value (green), medium retention value (yellow) and trees of low retention value (red), with the TPZ outlined in blue. Source: Bird Trees Consulting, DRG A01.

The Arboricultural assessment prepared by Birds Tree Consulting Pty Ltd considered the vegetation of the existing landscape and detailed the health and condition of trees within Concord High School, including trees along Stanley Street, outside the school boundary. The assessment of landscape significance and retention value of vegetation was determined using a combination of environmental, cultural, physical, and social values. This is made in accordance with the Institute of Australian Consulting Arboriculturists (IACA) Significance of a Tree, Assessment Rating System (STARS). The preliminary report noted that of the 142 trees observed, 57 are identified as being of high environmental and landscape significance. The trees range in species and age. Refer to plan below (Figure 78).

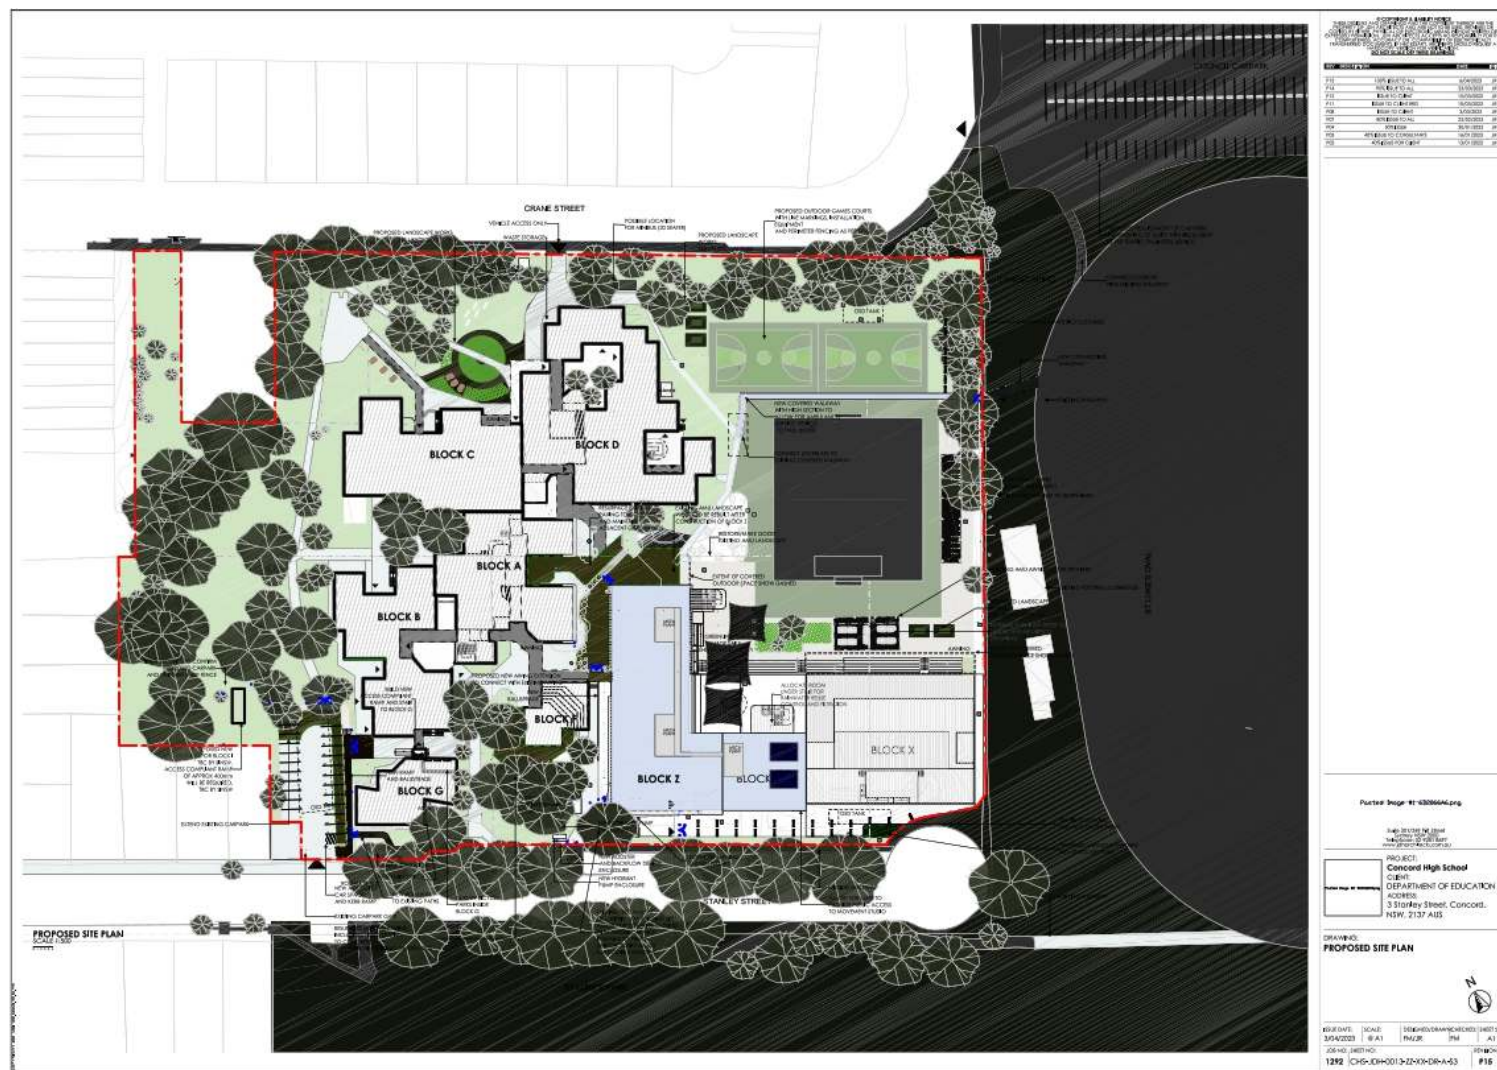
Figure 81. Proposed site plan with new blocks and extended carpark on south-west side. *Source:* JDH Architects.

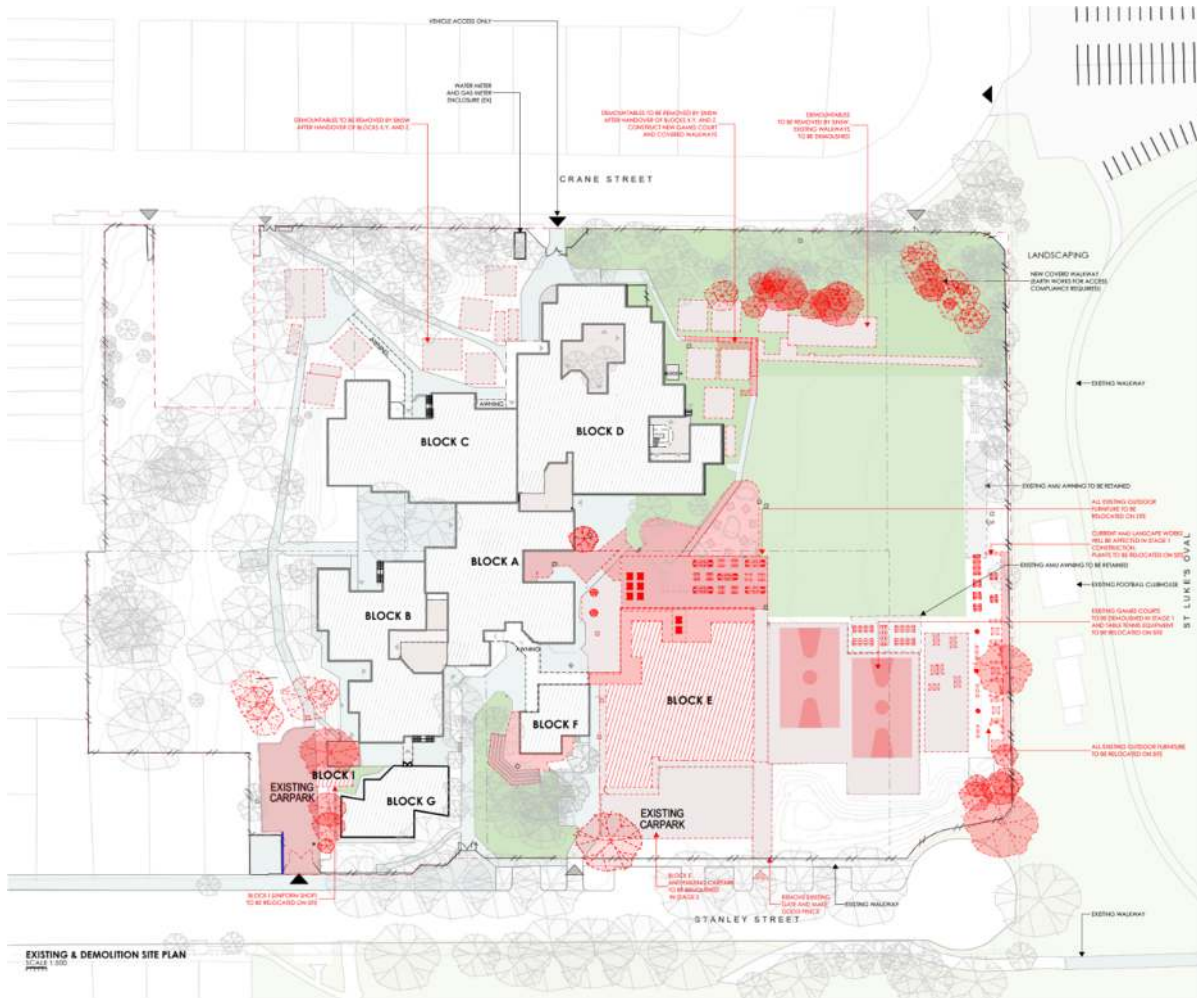
Figure 82. Demolition plan of the existing buildings, structures, and landscape elements at Concord High School. *Source:* JDC Architects 2023.

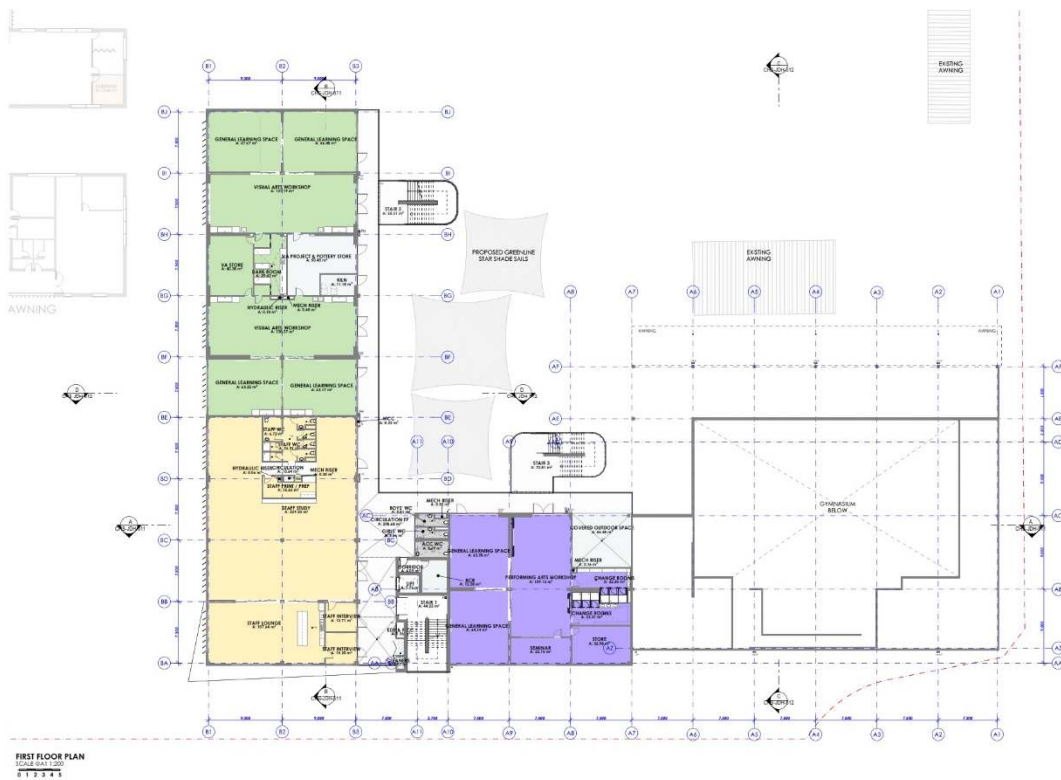
Figure 85. First floor plan. *Source:* JDC Architects 2023.

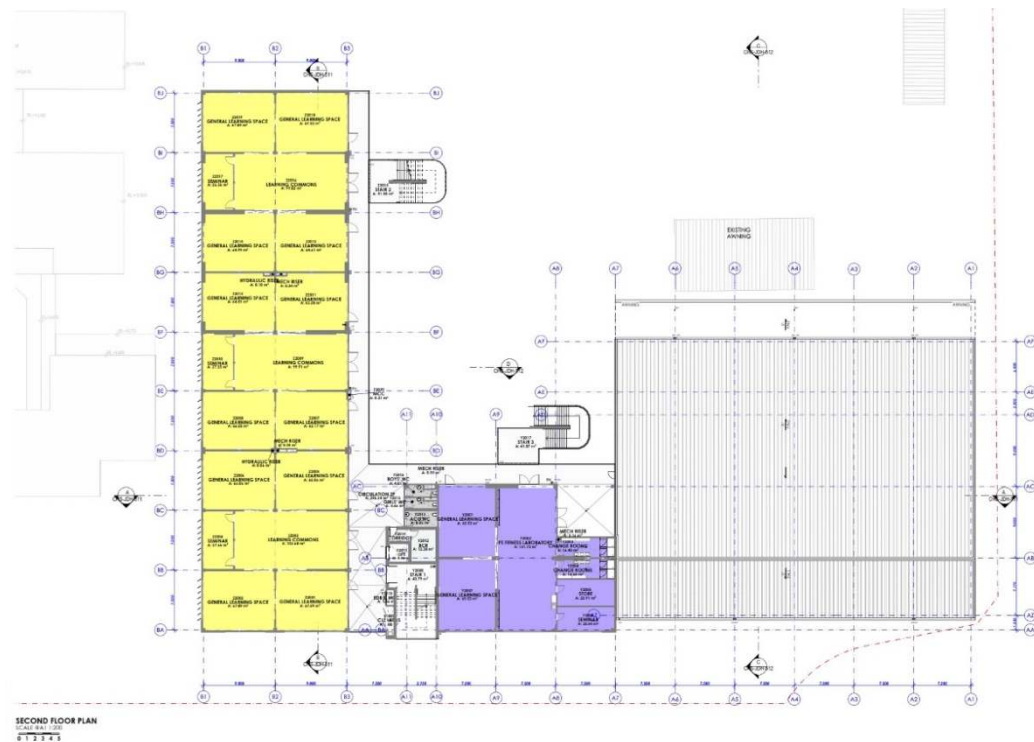
Figure 86. Second floor plan. *Source:* JDC Architects 2023.

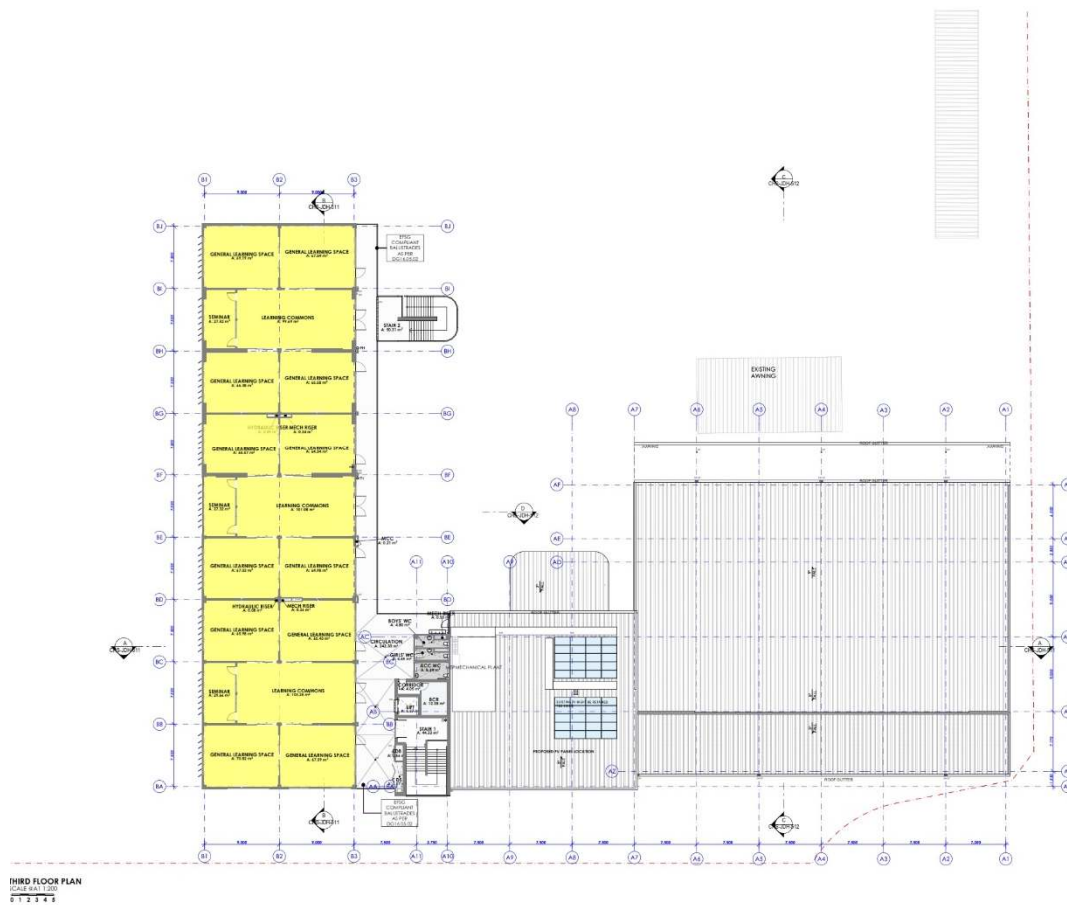
Figure 87. Third floor plan. *Source:* JDC Architects 2022.
