Concord High School

Statement of Heritage Impact

Prepared for School Infrastructure NSW

June 2023 – Final Update

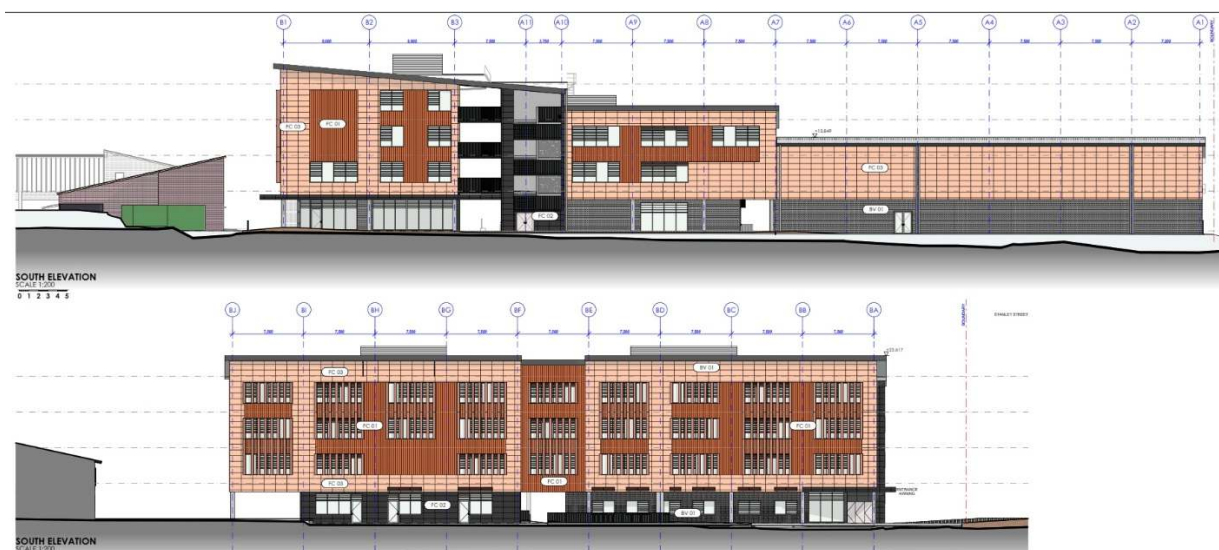
Figure 88. Indicative elevations of the south and west elevations, not to scale. *Source:* JDC Architects 2023.

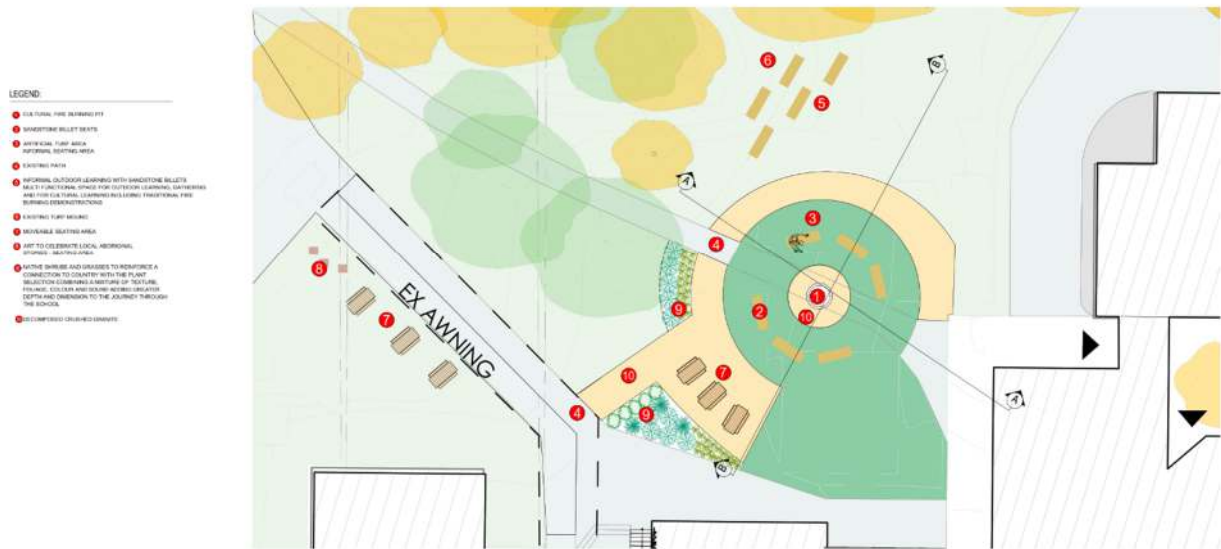
GROUND FLOOR
INFORMAL OUTDOOR
LEARNING AREA DETAIL

Figure 91. Landscape Schematic Design, Informal Outdoor Learning Area Detail. *Source:* Space Landscape Design, 2023.

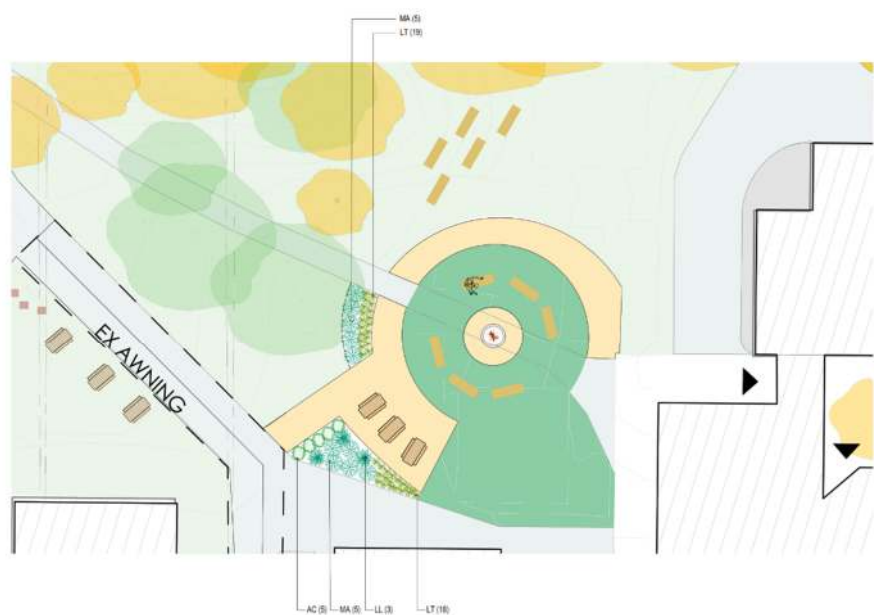
The selection is to reinforce the connection to existing plantings from the 1930's tannery and 1970's planned gardens. The deciduous tree will provide summer shade to the seating area and allow for winter sun.

Figure 92. Landscape Schematic Planting Plan, Informal Outdoor Learning Area. *Source:* Space Landscape Design, 2023.

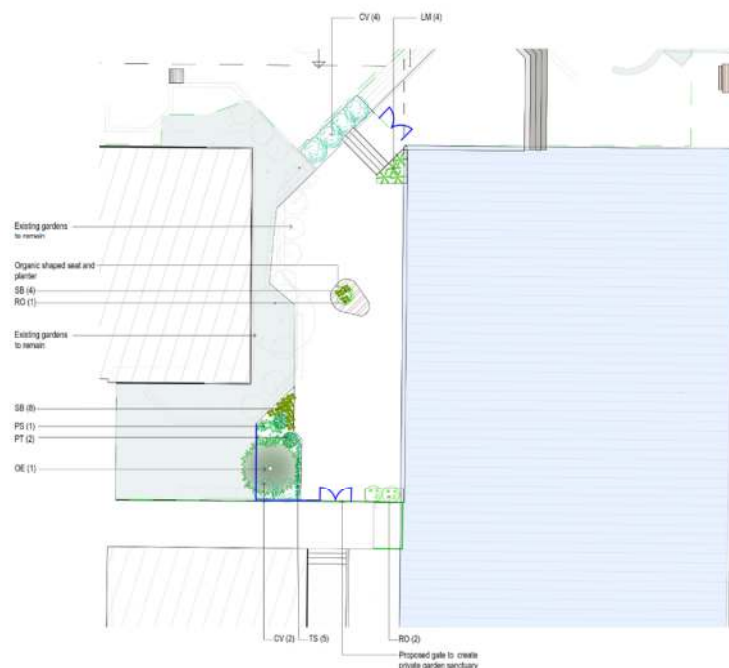
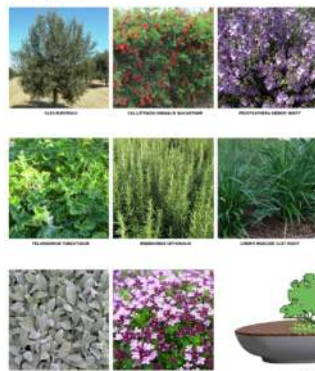
Figure 94. Landscape Schematic Planting Plan, Sensory Garden. Source: Space Landscape Design, 2023.
