# Detailed Site Investigation - Concord High School

3 Stanley Street, Concord NSW 2137

Prepared for School Infrastructure New South Wales

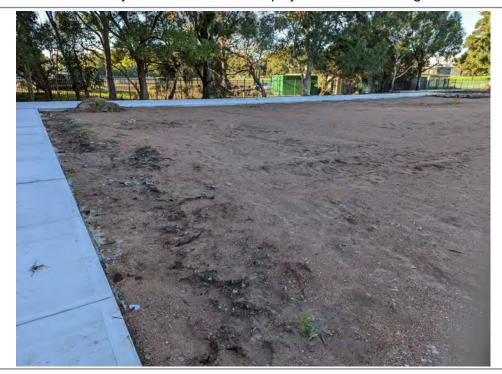
Photo 2: 20/06/2022 - BH14 sample location in the northeast of the site, looking east.

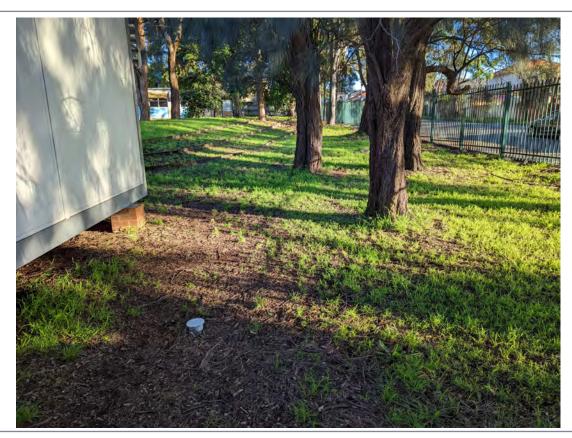
Photo 3: 20/06/2022 - lunch area near BH03, looking south.

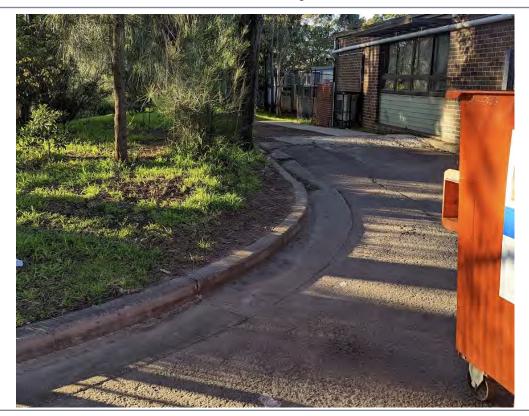
Photo 4: 20/06/2022 - BH08 sample location, looking east.

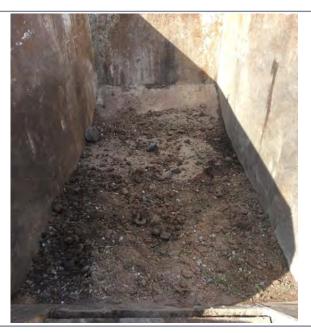
Photo 5: 21/06/2022 - Waste soil in skip bin (approx 100 kg).

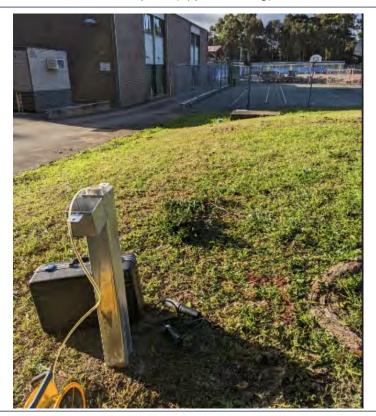
**Photo 6:** 28/06/2022 - MW01 location on the mound at the south of the site, looking north.

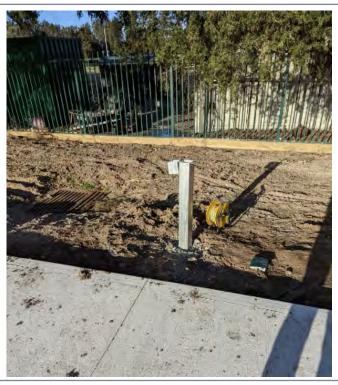
Photo 7: 28/06/2022 - MW02 location on the at the east of the site, looking east.

- a hydrogeological study including levels survey and data logging of wells to determine groundwater flow and risk to potential ecological receptors from various groundwater impacts observed in MW02 and dissolved metals in all wells;

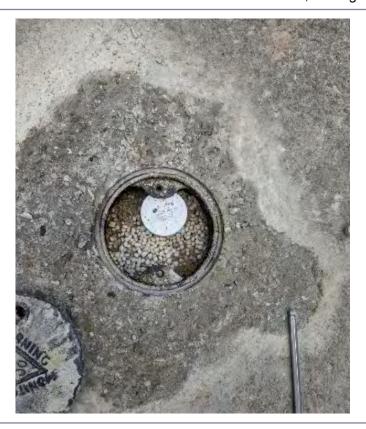
**Photo 8:** 28/06/2022 - MW03 location in the car park at the south of the site.

- resampling all wells is recommended due to the potential for laboratory crosscontamination and to confirm low-level PFAS results. Determine if any significant historical fire events were recorded in the vicinity of MW03 where firefighting foams may have been used that may have been a potential source of PFAS. No soil PFAS impacts were detected, however, detection limits were higher than those used for groundwater;

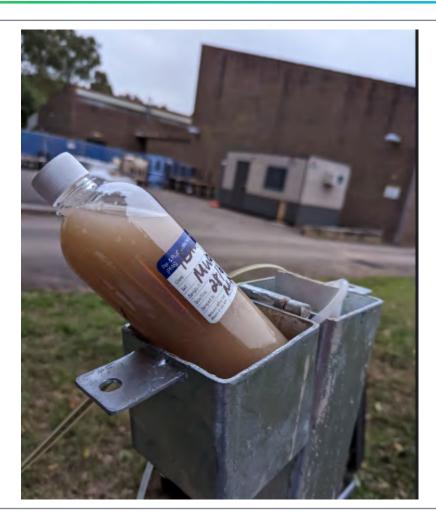
**Photo 9:** 28/06/2022 - Turbid groundwater sampled from MW03.

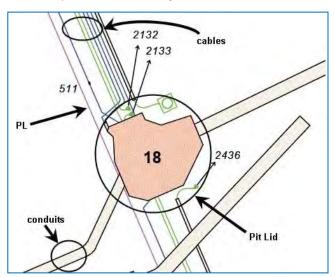
Figure 8

Underground "pits" are numbered on Ausgrid plans, positioned relative to the "property line" (PL), and can be found on either the footpath (nature strip) or the road (refer figure 8).

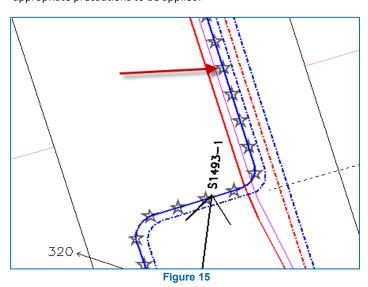
The "star" symbols over the cable indicates that it may be susceptible to deterioration or defects or the cable may contain an exposed conductive sheath or armour which could pose an electrical risk to workers.

Cables that are in duct lines have this symbology covered so an at-risk cable is indicated only within a cross section by a "#" appended to its cable code as illustrated below.
