# Remediation Action Plan for Concord High School

5 Stanley Street, Concord NSW 2137

Prepared for School Infrastructure NSW

Version: 2.0 Reference: 20220522

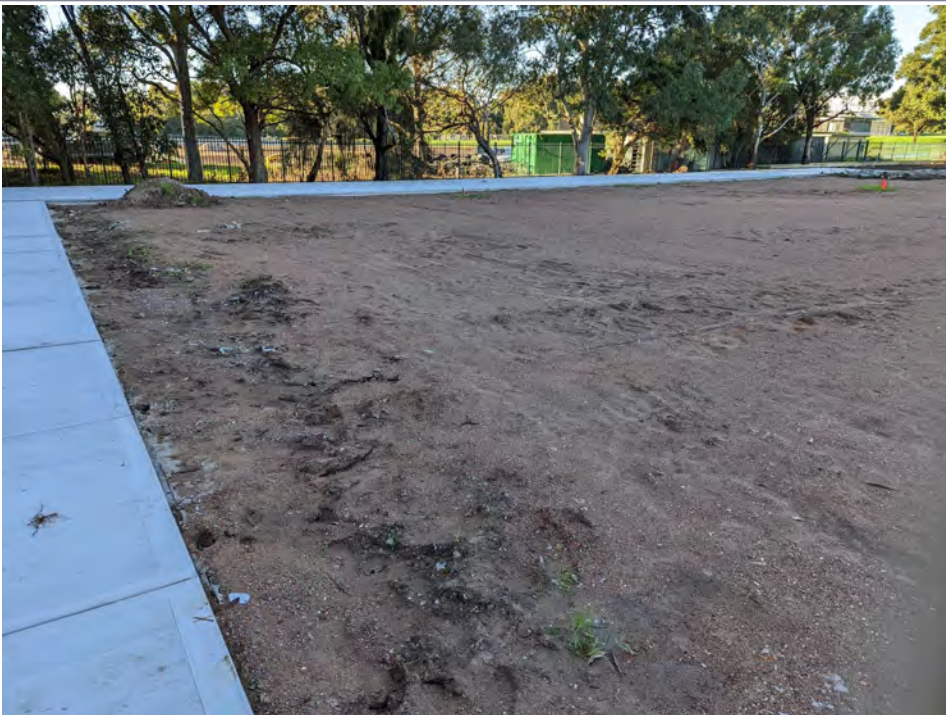
**Photo 2:** 20/06/2022 - BH14 sample location in the northeast of the site, looking east.

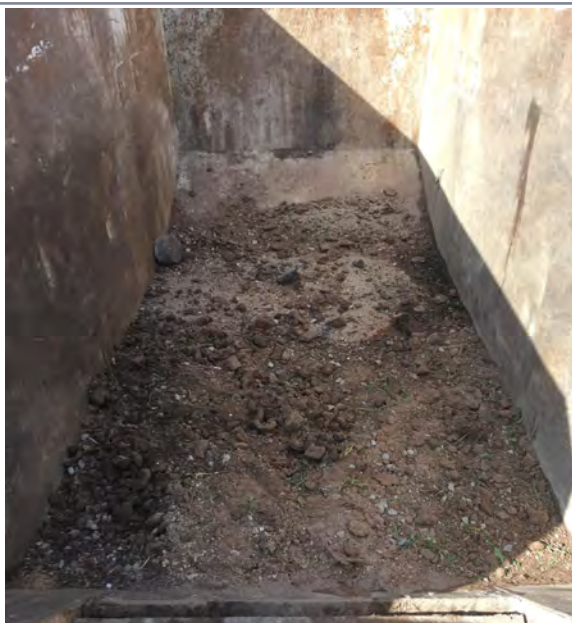
**Photo 5:** 21/06/2022 - Waste soil in skip bin (approx 100 kg).

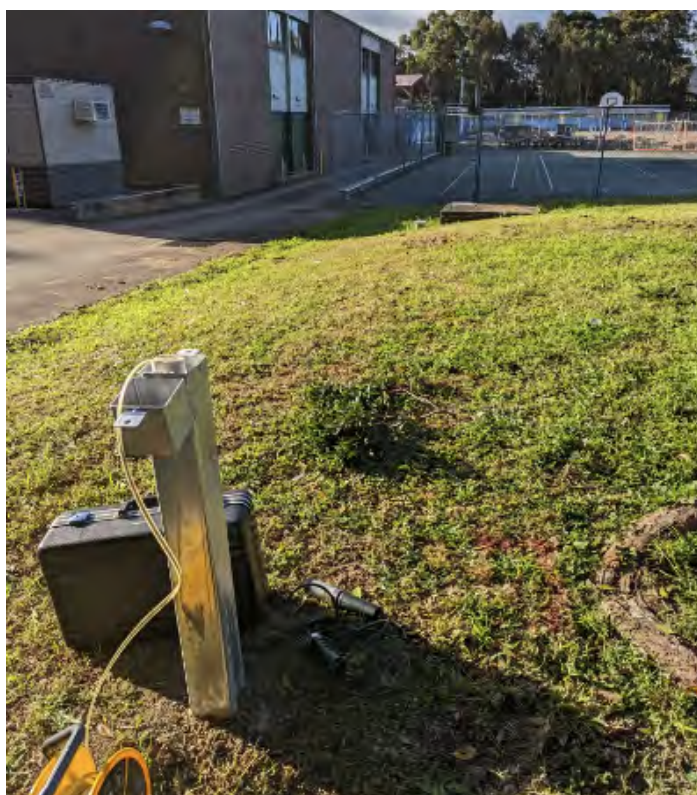
**Photo 6:** 28/06/2022 - MW01 location on the mound south of the site, looking north.

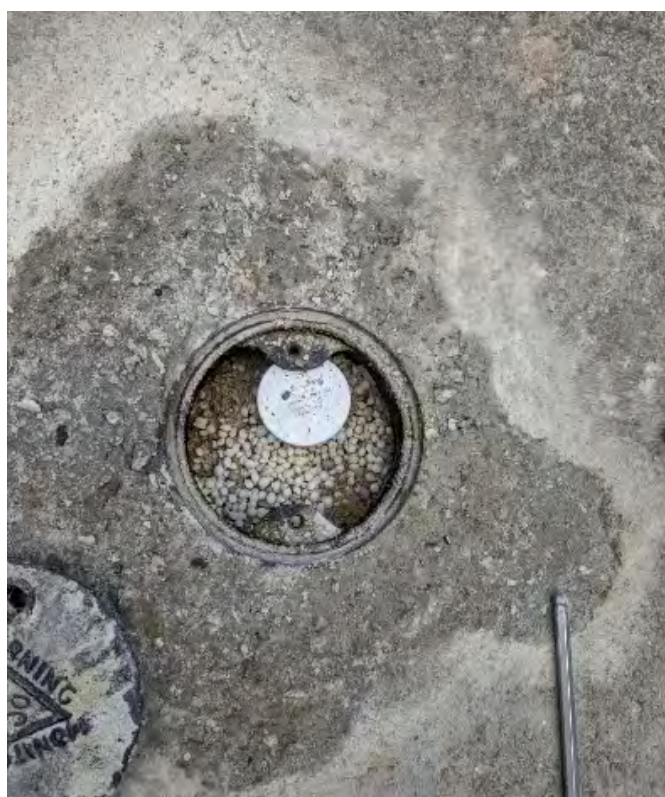
**Photo 8:** 28/06/2022 - MW03 location in the car park in the south of the site.

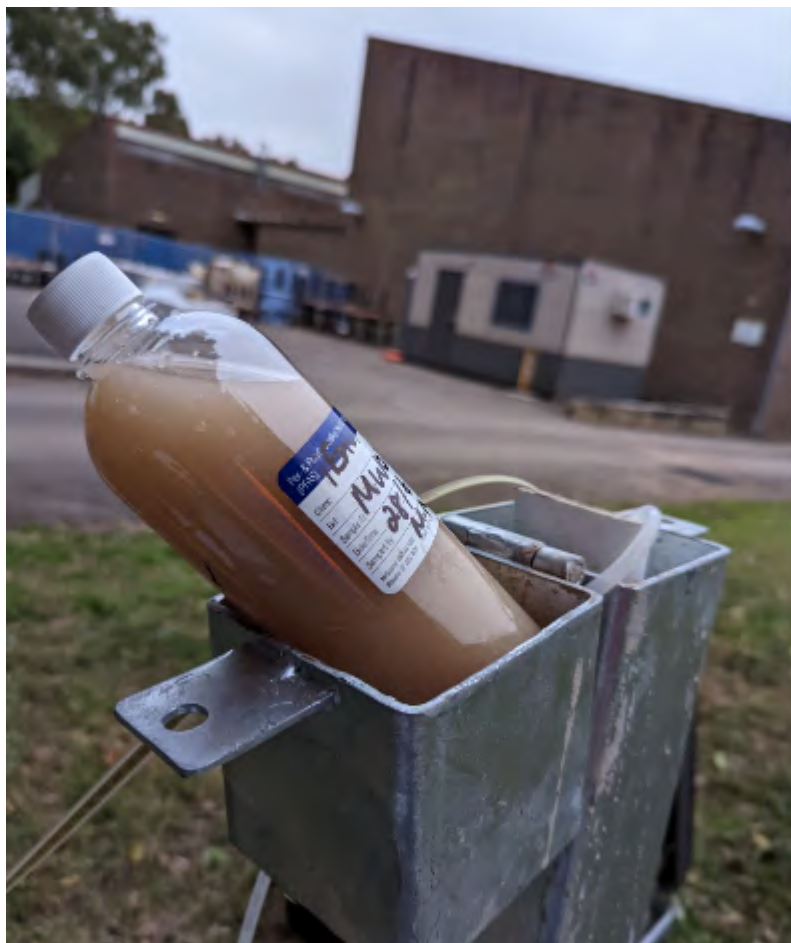
**Photo 9:** 28/06/2022 - Turbid groundwater sampled from MW03.
