ARBORICULTURAL IMPACT ASSESSMENT  
&  
TREE PROTECTION SPECIFICATION

REF: L&C02367 | 25 May 2023 | v1  
SITE ADDRESS | 32 Trevenar St, Ashbury  
PREPARED FOR | Andrew Murphy c/- Designcorp Architects  
PREPARED BY |  
**Dr Matthew Laurence**  
BSc. (Hons)  
PhD (Plant Pathology)  
Grad Cert (Arboriculture)

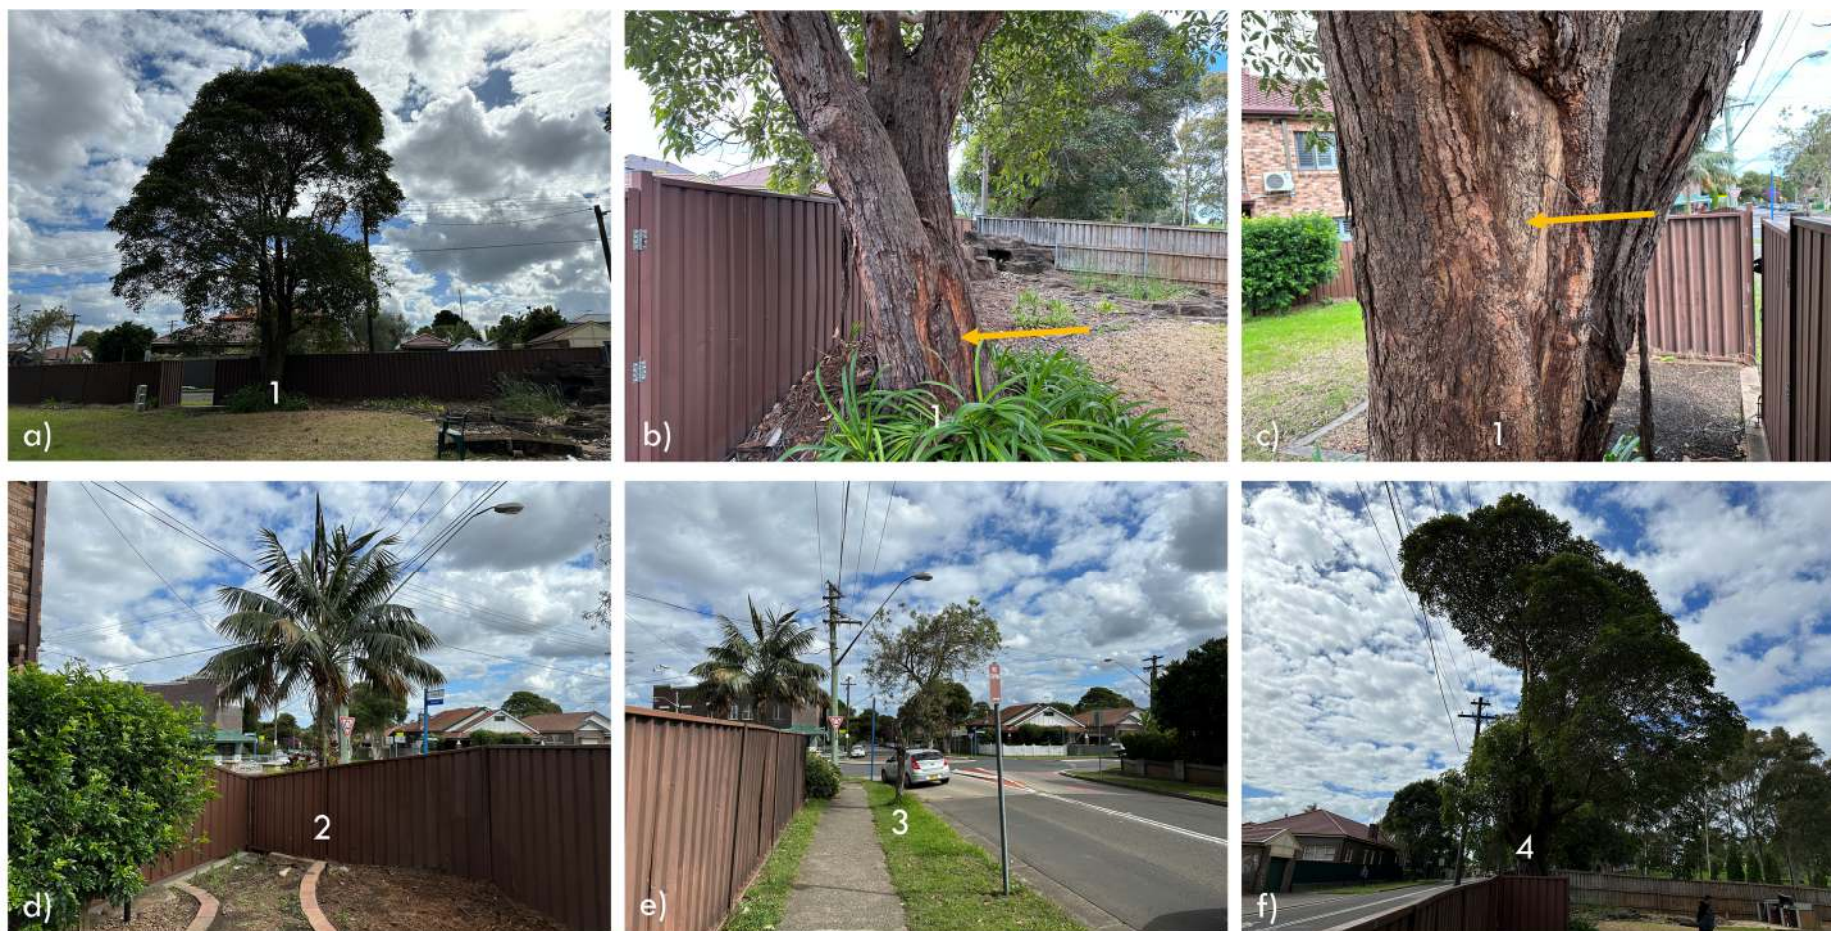
## 14.0 APPENDIX 9 | PLATES

4.1.2 The Tree was allocated a fair structural rating due to a cavity observed on the trunk and first order branches and there is potential for a column of decay extend above and below the opening (Appendix 9). However, internal investigations on the extent of the decay column were beyond the scope of this Report.

a) Showing Tree 1. b) Showing trunk cavity on Tree 1. c) Showing detail of trunk cavity of Tree 1. d) Showing Tree 2. e) Showing street tree, Tree 3. f) Showing Tree 4.

4.1.4 Given the size and location of the encroachment, the long term structural and physiological viability of Tree 1 is highly likely to be compromised by the proposed encroachment and the tree will need to be removed to accommodate the works.

4.1.6 Removal and replacement with a healthy advanced size specimen would replace the loss of amenity within a medium to long timeframe.

4.1.7 Refer to Appendix 5 and Plates a & b of Appendix 9 for further detail.
