Report on
Additional Geotechnical Investigation

Proposed Pool and Park Redevelopment
Kogarah War Memorial Pool, Carss Park

Prepared for
SJB Architects c/-SJB Planning

Project 99751.01
September 2020

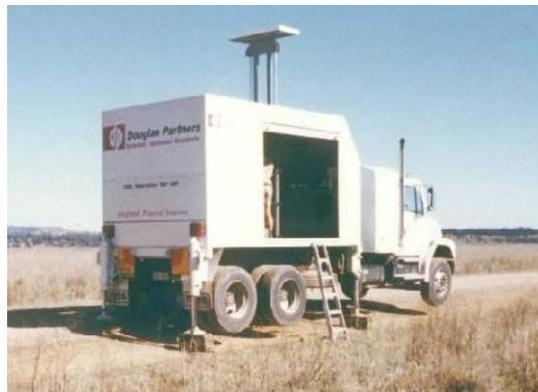
Figure 2: Purpose built CPT rig

The cone is thrust into the ground at a steady rate of about 20 mm/sec, usually using the hydraulic rams of a purpose built CPT rig, or a drilling rig. The testing is carried out in accordance with the Australian Standard AS1289 Test 6.5.1.
