Snowmaking and Services Corridor Snowgums to Kareela, Thredbo NSW

Geotechnical Assessment

Our ref: 7228-G1 Rev 1
9 August 2023

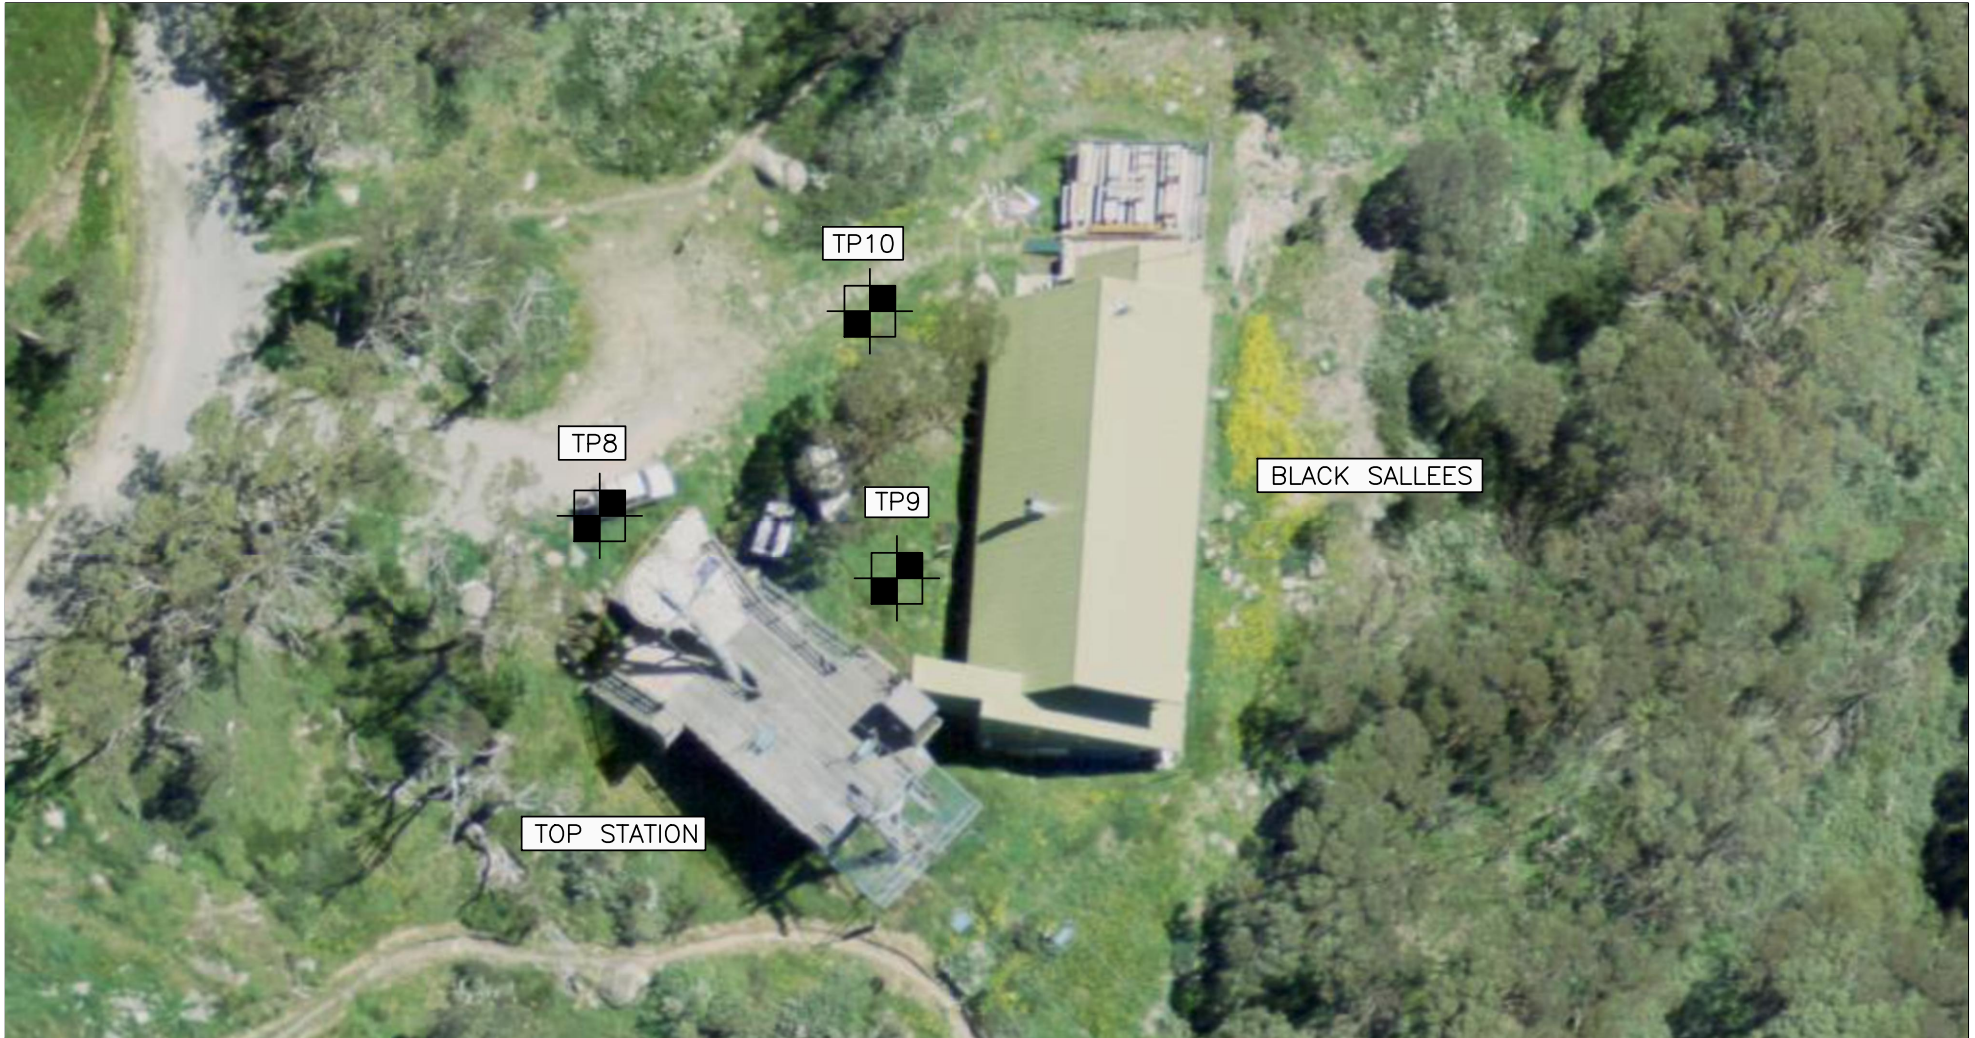
2

Test Pit Location

TEST LOCATION – TOP STATION

Previous test pitting undertaken in October 2021 for the Snowgums replacement included three test pits at the top station. Engineering logs are provided in Appendix B together with their explanatory notes.

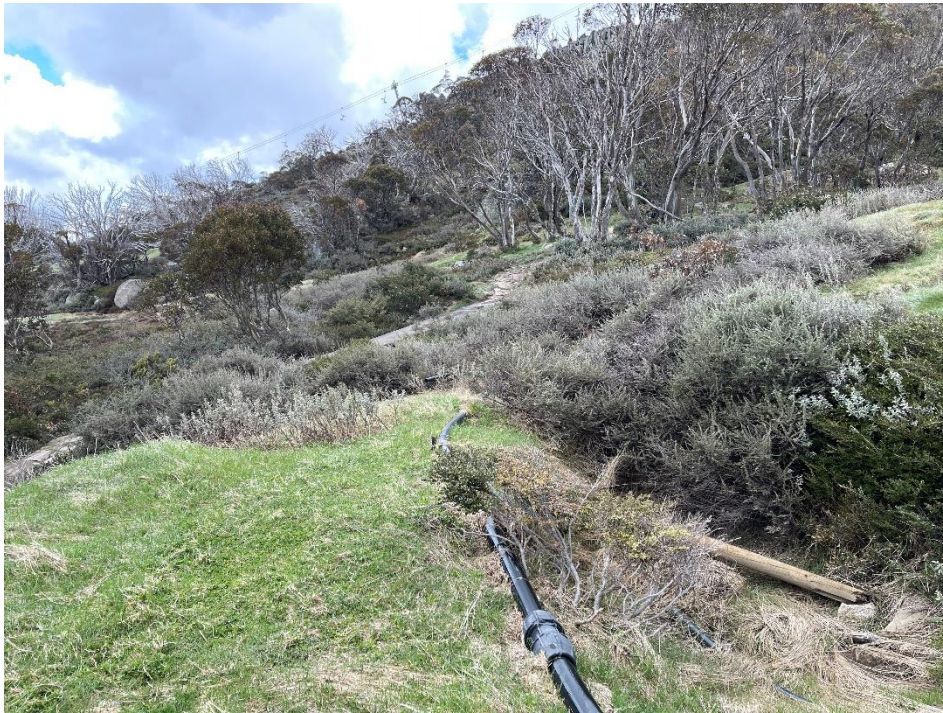
Photo 1

View of slope
south-west of Black
Salles

A series of photographs illustrating the alignment are shown in Appendix C. The landscape is irregular with numerous granite boulders and outcrop, areas of topsoil and alpine vegetation, and several drainage lines flowing across the alignment. There are also existing shallow buried services in the vicinity with some daylighting.

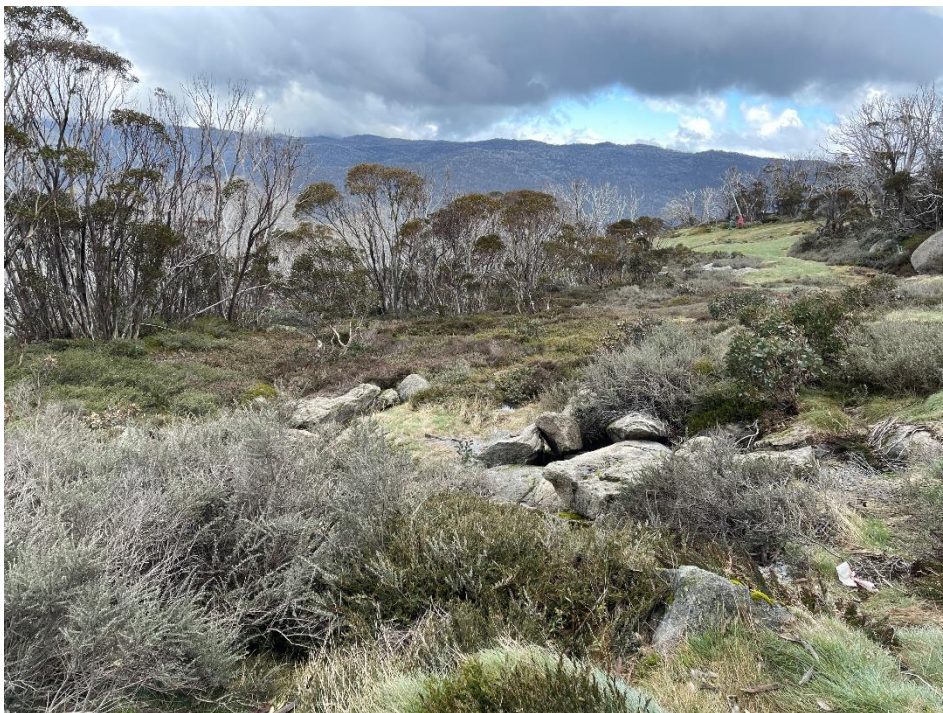
Photo 2

Wet area adjacent
to route. New
alignment located
within the disturbed
ski run adjacent.

The site observations indicated there are several drainage lines that the service trench will cross. At the top station, groundwater was not encountered during the previous test pitting investigation but could be present at various locations along the route alignment.

Temporary surface water diversions will be required where cutting the sections of trenching through the drainage lines. Where groundwater is encountered within trench excavations, temporary diversion downslope will be required until the affected section of trench can be completed.

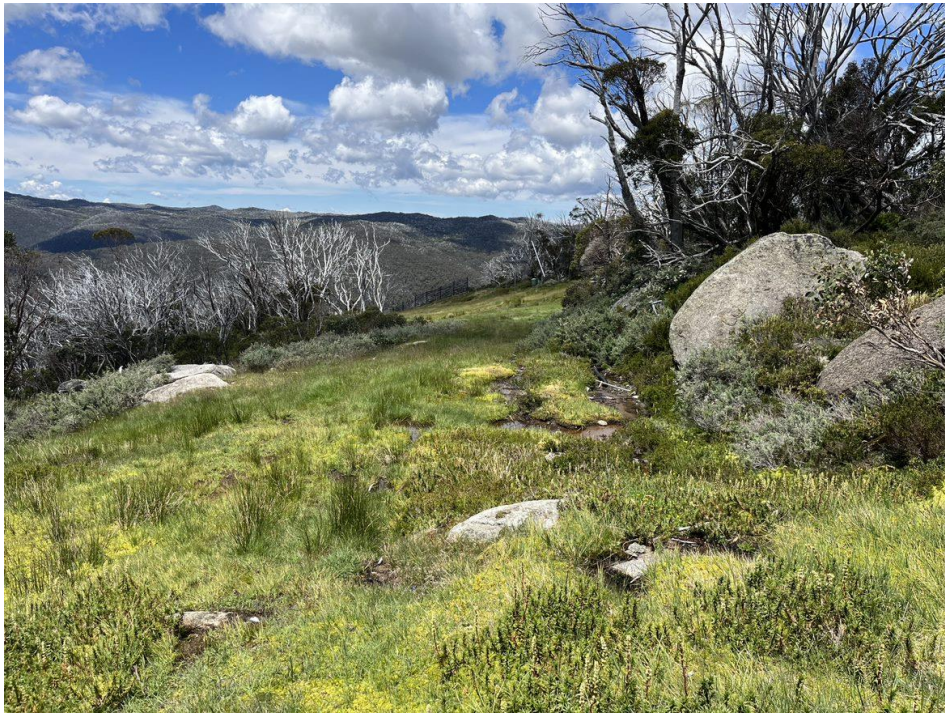
Photo 3

Wet area above
Kareela Hutte.
Source: Kosciuszko
Thredbo Pty Ltd.

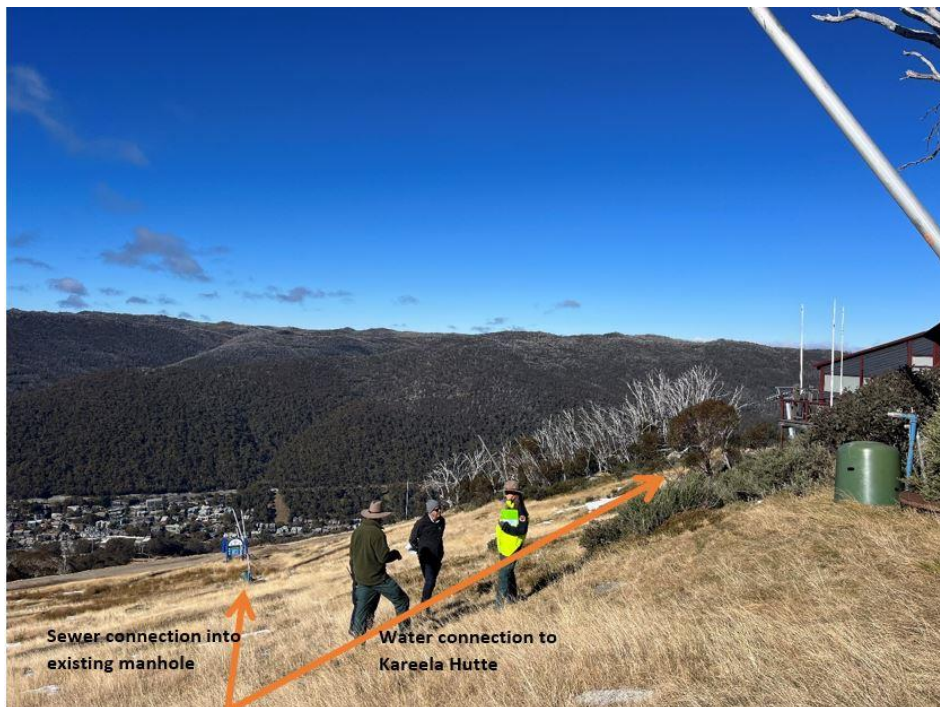
Photo 4

View of service
trench entry to
Kareela Hutte.
Source: Kosciuszko
Thredbo Pty Ltd

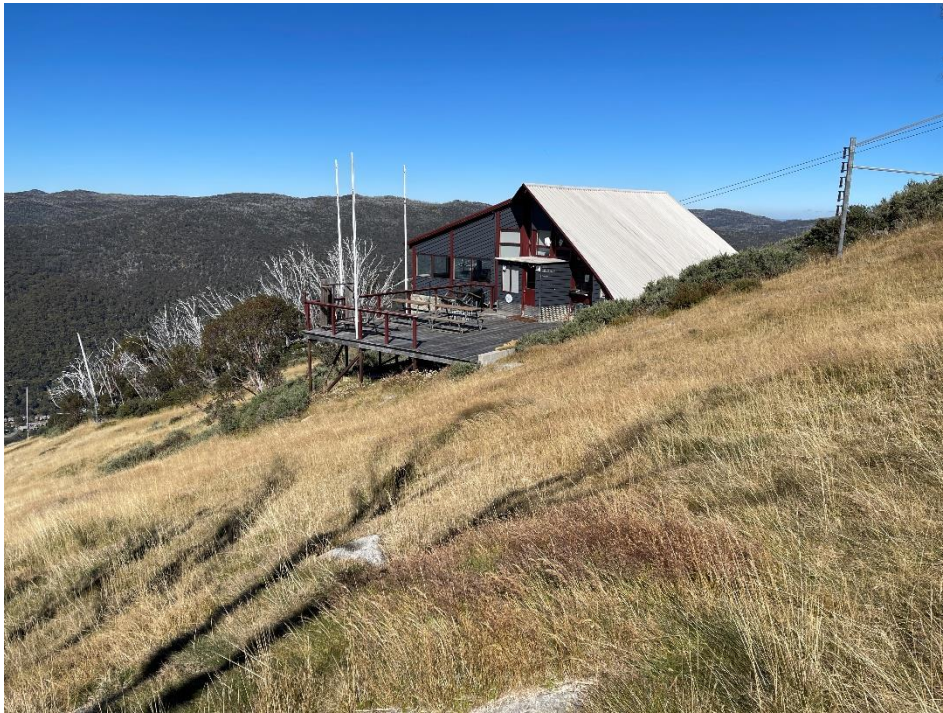
Photo 5

View of northern side of Kareela Hutte where service trench will approach.
