Re: Land Capability Assessment – 37 Annie Pyers Drive Gundagai NSW 2722

Attachment A : *Location maps and proposed development plan*

Attachment B : *Investigation locations*

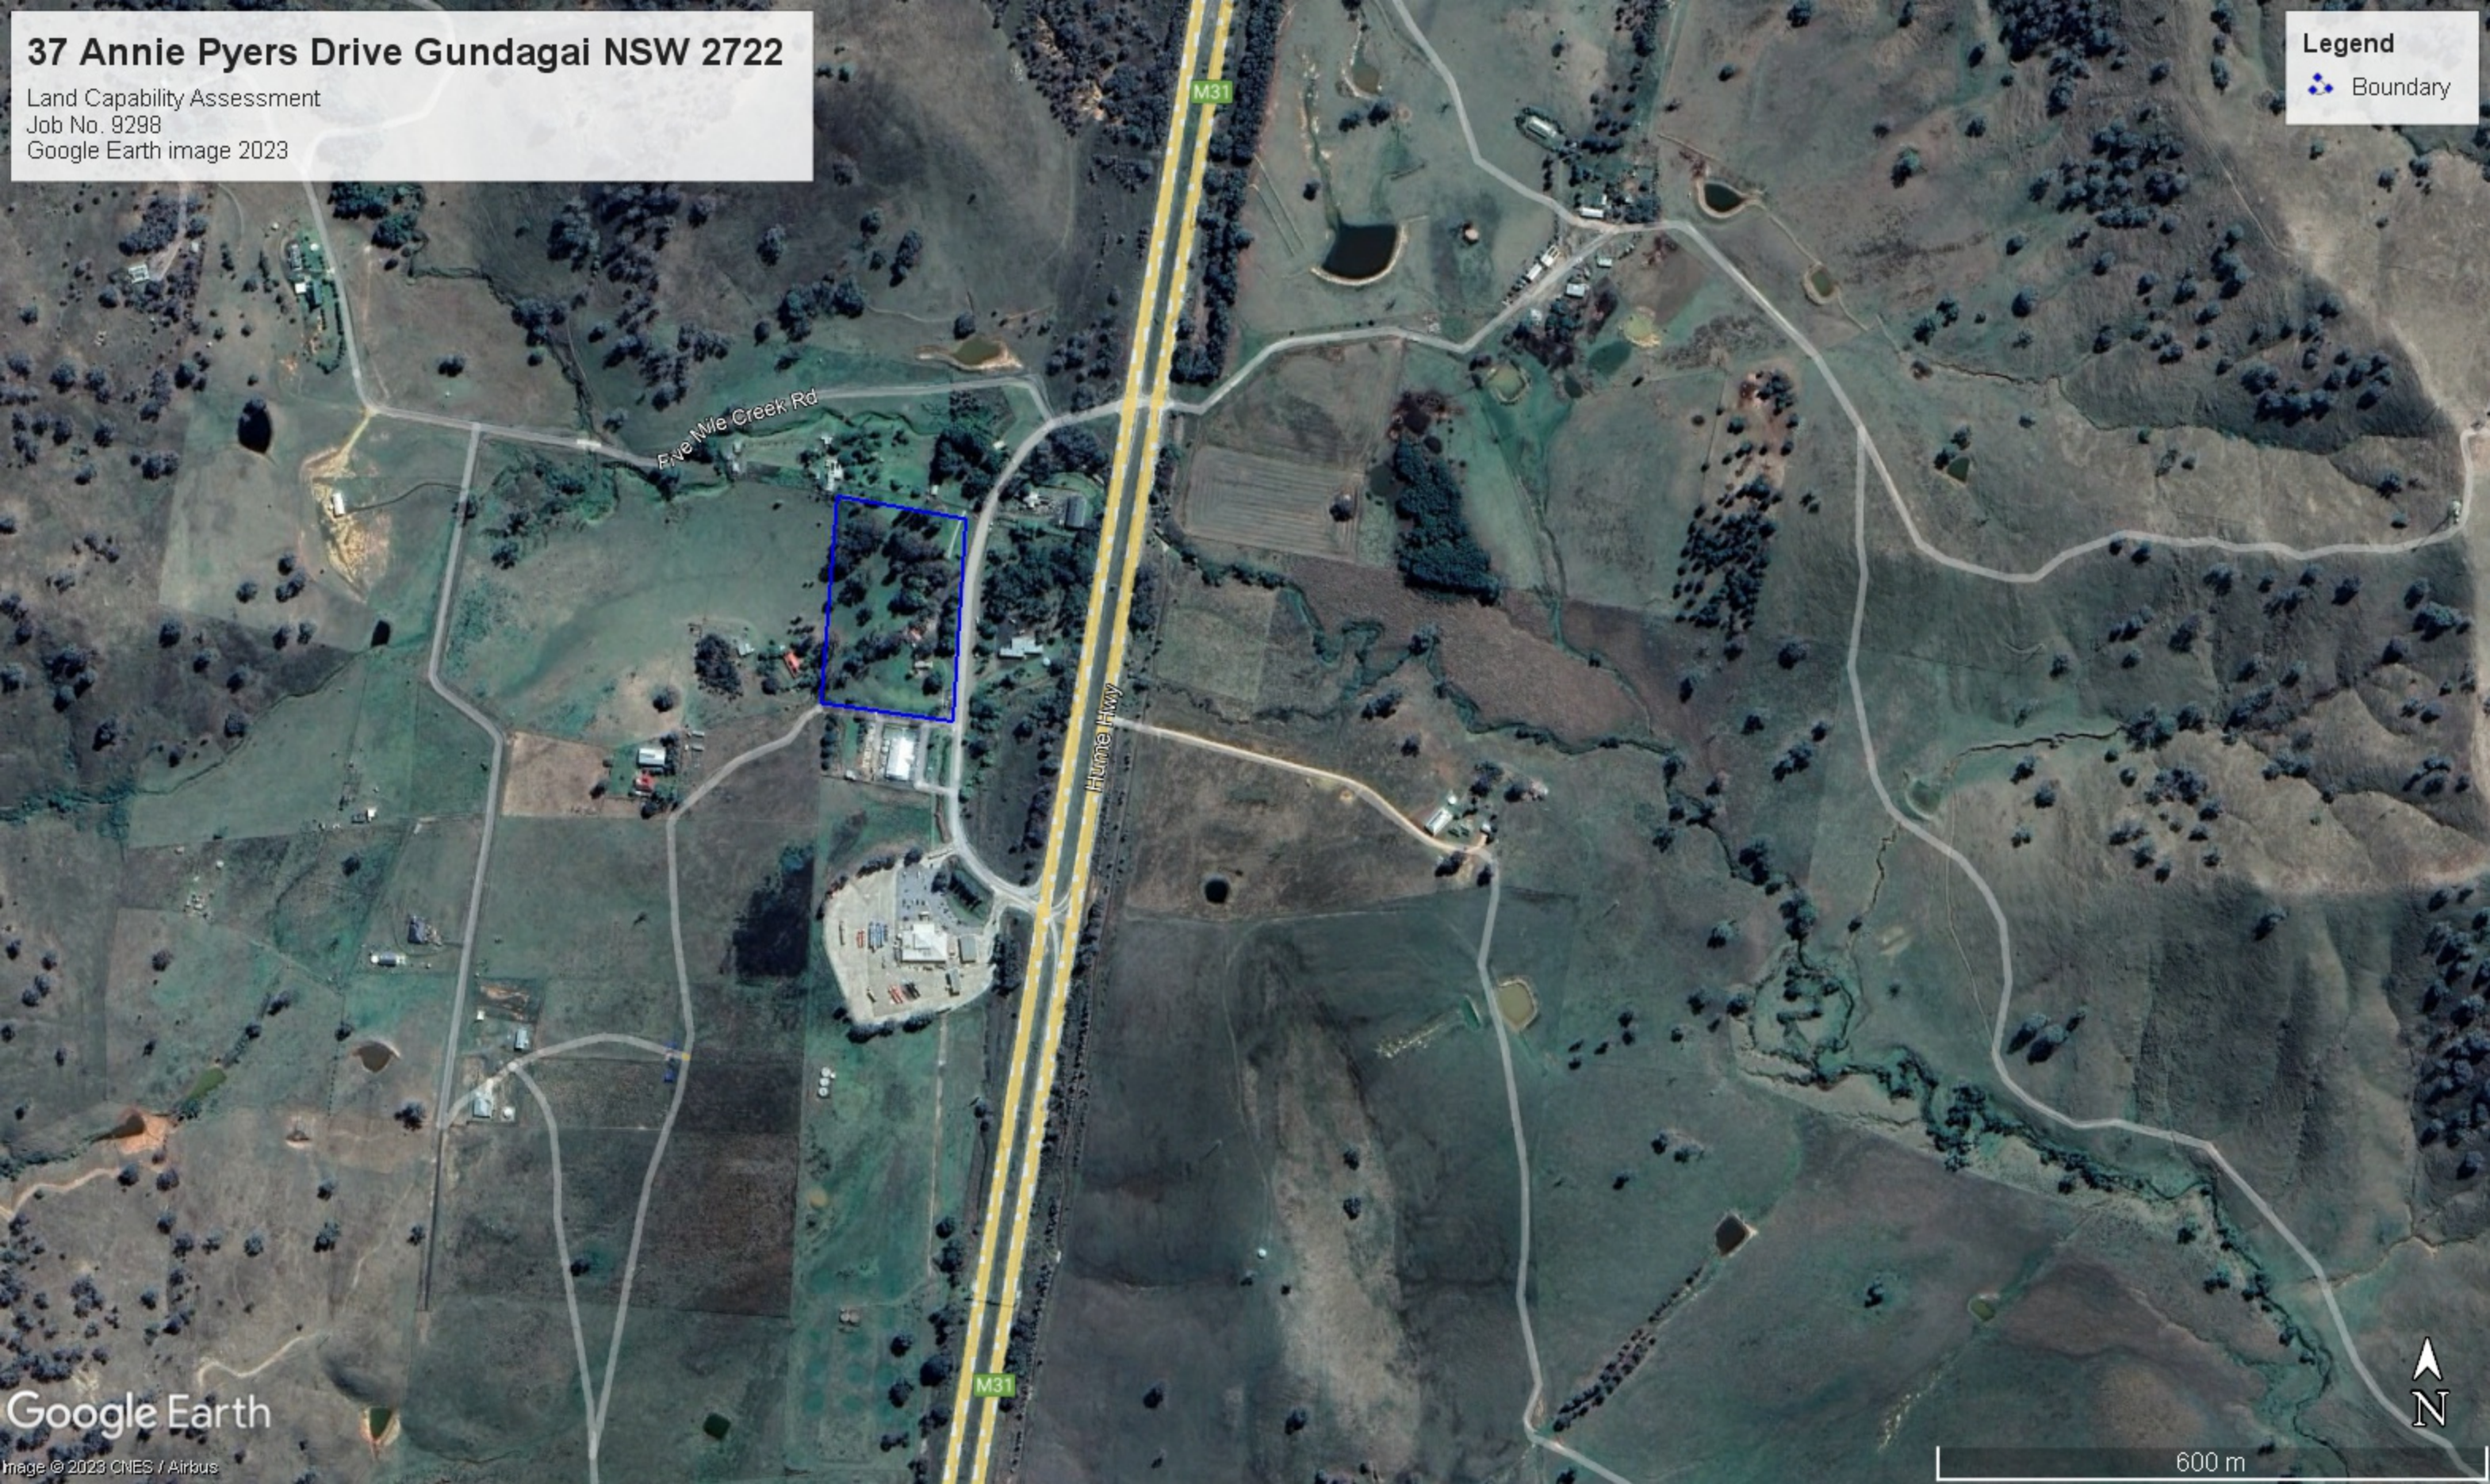
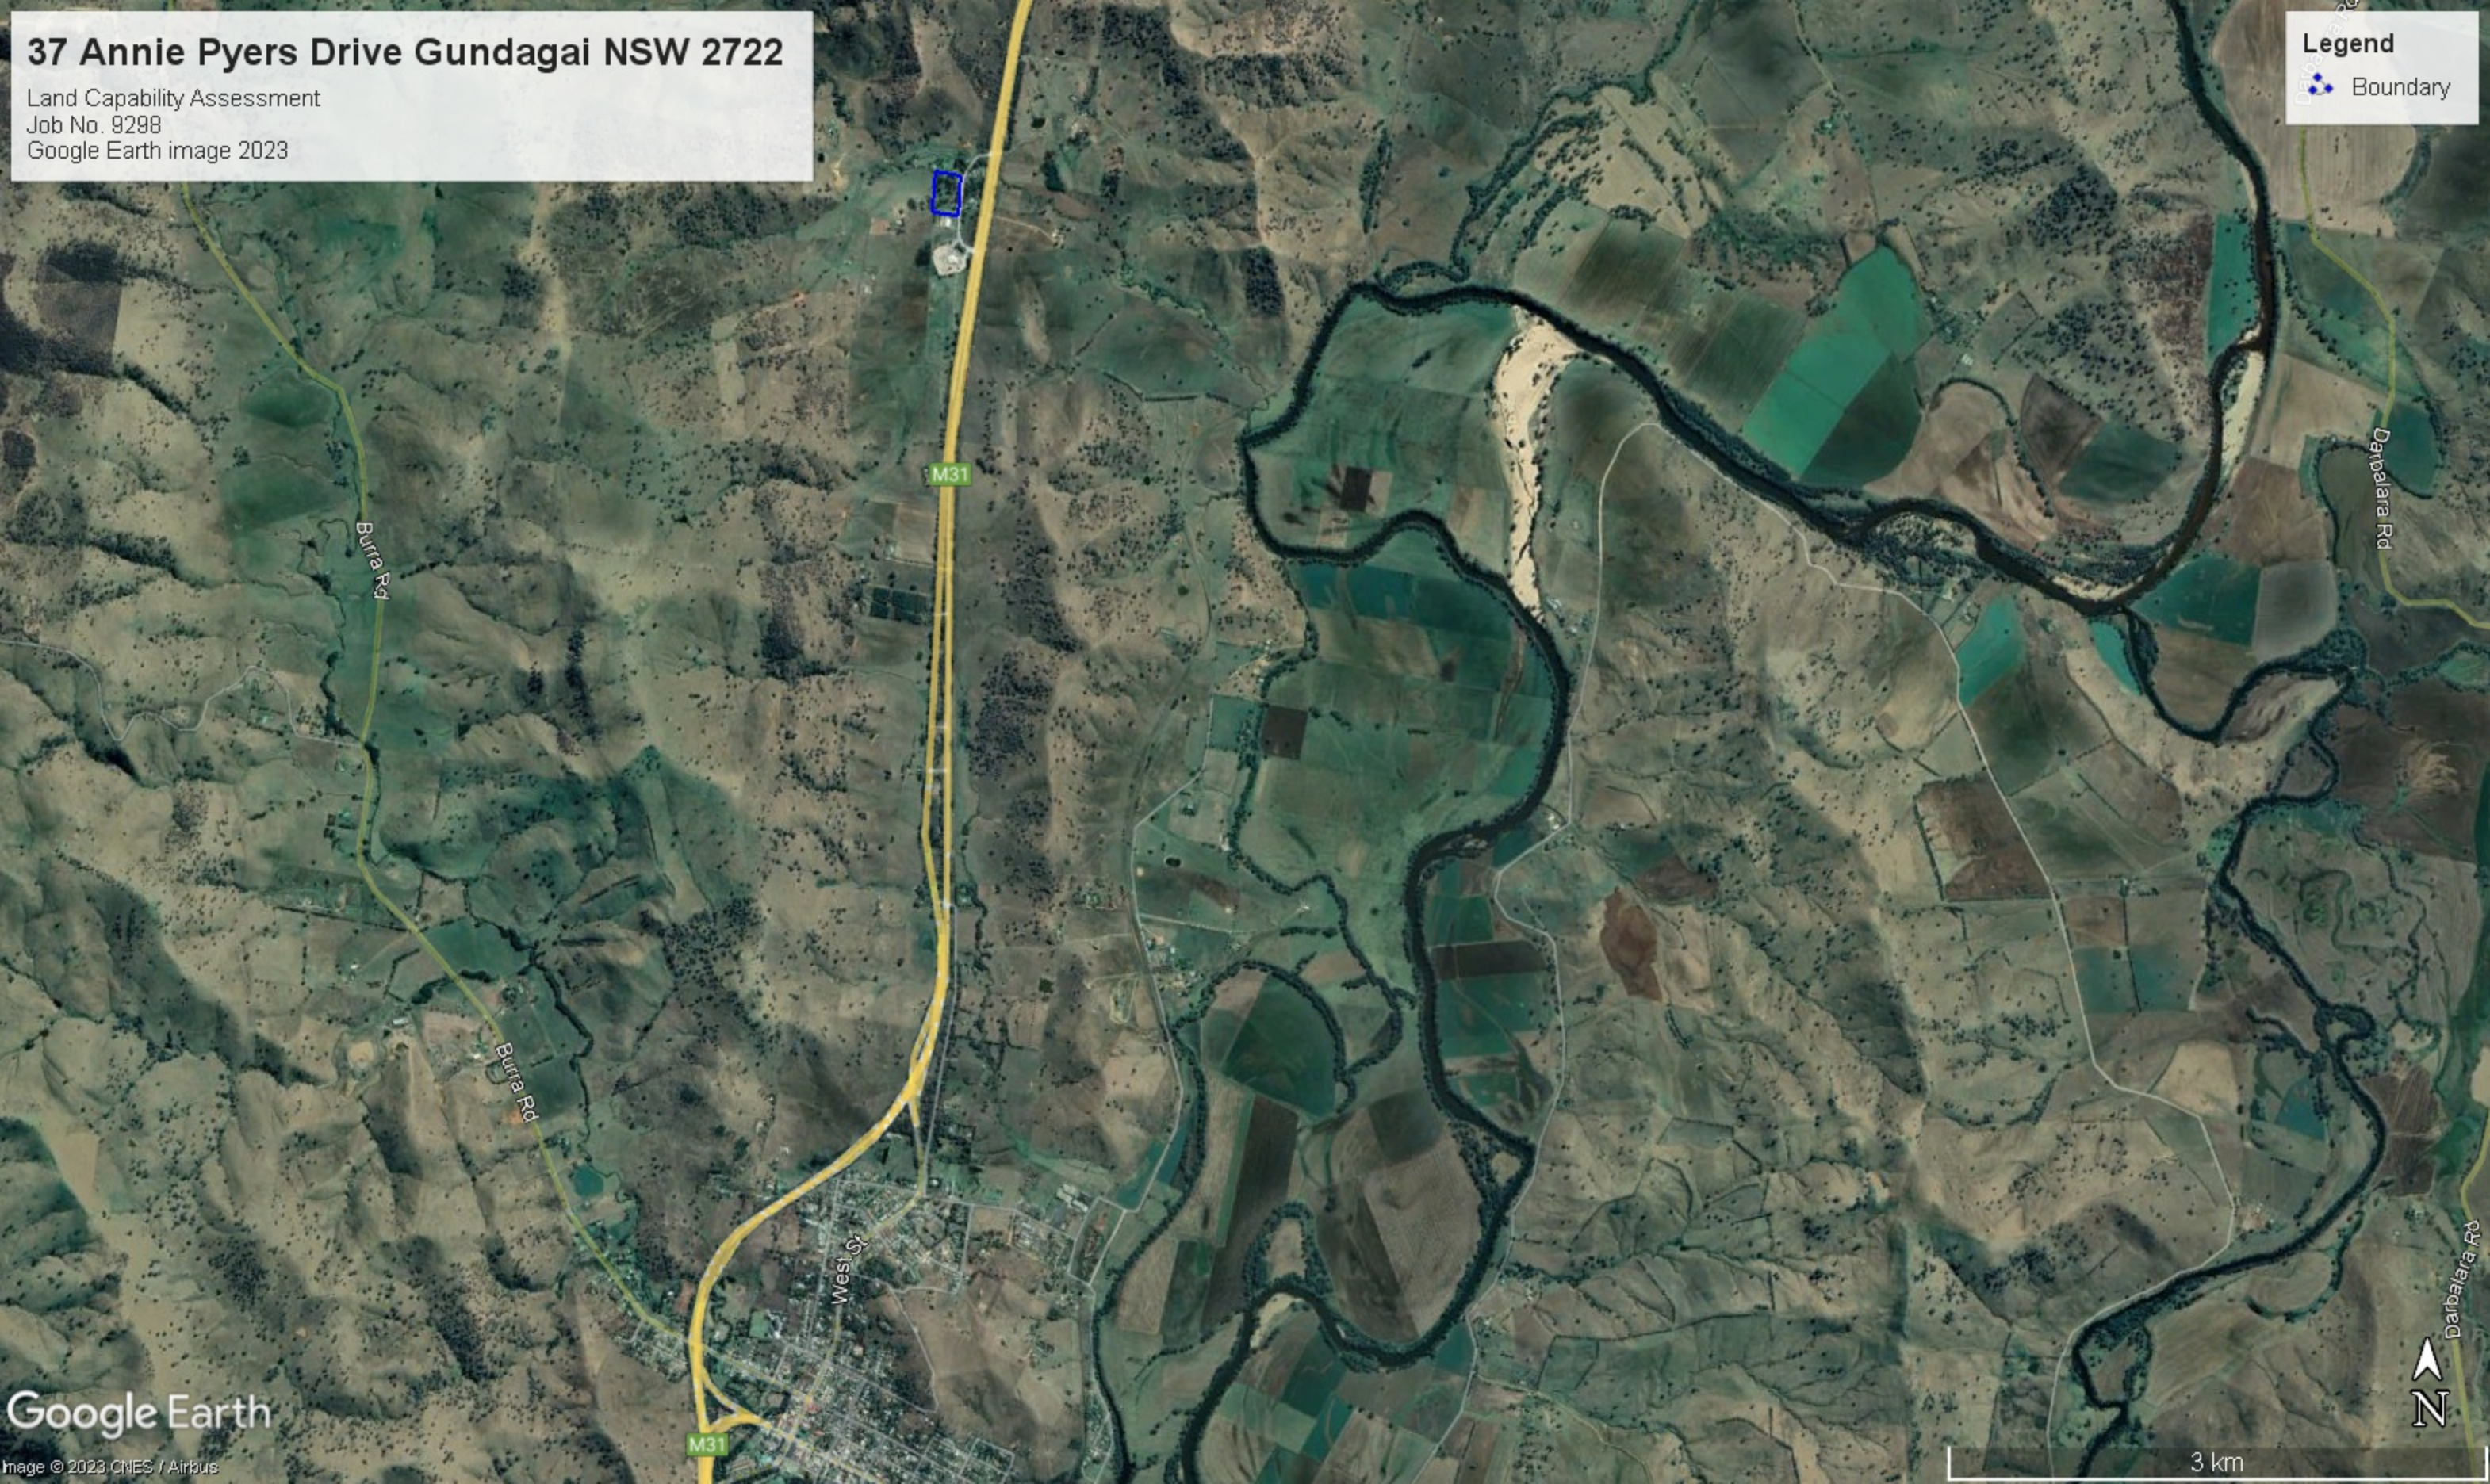
The site is a 2.7ha (approx.) land parcel with a real property description of Lot 2 DP 160191 and Lot 529B DP 203601 and is located on the western side of Annie Pyers Drive off the Hume Highway approximately 8km north of Gundagai. Location maps and a plan of the proposed development can be seen in **Attachment A**.

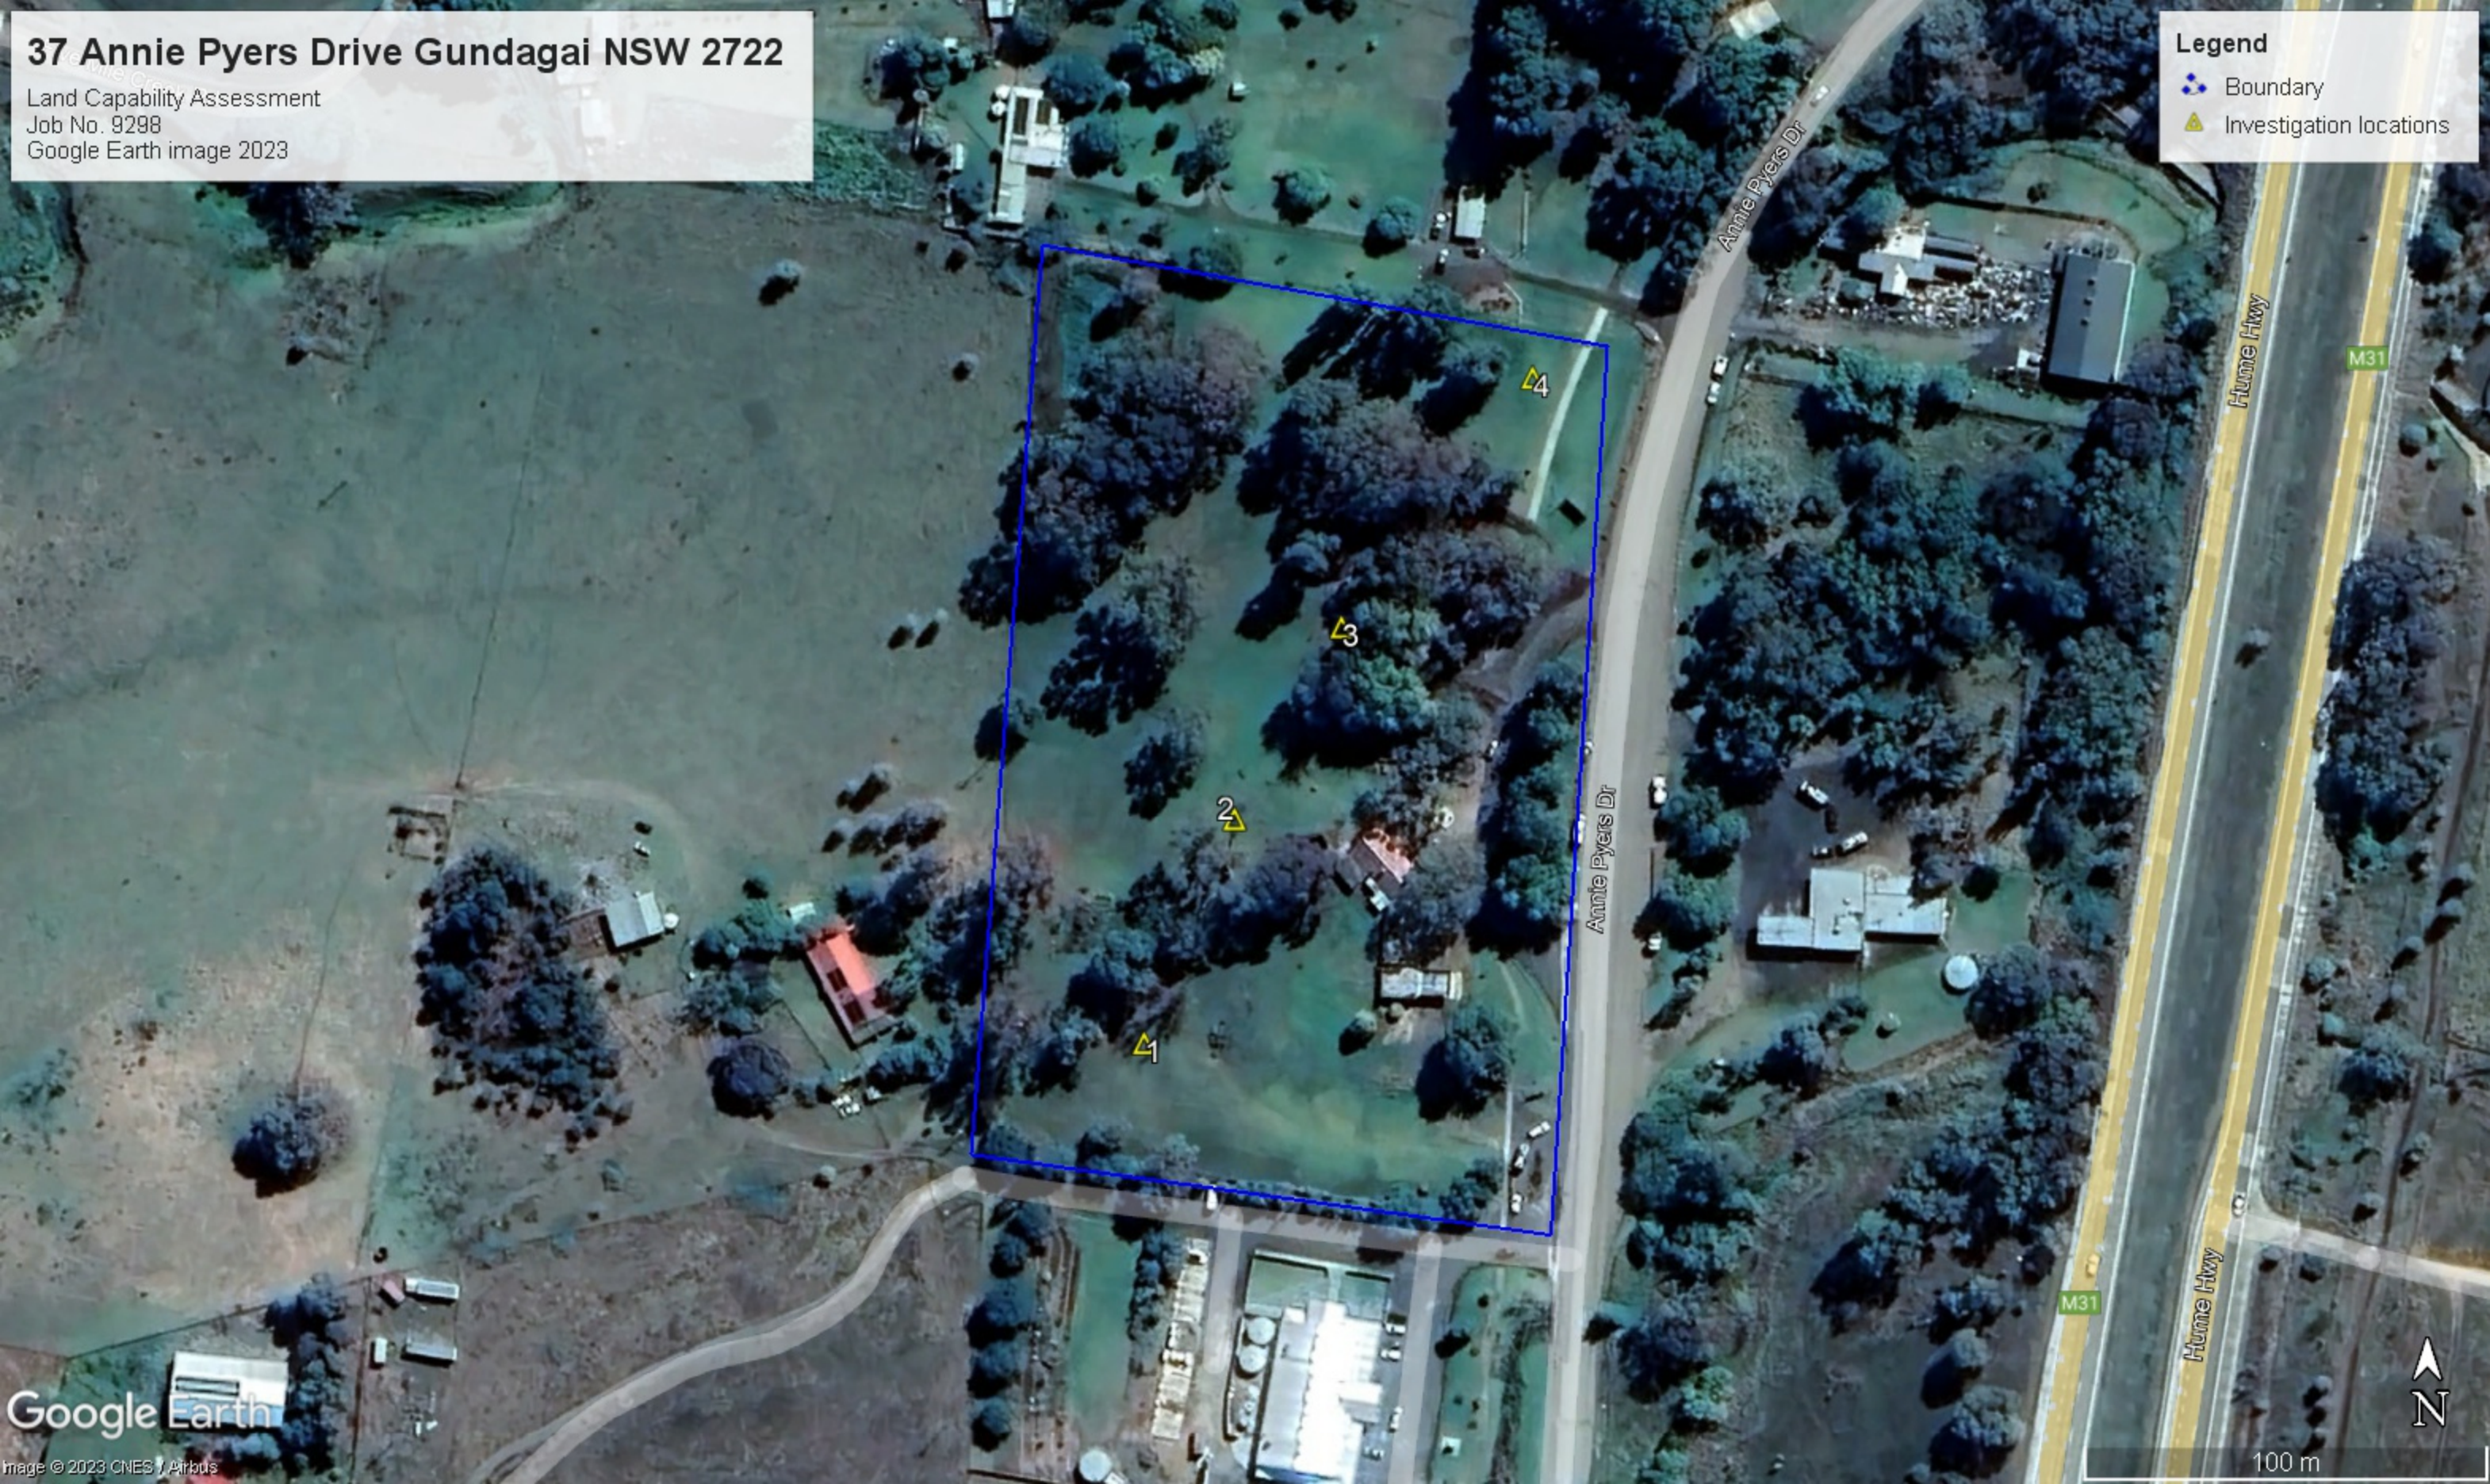
McMahon conducted a site and soil assessment and found that soils on site have a strong relationship with the slope sequence, which are characterised by deep reddish clayey residual soil on the high elevations, deep brownish clay loam colluvial and residual soil on the mid elevations, and deep dark brown clay loam alluvial soil on the low elevations. A map of the investigation locations can be seen in **Attachment B** and the log sheets with soil descriptions and field test results can be seen in **Attachment C**.
