PRELIMINARY SITE INVESTIGATION

**Dog on the Tuckerbox
37 Annie Pyers Drive
Gundagai NSW 2722**

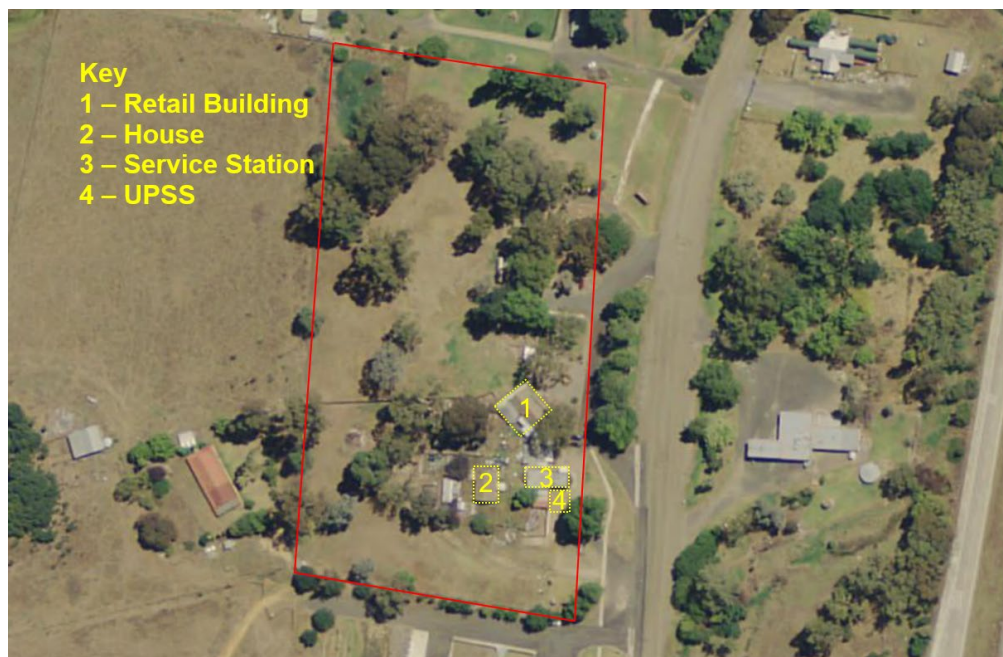
Figure 2.2 – Site Layout

There is a commercial building on the Site that is used for retail purposes which is connected to a service station. There is also a residential building behind the service station. The service station includes a small retail area, forecourt and an Underground Petroleum Storage System (UPSS).

Most of the area across the Site is grass covered with some trees. However, there is a gravel driveway leading to the service station forecourt which is concrete paved. There is also dip/fill points and vent pipe indicating the presence and approximate locations of three Underground Storage Tanks (USTs).

The Site is outlined in red and surrounding properties shown on Figure 2.2 – Site Layout.

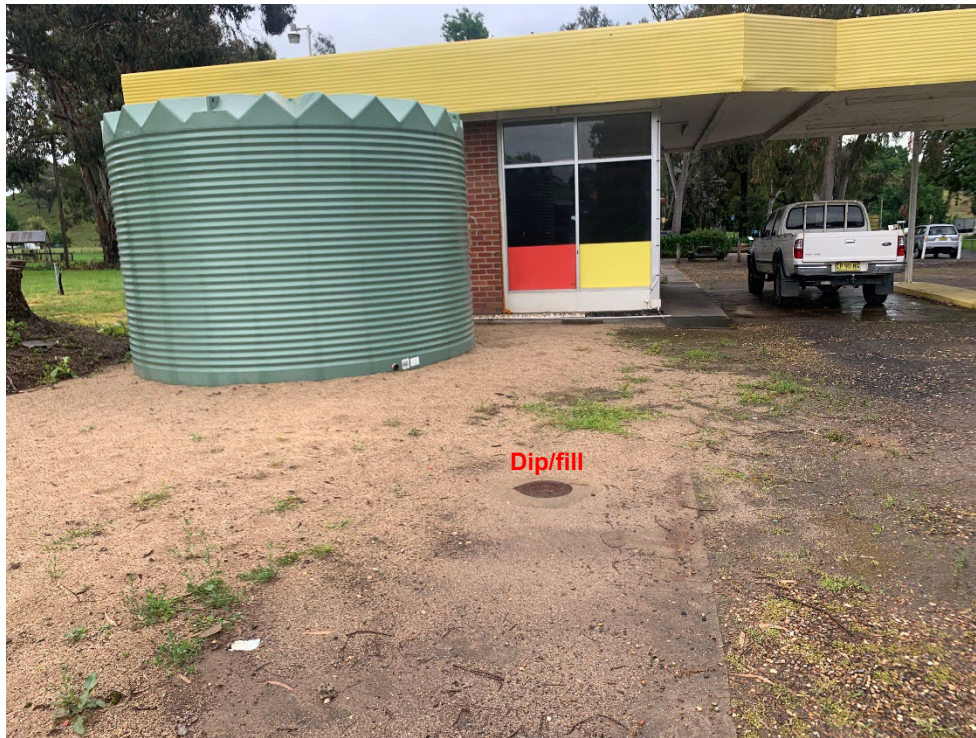
During the inspection three fill points for USTs were observed and there are three vent pipes attached to the rear wall of the service station building. Based on these observations there is likely to be at least 3 USTs at the Site. However, it is acknowledged that if the service station was commissioned in 1961 additional USTs may have been installed and redundant USTs decommissioned but left in place.

The dip/fill points observed at the Site was directly south of the closed service station building and the vent pipes at the south west corner of the service station building. The service station building is shown in Figure 7.1 – Service Station Building with one of the dip fill points in this area visible. The vent pipe are shown in Figure 7.2 – Rear of Building.

- The UPSS at the Site is decommissioned in accordance with current Australian Standards and relevant NSW regulations by an appropriately licenced civil contractor. The decommissioning is considered to be Category 2 remediation work which requires notification of the decommissioning of the UPSS to the local Council. Notification must also be submitted to Safework NSW in accordance with Dangerous Good Licensing. All UPSS should be disposed of appropriately at a licenced facility permitted to receive the tanks and pipes;

- An environmental assessment must be undertaken during the removal of the UPSS in accordance with NSW EPA guidelines. Where soil or groundwater contamination is encountered at levels considered to represent a potential risk to human health or the environment, remediation must be undertake;
