REMEDIAL ACTION PLAN

PROPOSED SENIORS LIVING DEVELOPMENT
669 - 683 OLD SOUTH HEAD ROAD, VAUCLUSE NSW

PREPARED FOR
OSHR AT VAUCLUSE HOLDINGS PTY LTD
REPORT ID: E23026VAU-R03F

Date: 16th November 2022

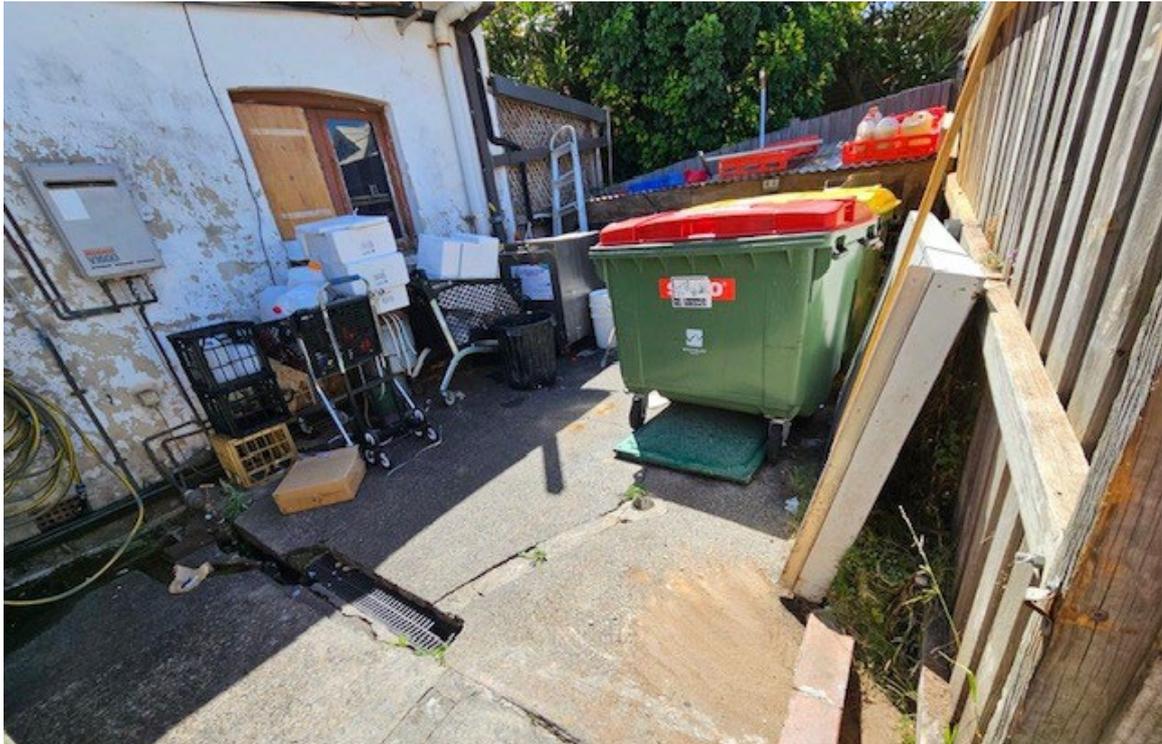
Plate 1: Rear yard of No. 669 Old South Head Road

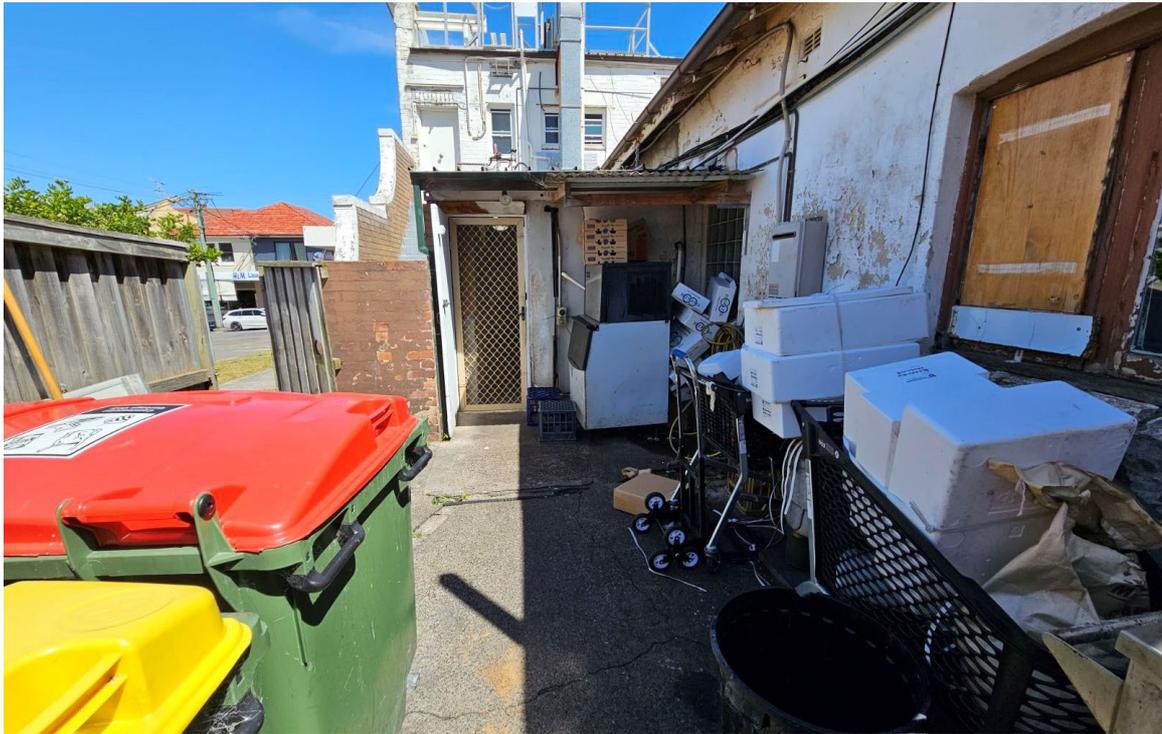
Plate 2: Rear Yard of No. 669 South Head Road

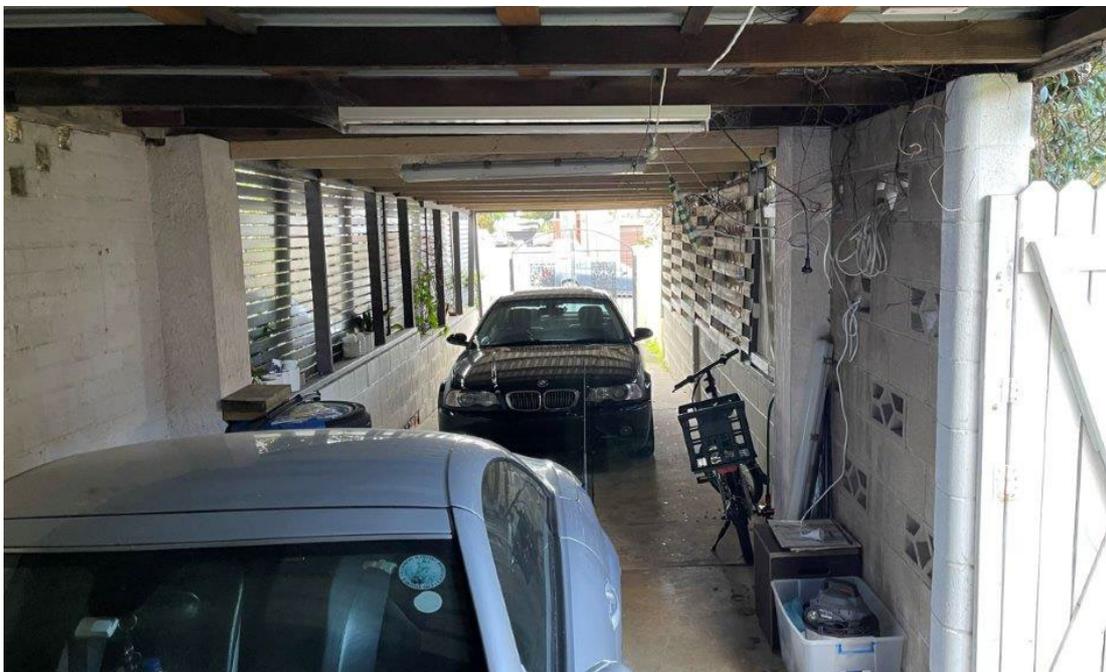
Plate 3: Driveway at the rear of No. 671 Old South Head Road

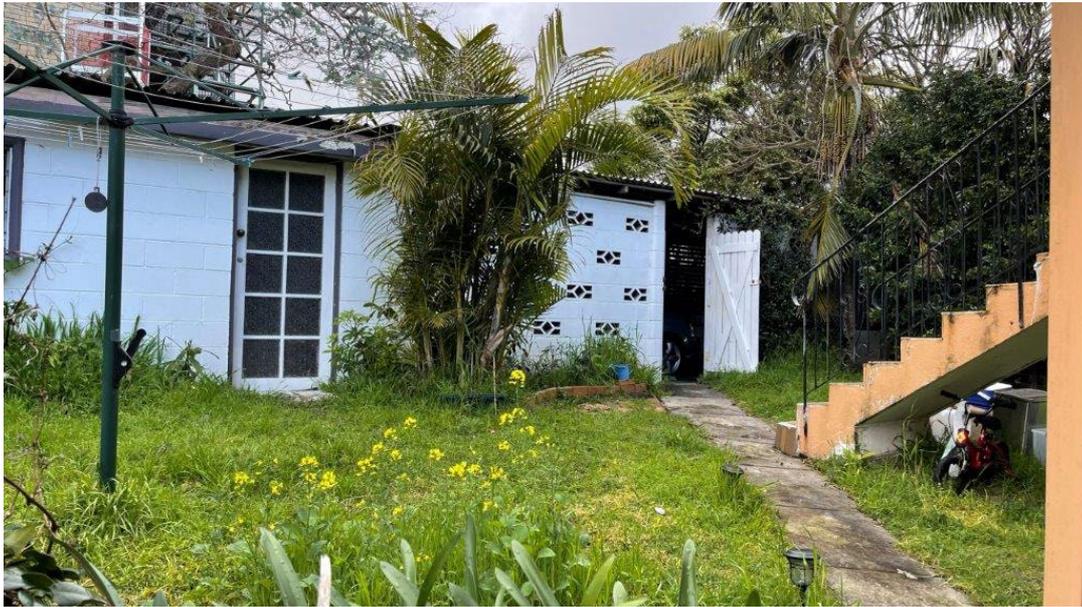
Plate 4: Rear Yard of No. 671 South Head Road

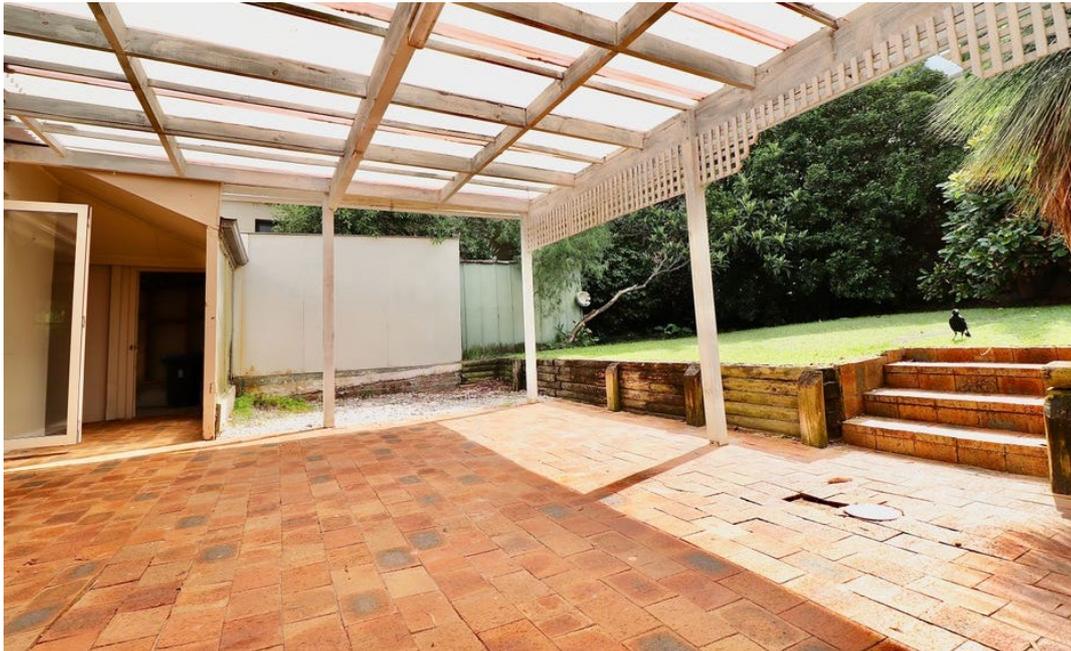
Plate 6: Rear Yard of No. 673 South Head Road

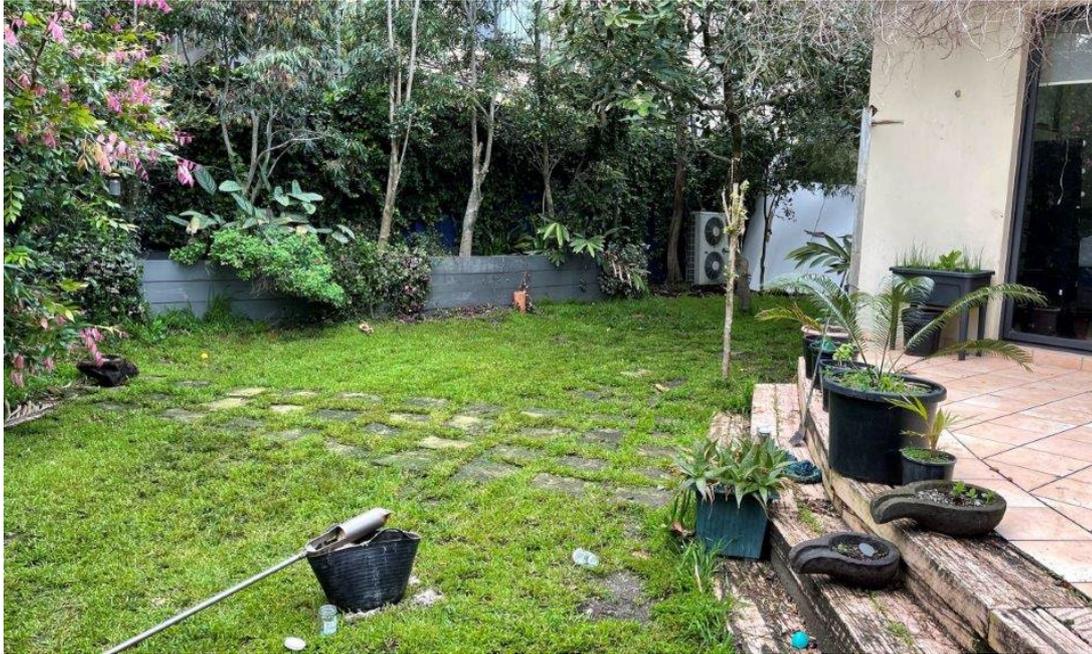
Plate 8: Rear yard of No. 675 Old South Head Road

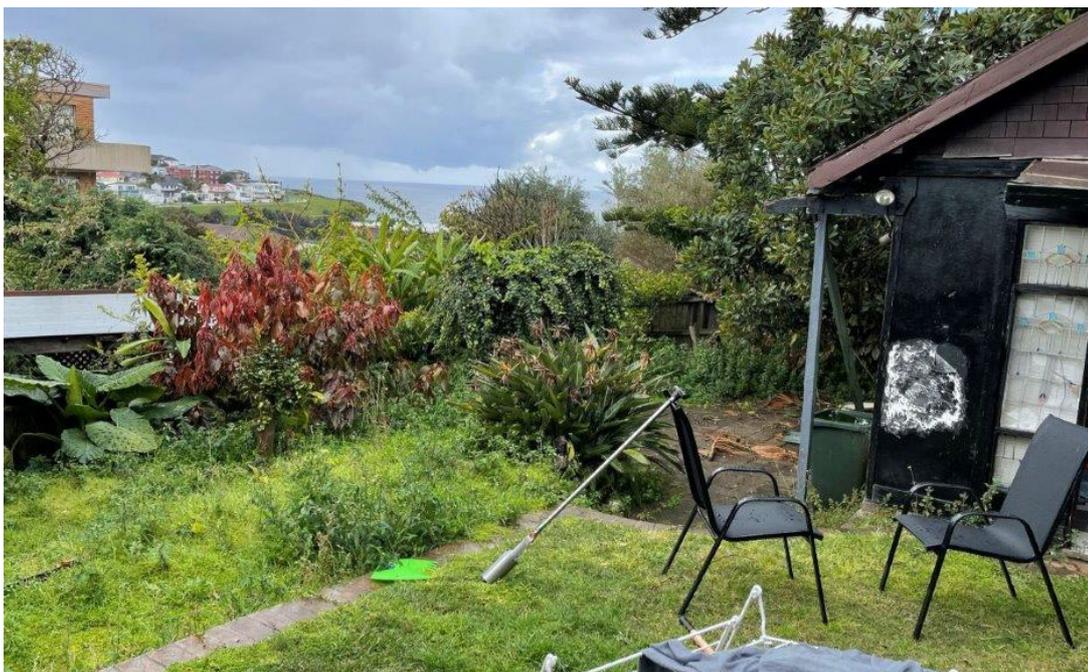
Plate 11: Rear yard of No. 679 Old South Head Road

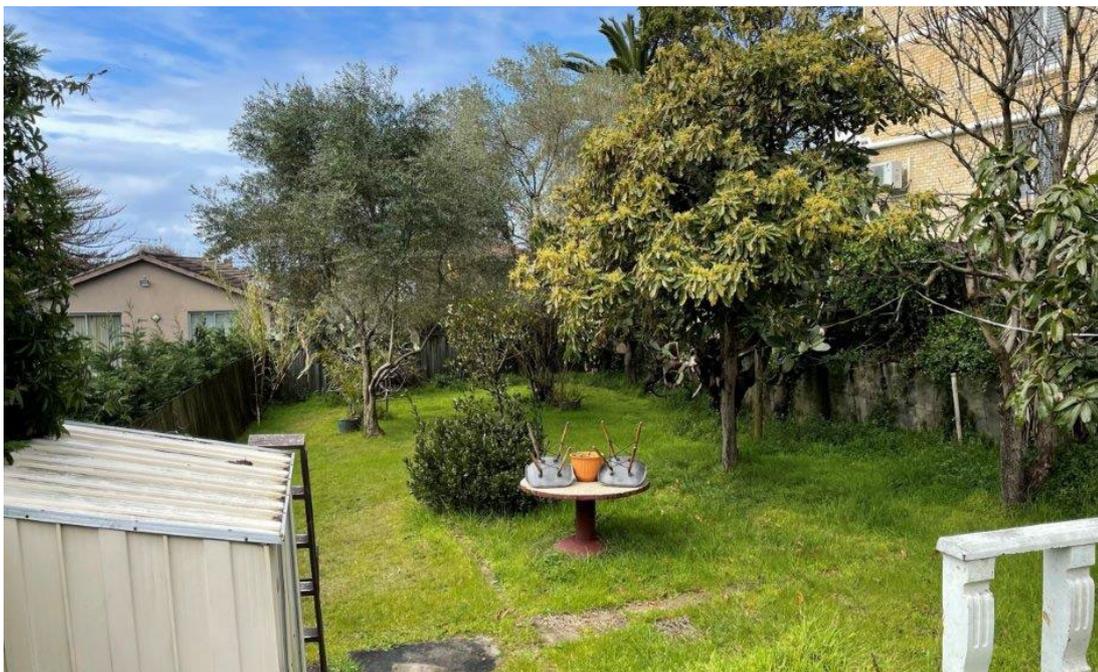
Plate 13: Rear yard of No. 681 Old South Head Road

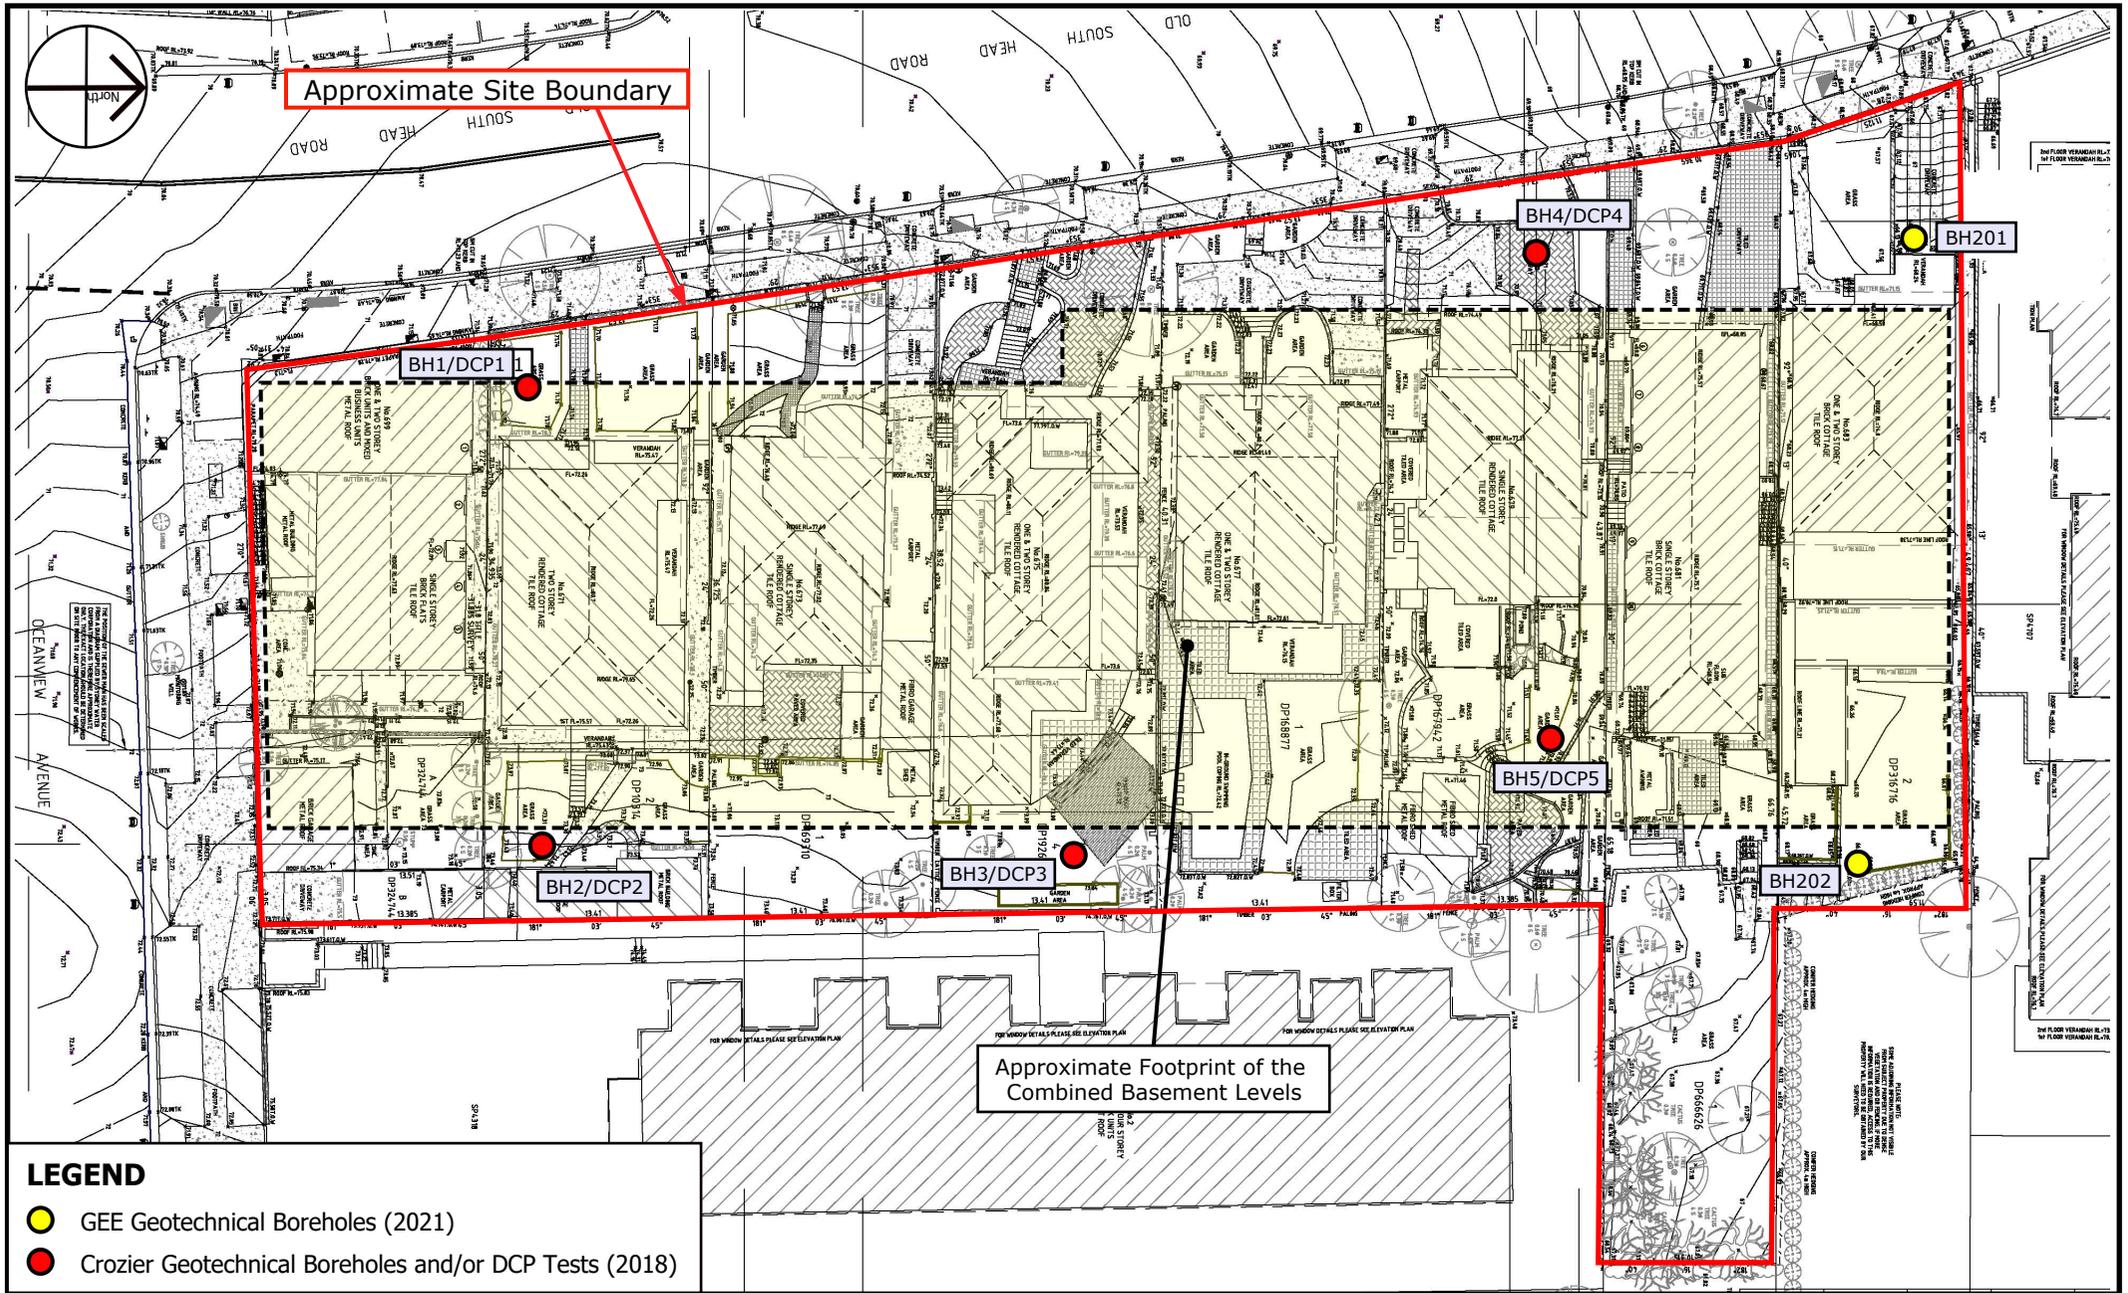
FIGURE No.: 2
 REVISION: A

- GEE Geotechnical Boreholes (2021)
- Crozier Geotechnical Boreholes and/or DCP Tests (2018)
