GEOTECHNICAL INVESTIGATION REPORT

PROPOSED SENIORS LIVING DEVELOPMENT
671 - 683 OLD SOUTH HEAD ROAD, VAUCLUSE NSW

PREPARED FOR
OSHR AT VAUCLUSE HOLDINGS PTY LTD
REPORT ID: G21071VAU-R01F

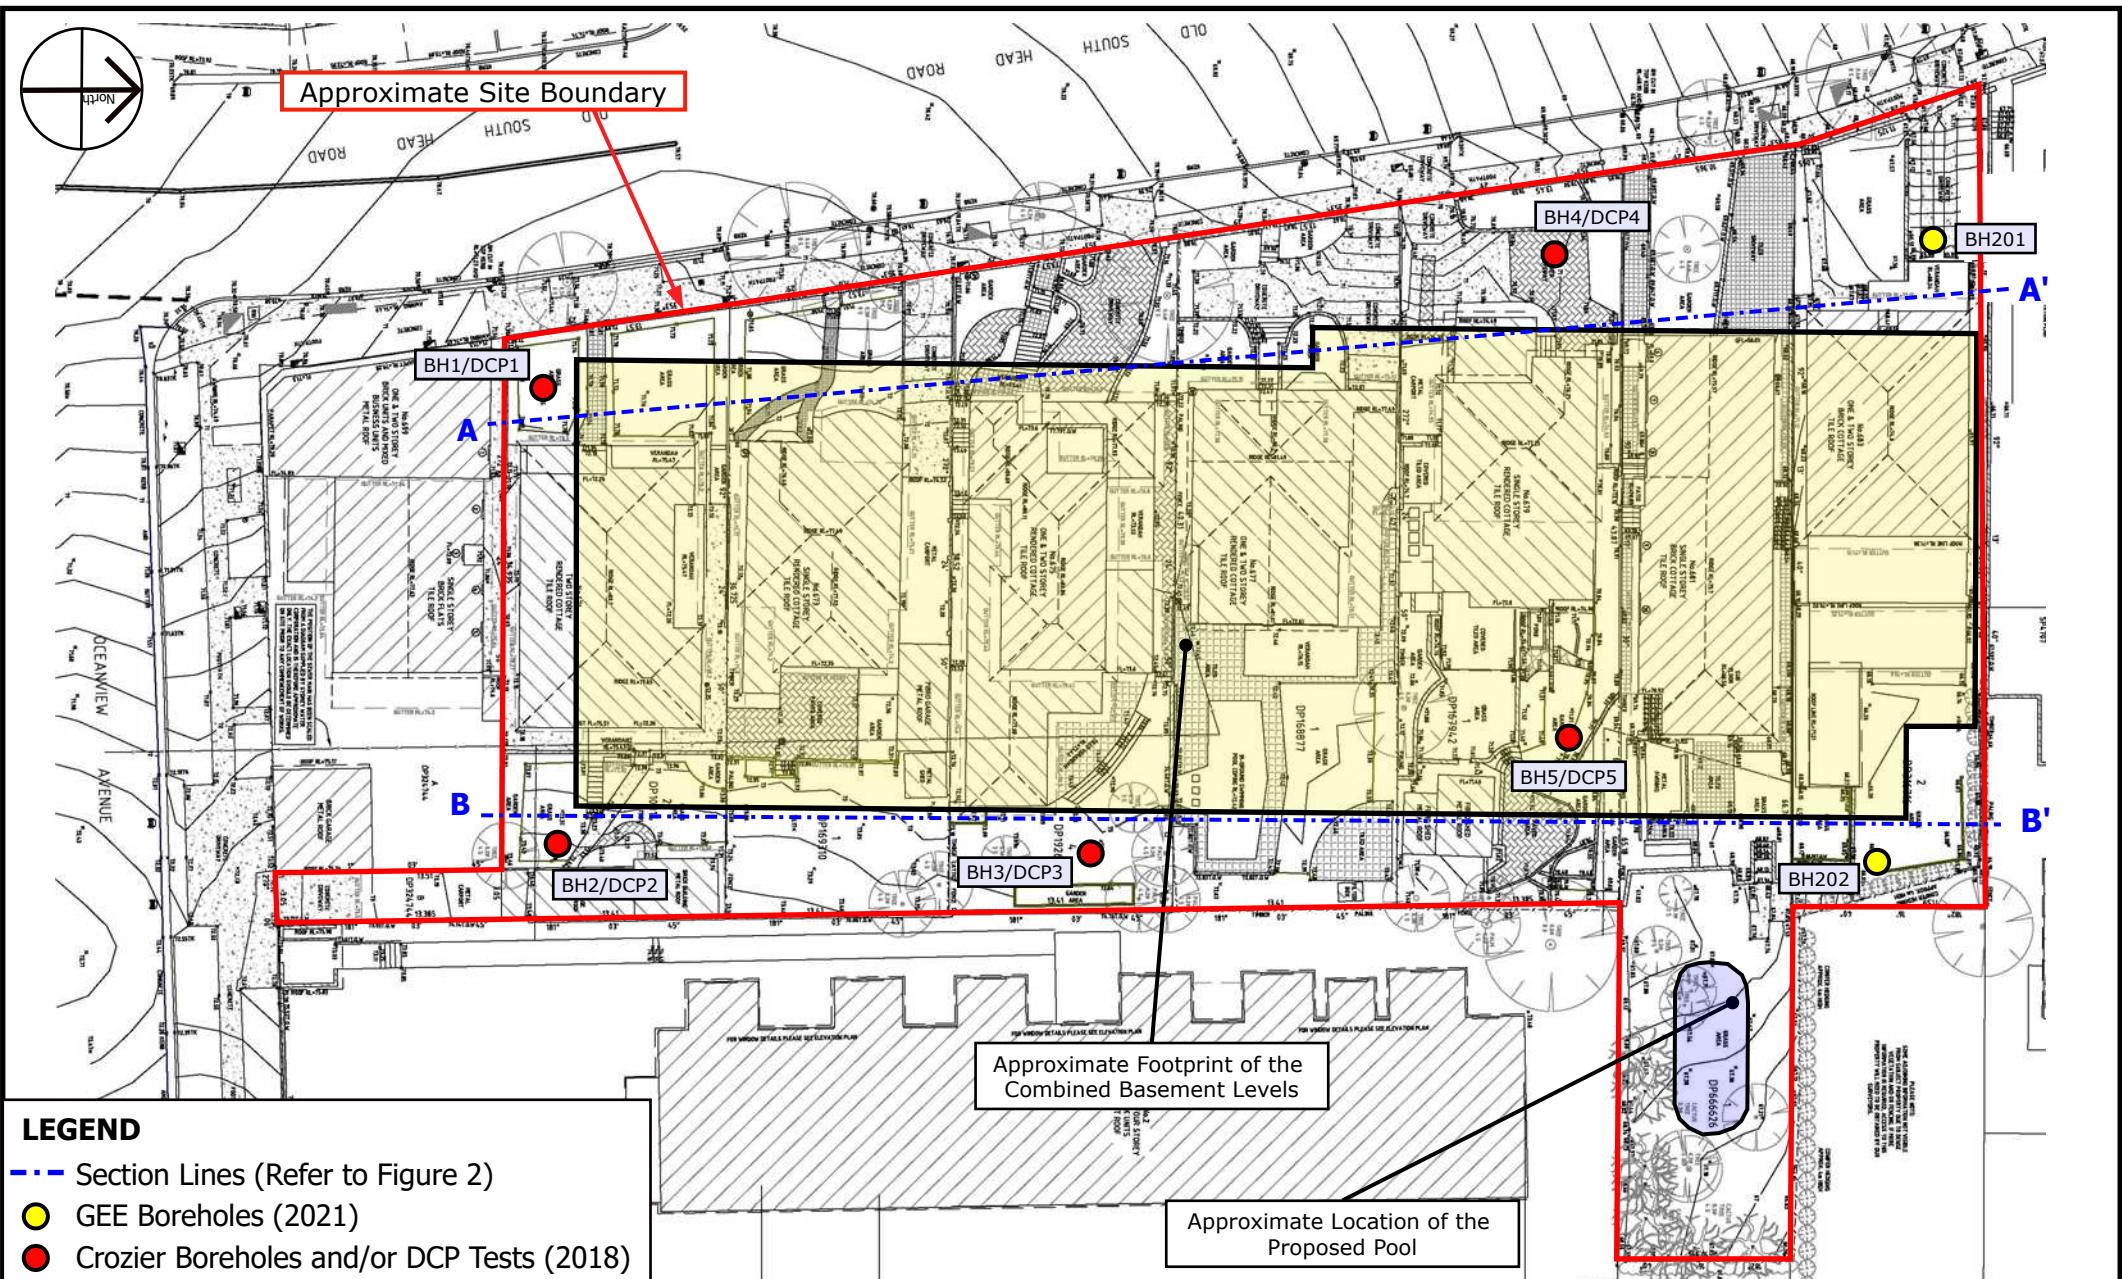
- 1 – Site Plan
- 2 – Site Sections A-A' and B-B'

- Section Lines (Refer to Figure 2)
- GEE Boreholes (2021)
- Crozier Boreholes and/or DCP Tests (2018)

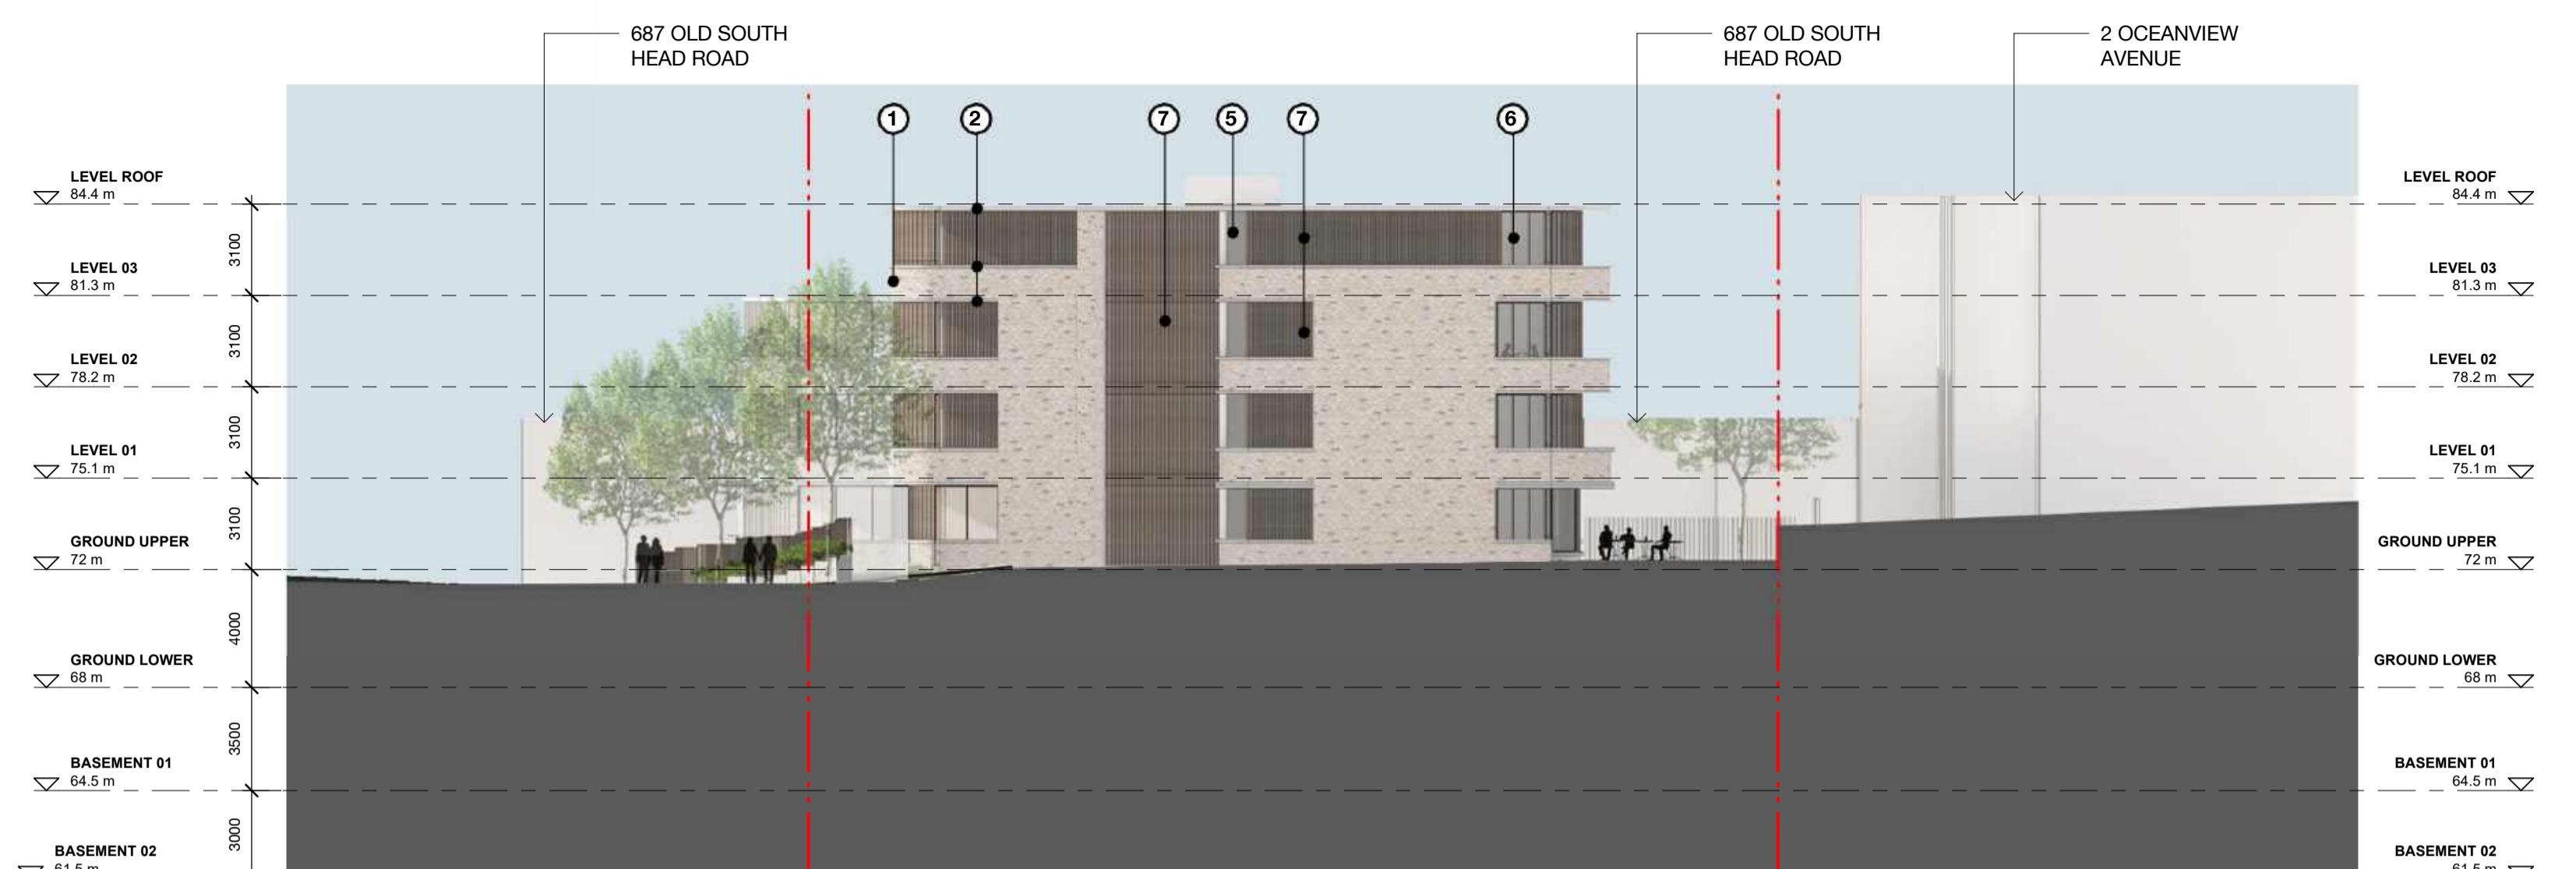
1 SOUTH ELEVATION

- ① BRICK
- ② CONCRETE SLAB
- ③ TERRACOTTA SCREEN
- ④ GLASS BRICKS
- ⑤ GLASS - FIXED, AWNING WINDOWS AND SLIDING DOORS
- ⑥ METAL 01 - GLAZING FRAMES
- ⑦ METAL 02 - BALUSTRADE HANDRAILS
- ⑧ LANDSCAPE PLANTING
