Statement of Environmental Effects

Sonnblick Lodge demolition

10 Bobuck Lane, Thredbo Alpine Village

November 2023

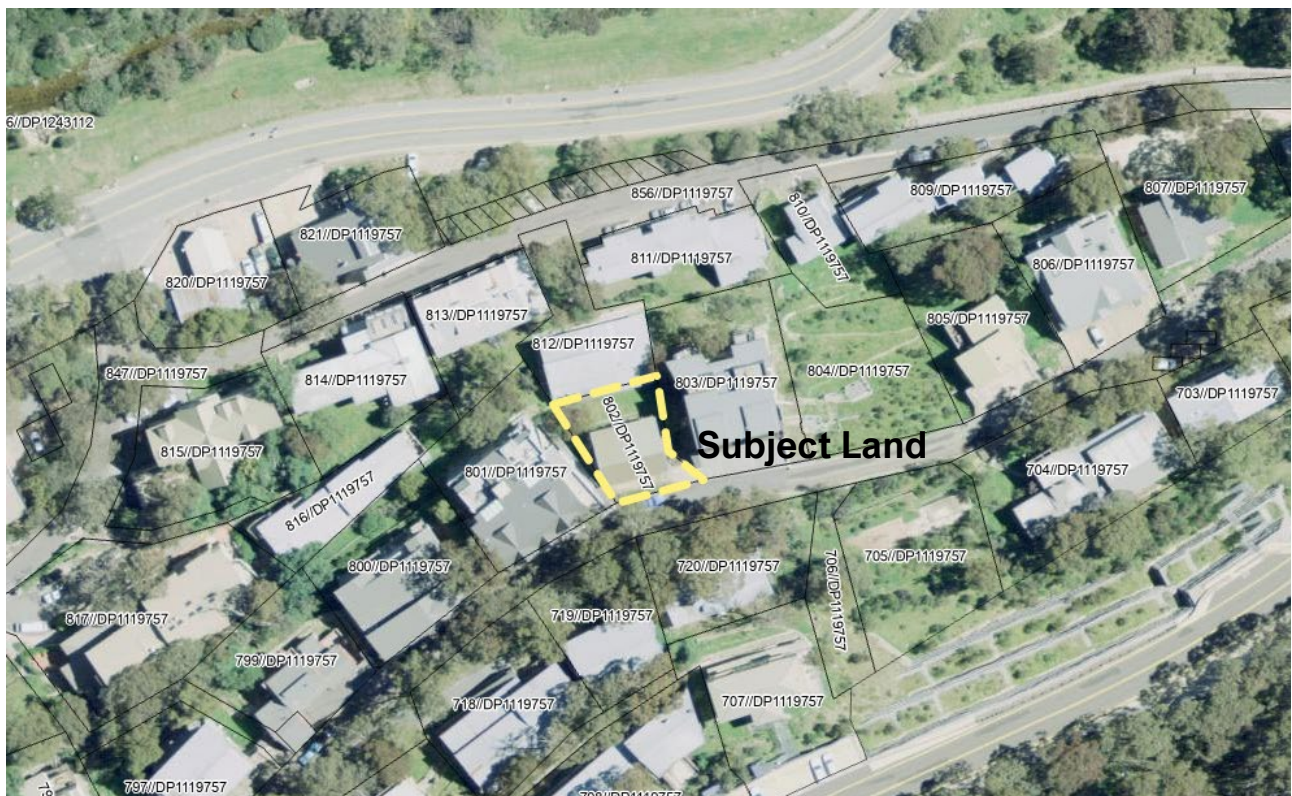
Figure 1-1 Aerial image of the subject land (Source: NSW Planning Portal, 2023)

The subject land is described as 10 Bobuck Lane, Thredbo, as shown in Figure 1-1. The land is legally identified as Lot 802 DP1119757. The land is surrounded by lodge accommodation within the Thredbo Village, see Figure 1-2. The land slopes from south to north and has minimal vegetation present. The land is near the Thredbo Landslide Site Memorial.

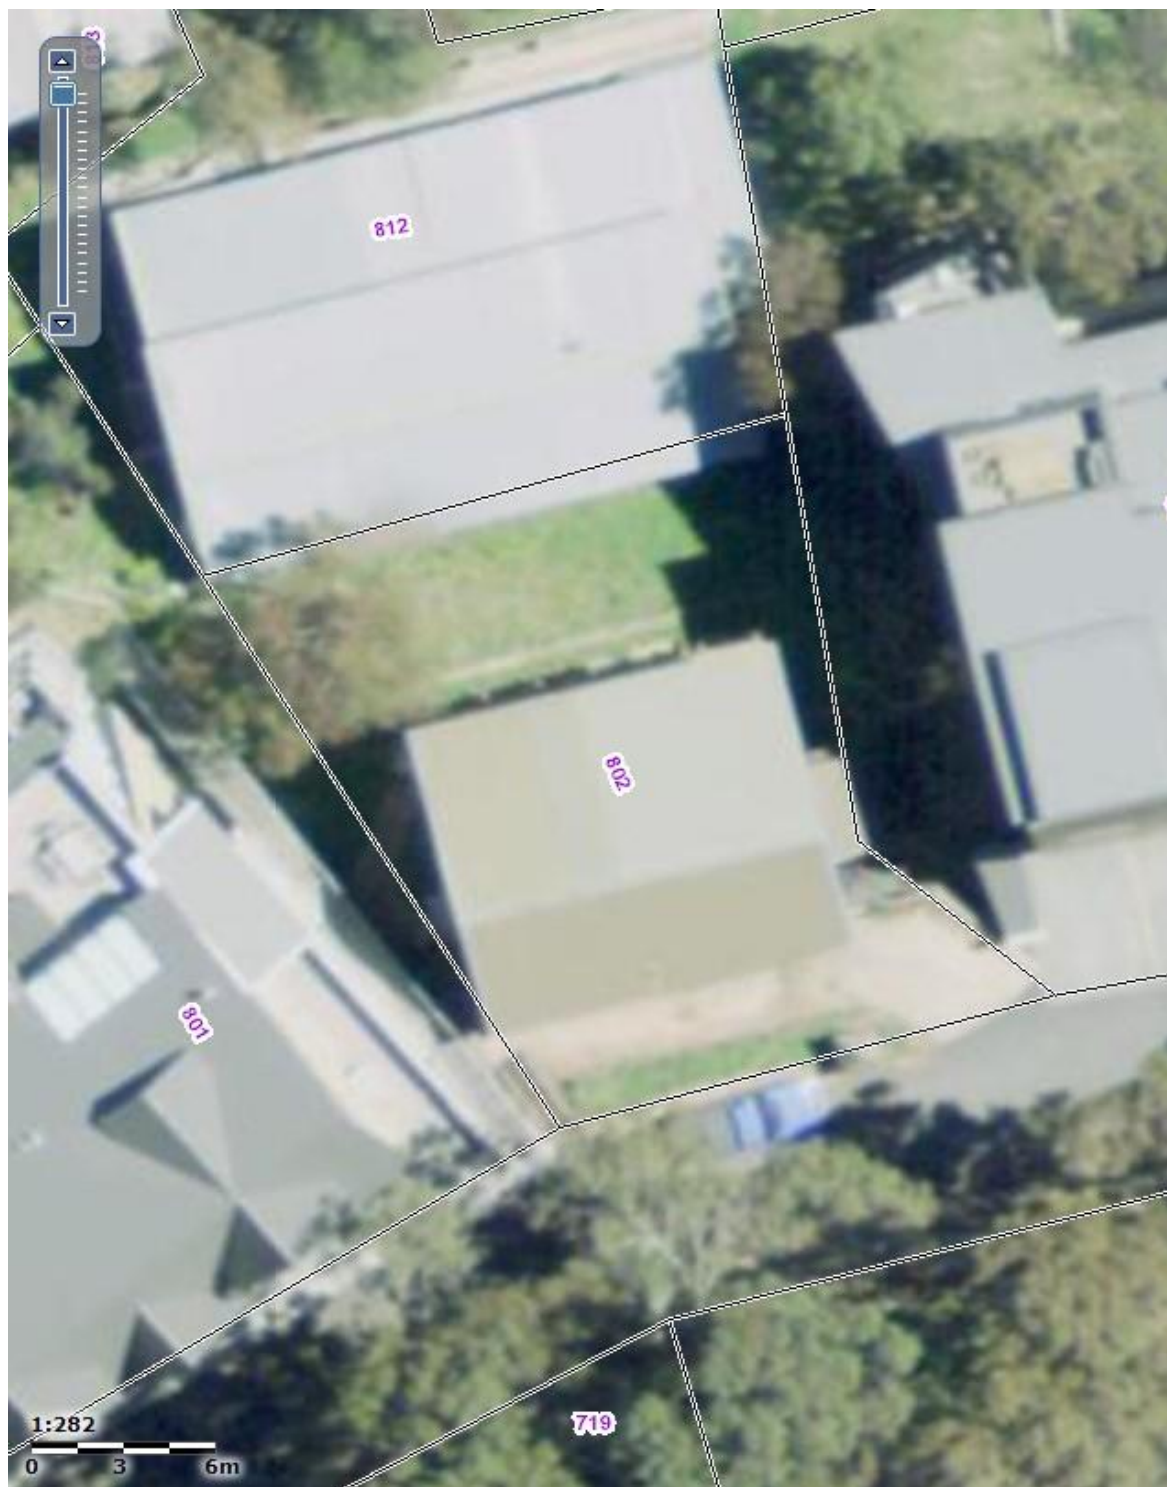
FIGURE 1

KOSCIUSZKO THREDBO PTY LTD
PROPOSED DEMOLITION & REDEVELOPMENT - SONNBlick LODGE – 10 BOBUCK LANE, THREDBO, NSW
RECENT AERIAL PHOTOGRAPH

The site dips north at the angle of ~35° to 40° from ~RL1398 to ~RL1390 across the block. It does appear that some excavation spoil may have potentially been placed on the downslope portion of the site, assuming from cut-to-fill (~0.5m/1.0m) platform construction. Figure 1 shows the site locality, while Figure 2 is a recent aerial photograph showing the present site layout and the location of the proposed development. Figure 3 is a survey plan of the site, showing the surface

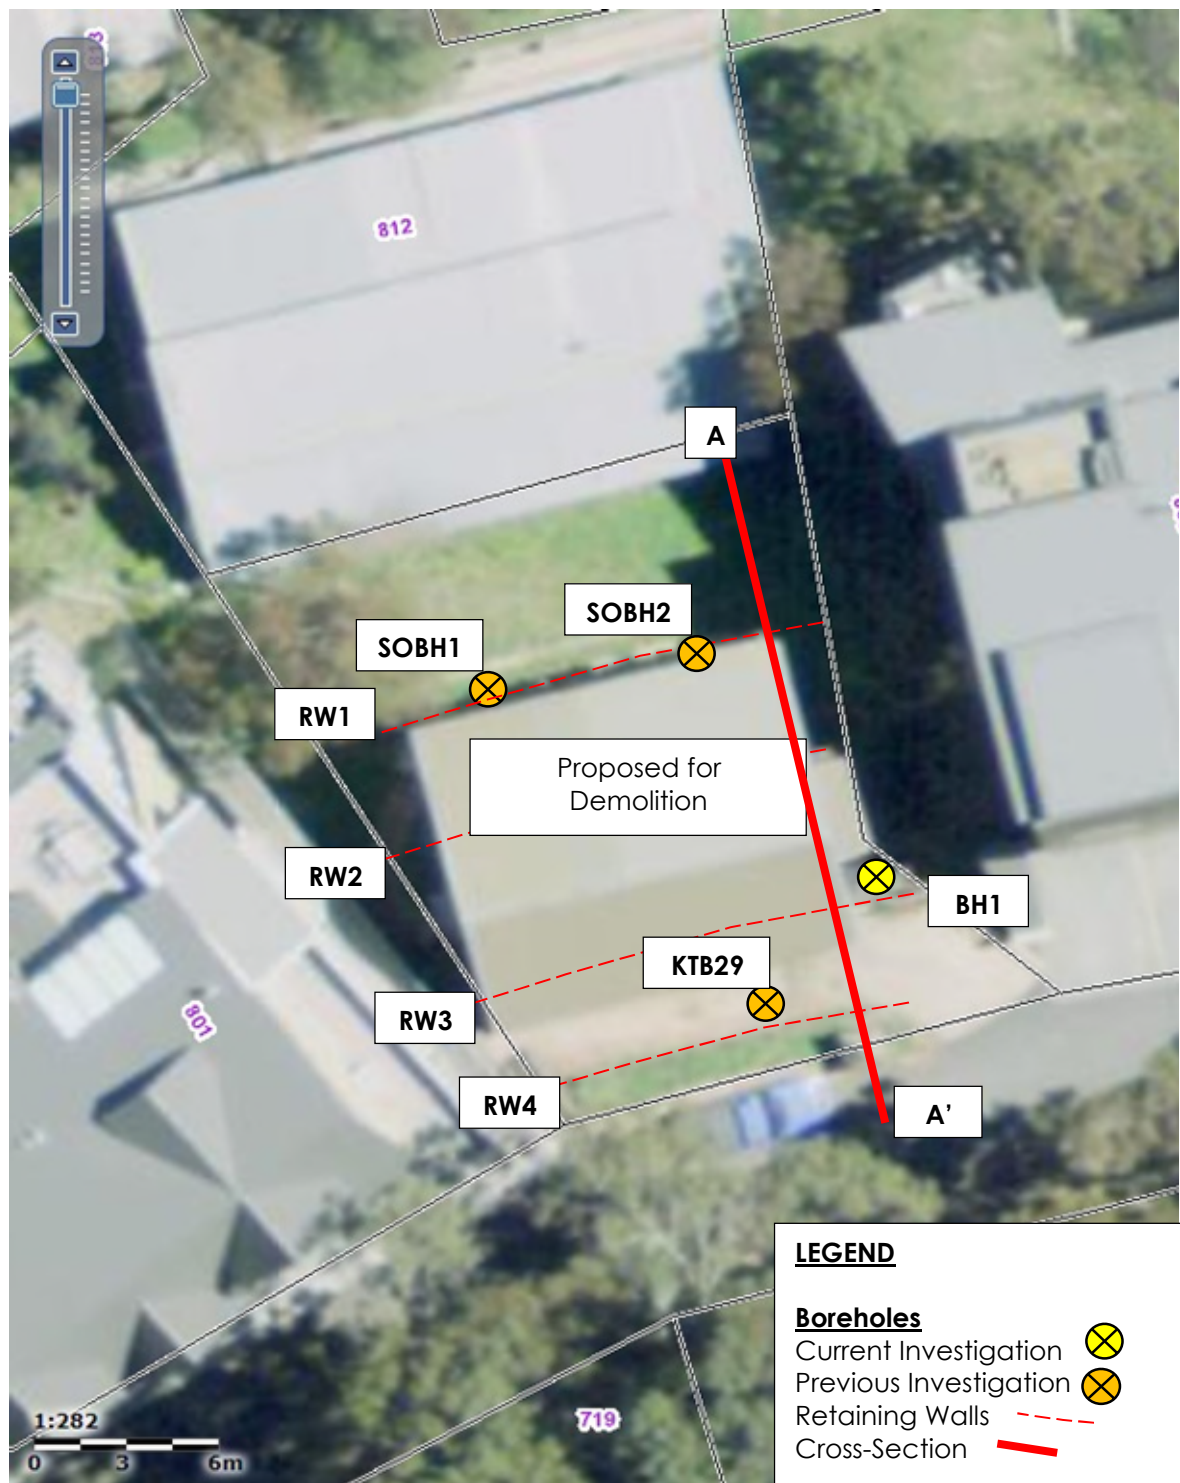
FIGURE 2

KOSCIUSZKO THREDBO PTY LTD
 PROPOSED DEMOLITION & REDEVELOPMENT - SONNBLICK LODGE – 10 BOBUCK LANE, THREDBO, NSW
 AERIAL PHOTOGRAPH & BOREHOLES LOCATIONS

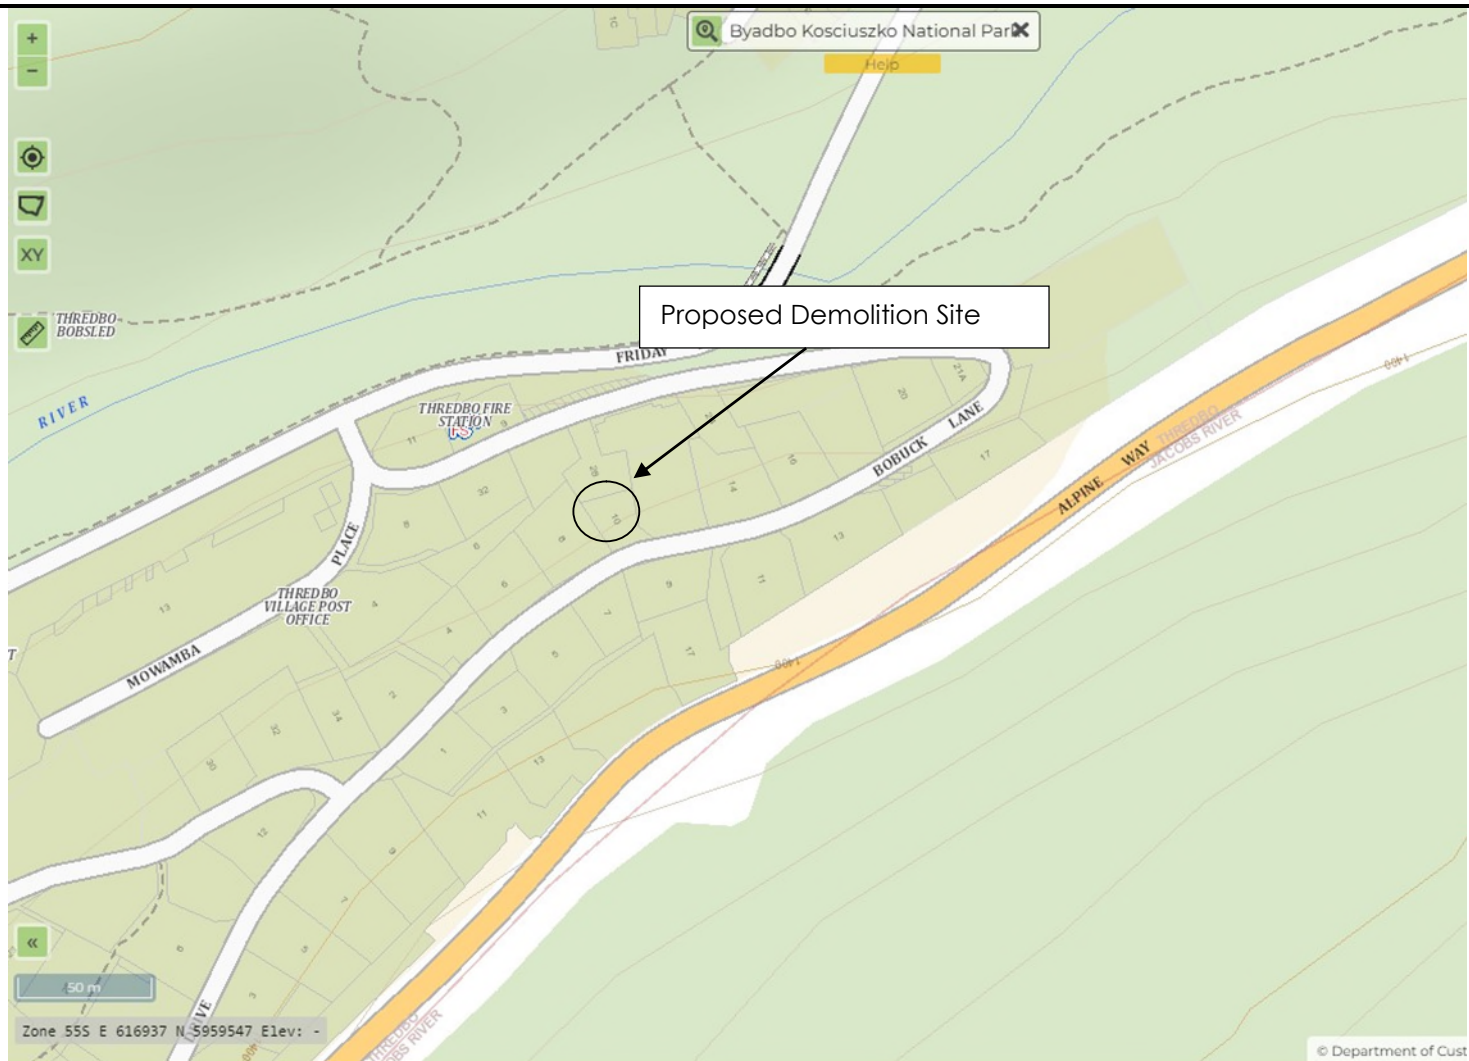
FIGURE 3

KOSCIUSZKO THREDBO PTY LTD
PROPOSED DEMOLITION & REDEVELOPMENT - SONNBLICK LODGE – 10 BOBUCK LANE, THREDBO, NSW
CONTOUR PLAN

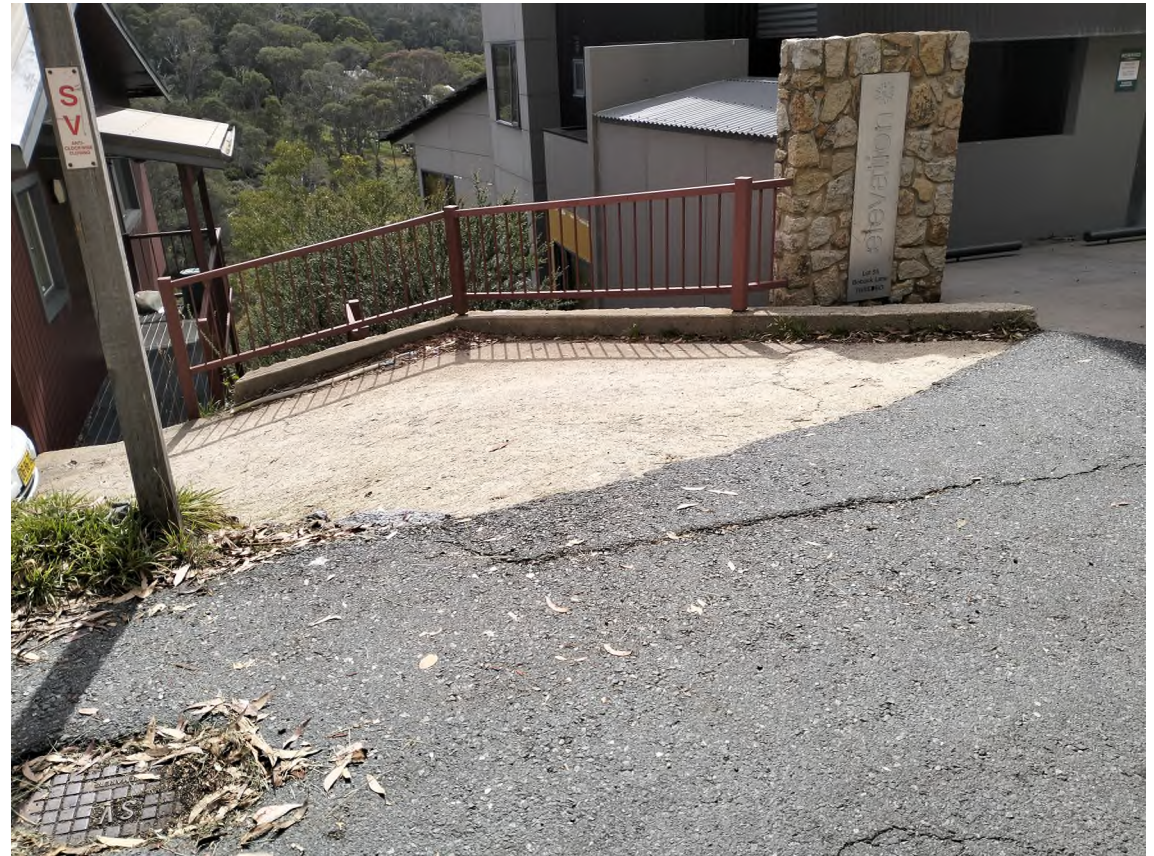
FIGURE 5

KOSCIUSZKO THREDBO PTY LTD
PROPOSED DEMOLITION & REDEVELOPMENT - SONNBLICK LODGE – 10 BOBUCK LANE, THREDBO, NSW
SITE PHOTOGRAPHS – TENSION CRACKS ON THE ROAD PAVEMENT

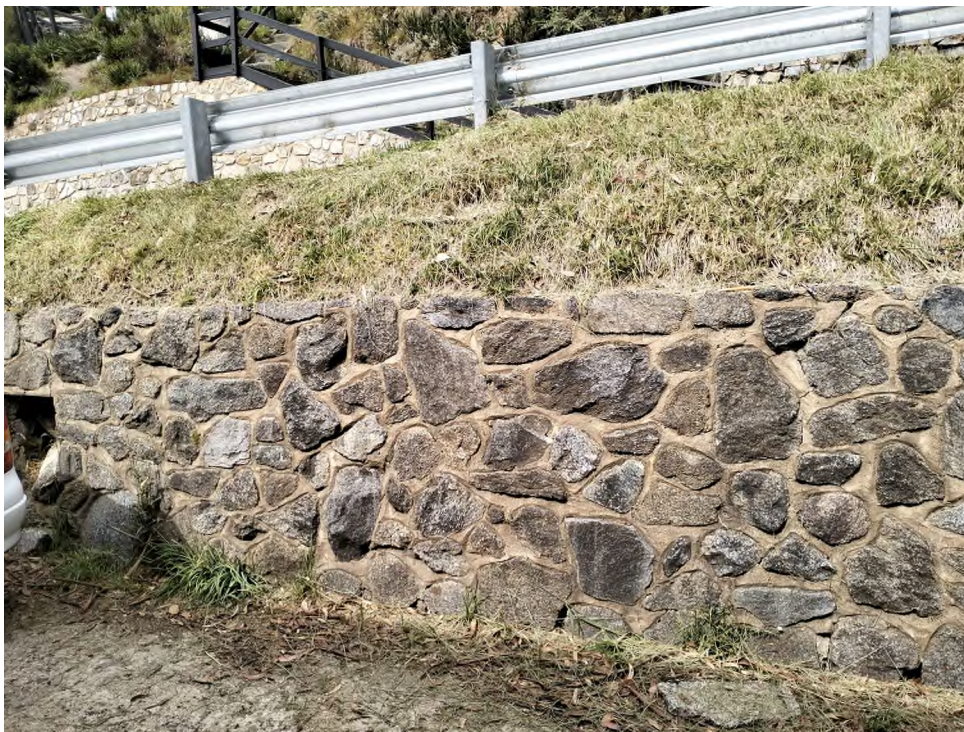
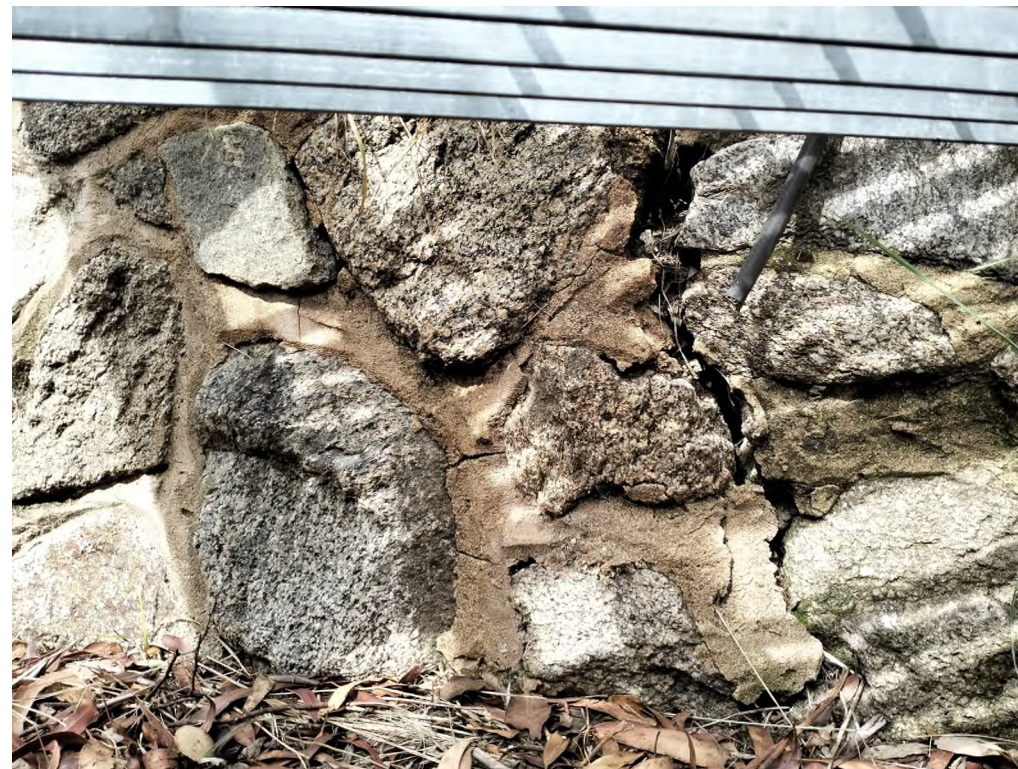
FIGURE 6

KOSCIUSZKO THREDBO PTY LTD
 PROPOSED DEMOLITION & REDEVELOPMENT - SONNBlick LODGE – 10 BOBUCK LANE, THREDBO, NSW
 SITE PHOTOGRAPHS – RW4 (BELOW BOBUCK LANE)

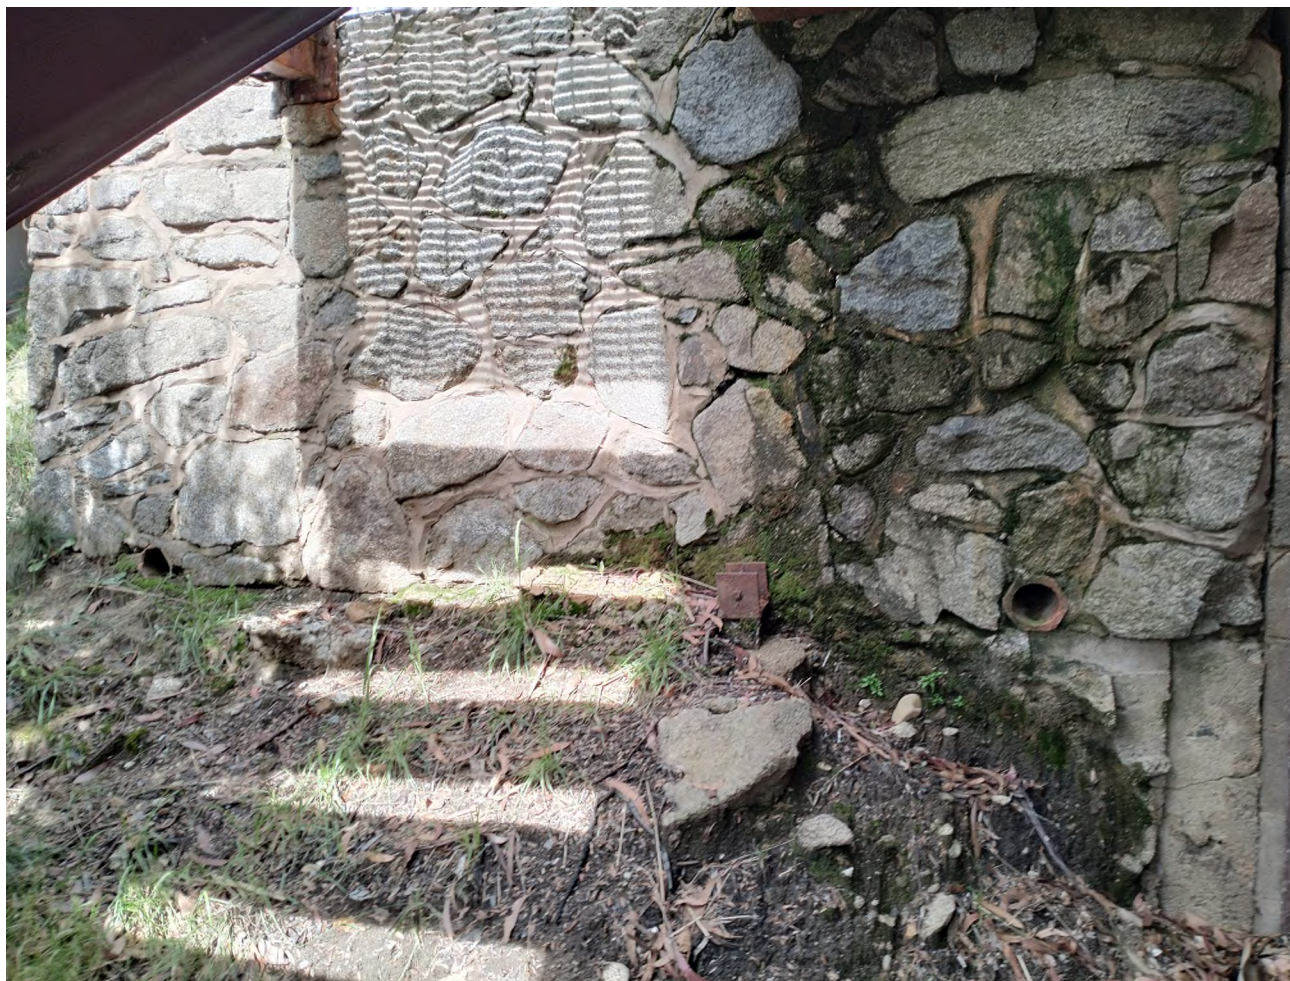
FIGURE 7

KOSCIUSZKO THREDBO PTY LTD
PROPOSED DEMOLITION & REDEVELOPMENT - SONNBlick LODGE – 10 BOBUCK LANE, THREDBO, NSW
SITE PHOTOGRAPH – RW3

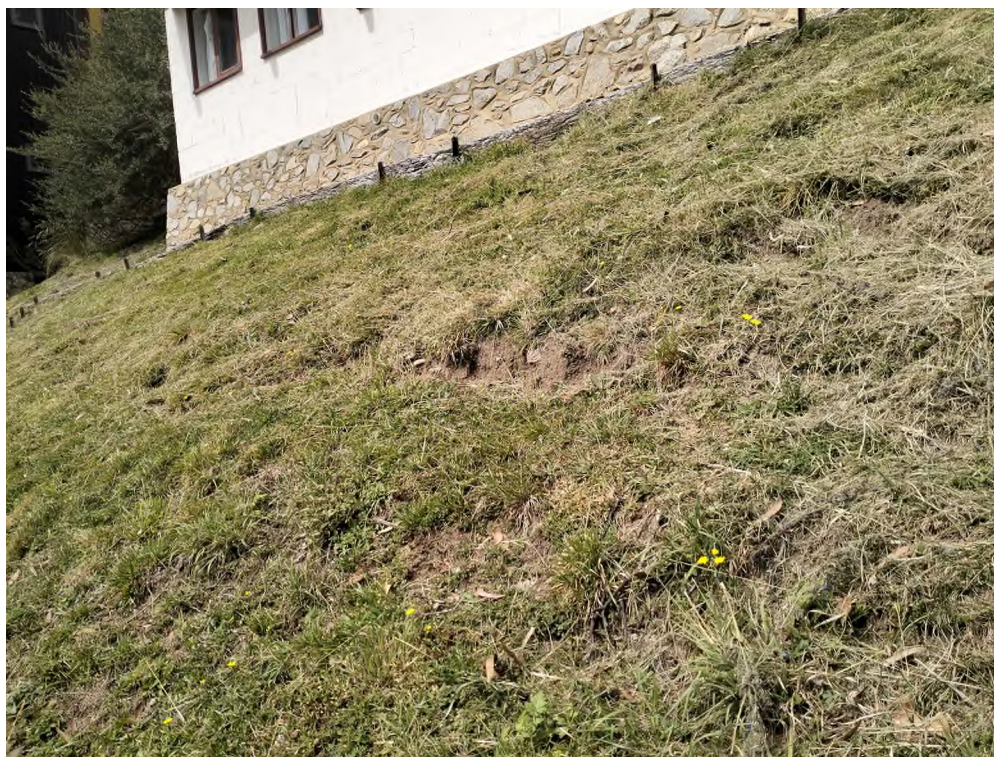
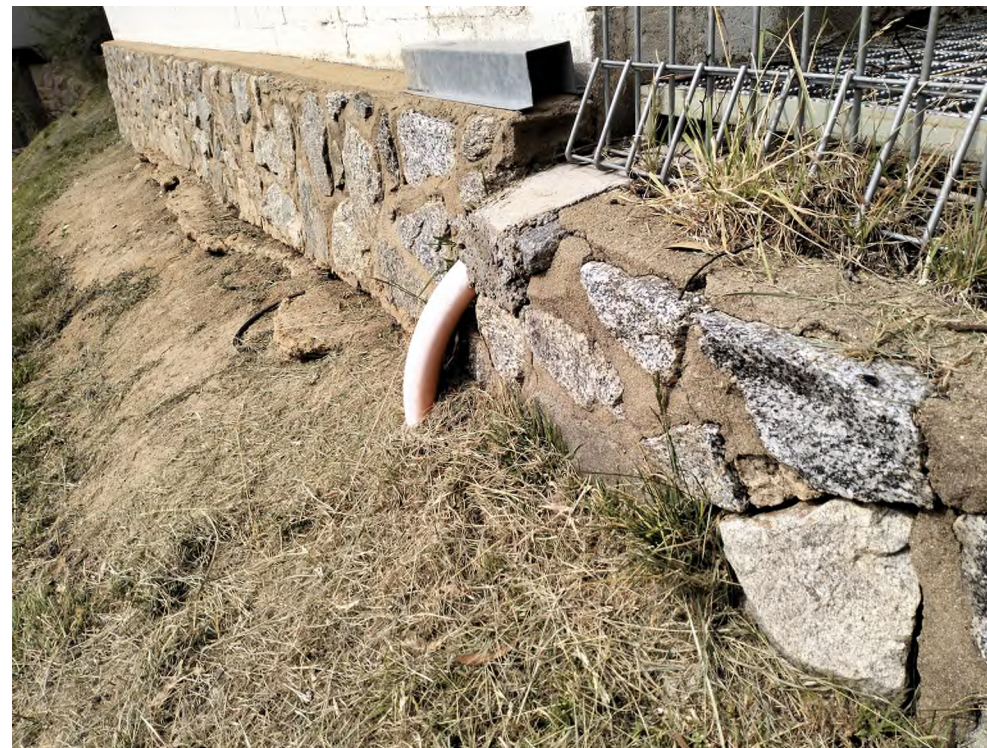
KOSCIUSZKO THREDBO PTY LTD
 PROPOSED DEMOLITION & REDEVELOPMENT - SONNBlick LODGE – 10 BOBUCK LANE, THREDBO, NSW
 SITE PHOTOGRAPHS

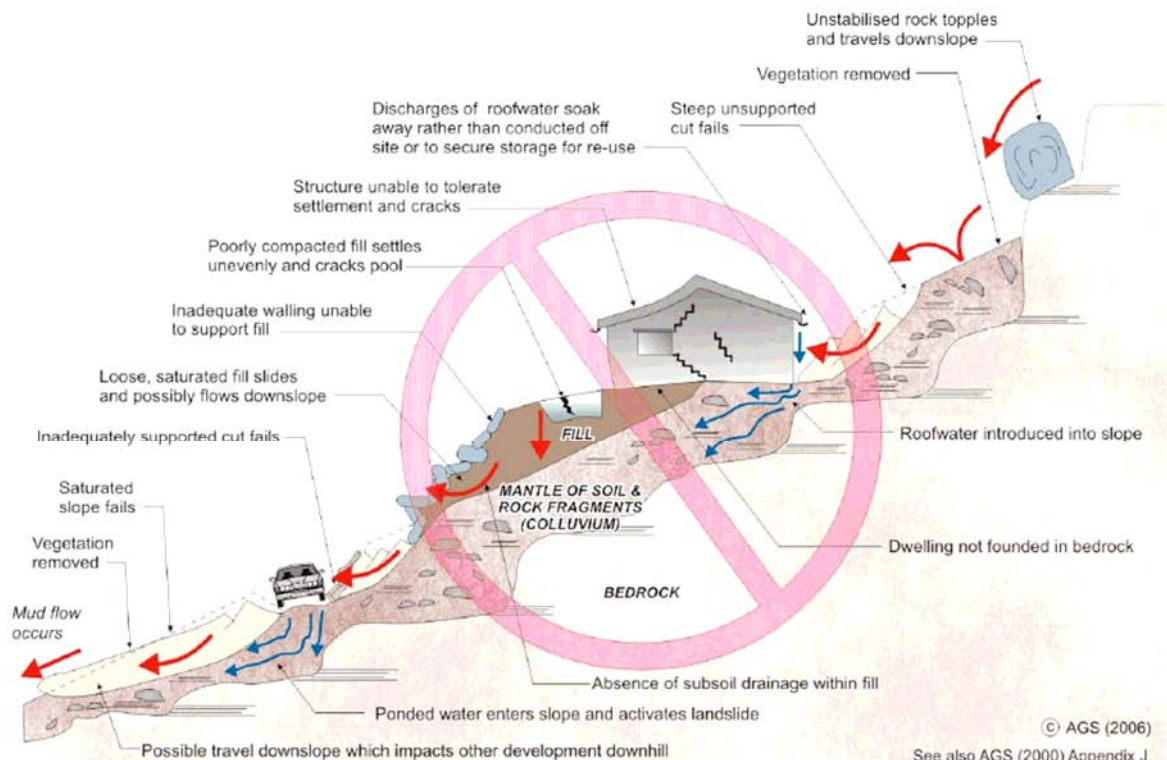
EXAMPLES OF **POOR** HILLSIDE PRACTICE

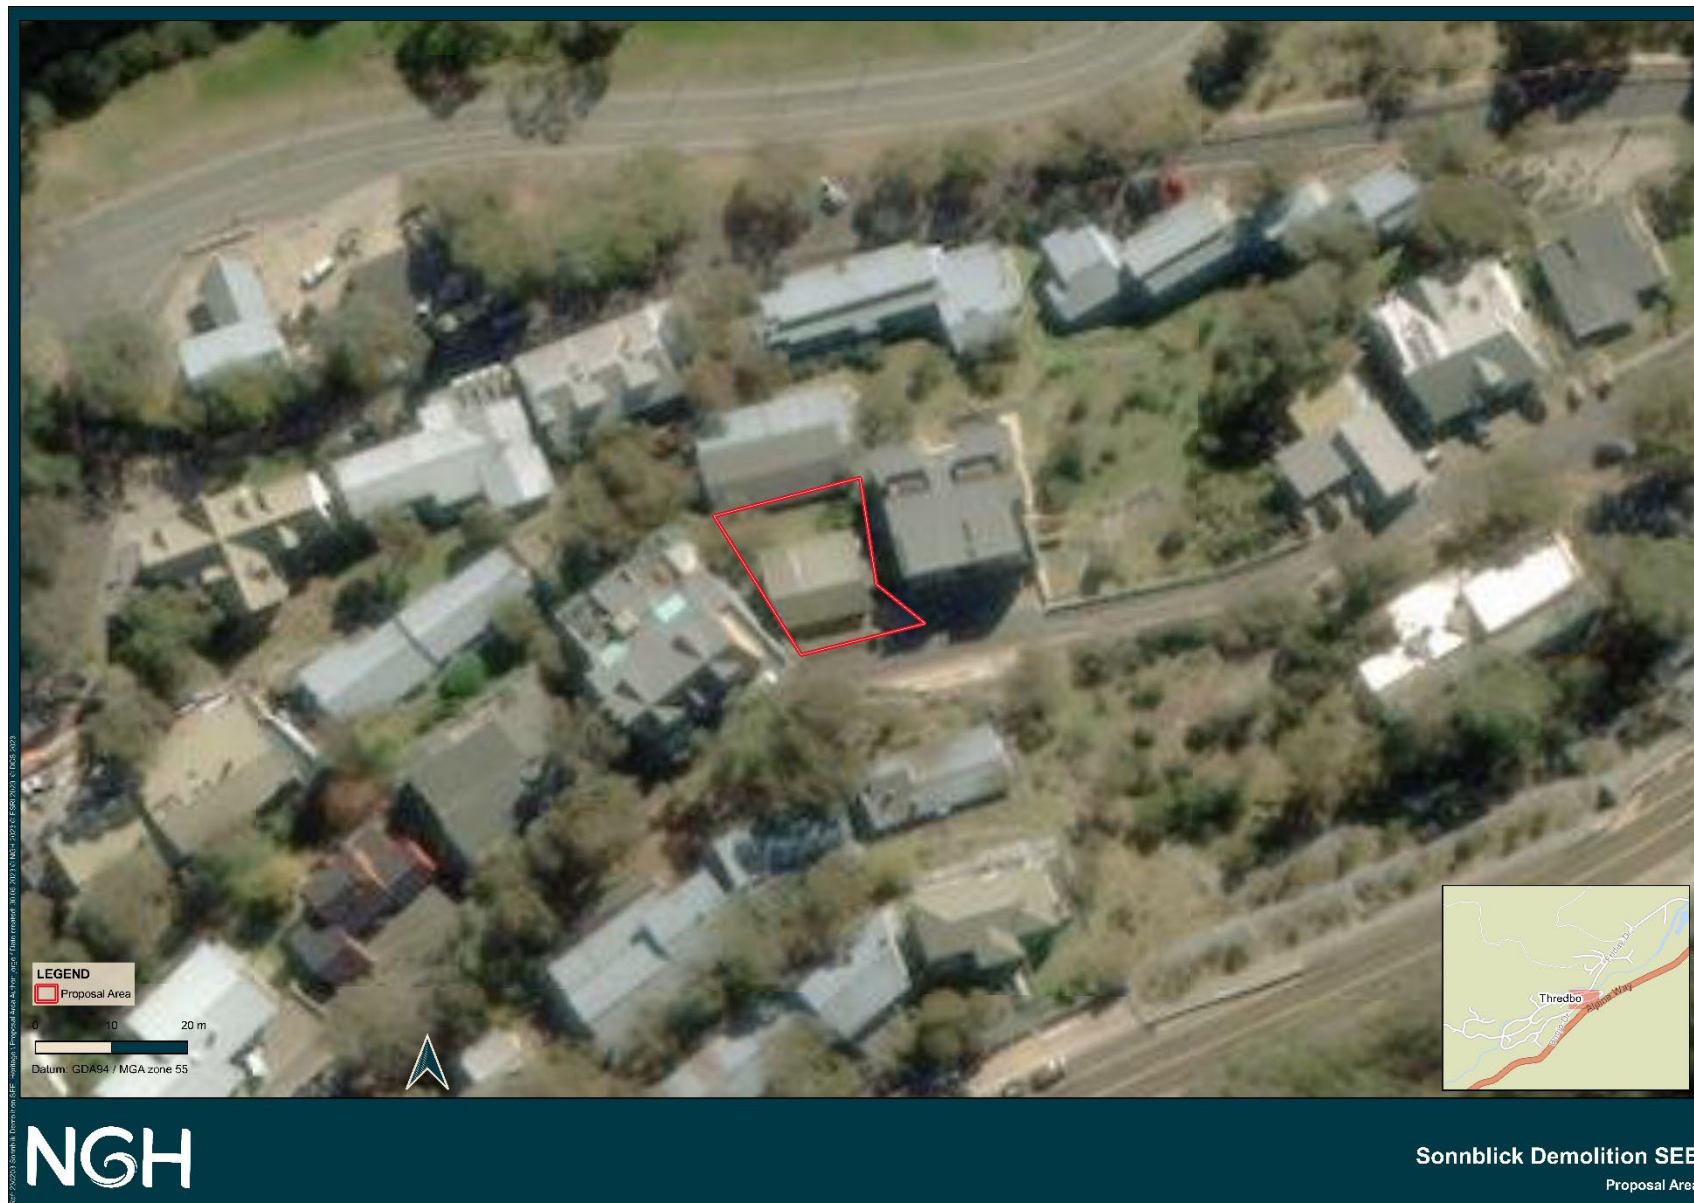
Figure 1-2 The Proposal Area

The subject site is located within Lot 802 DP1119757, at 10 Bobuck Lane, Thredbo (the Proposal Area) (Figure 1-1, Figure 1-2). It is within the Snowy Monaro Regional Council Local Government Area (LGA) and is situated in the eastern precinct of the Thredbo Village. The lodge has been used for staff accommodation and comprises three apartments with 16 beds in total.

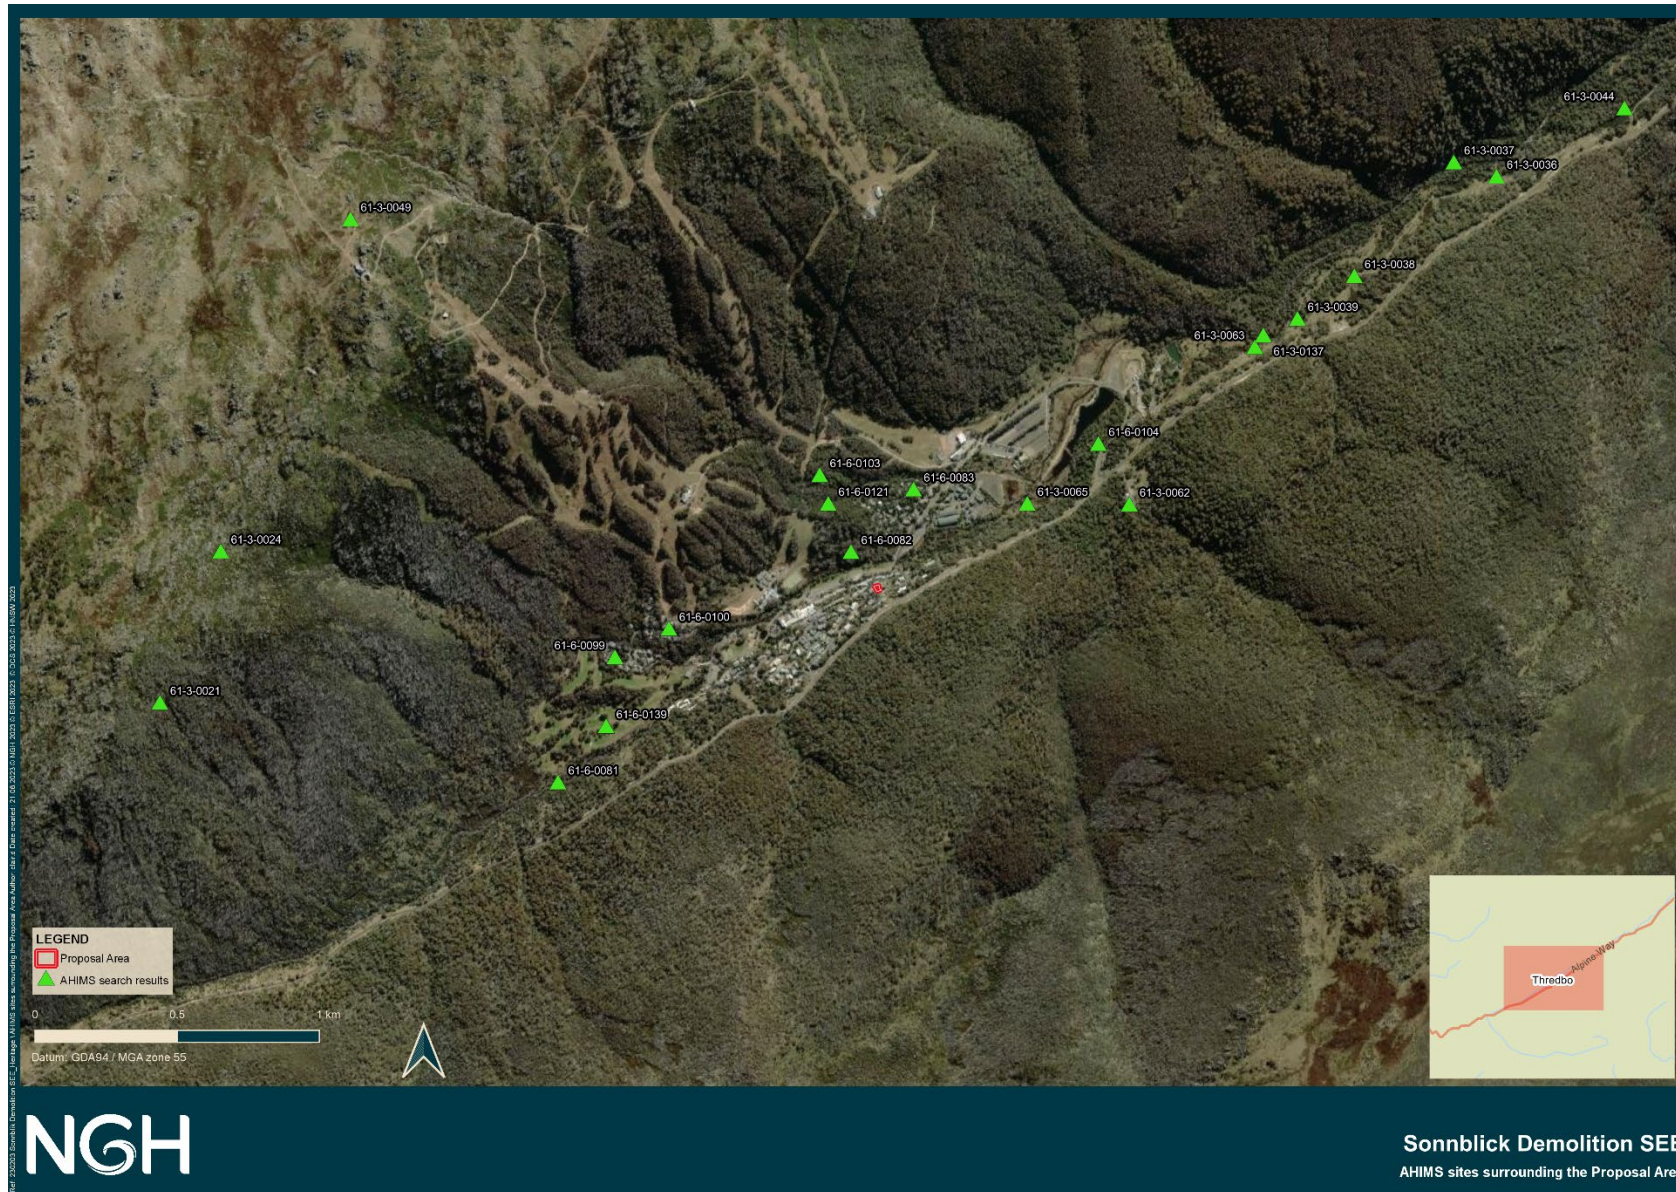
Figure 4-1 AHIMS sites surrounding the Proposal Area

Thredbo River is located 85m north and is a perennial river within the Snowy River catchment. The Thredbo River is impacted by seasonal climate changes, with high flows during the spring snow melt and snow and ice during the winter season (Envirokey 2015:31). Friday Flat Creek is located 870m south-east and Bullock Yard Creek is located 3.077km east. The Thredbo River and its tributaries would have provided freshwater and food resources for Aboriginal people. Past Aboriginal activity along the Thredbo River is evidenced by the previously recorded AHIMS sites, see Figure 4-1.

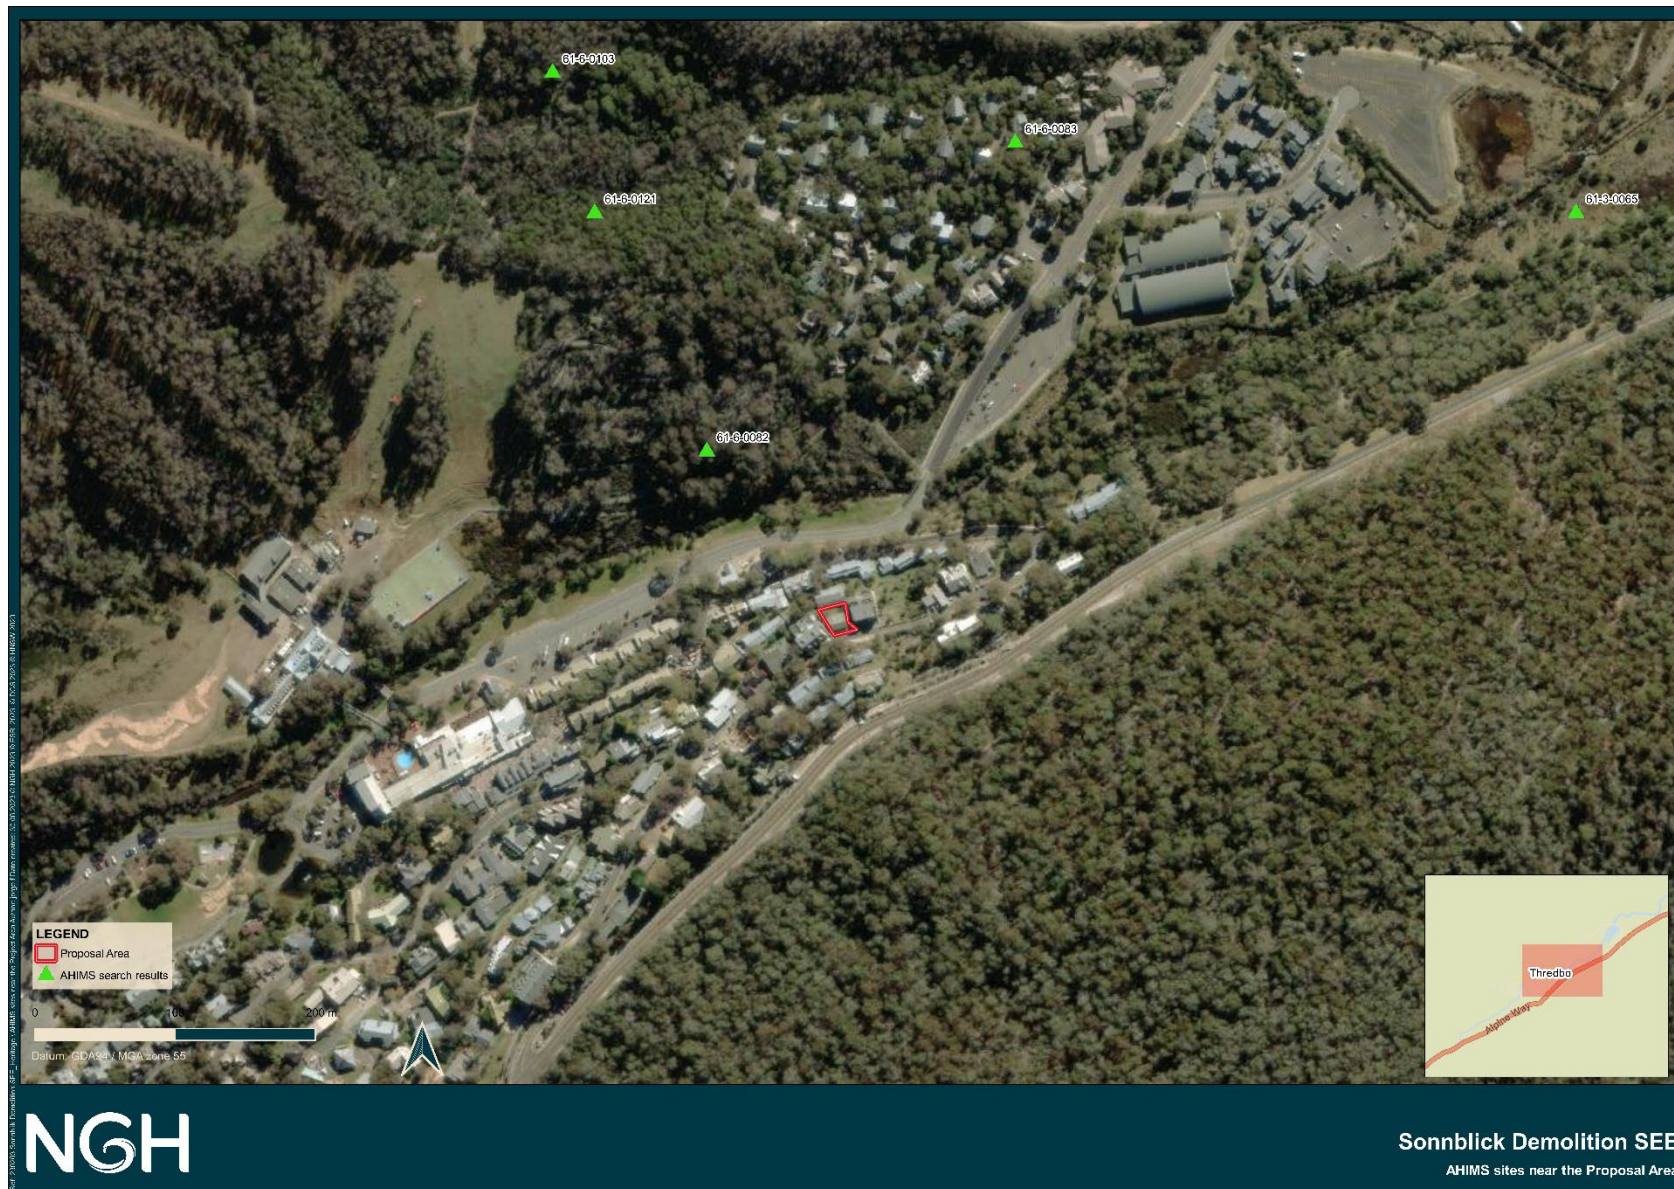
Figure 4-2 AHIMS sites near Proposal Area

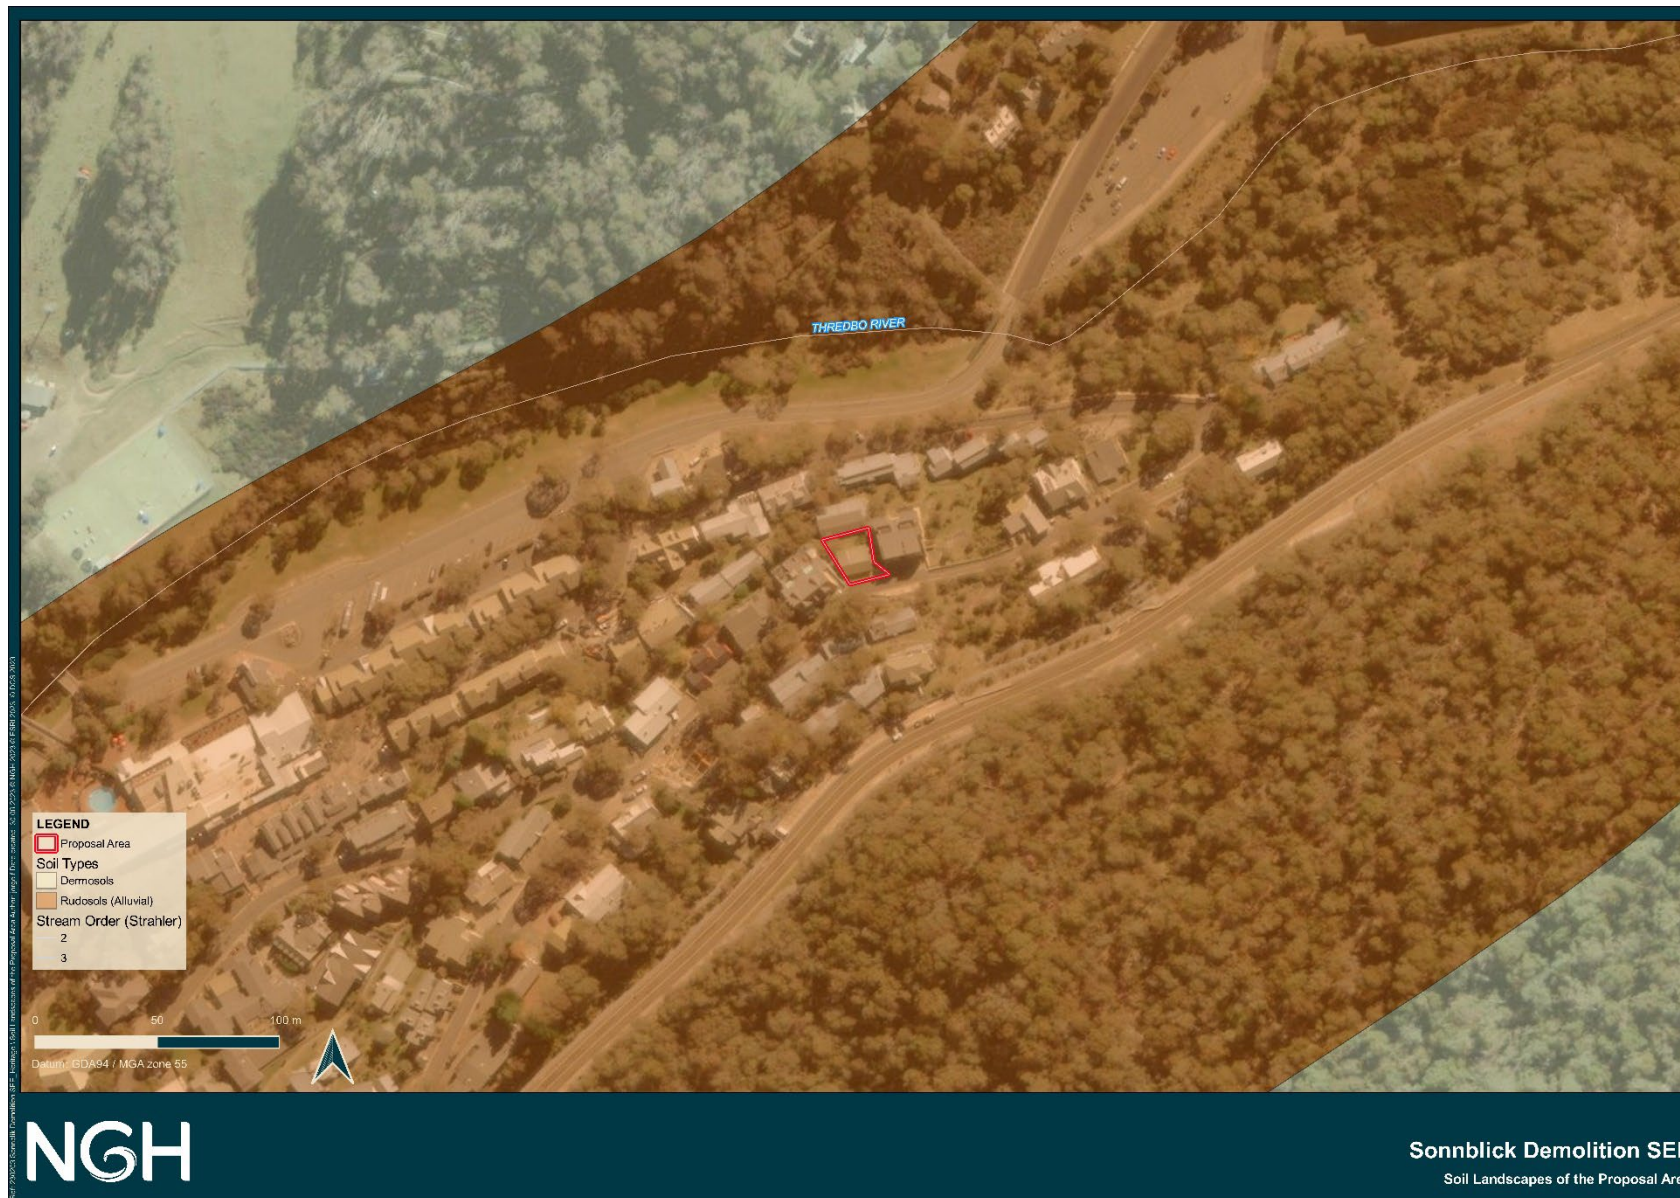
Figure 4-3 Soil landscape of the Proposal Area and near vicinity

As shown in Figure 4-3, the soil type of the Proposal Area is alluvial rudosols, which is associated with high exposed ridges and elevated stony slopes (EMM Consulting 2017:21). Soils are often shallow, with bedrock being located near the surface (EMM Consulting 2017:22). Shallow soils such as alluvial rudosols have implications for the potential and survivability of Aboriginal objects and are unlikely to contain deep and/or stratified archaeological deposits. In addition, it is likely that soil has been moved and possibly introduced for stability of the lodge and construction of the driveway and retaining walls.

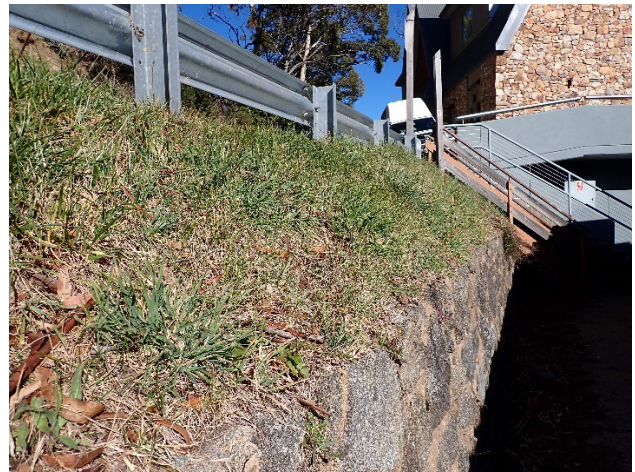
Plate 4-2 Photograph of exotic grasses at rear of property, and topography considerably cut into for retaining wall.

The general elevation of the Main Range Montane soil landscape is 100m to 1,500m and Thredbo Village is located at 1,365m (Mitchell 2002:8). The Proposal Area is located on a steep slope, that has been modified for the construction of the lodge, driveway and associated infrastructure (see Plate 4-2).
