Statement of Environmental Effects

Sonnblick Lodge demolition

10 Bobuck Lane, Thredbo Alpine Village

November 2023

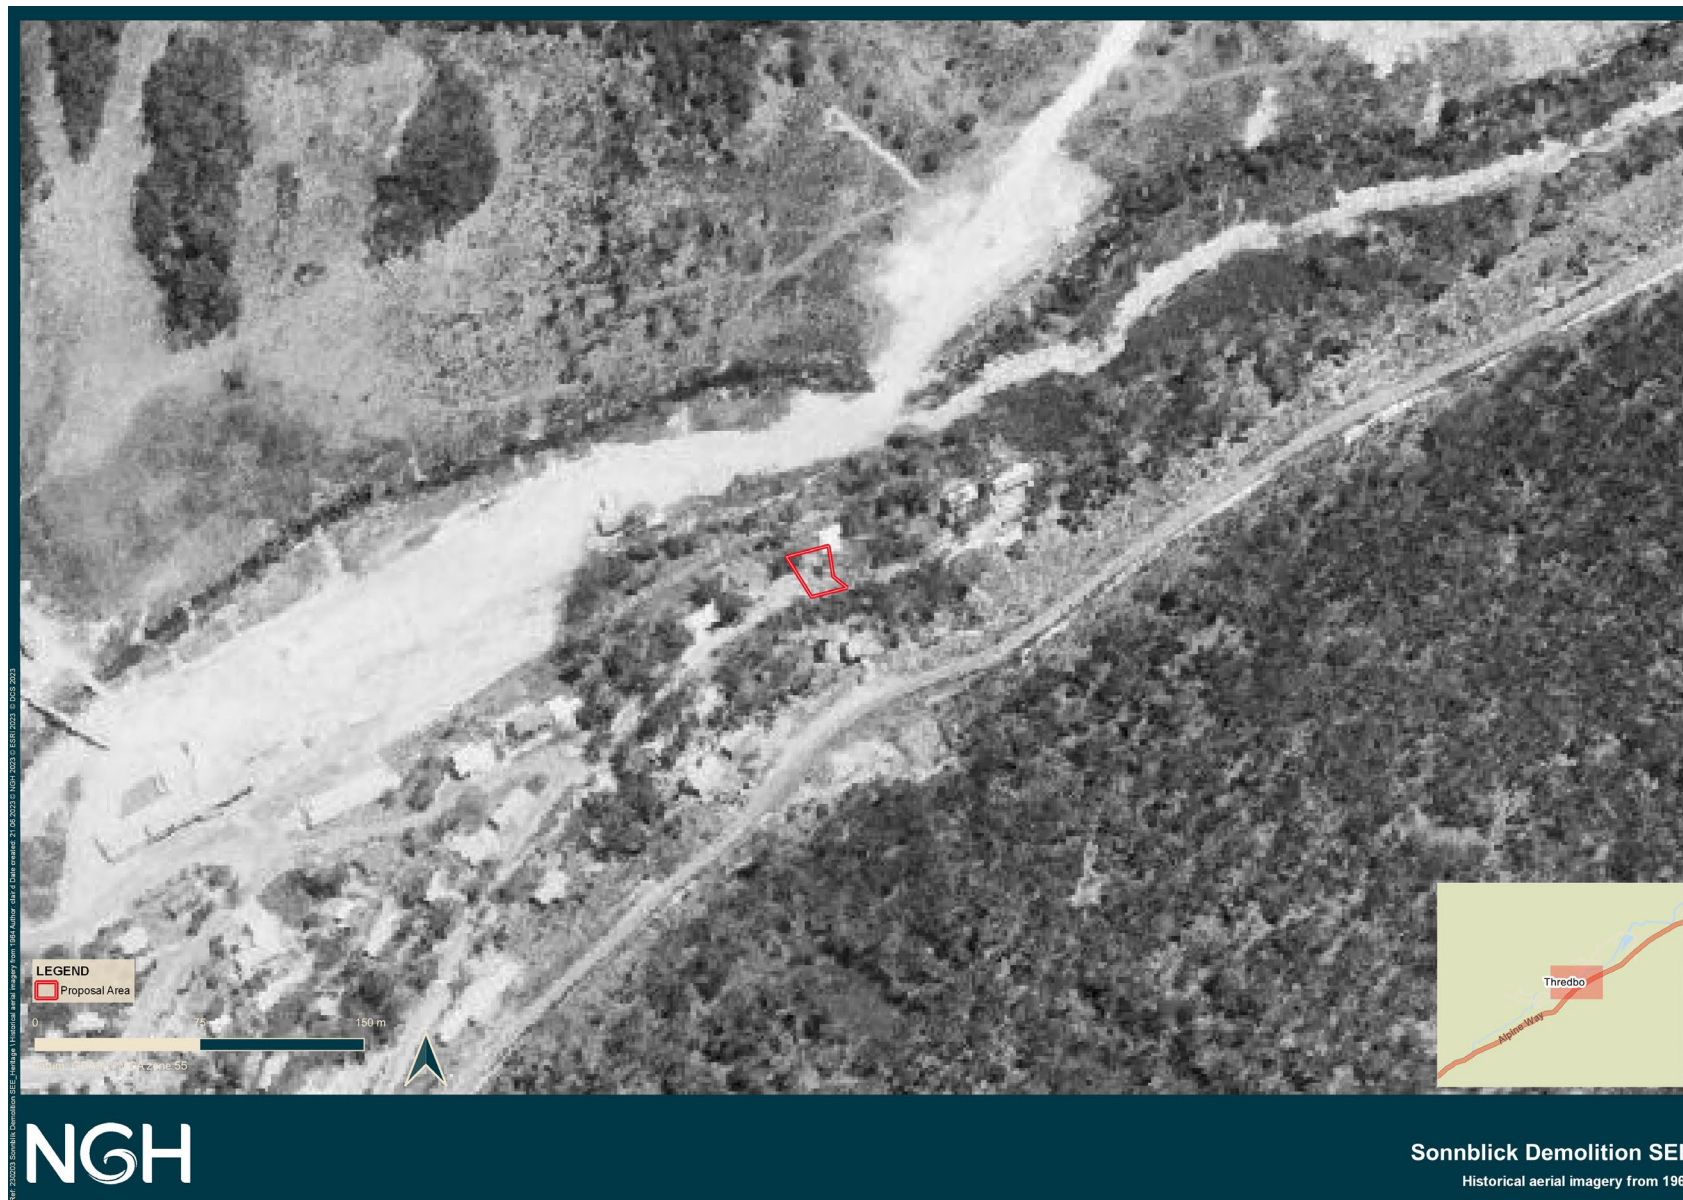
Figure 4-5 Historic aerial imagery from 1964

Historical aerial imagery from 1964 (Figure 4-5) shows that by this year the Proposal Area had been mostly cleared of vegetation. Thredbo village at this time remained largely undeveloped, compared to the image from 1992 (Figure 4-6). The image from 1992 (Figure 4-6) shows that the lodge had been constructed by this year and all vegetation had been cleared. Development surrounding the Proposal Area has increased significantly and all roads had been formalised.

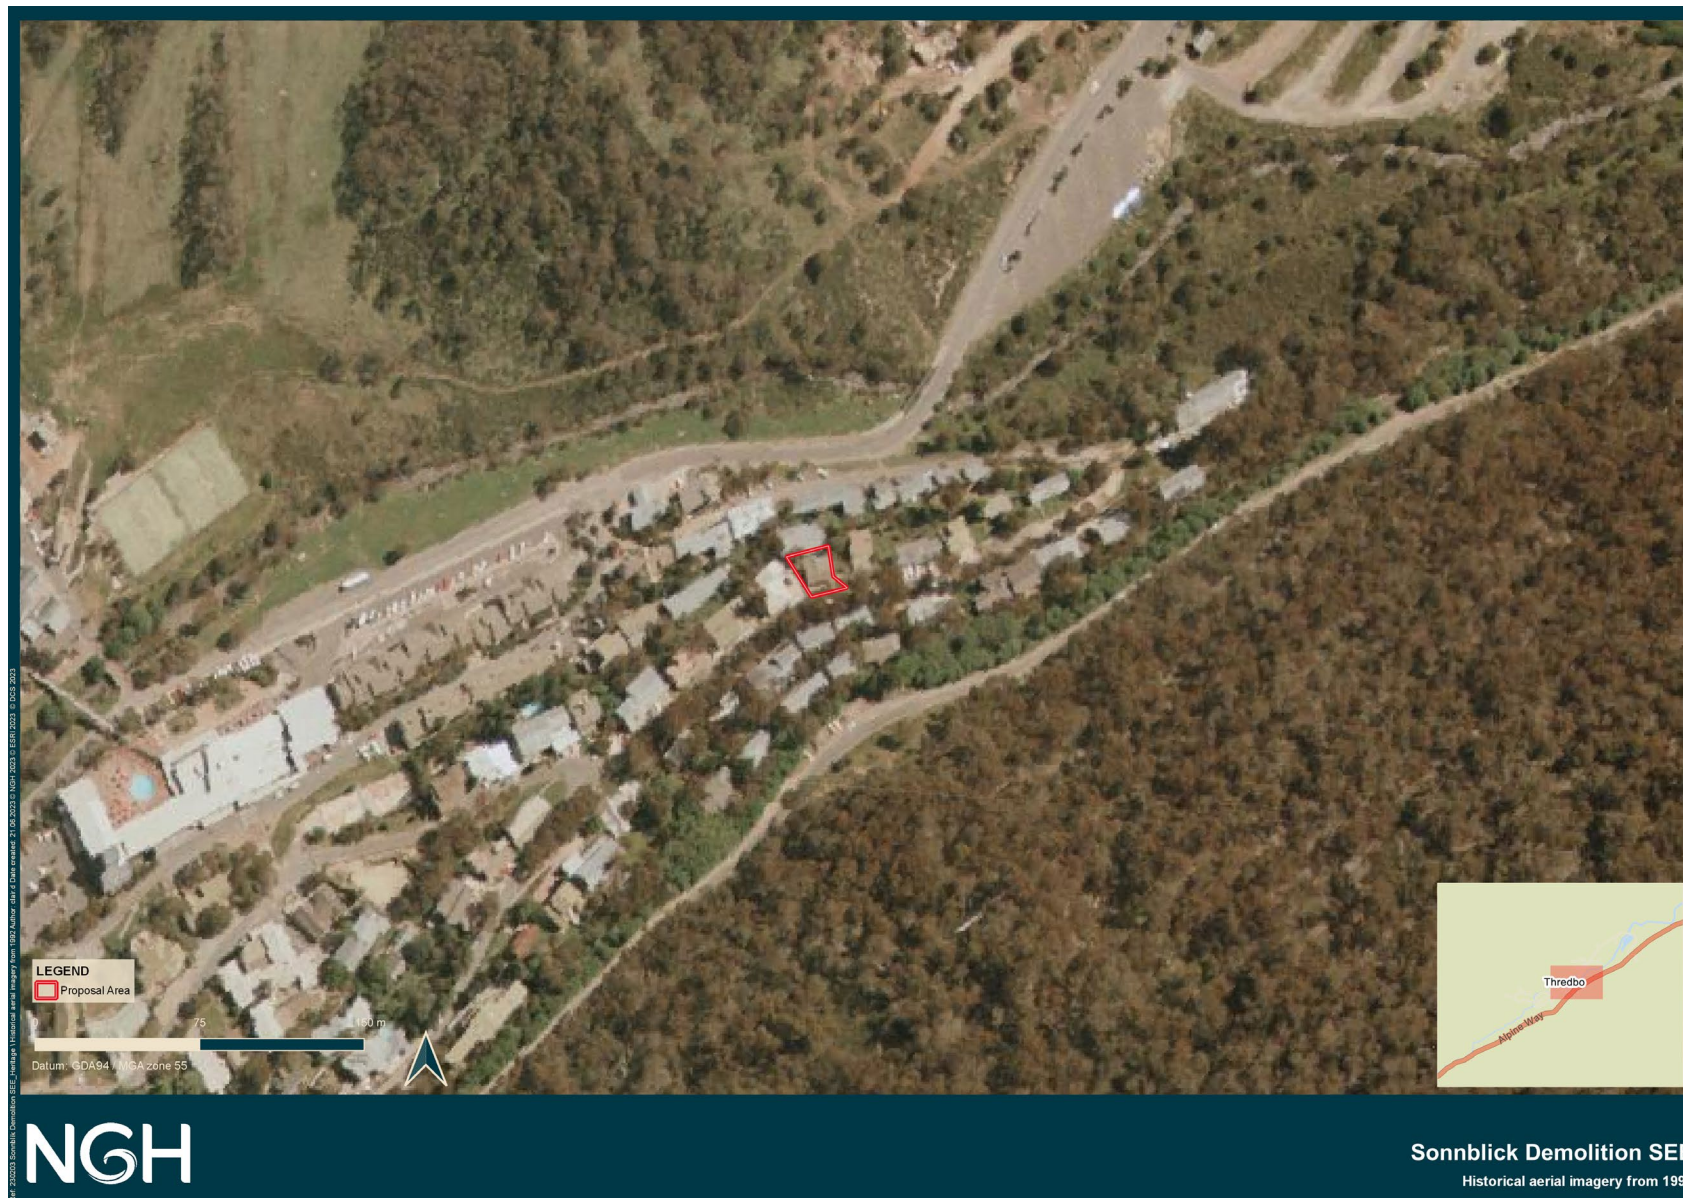
Figure 4-6 Historic aerial imagery from 1992

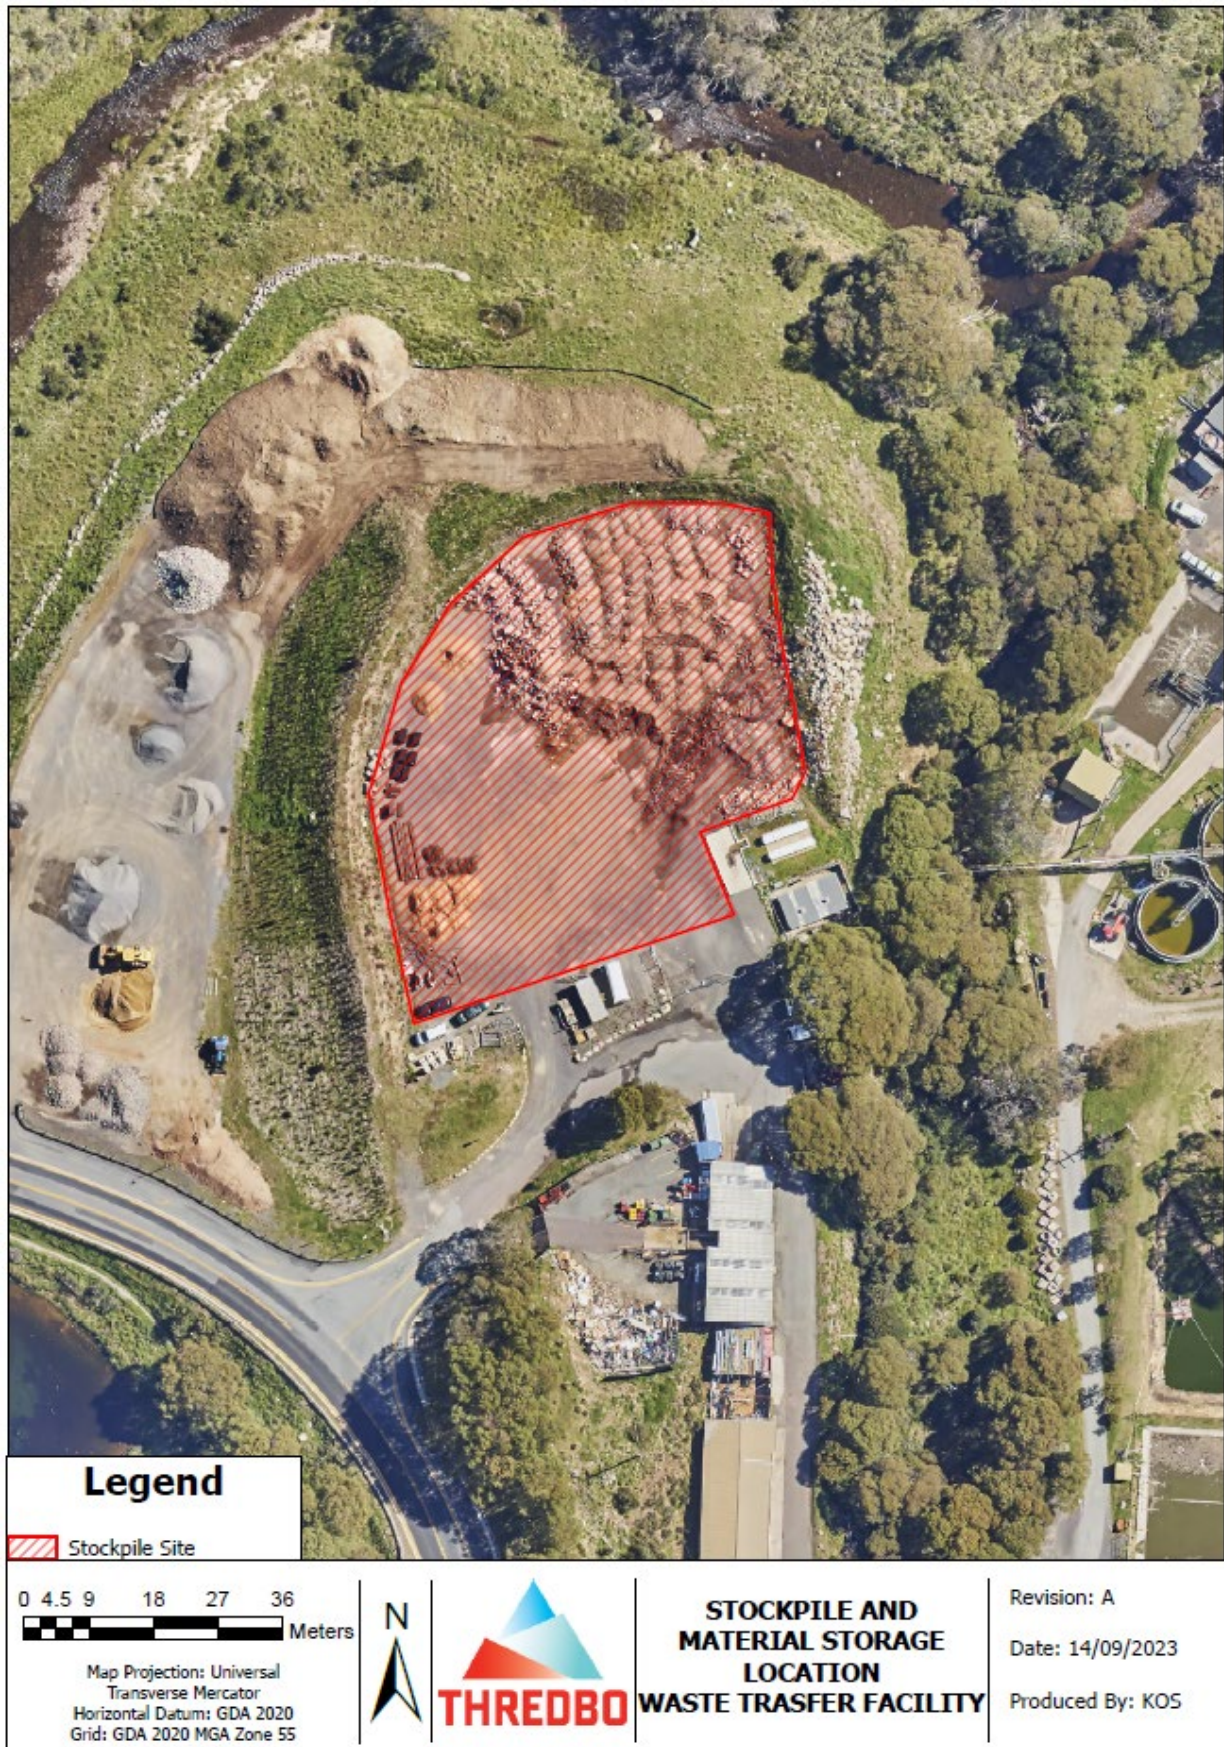
Figure 1 Stockpile location

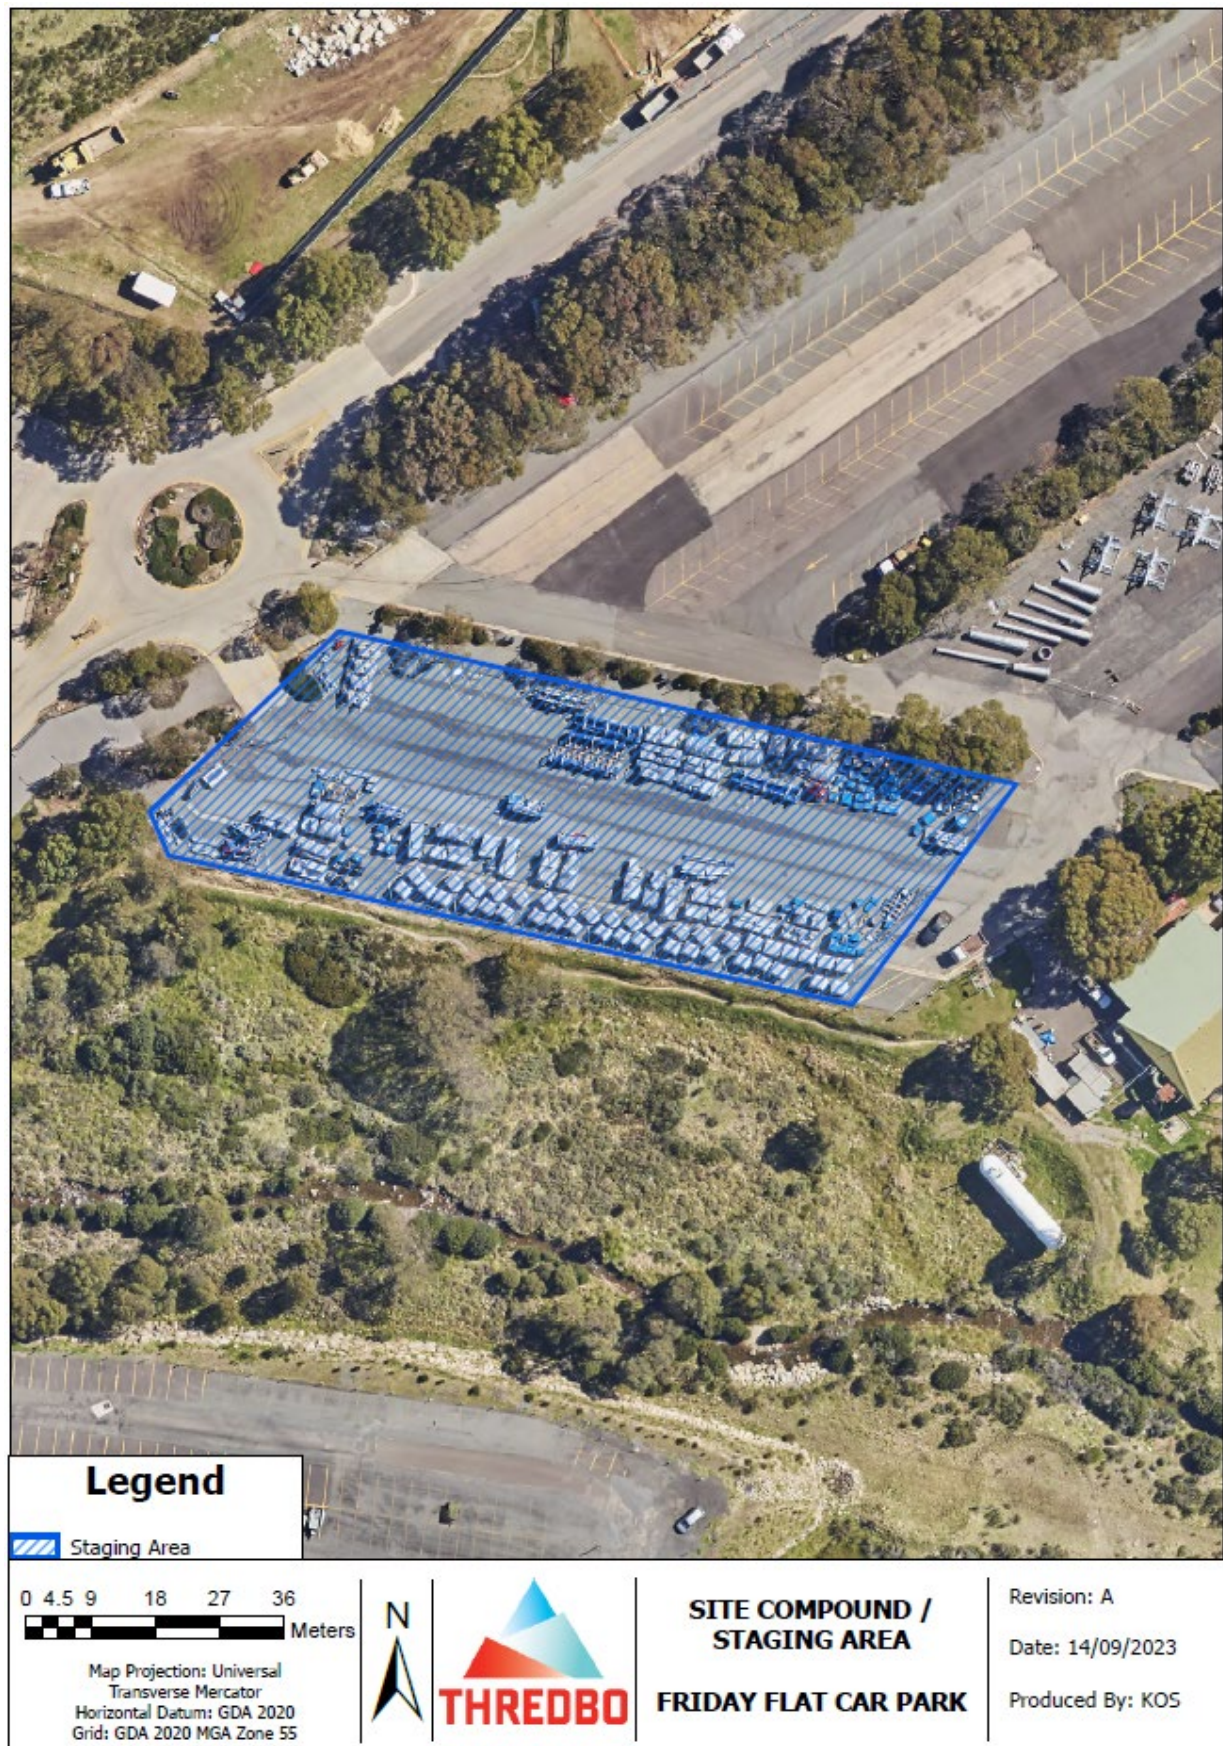
Figure 2 Compound location

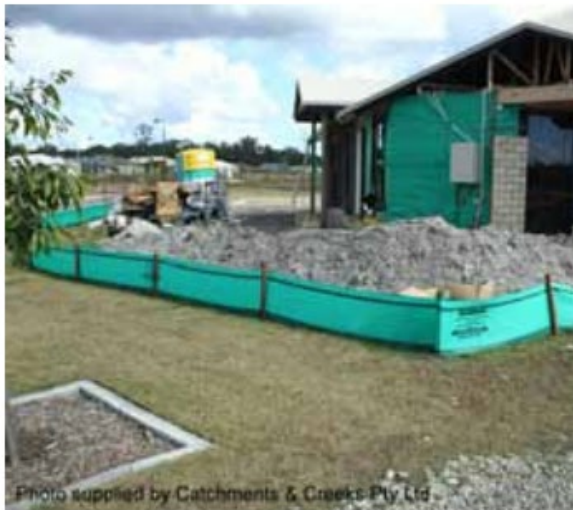
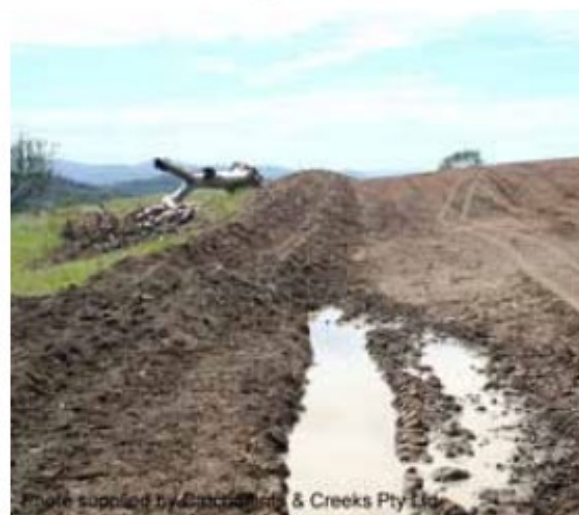
Figure 3 Erosion and sediment controls (Source: Catchments & Creeks Pty Ltd, 2012)

Sediment fence

Flow diversion bank

Rock check dam
