# **Site Environmental Management Plan (SEMP)**

**Sonnblick Lodge Demolition**

Thredbo Alpine Resort  
Kosciuszko National Park, NSW

February 2023

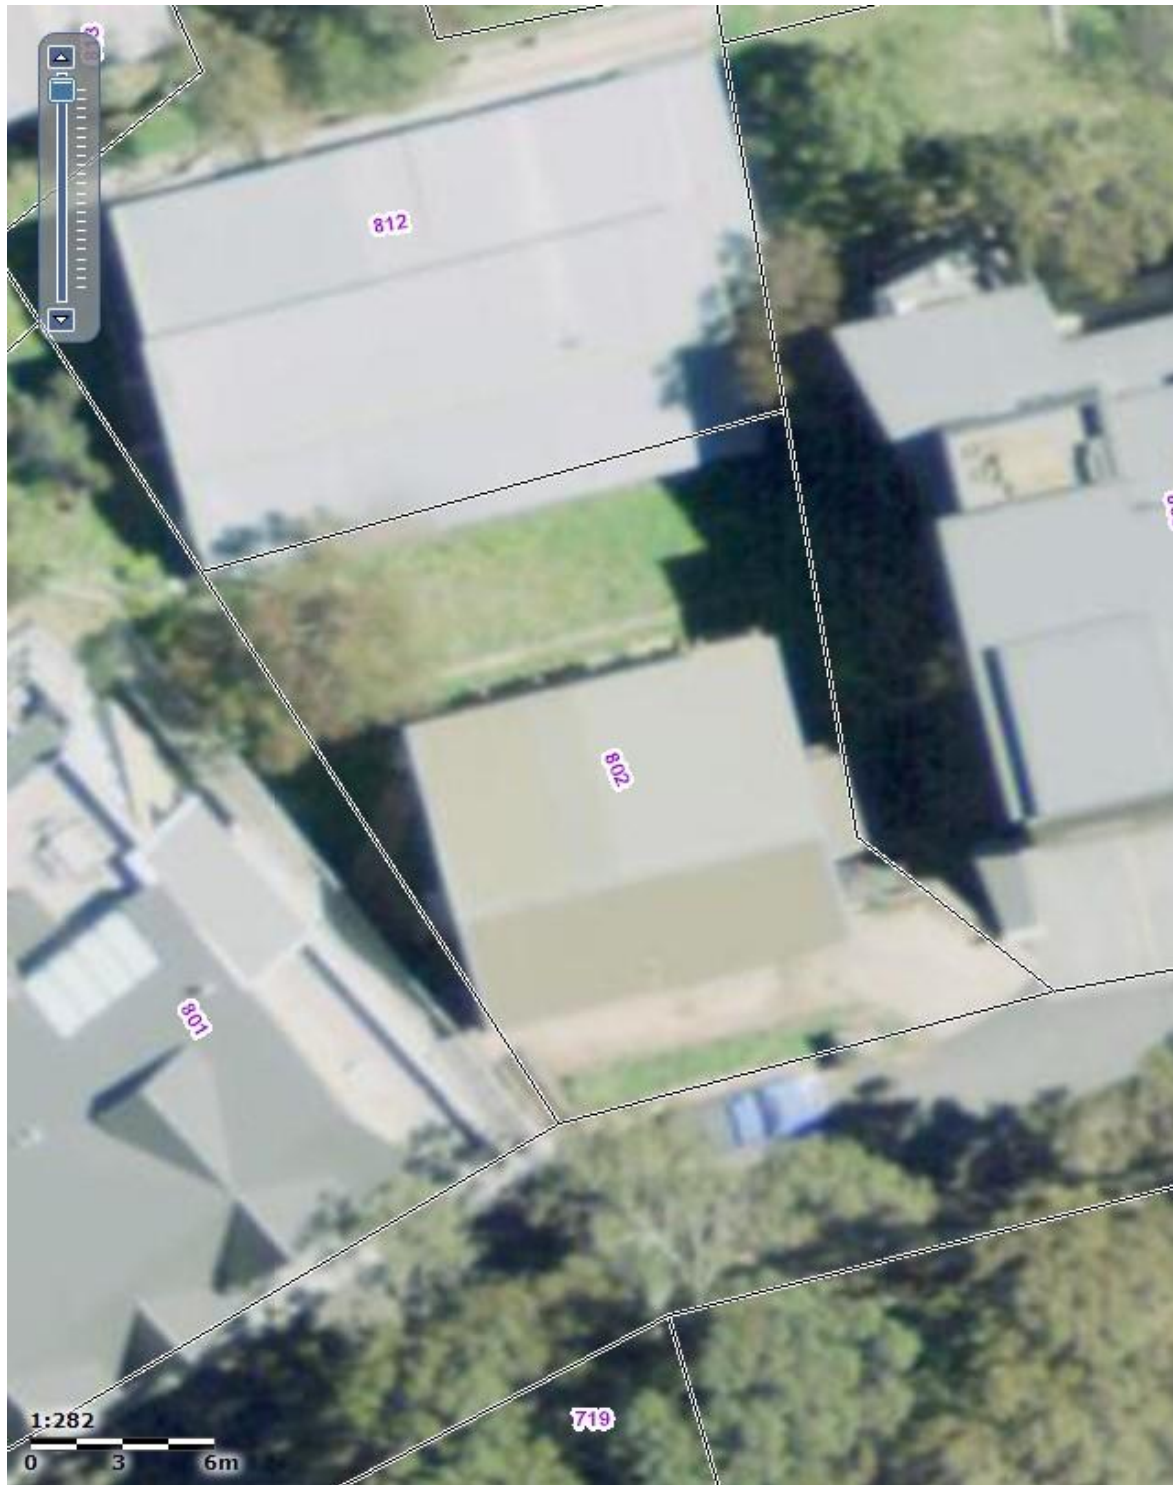
**FIGURE 1**

**KOSCIUSZKO THREDBO PTY LTD  
PROPOSED DEMOLITION & REDEVELOPMENT - SONNBLICK LODGE – 10 BOBUCK LANE, THREDBO,  
NSW  
RECENT AERIAL PHOTOGRAPH**

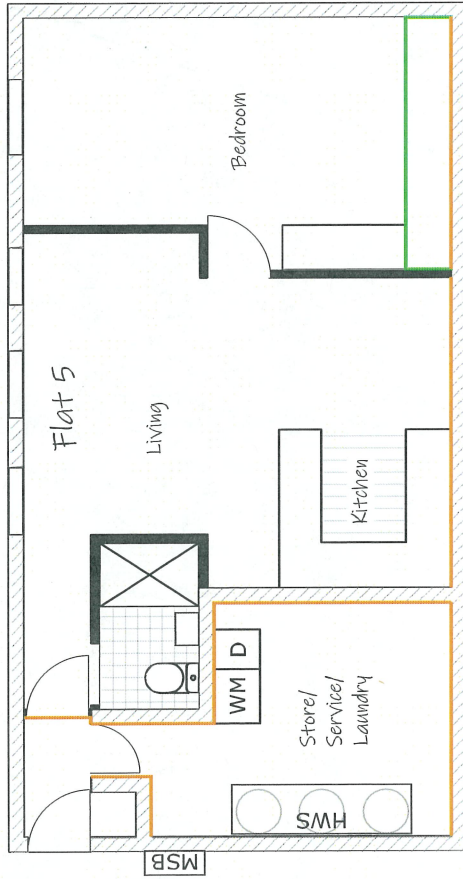
1 Level 1  
A102  
Scale: 1 : 100

Decking to be replaced and Balustrade to comply with NCC, Vol.2, 3.9.2.3 and AS 3959—2009 "Construction Of Buildings in Bushfire Prone areas"

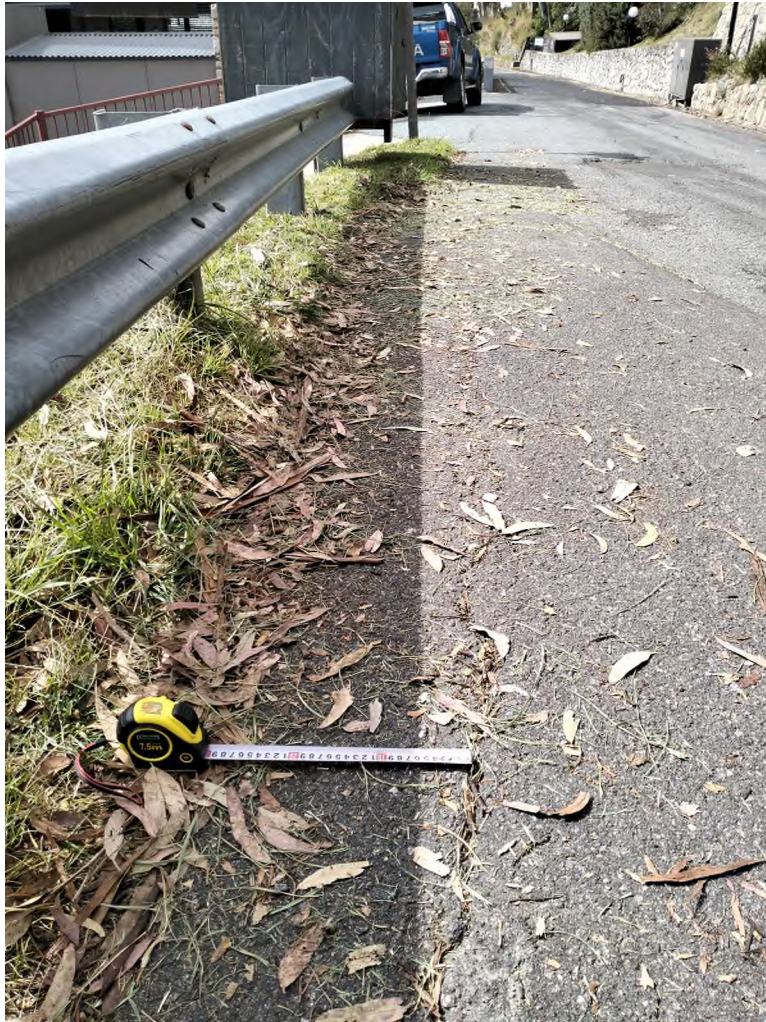
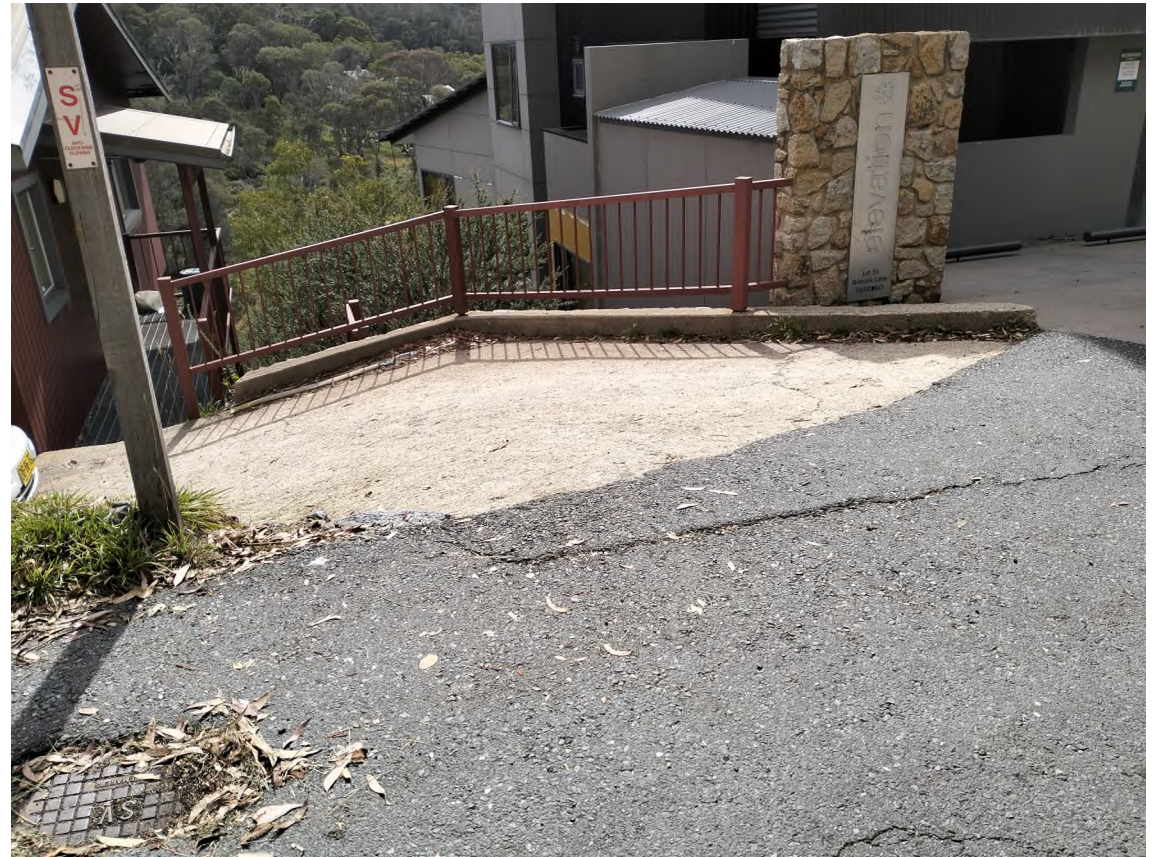
**FIGURE 5**

**KOSCIUSZKO THREDBO PTY LTD  
PROPOSED DEMOLITION & REDEVELOPMENT - SONNBLICK LODGE – 10 BOBUCK LANE, THREDBO, NSW  
SITE PHOTOGRAPHS – TENSION CRACKS ON THE ROAD PAVEMENT**

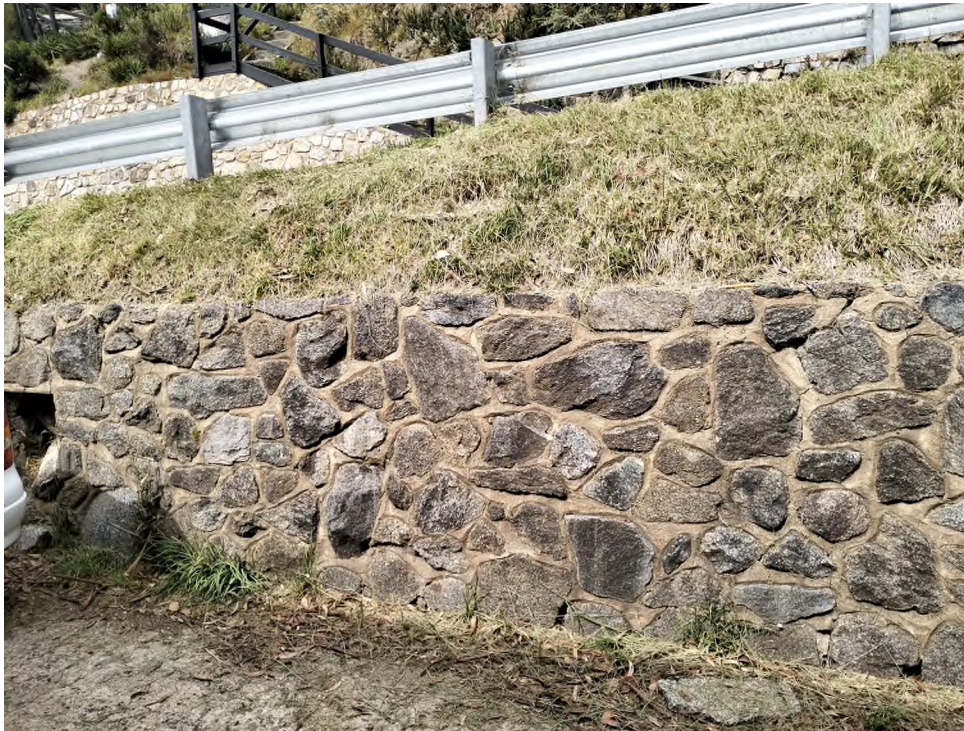
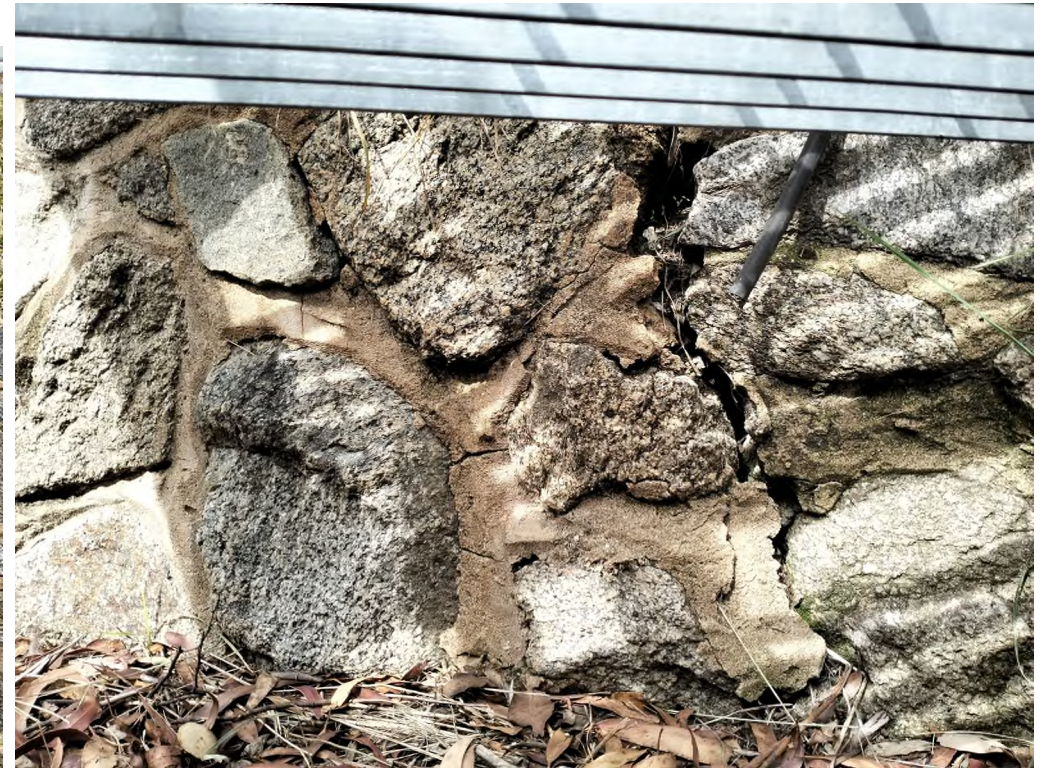
**FIGURE 6**

**KOSCIUSZKO THREDBO PTY LTD  
PROPOSED DEMOLITION & REDEVELOPMENT - SONNBlick LODGE – 10 BOBUCK LANE, THREDBO, NSW  
SITE PHOTOGRAPHS – RW4 (BELOW BOBUCK LANE)**

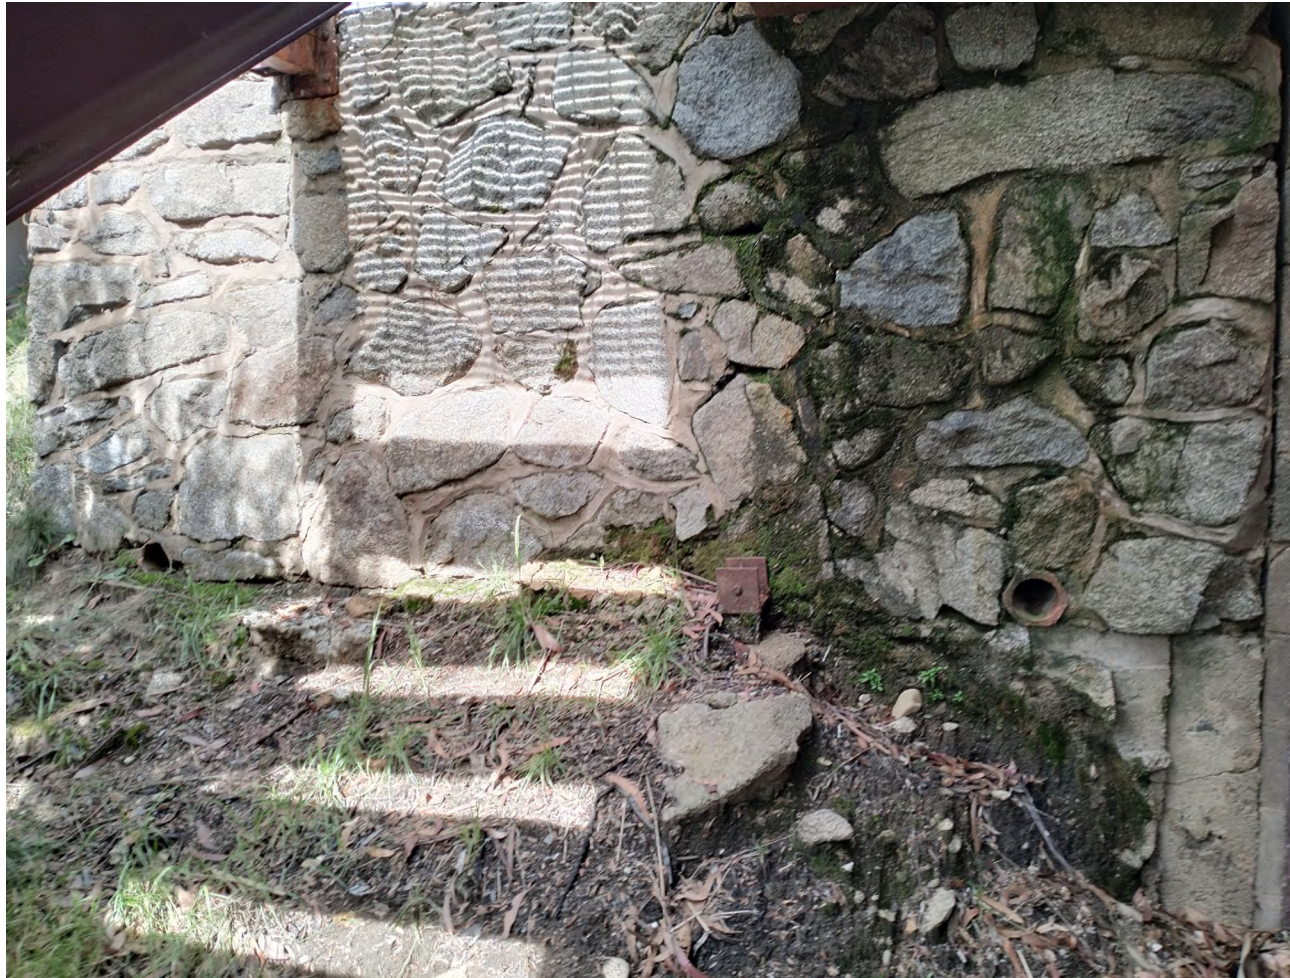
**FIGURE 7**

**KOSCIUSZKO THREDBO PTY LTD  
PROPOSED DEMOLITION & REDEVELOPMENT - SONNBLICK LODGE – 10 BOBUCK LANE, THREDBO, NSW  
SITE PHOTOGRAPH – RW3**

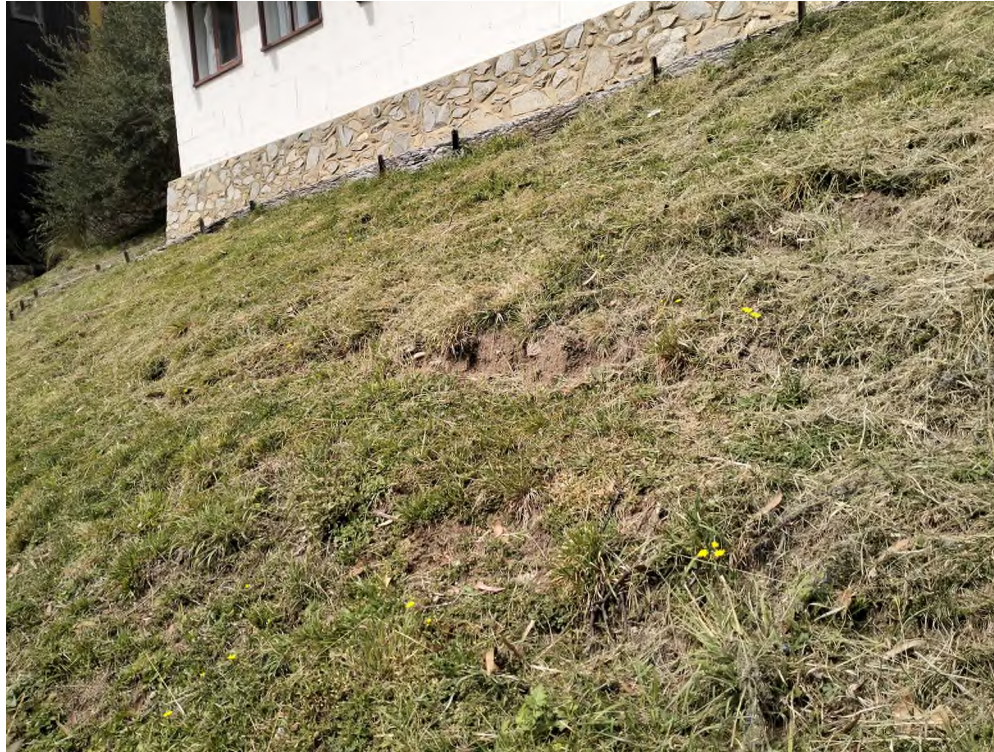
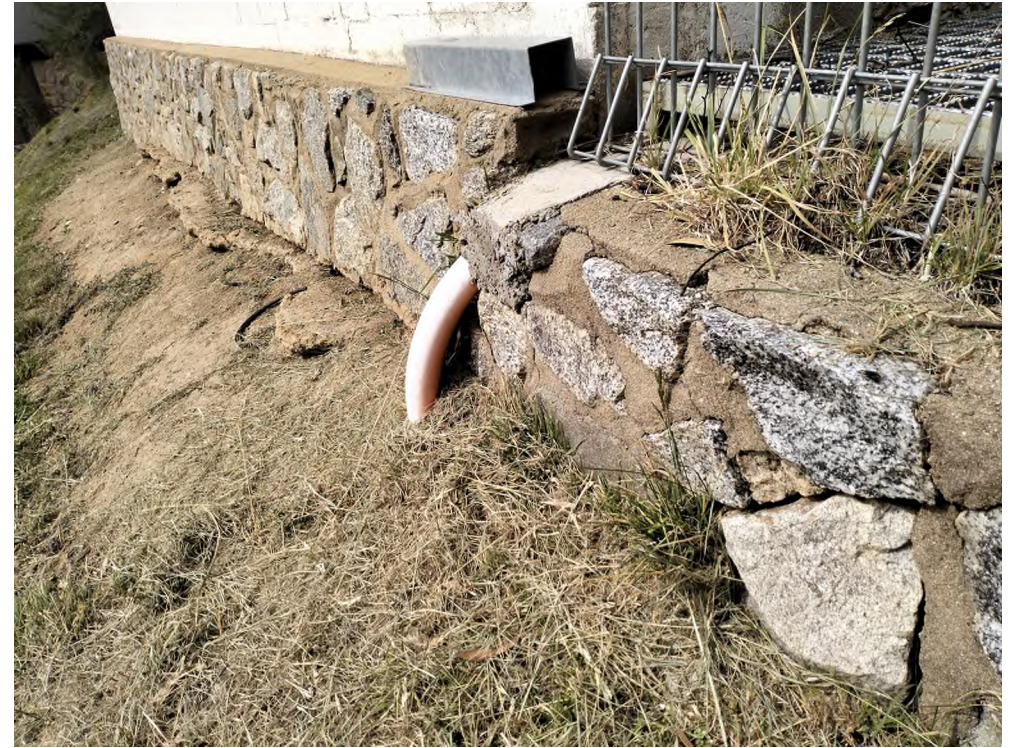
**KOSCIUSZKO THREDBO PTY LTD  
PROPOSED DEMOLITION & REDEVELOPMENT - SONNBlick LODGE – 10 BOBUCK LANE, THREDBO, NSW  
SITE PHOTOGRAPHS**

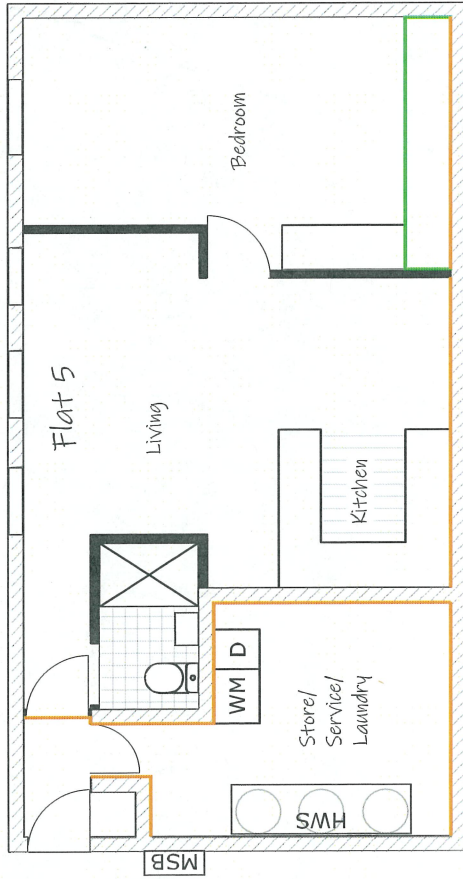
1 Level 1  
A102  
Scale: 1 : 100

Decking to be replaced and Balustrade to comply with NCC, Vol.2, 3.9.2.3 and AS 3959—2009 "Construction Of Buildings in Bushfire Prone areas"

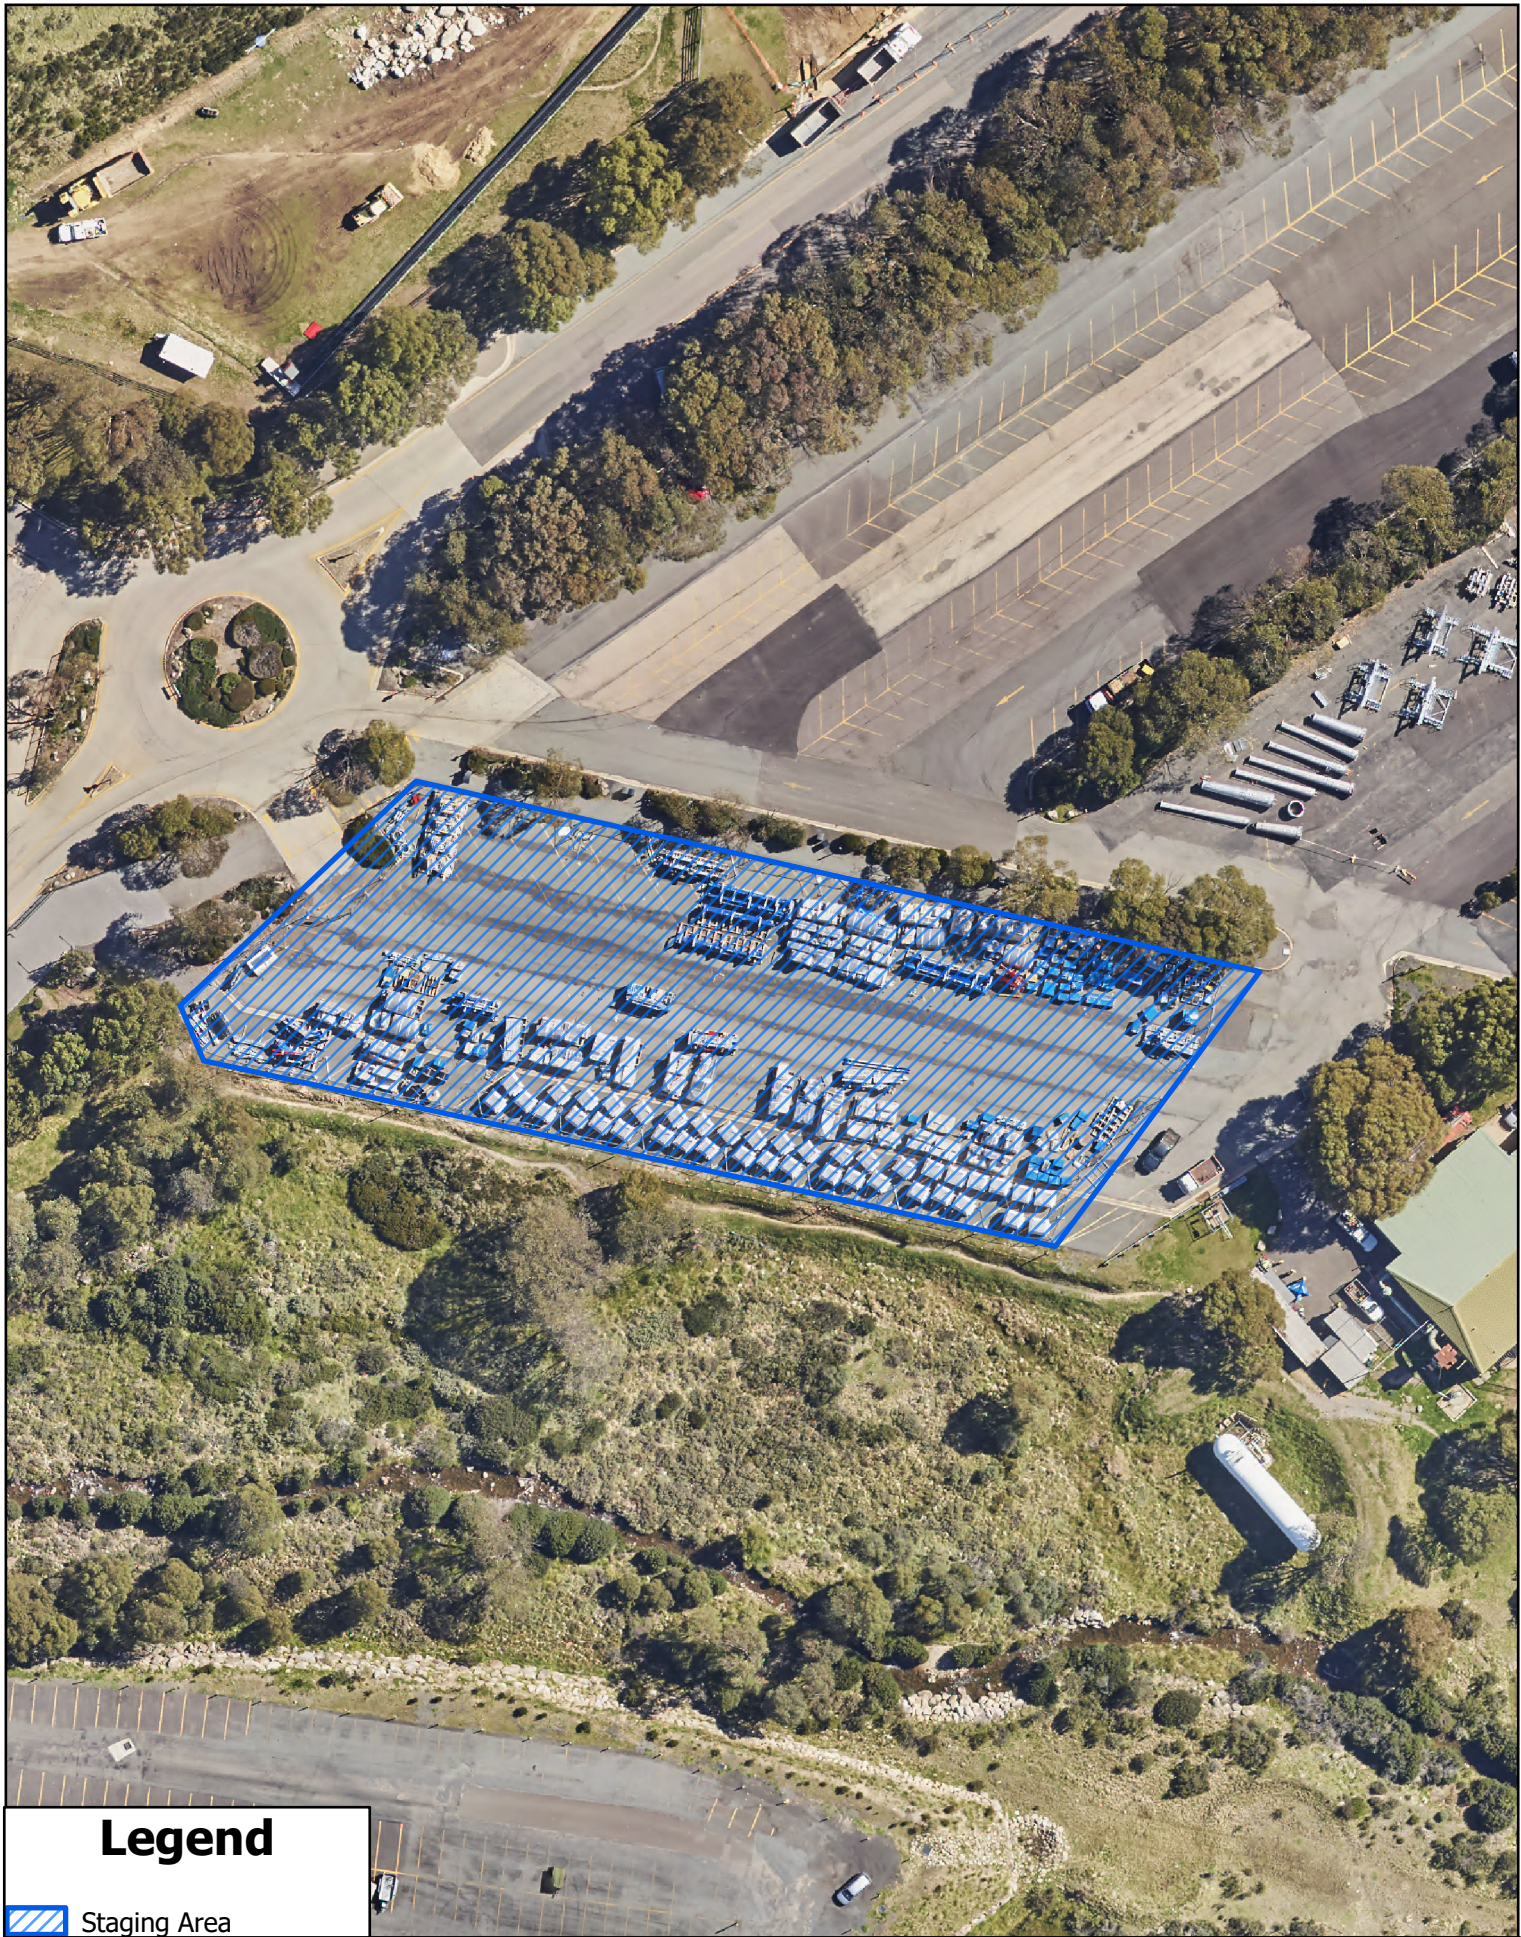
## Appendix B      Stockpile and Material Storage Areas

**SITE COMPOUND /  
STAGING AREA**  
**FRIDAY FLAT CAR PARK**

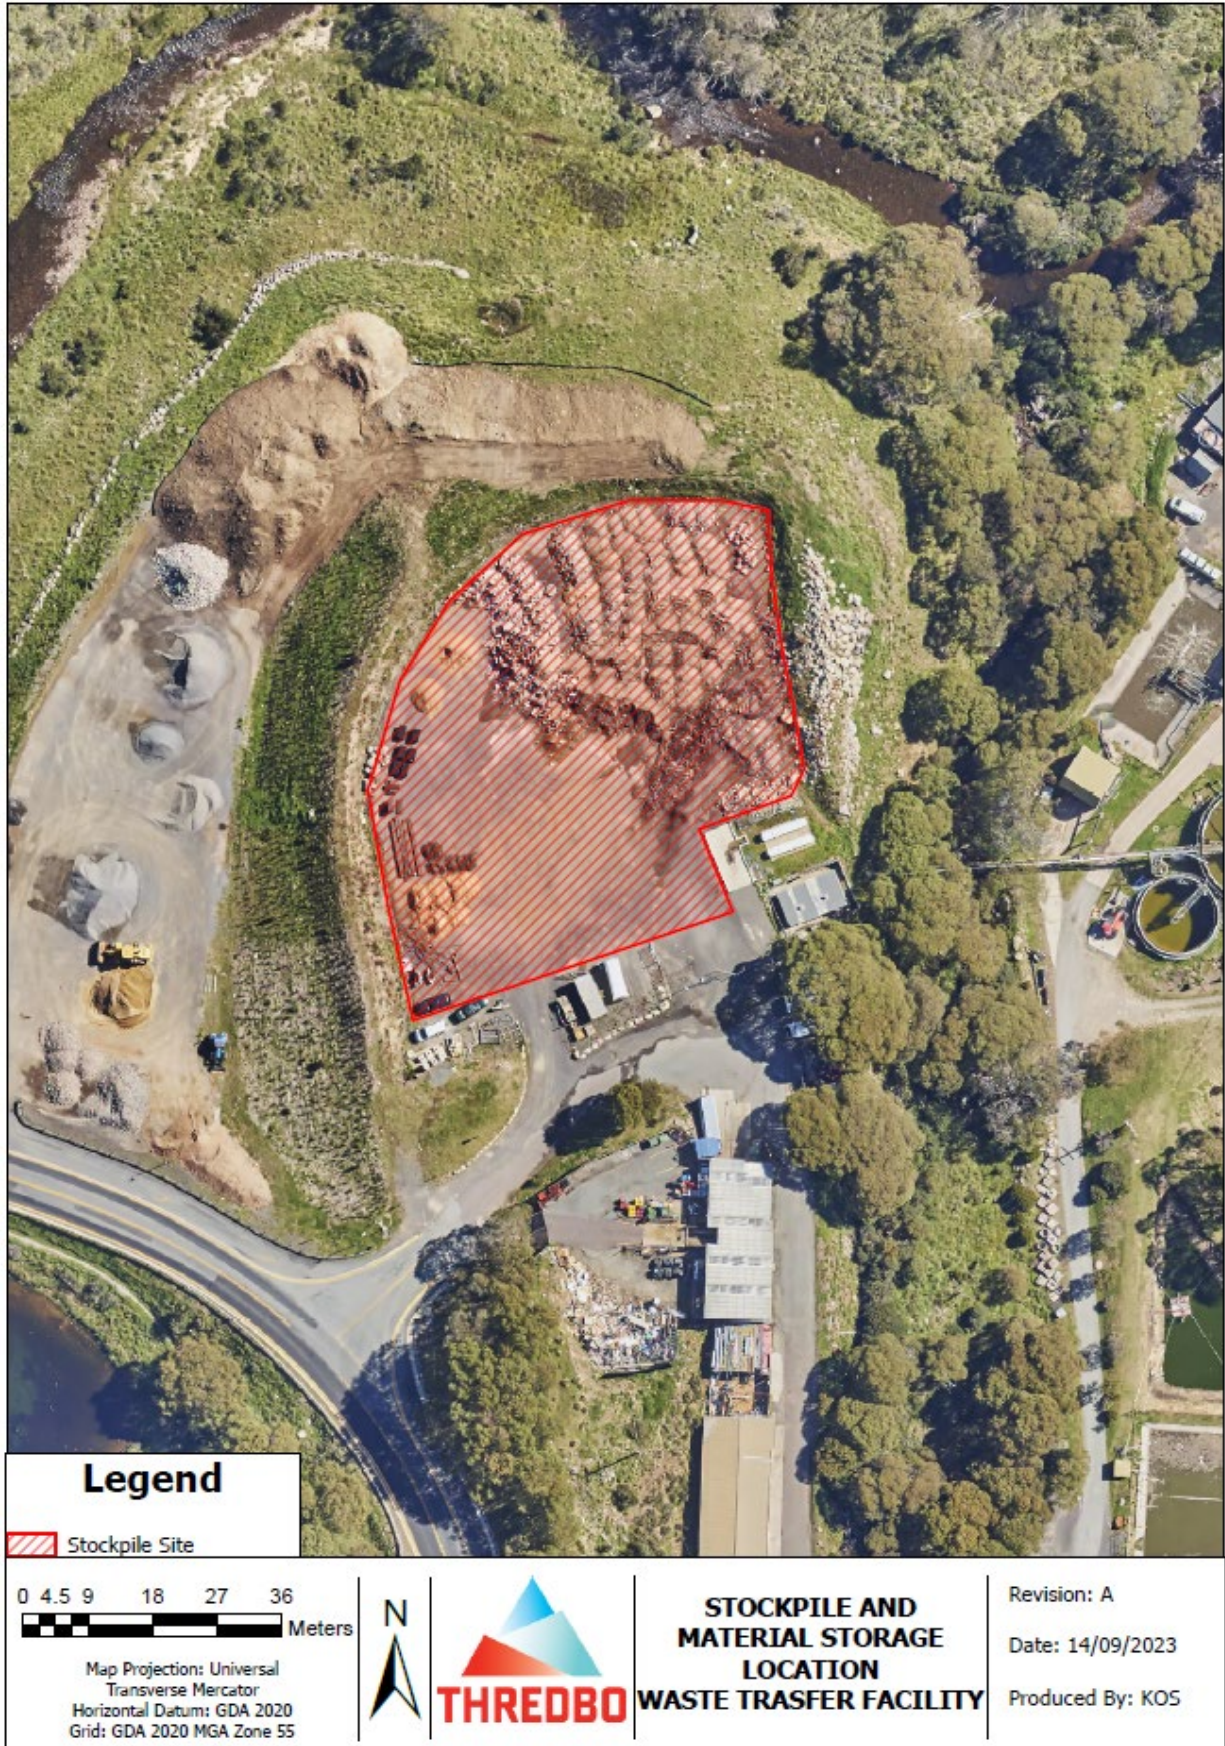
**Figure 1** Stockpile location

- Soil stockpiles to be managed in accordance with the Soil Stockpile Guidelines.
- Refer **Attachment A** for recommended controls, including installation notes and examples.
- Refer to **Figure 1** and **Figure 2** for the location of the nominated stockpile and compound sites.

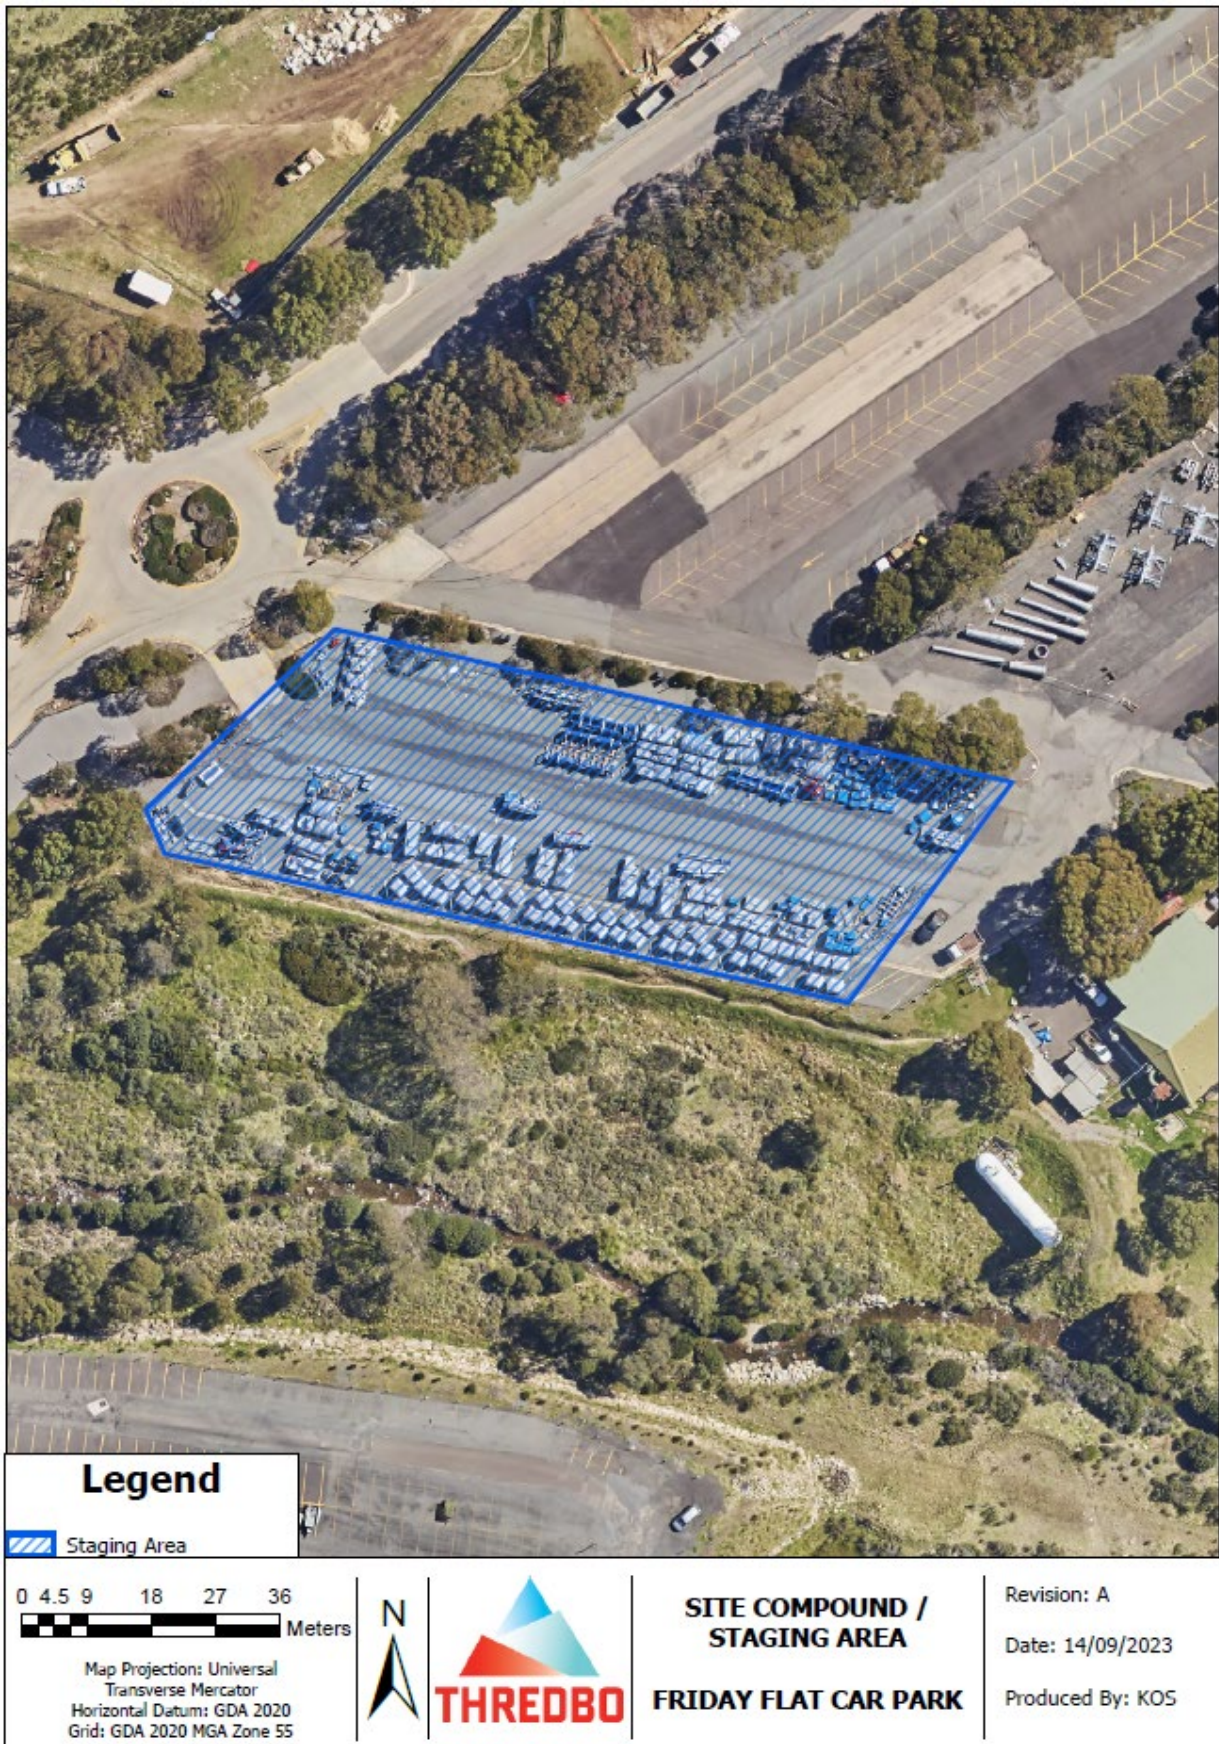
Figure 2 Compound location

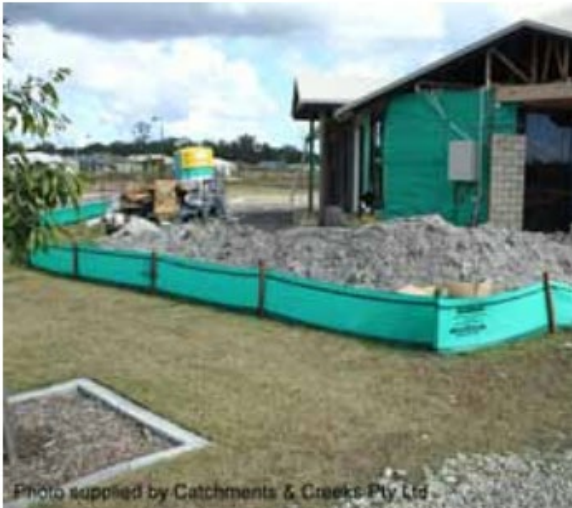
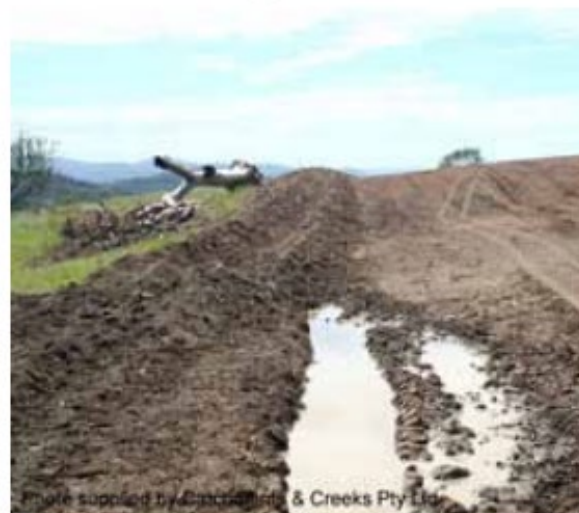
**Figure 3** Erosion and sediment controls (Source: Catchments & Creeks Pty Ltd, 2012)

**Sediment fence**

**Flow diversion bank**

**Rock check dam**
