15 December 2023

| Name of heritage item: | Blakebrook Public School |
| Address and location: | 417 Rosehill Road Blakebrook, NSW 2480 |
| Statement of heritage impact for: | Blakebrook Public School, DA2 Concept Design |

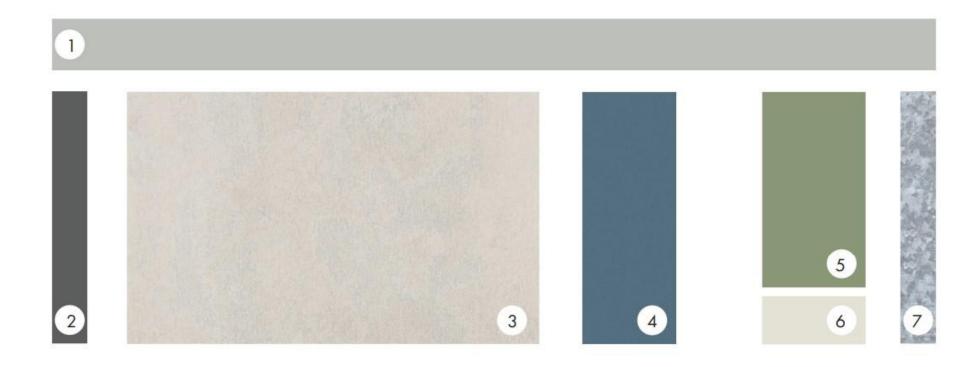
Plate 3.7 External colour palette

1 - Roofing, Fasica, Gutters, Downpipes and First Floor External Soffit

2 - Window/ Door Frames and Mechanical Grilles

3 - General CFC Wall Colour

4 - Lift Wall Colour

5 - Metal Work Screen/ Window Shade Colour

6 - Undercroft Ceiling Colour

7 - Undercroft Columns

The colour palette of the development draws from the surrounding landscape which includes Common Lantana (which is not endemic and is classified as a Class 5 noxious weed (DPI, 2008)). The new raised structure will incorporate a muted palette that reflects the native natural environment and allows it to sit within the landscape rather than to dominate it. The colour selection includes green, grey-blue, and grey of varying shades and is shown in Plate 3.7.
