# Northern River Schools Cluster

## Geotechnical Investigation Report – Blakebrook Public School

Reference: SYDGE319200AI Rev.1  
(ADCO Reference: BLA-GEO-PP-RPT-0002)

**Tetra Tech Coffey**

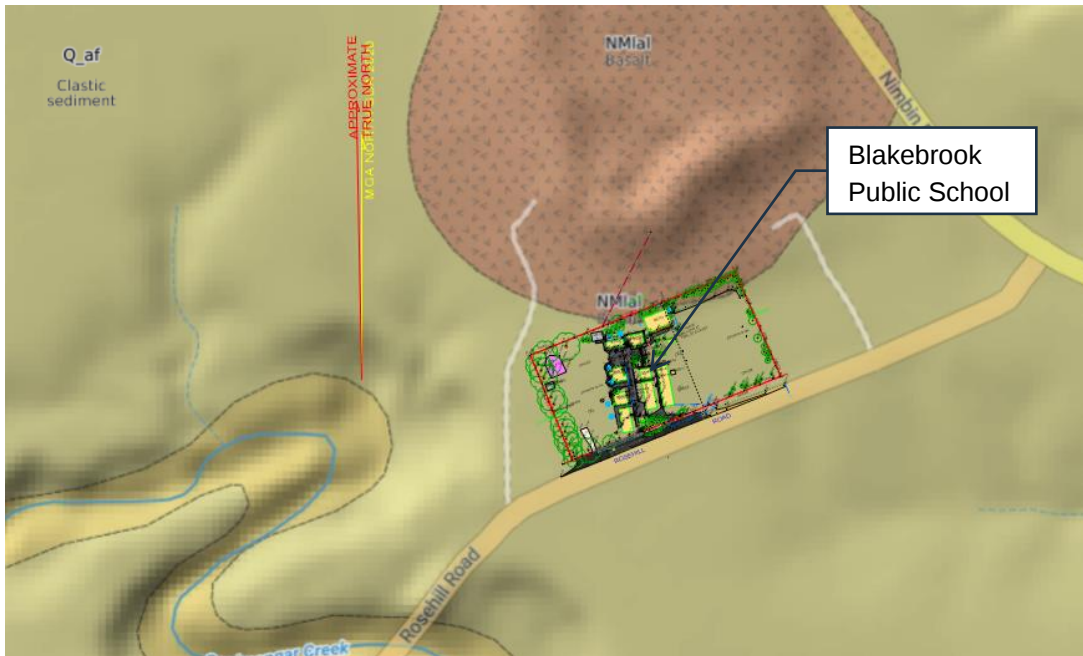
Figure 1 – Local geology condition at Blakebrook Public School

According to the Geological Survey of Tweed Heads map, the site is underlain by Quaternary alluvium (Q\_af) comprising “silt, very fine to medium grained lithic to quartz rich sand, clay”. The area to the north of the site is indicated to be underlain by Lismore Basalt (NM1a1) as shown in Figure 1.

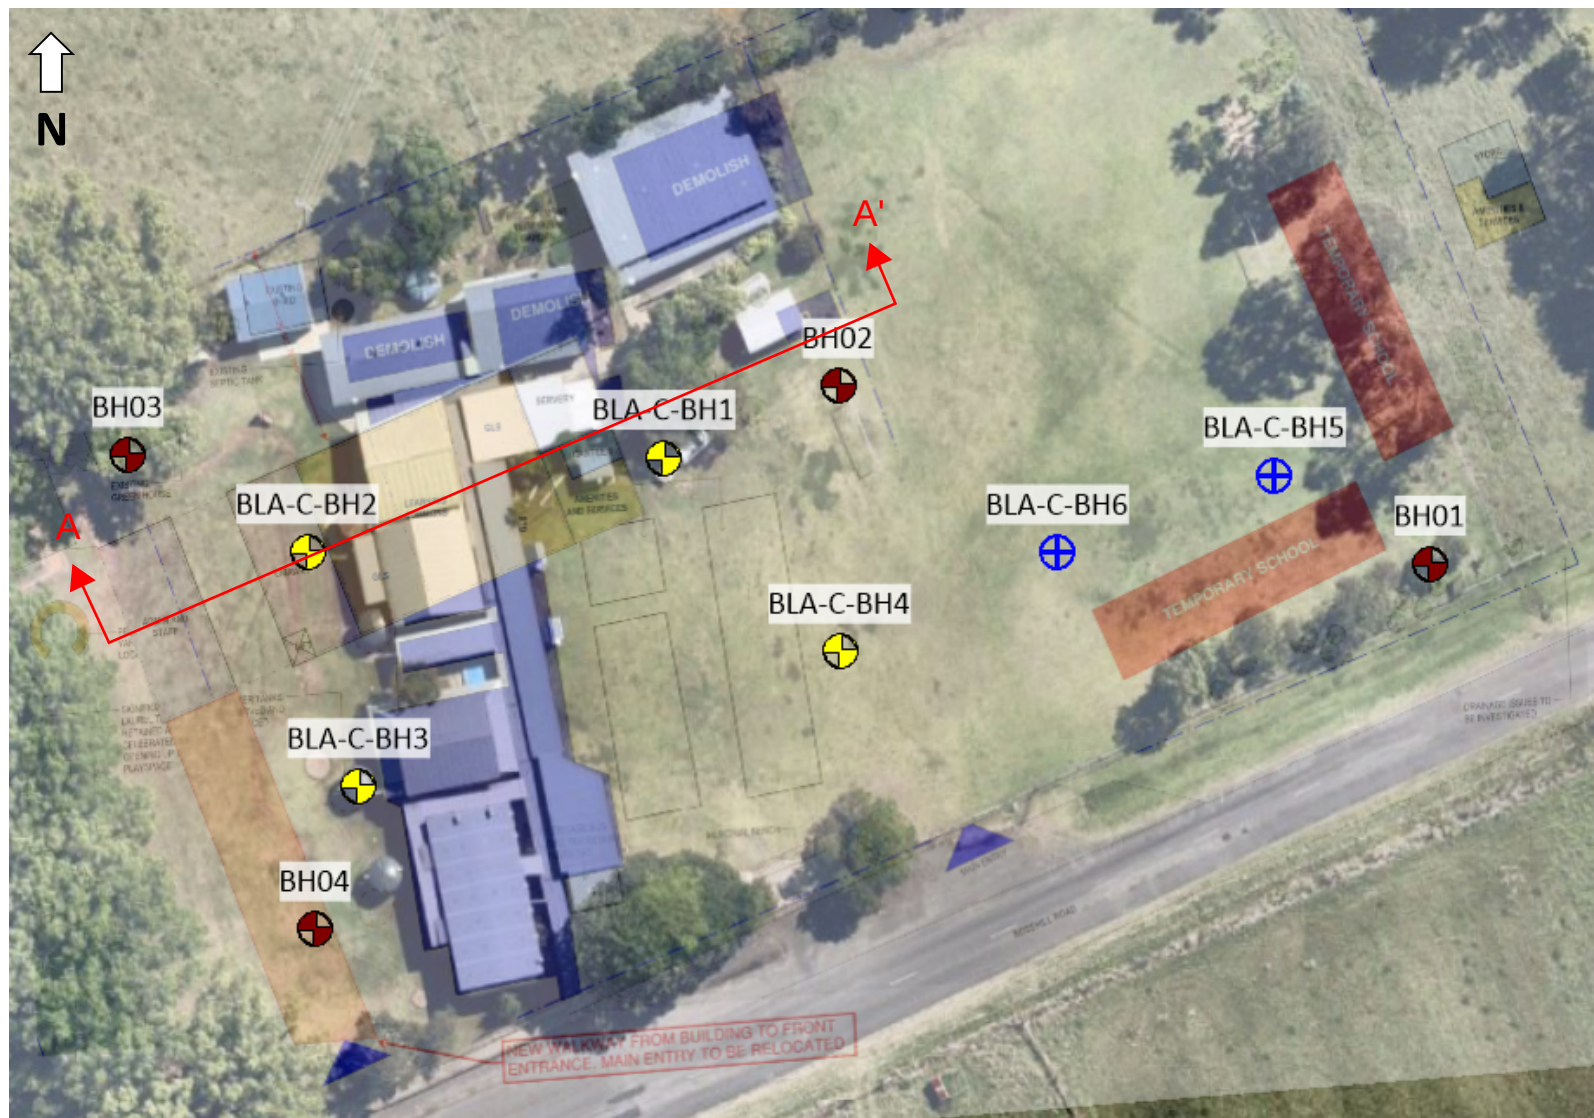
| title: | <b>Borehole Location Plan</b> | | |

- 2022 Geotechnial boreholes by DP
- 2023 Geotechnical boreholes by Coffey
- 2023 Environmental boreholes by Coffey
