Statement of Environmental Effects

Kosciuszko Flow Trail Realignment, Little Beauty Jumps
Bypass and Wombat Walk Connector Mountain Bike Trails

Thredbo Alpine Resort
Kosciuszko National Park, NSW

January 2024

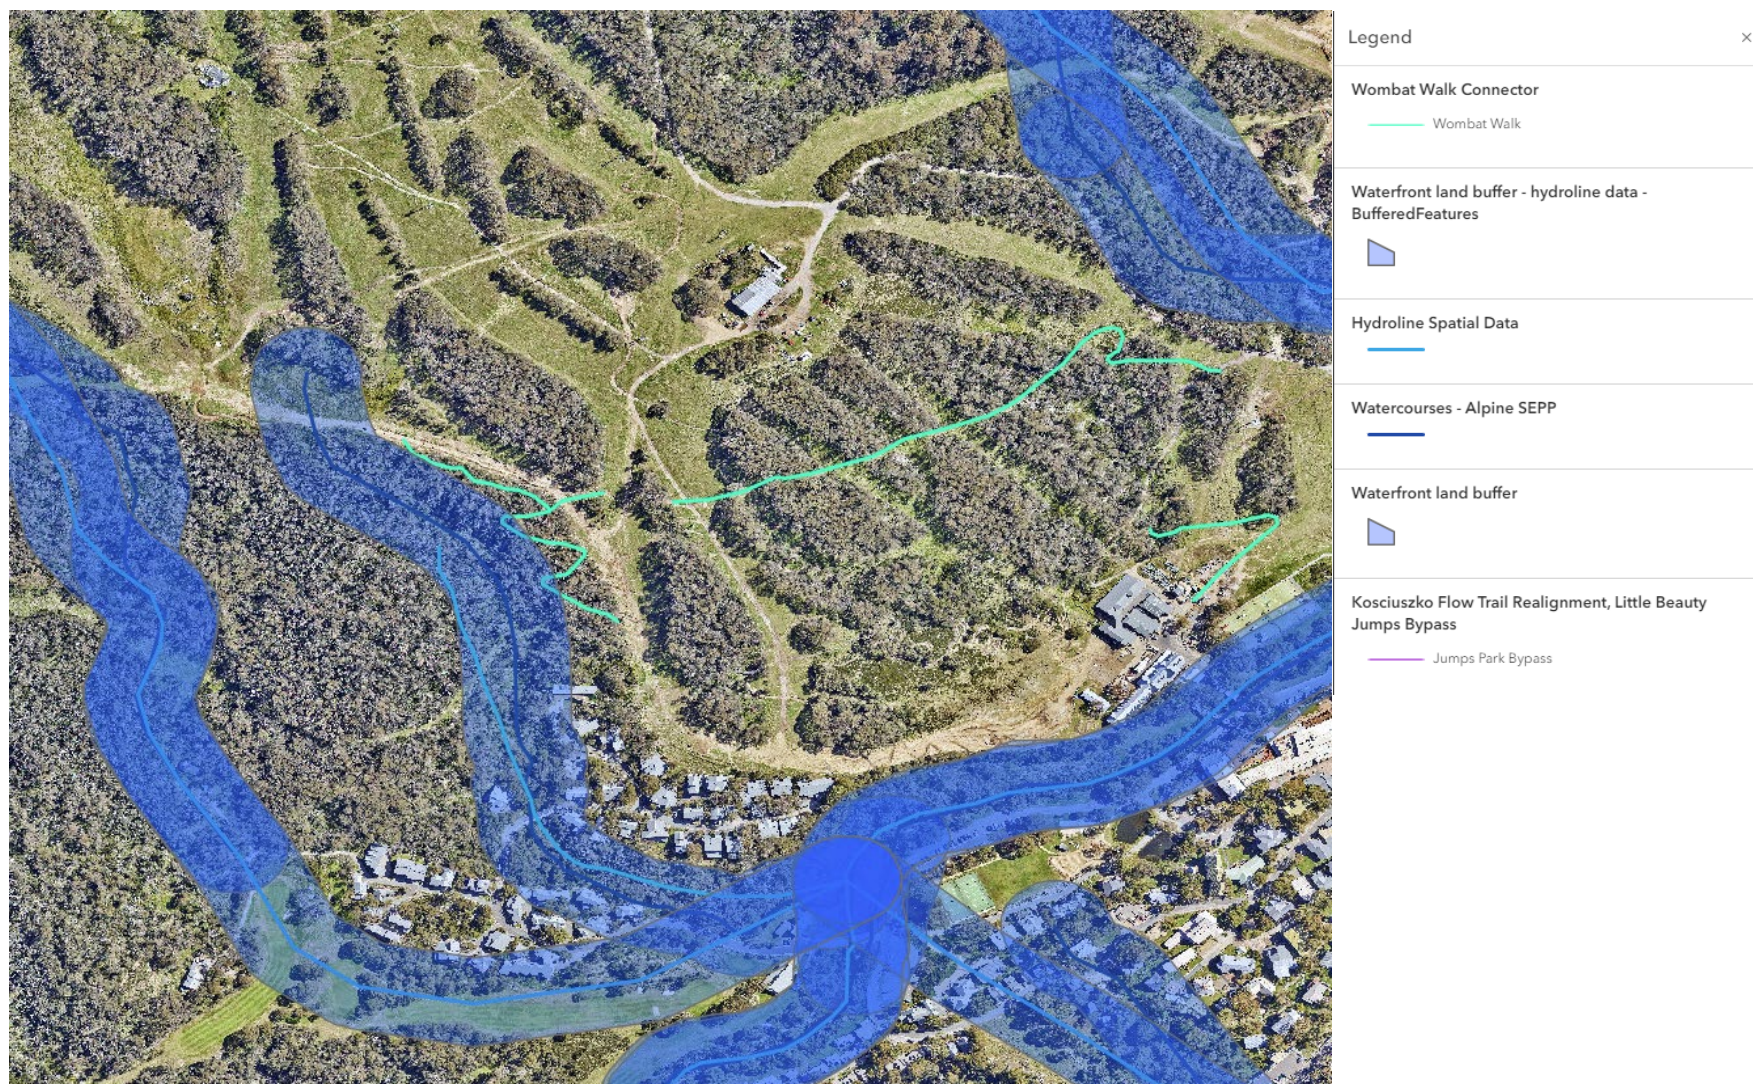
Figure 7: Waterfront Land Review

A review of the *Water Management (General) Regulation 2018 Hydro Line spatial data* (NSW Government 2018) and the *State Environmental Planning Policy (Kosciuszko National Park – Alpine Resort) 2007 Thredbo Alpine Resort, Sheet 1 of 5* (DoP 2006) confirms the Flow Trail Realignment is located within 40 m of a mapped watercourse. It is noted the mapped watercourse alignments for both datasets are not entirely accurate. The Wombat Walk Connector is not located within 40m of a mapped watercourse, refer **Figure 7**.

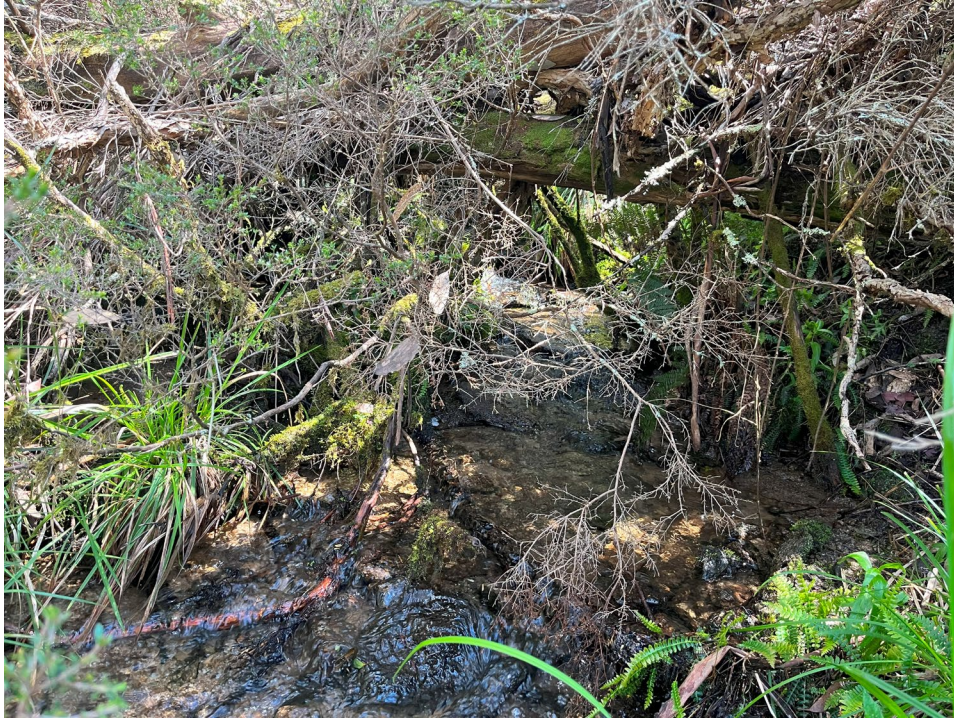
The watercourse is classified as a first order stream under the Strahler system. The channel width ranges from approximately 1.2-1.5 m wide along the length of the site. For the purposes of this assessment the channel stream width depicted on **Figure 8** is 1.5 m for the entire length. Photos of the minor watercourse for context are provided in **Plate 4** and **Plate 5**.

Plate 4: First order watercourse within 40 m of the Development (facing upstream)

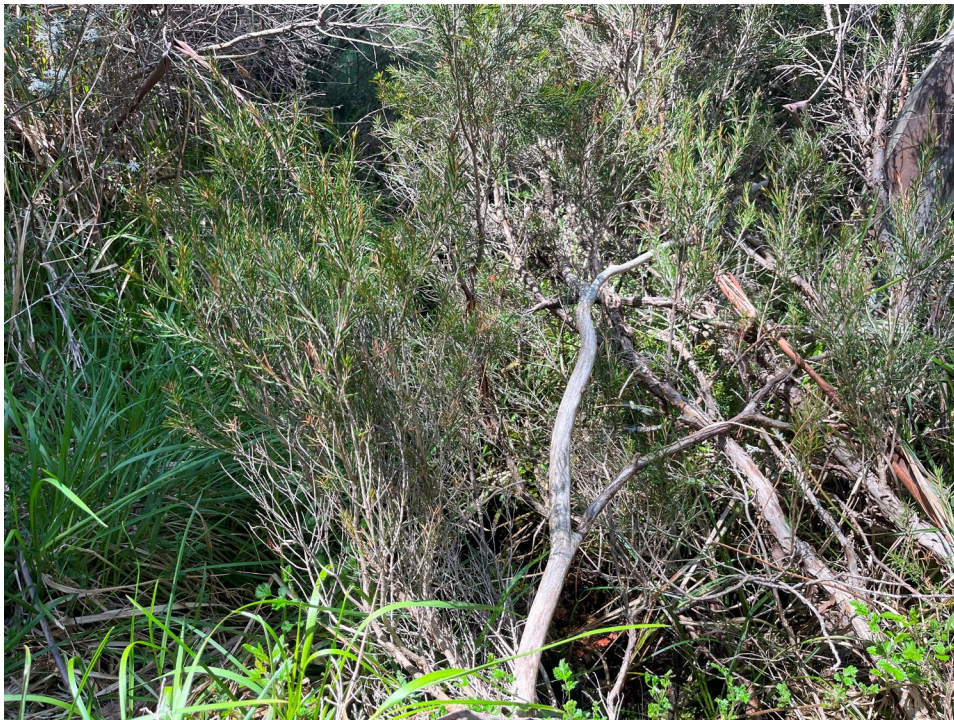
Plate 5: First order watercourse within 40 m of site (facing downstream)
