Statement of Environmental Effects

Kosciuszko Flow Trail Realignment, Little Beauty Jumps
Bypass and Wombat Walk Connector Mountain Bike Trails

Thredbo Alpine Resort
Kosciuszko National Park, NSW

January 2024

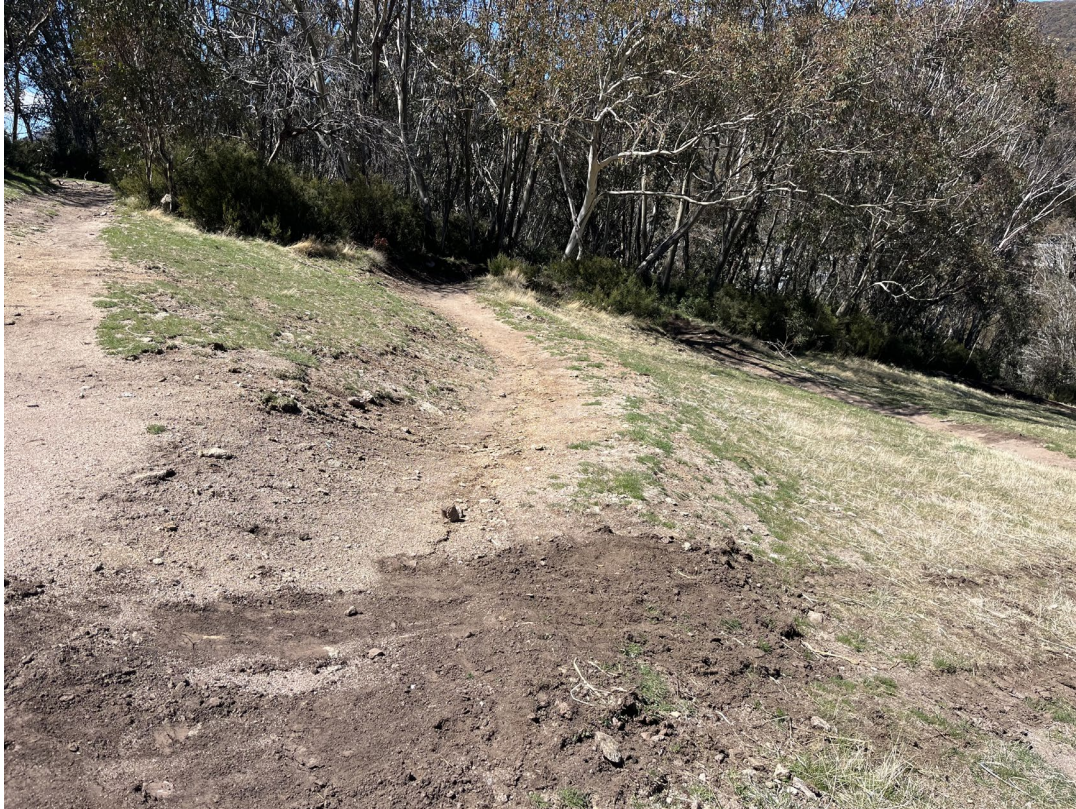
Plate 1: Section of Kosciuszko Flow trail below Wombat Walk access track on Milk Run to be closed

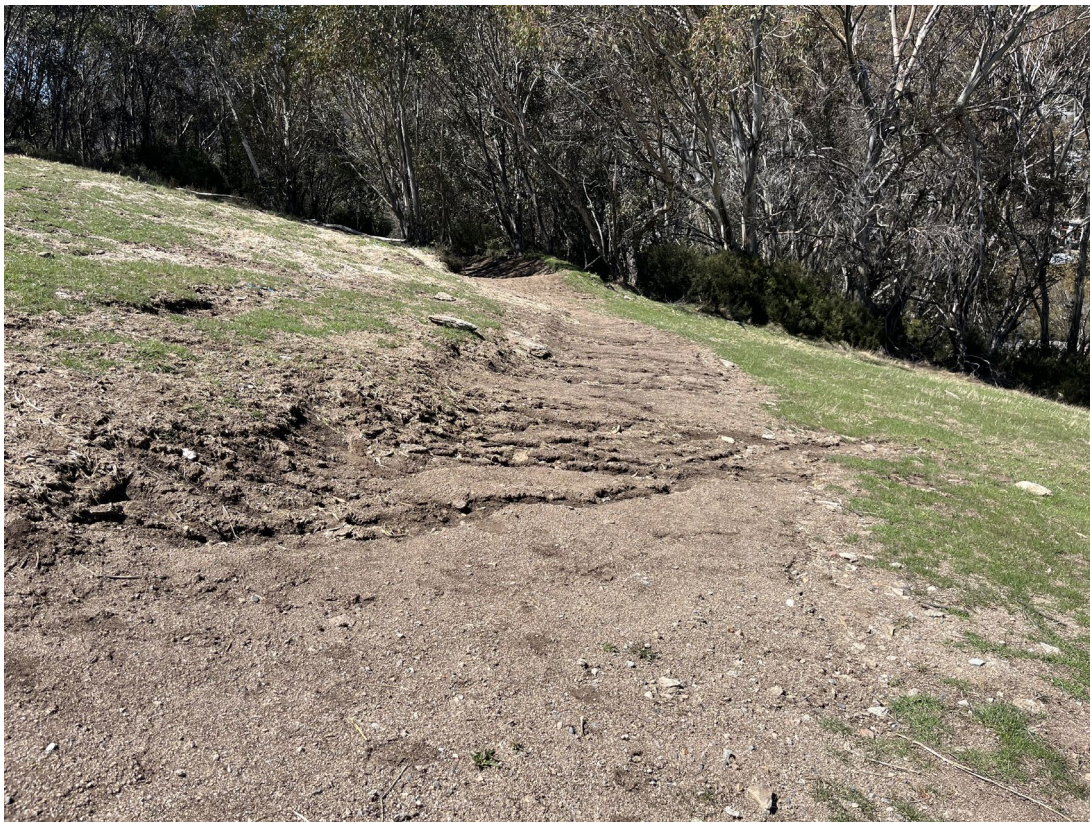
Plate 2: Section of Kosciuszko Flow Trail on Milk Run ski slope to be closed

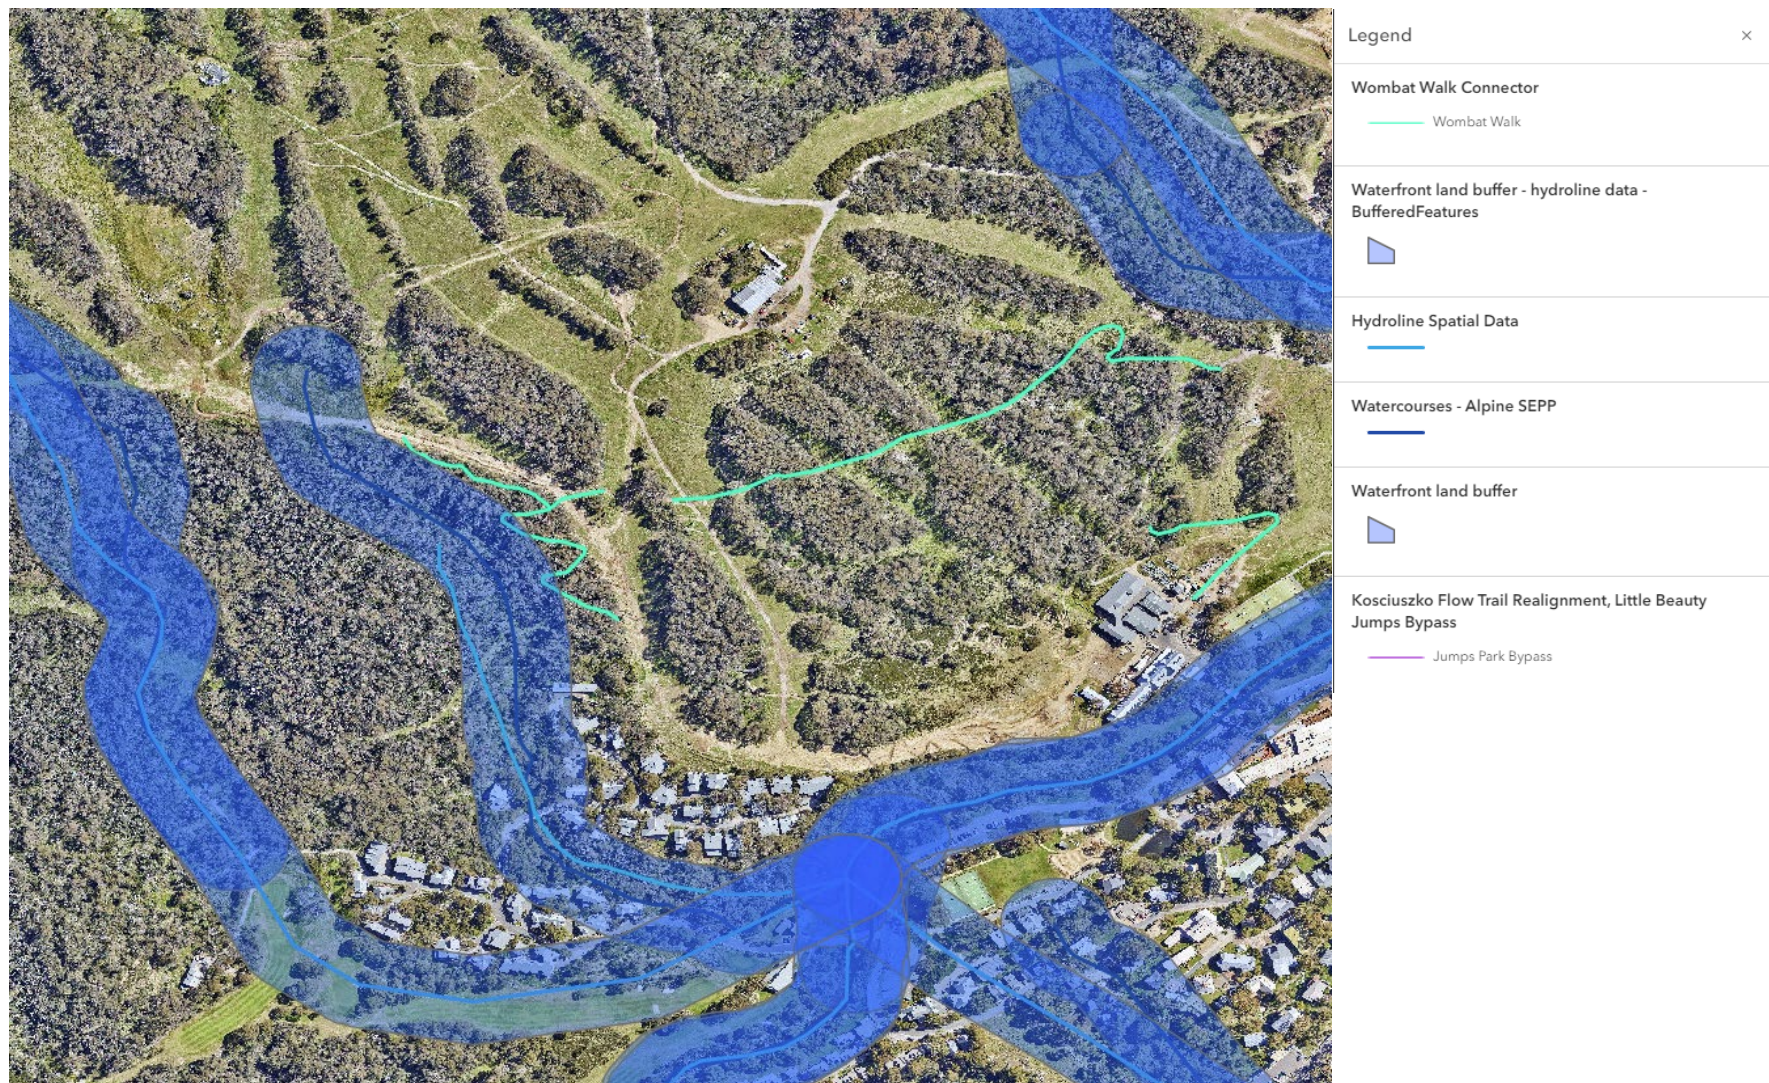
Figure 7: Waterfront Land Review

A review of the *Water Management (General) Regulation 2018 Hydro Line spatial data* (NSW Government 2018) and the *State Environmental Planning Policy (Kosciuszko National Park – Alpine Resort) 2007 Thredbo Alpine Resort, Sheet 1 of 5* (DoP 2006) confirms the Flow Trail Realignment is located within 40 m of a mapped watercourse. It is noted the mapped watercourse alignments for both datasets are not entirely accurate. The Wombat Walk Connector is not located within 40m of a mapped watercourse, refer **Figure 7**.

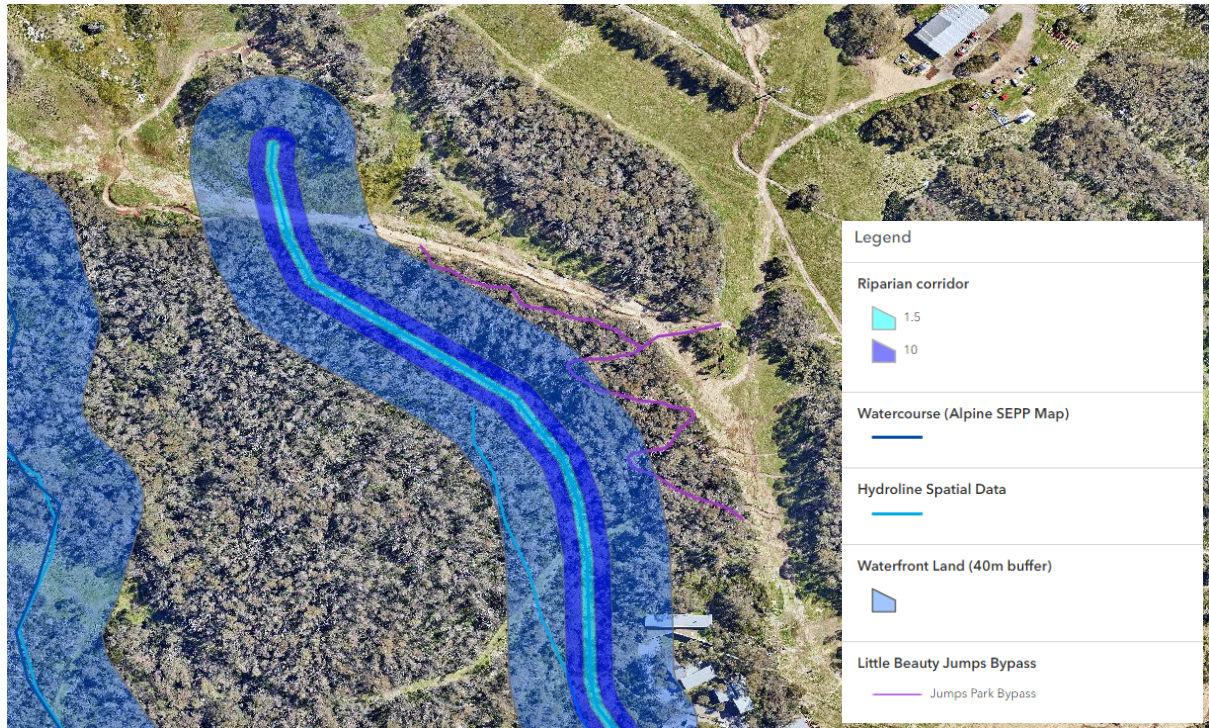
Figure 8: Riparian Corridor Assessment

Two short sections of the Flow Trail Realignment, approximately 65.90 m (36.60m + 29.30m) are located within 40 m of a mapped watercourse (**Figure 8**). Therefore, an assessment has been carried out in accordance with the *DPE Fact Sheet: Controlled Activities – Guidelines for riparian corridors on waterfront land*.

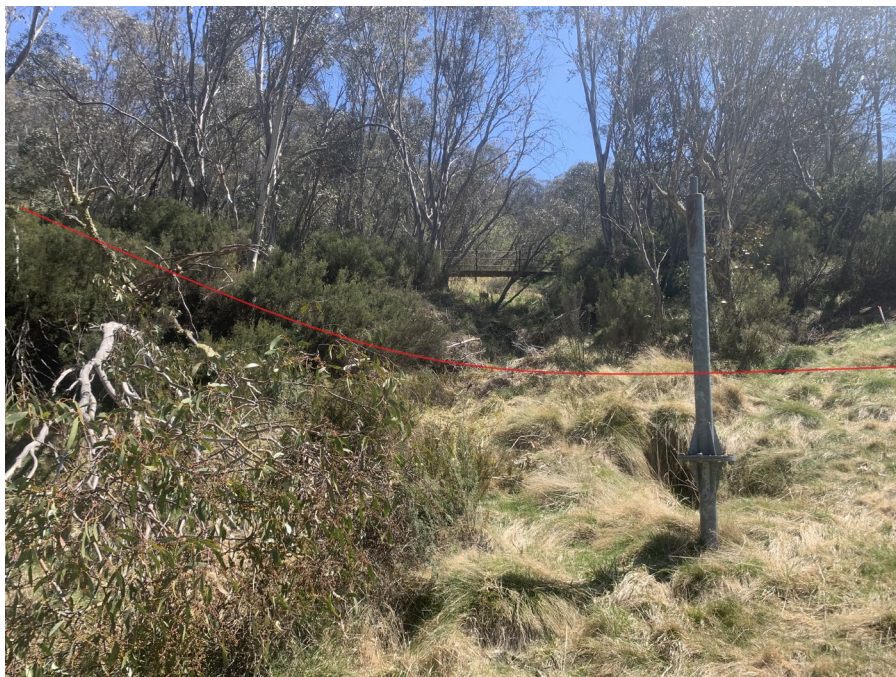
The lower section of the Wombat Walk Connector will traverse a wet area / drainage line below the existing Home Run trail platform located northeast of the Snowgums Chairlift bottom station, refer **Plate 3**.

Plate 3: Wet Area / Drainage Line – Platform Location

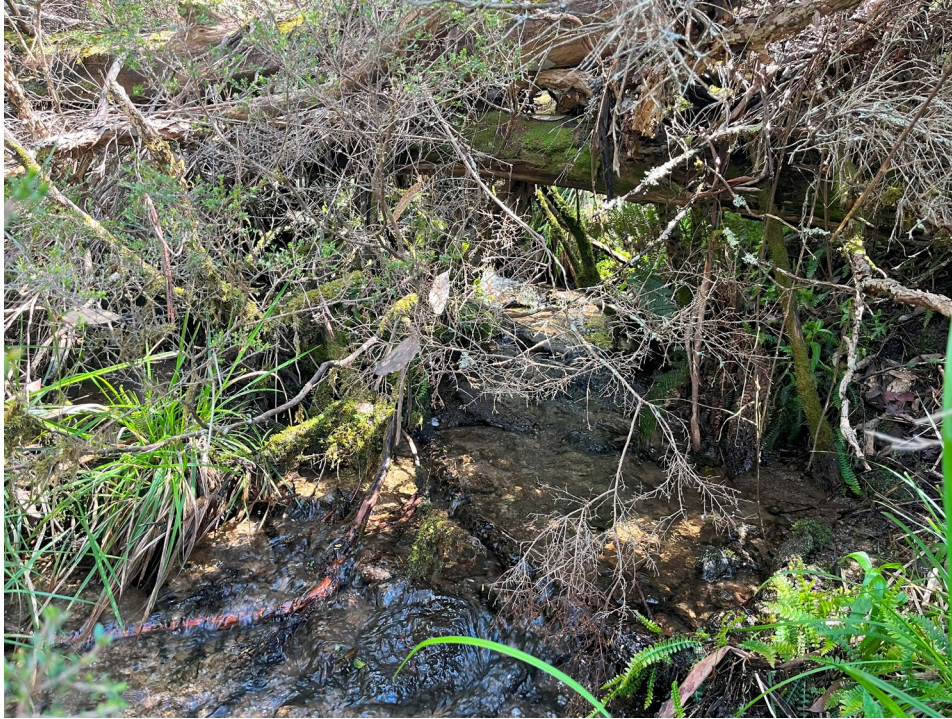
The watercourse is classified as a first order stream under the Strahler system. The channel width ranges from approximately 1.2-1.5 m wide along the length of the site. For the purposes of this assessment the channel stream width depicted on **Figure 8** is 1.5 m for the entire length. Photos of the minor watercourse for context are provided in **Plate 4** and **Plate 5**.

Plate 4: First order watercourse within 40 m of the Development (facing upstream)

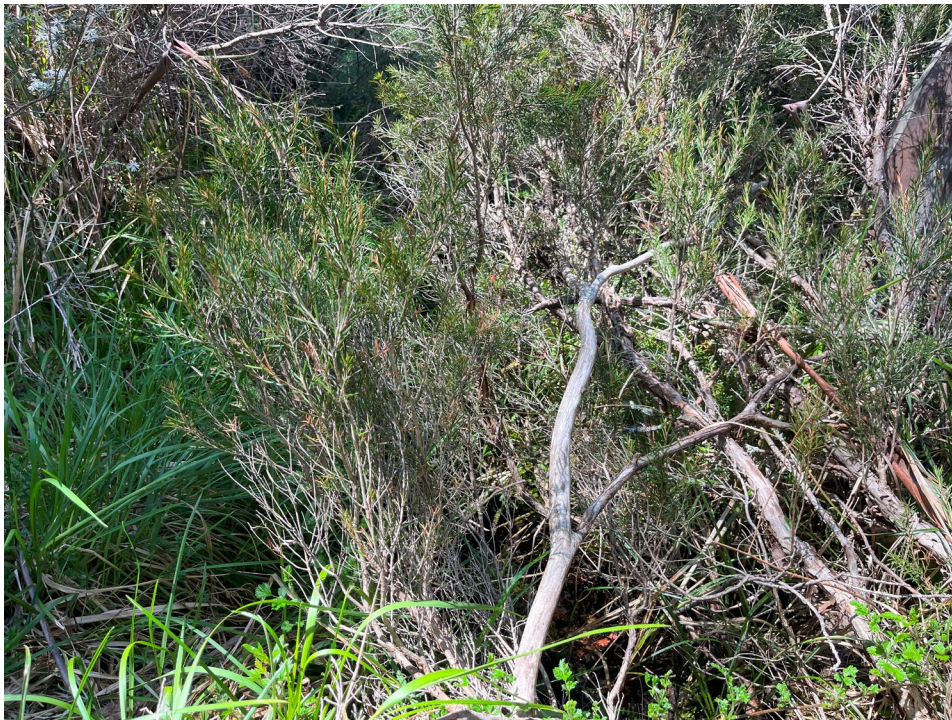
Plate 5: First order watercourse within 40 m of site (facing downstream)

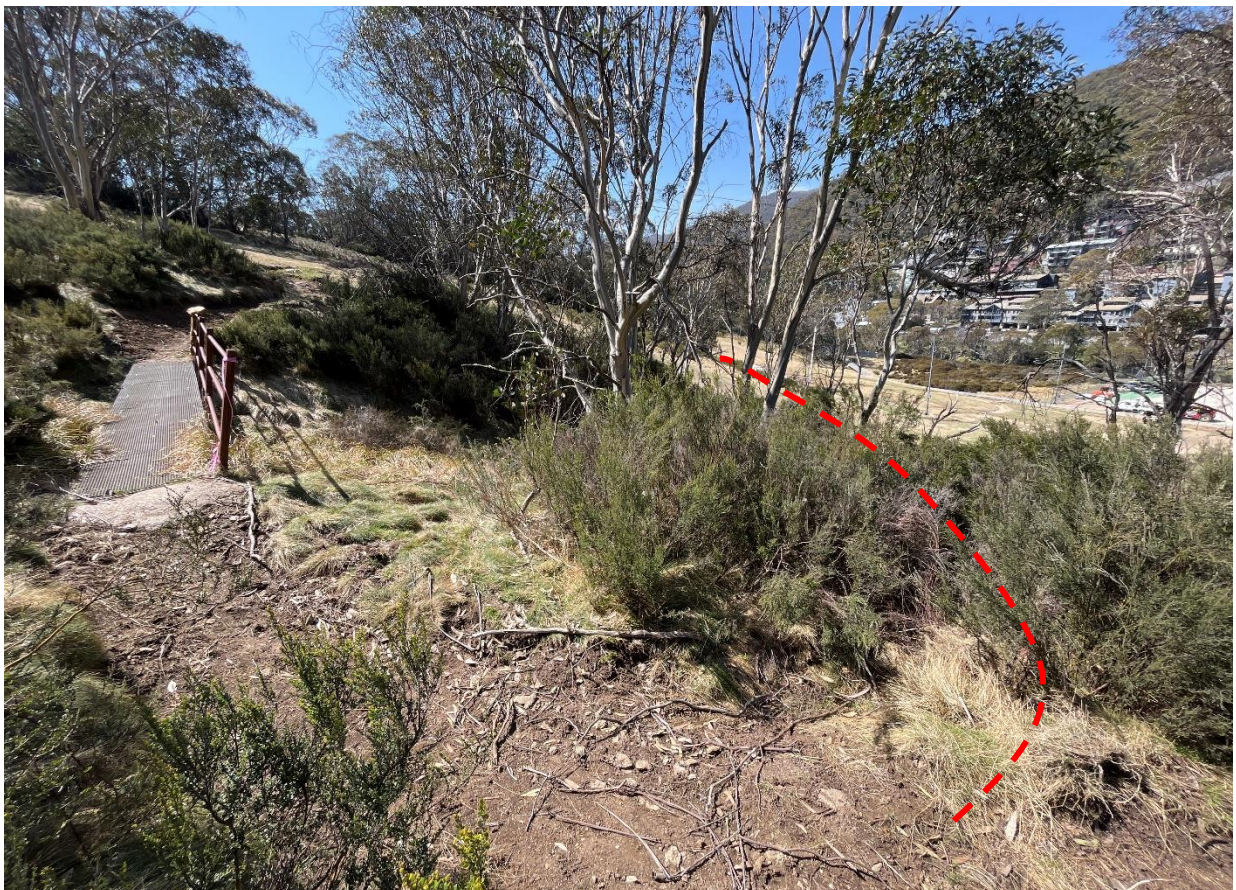
Photo 10: The lower part of the new Wombat Walk will include a platform where it traverses a minor watercourse.
