## PRELIMINARY SITE INVESTIGATION

5 McDermott Avenue, Goonellabah, NSW 2480

Job Number: 218158

Social Futures

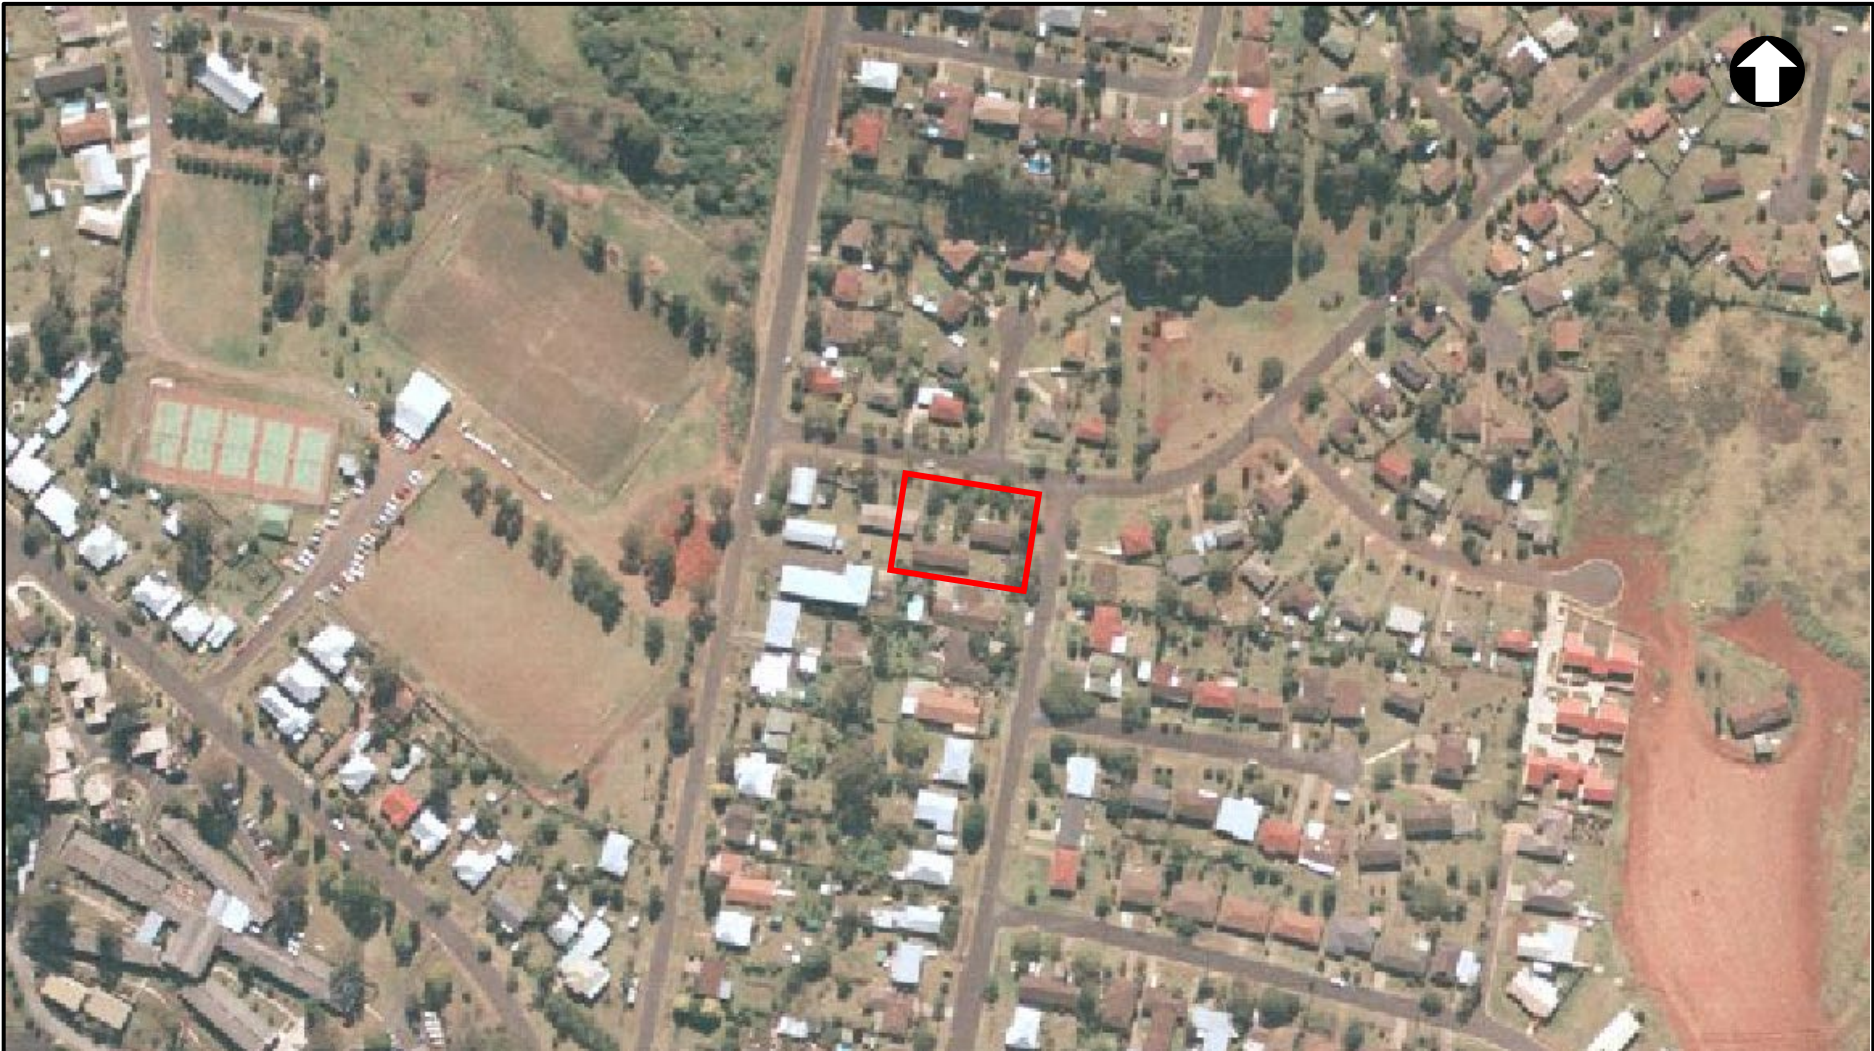
**Figure 5 – Historical Aerial Imagery 1991**  
5 McDermott Avenue Goonellabah, NSW 2480  
August 2023

Site Area (Approximate)

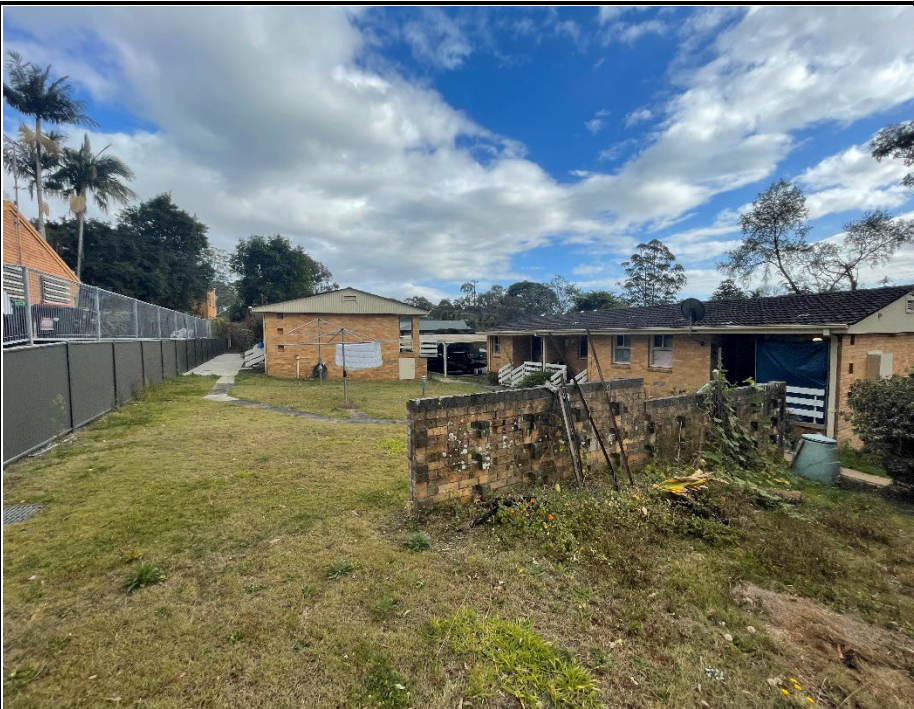
| Photo No. | Date | |
|---|---|---|
| <b>Description</b><br>The site, viewed from the south-east. Current building structures, as well as vegetated portions of the site can be observed. No obvious visible signs of contamination can be observed. | | |

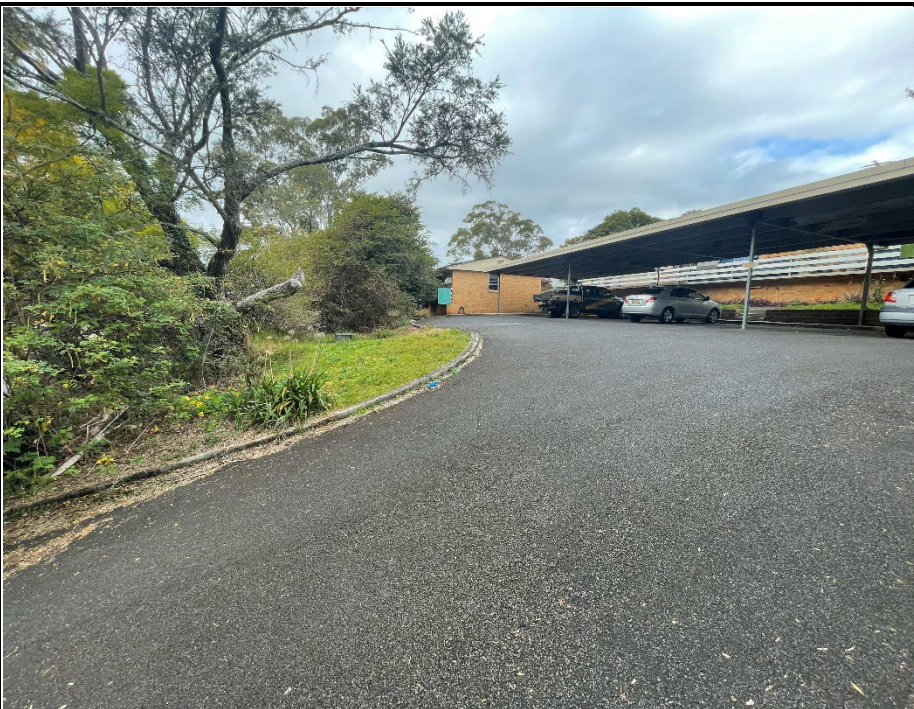
| Photo No. | Date | |
|---|---|---|
| <b>Description</b><br>The site, viewed from the north-west. A car shade can be observed in the centre of the site, as well as the bitumised driveway and car park. Vegetation can be observed to the north of the site. | | |

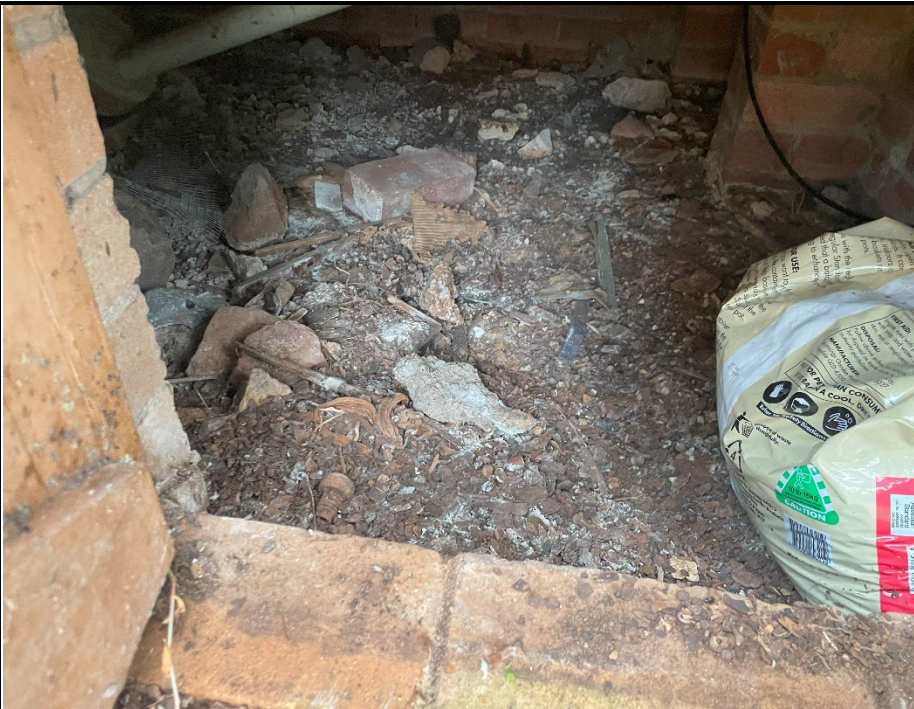
| Photo No. | Date | |
|---|---|---|
| 3 | 02/08/2023 | |

| Photo No. | Date | |
|---|---|---|
| <b>Description</b><br>Image depicts soils at sample location B1_01. Discarded building materials including bricks, metal bolts and plastics can be observed. A bag of potting mix is also present. | | |

Concentrations of zinc exceeding site specific EIL's were detected for samples B1\_01 and SS07. Both sample points were noted to be in the immediate vicinity of structures on site. Notably, levels of lead and zinc also exceed waste classification criteria for ENM (2014) criteria at sit B1\_01. No OCPs were detected.

It is noted that metal concentrations were also found to exceed criteria stated in the Excavated Natural Material Order (ENM) (2014), at site B1\_01. If excavated, waste soils will be required to be isolated and deposited off site at a registered, licensed facility.

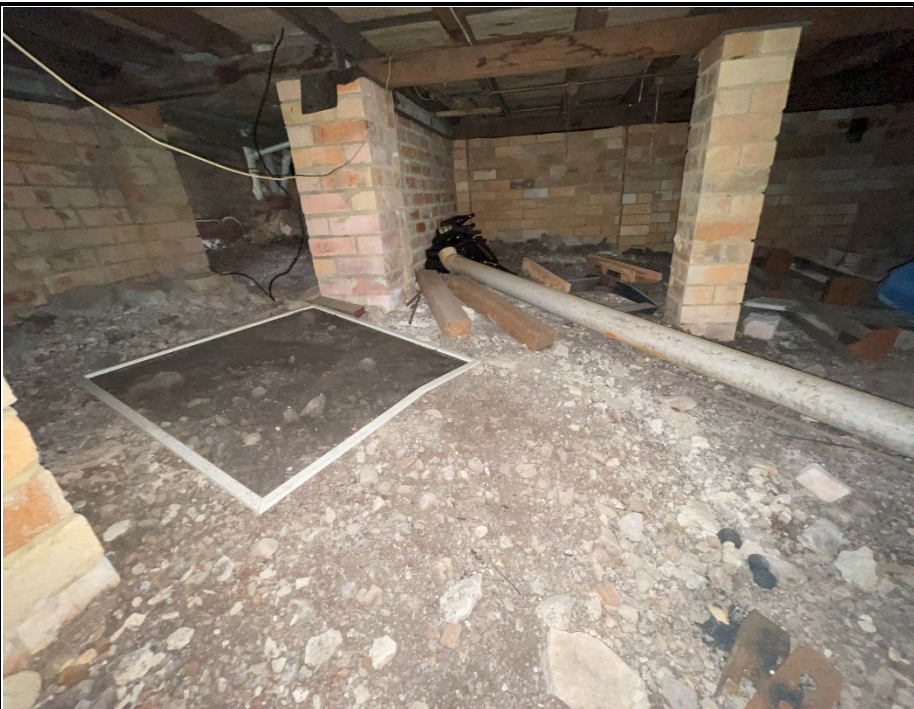
| Photo No. | Date | |
|---|---|---|
| 4 | 02/08/2023 | |

| Photo No. | Date | |
|---|---|---|
| <b>Description</b><br>Image depicts soils at sample location B2_02. Discarded building materials including wood, bricks, plastics and glass can be observed. | | |

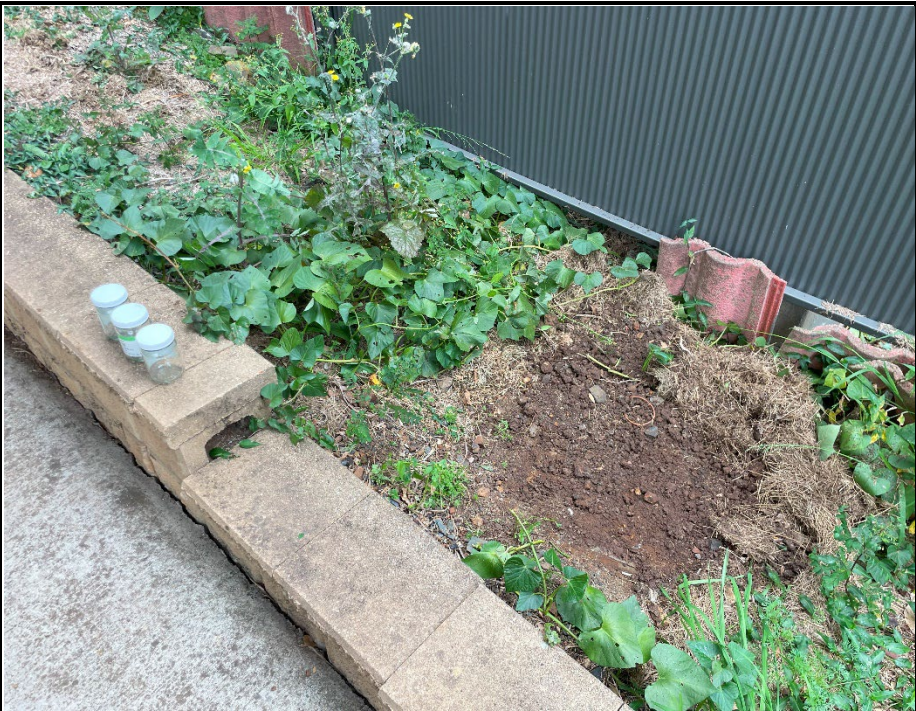
| Photo No. | Date | |
|---|---|---|
| 5 | 02/08/2023 | |

| Photo No. | Date | |
|---|---|---|
| <b>Description</b><br>Image depicts soil at sample location SS08. Building materials including tiles, and bricks can be noted next to the boundary fence. The sample location is partially vegetated. | | |
