Site Contamination Investigation

Client: Tamworth Aboriginal Medical Service

Site Address: Lot 2 DP 1264030
Tamworth NSW 2340

Our Reference : 40924-ER01_A

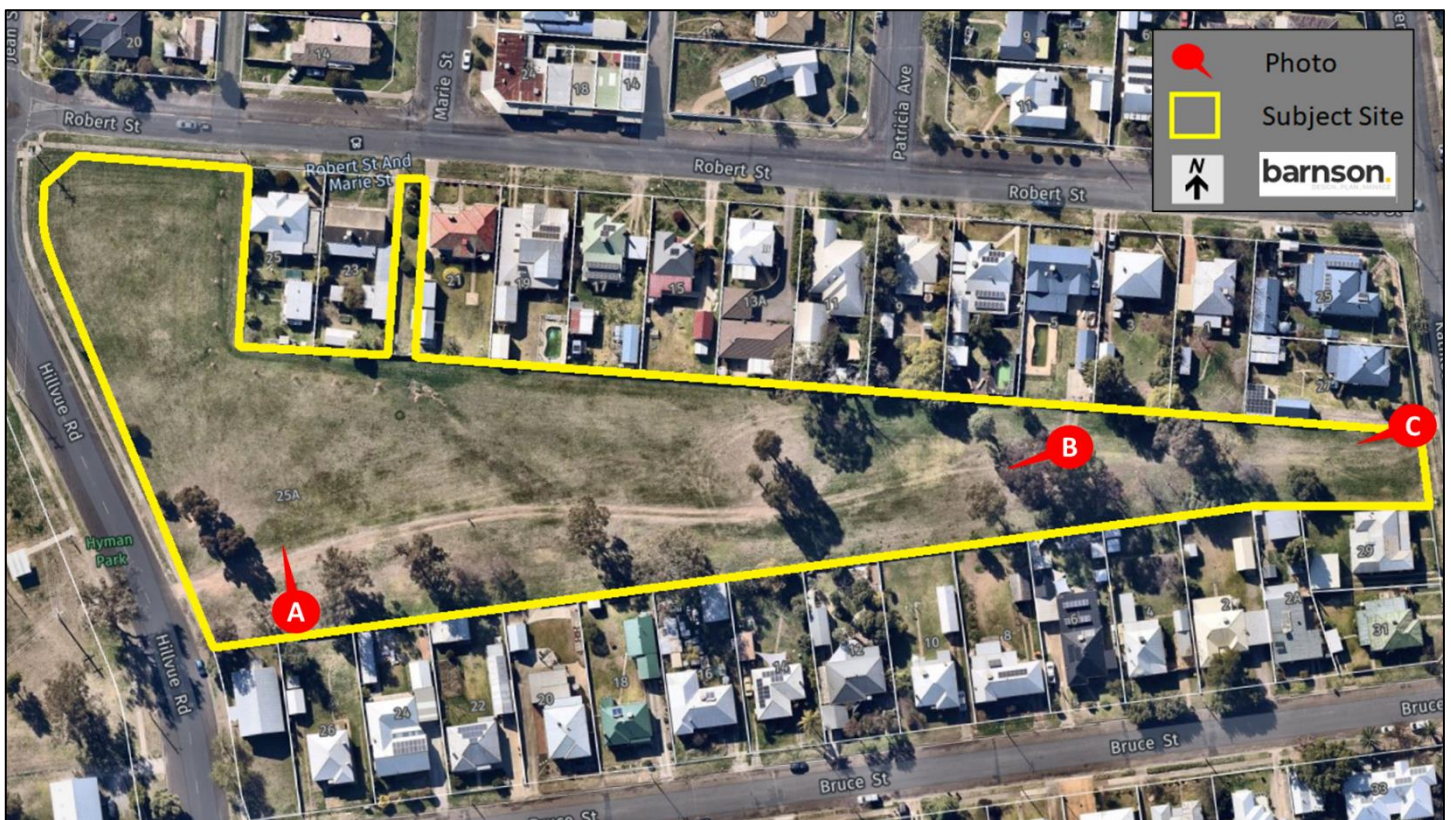
Figure 2.2: Existing Subject Site layout.

Figure 2.2 presents a plan of the Subject Site that is supplemented with photographs showing the different elements of the Site (Figure 2.3 to Figure 2.5). Figure 2.2 includes markers indicating the vantage point and direction of the photographs.

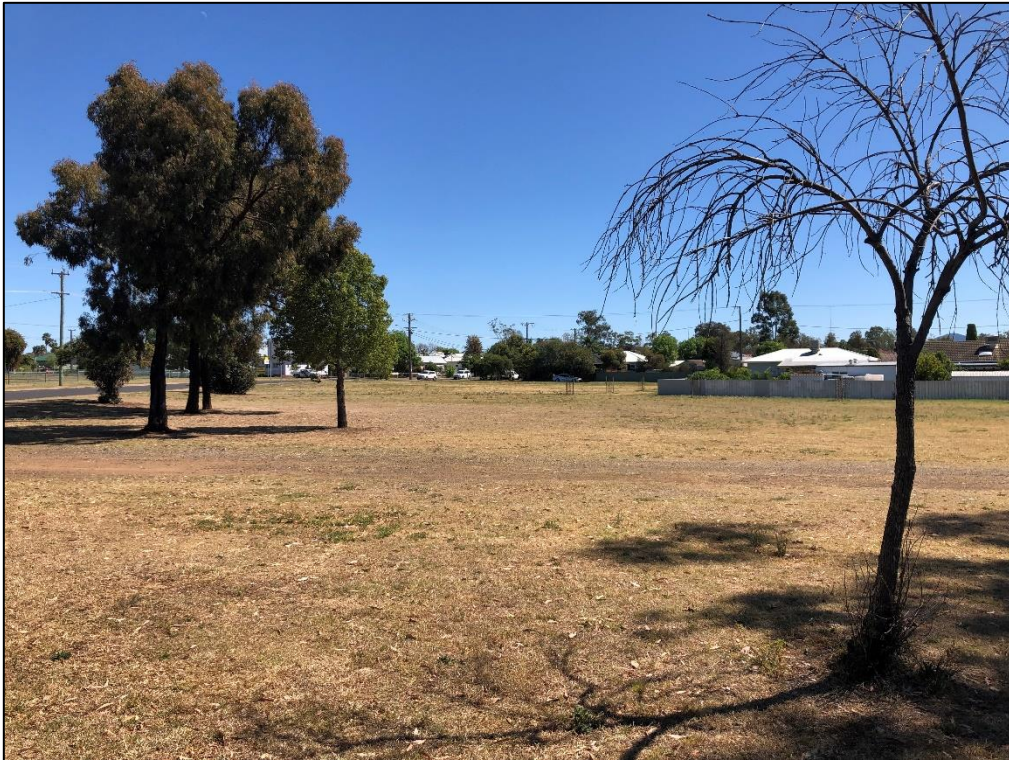
Figure 2.3: Photo A – Photo of western portion of the site, looking north.

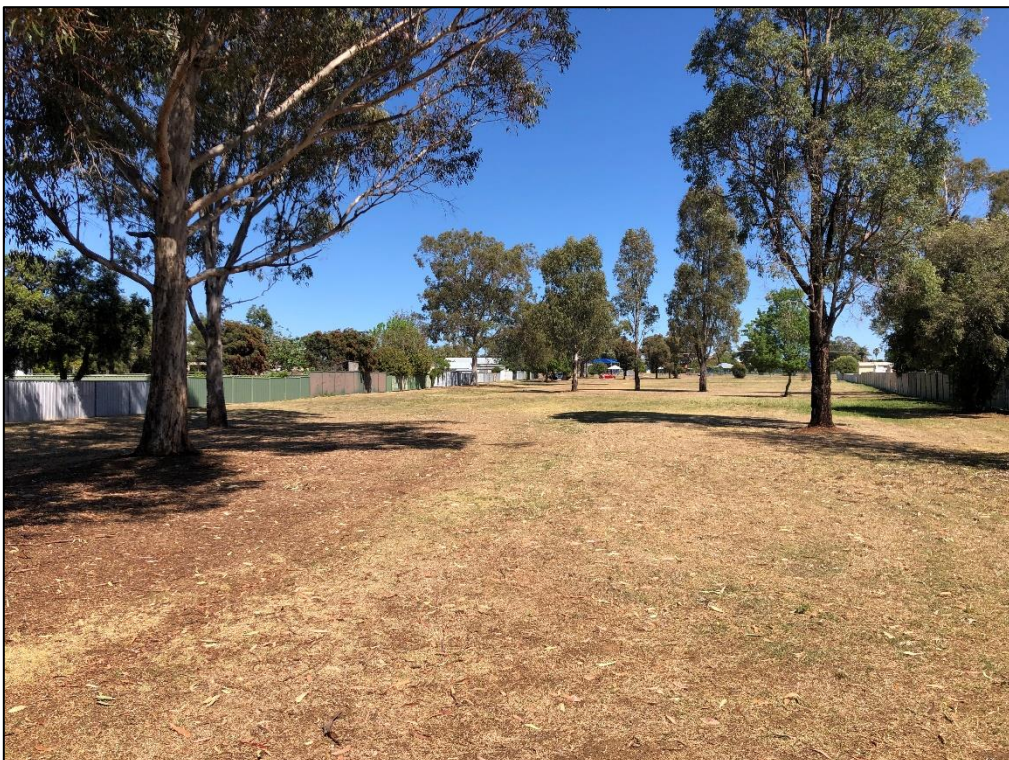
Figure 2.4: Photo B – View of car tracks crossing the site, looking west.

The use of motorised gardening equipment as well as other vehicles historically driving across the site (tracks are evident) have the potential to contribute to localised contamination of surface soils through leakage and spillage of hydrocarbon fuel and lubricants during use and refuelling of the equipment.

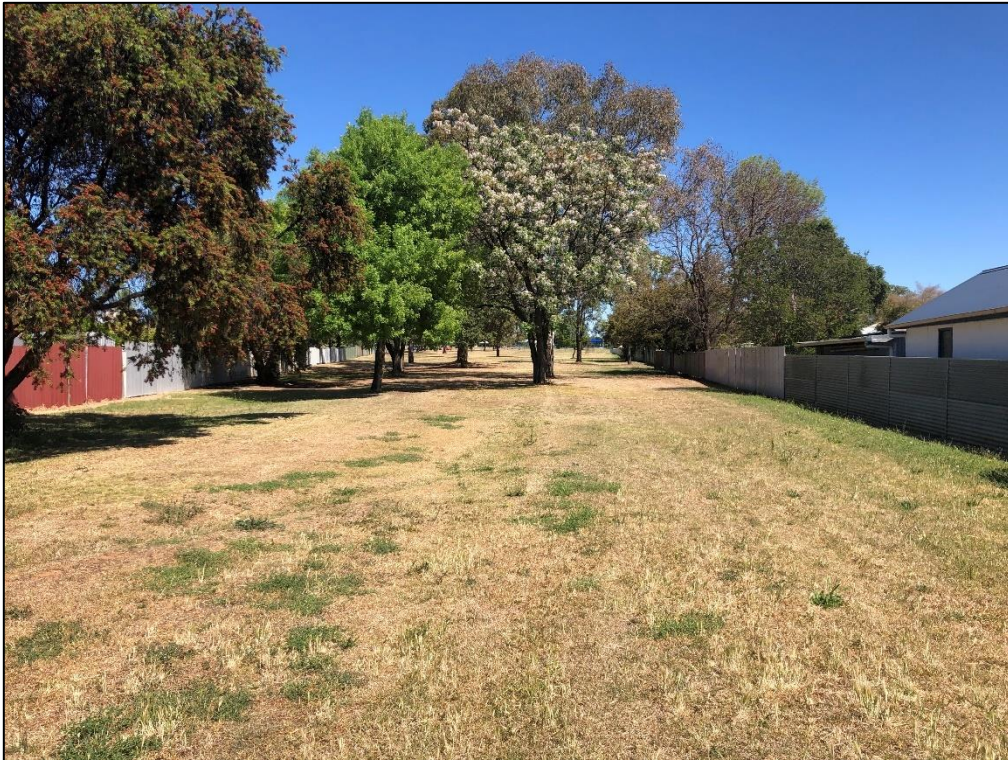
Figure 2.5: Photo C – View of vegetation and vehicle tracks.

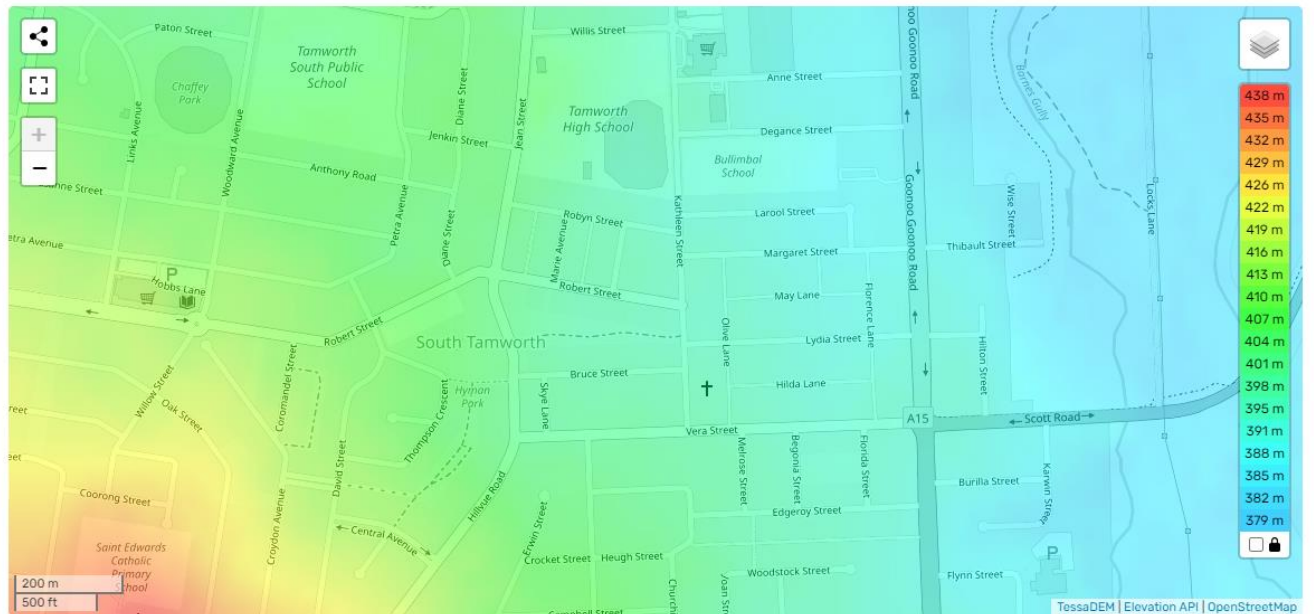
Figure 3.3: Subject Site topography.

Figure 3.3 presents topographical information overlain on the map of the Subject Site. The presented data shows that the Subject Site include a slight slope to the east.

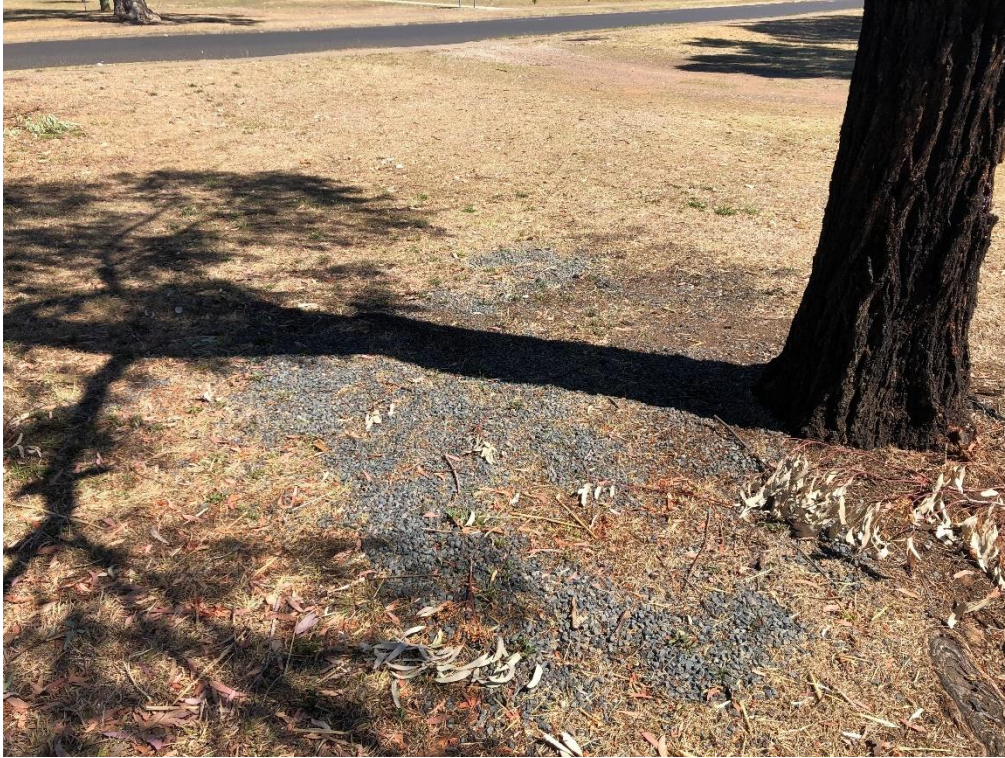
Figure 5.4: Gravel evident at base of a tree near Hillvue Road.

Some gravel, indicative of materials stockpiles is evident at the base of an existing tree (

- Figure 5.4) located near Hillvue Road.
- Small trees/vegetation have been planted in the north-western portion of the site (Figure 5.5:) along the path of a underground sewer/stormwater line.

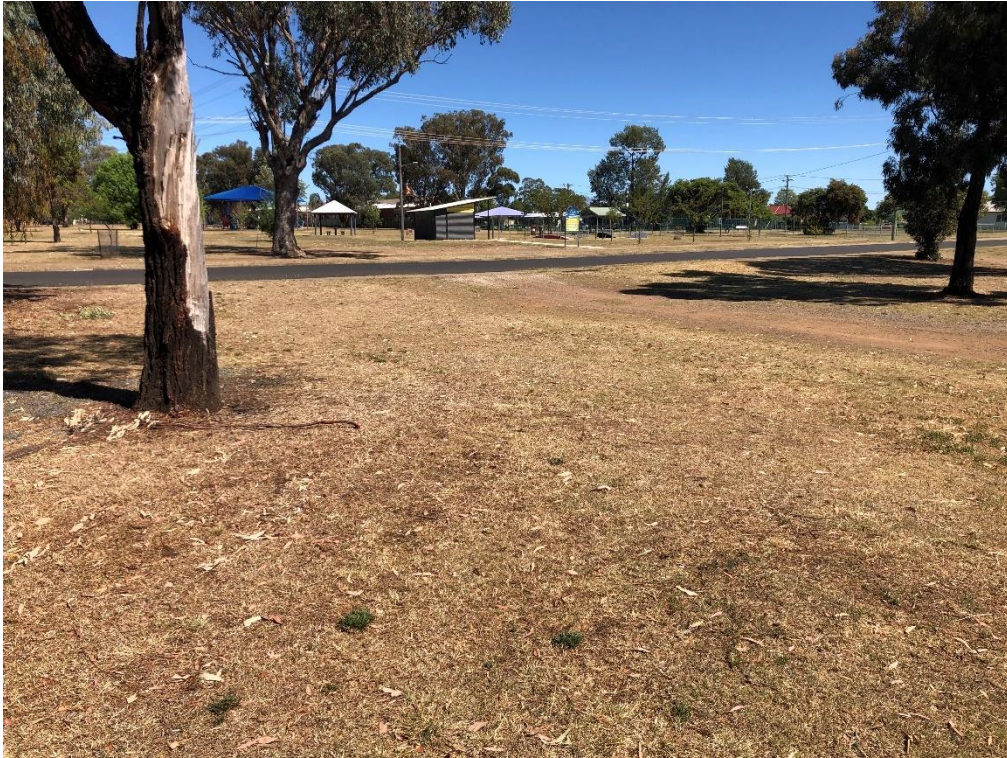
- The Subject Site is not fenced on all sides and access to the site is not controlled. The Site is therefore susceptible to vehicles crossing over the site, as well as uncontrolled disposal of waste (Figure 5.1). However, at the time of the inspection no evidence of any disposal or waste stockpiling or burial was evident.
- At the time Barnson conducted the site inspection, grass running along a neighbouring dwelling's fence-line has an obvious discolouration which may have been caused by pesticide use (Figure 5.2).
- Maintained grasses evident all over the site (Figure 5.3).

Figure 5.1: Photo from west depicting vehicle access.

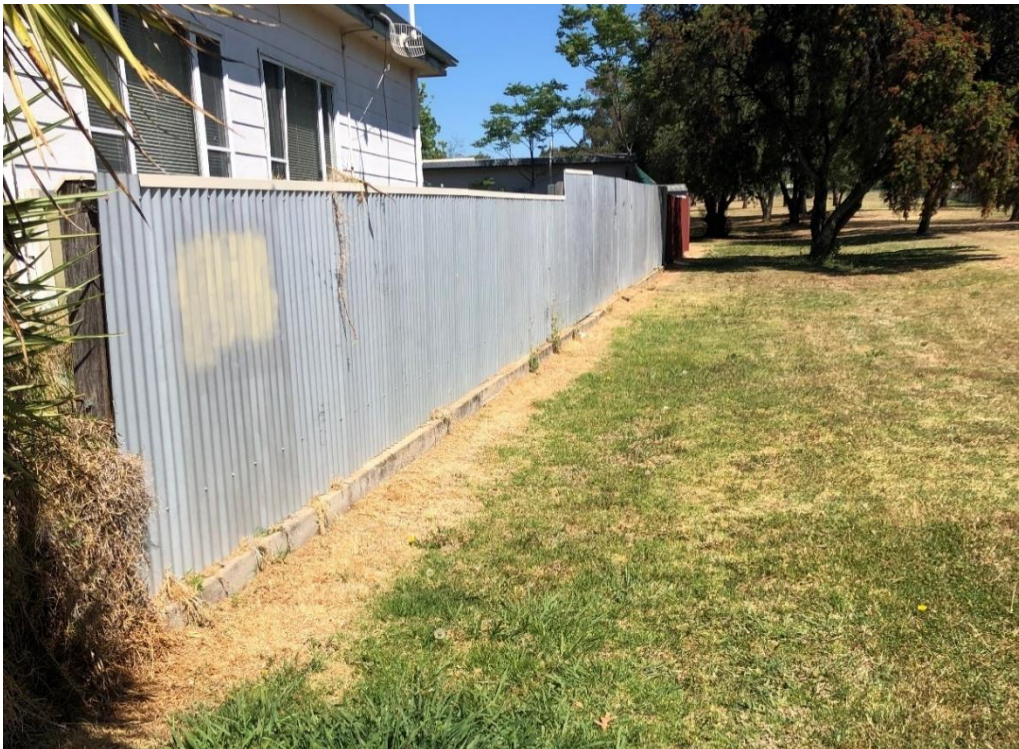
Figure 5.2: Photo of discoloured grasses along dwelling fence line.

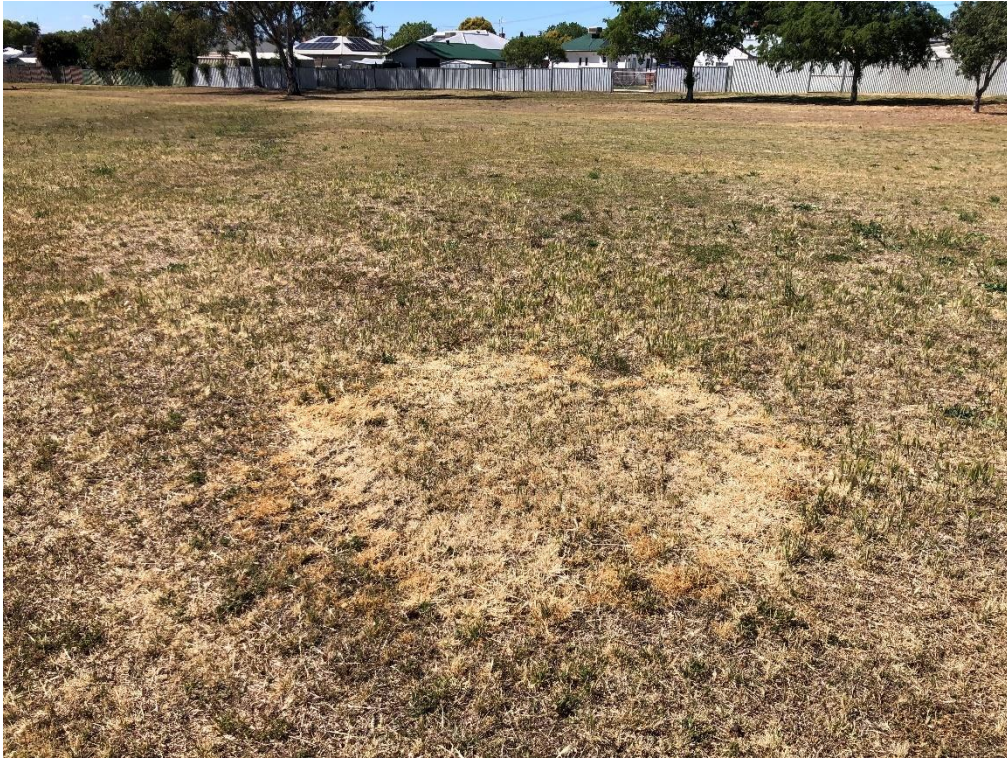
Figure 5.3: Maintained grasses in the central portion of the site.

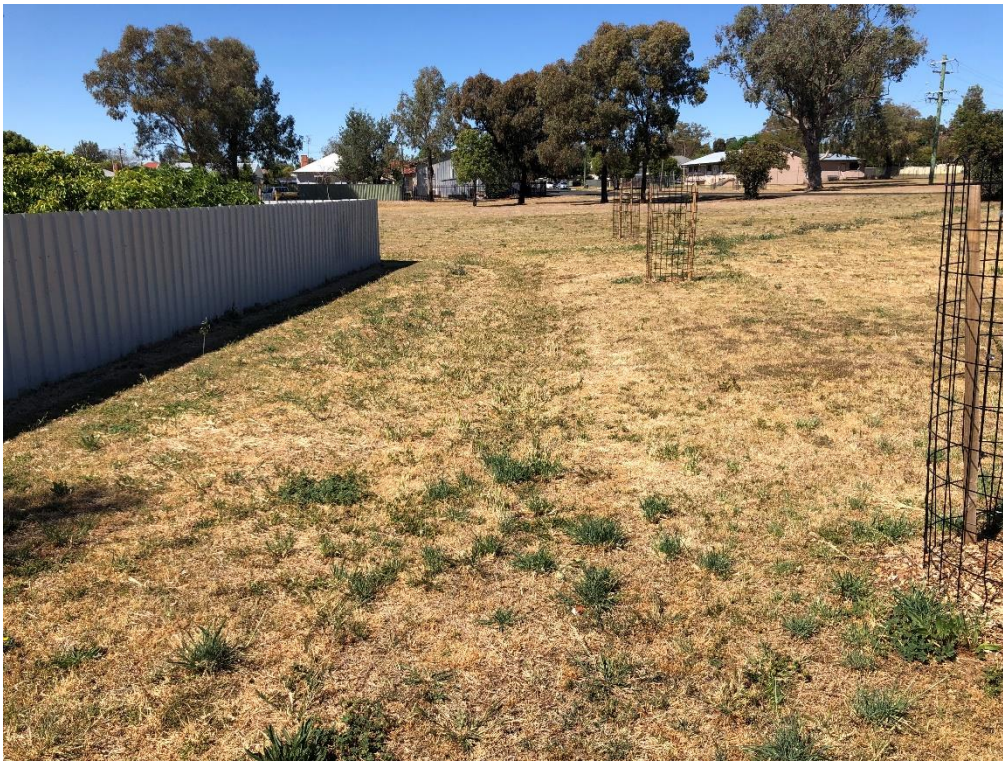
Figure 5.5: Newly planted vegetation.

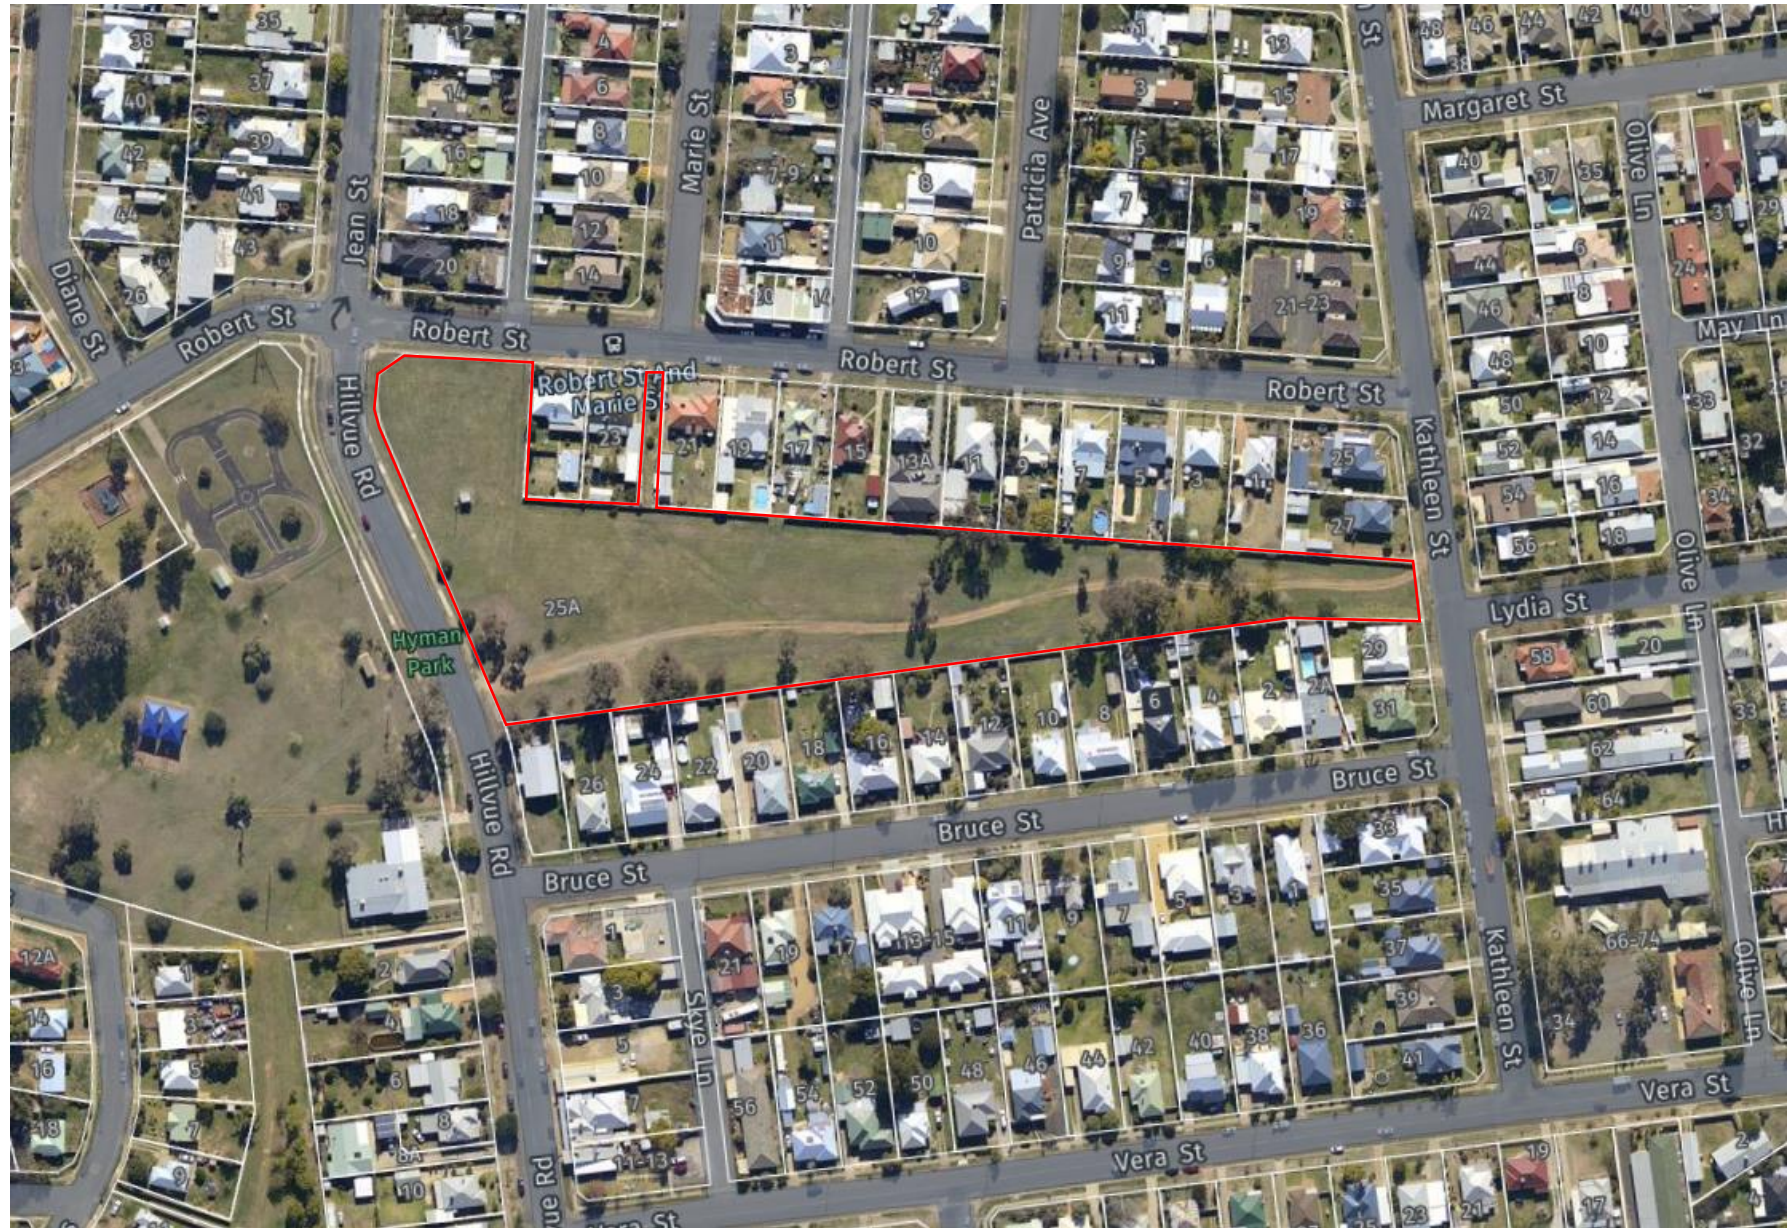
04/07/2014

1998 – 2014 In the western portion of the site, a single structure is observed, believed to be a weather station. A clear vehicle track is now evident running east to west; no other significant changes are observed.

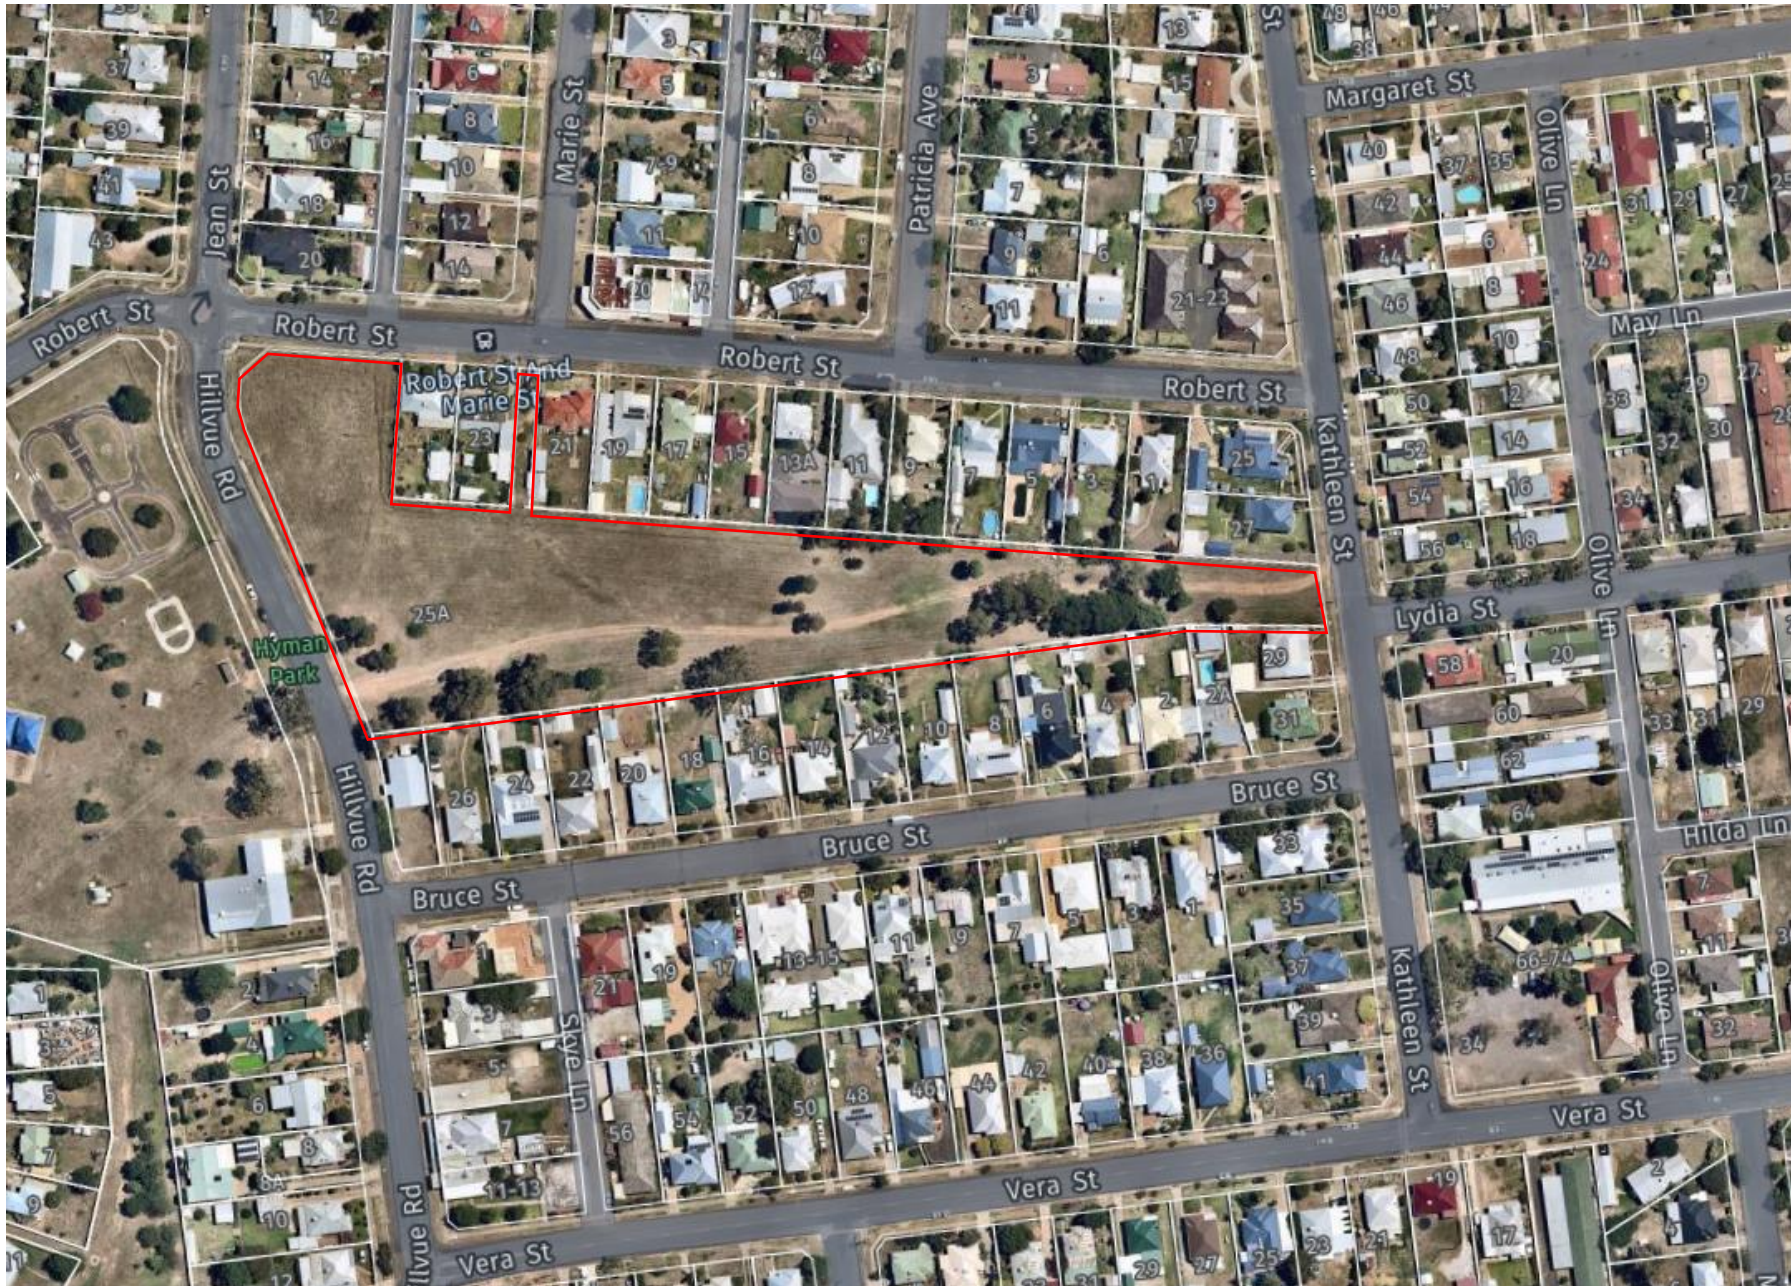
29/12/2016

2014 – 2016 The site remains largely the same as noted for 2014, however the weather station structure in the west has since been demolished. All other elements including neighbouring sites remain the same.
