WATER CYCLE MANAGEMENT STUDY

8 Lot Subdivision

Lot A DP 5411

34 Hillas St

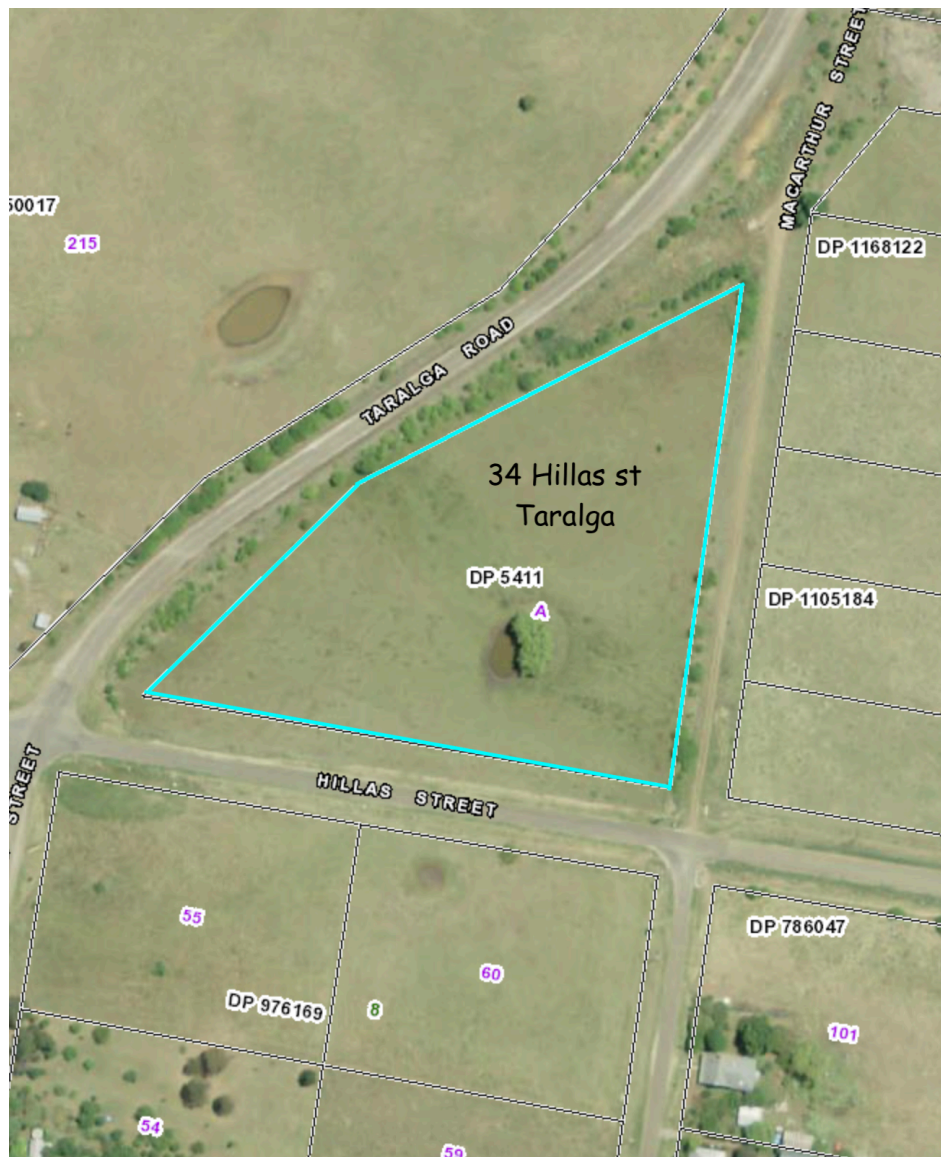
Figure1— Aerial View of 34 Hillas St from maps.six.nsw.gov.au

The site, Lot A DP 5411, No. 34 Hillas St Taralga is currently used for agistment of horses, the lot size is 1.8 Ha in area as shown below. The site slopes to the south east to Hillas St & Macarthur St intersection, there is an existing dam on site which is to be filled in & a drainage depression runs through the site graded to the south eastern corner.

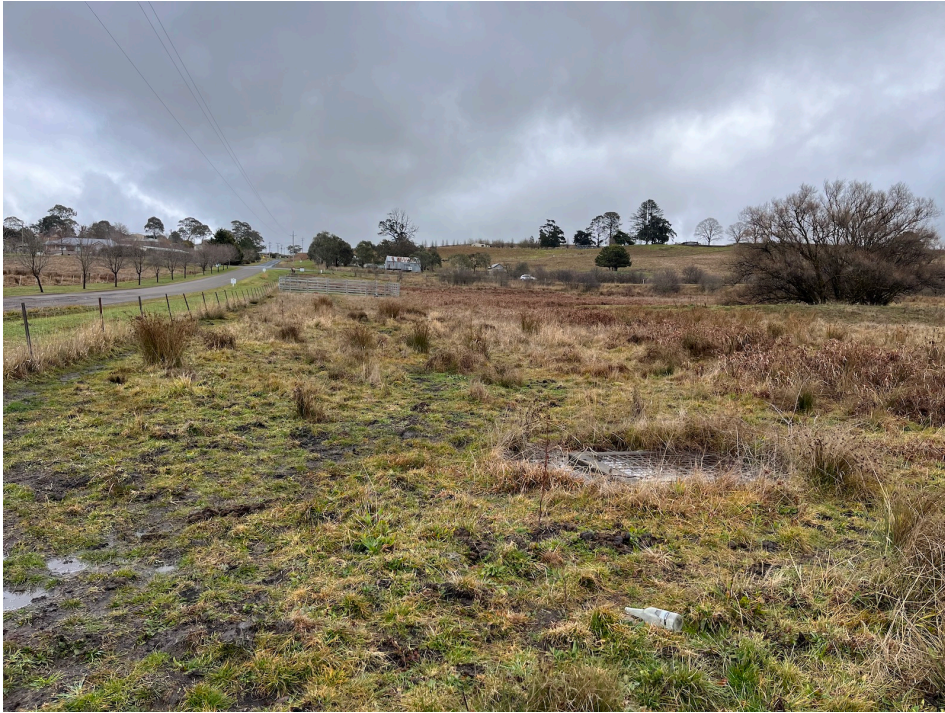
Figure 2 – Hillas St frontage

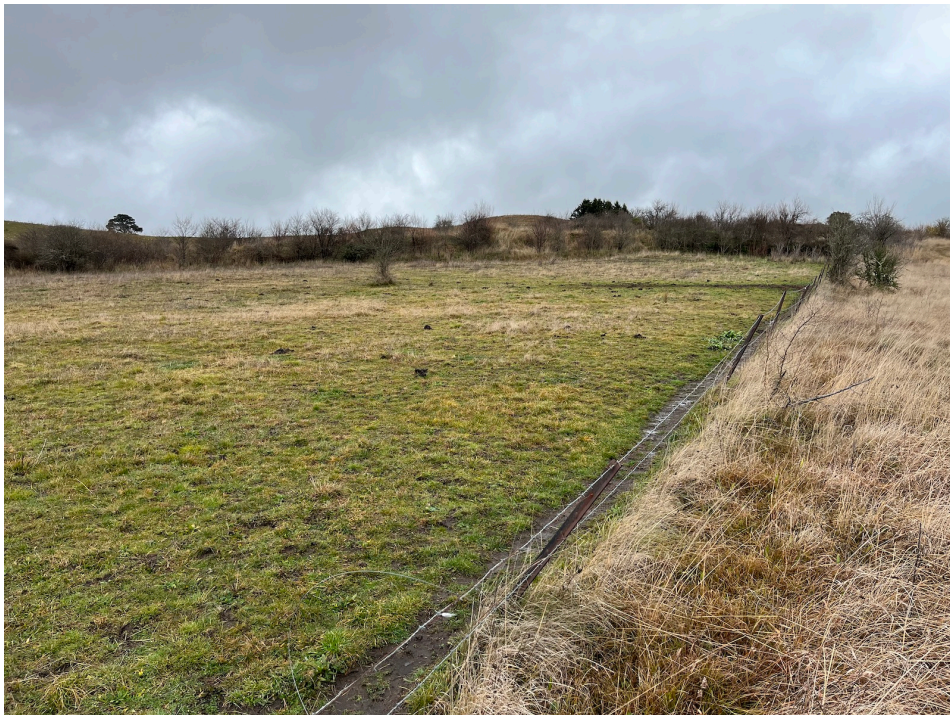
Figure 3 – Macarthur St Footage

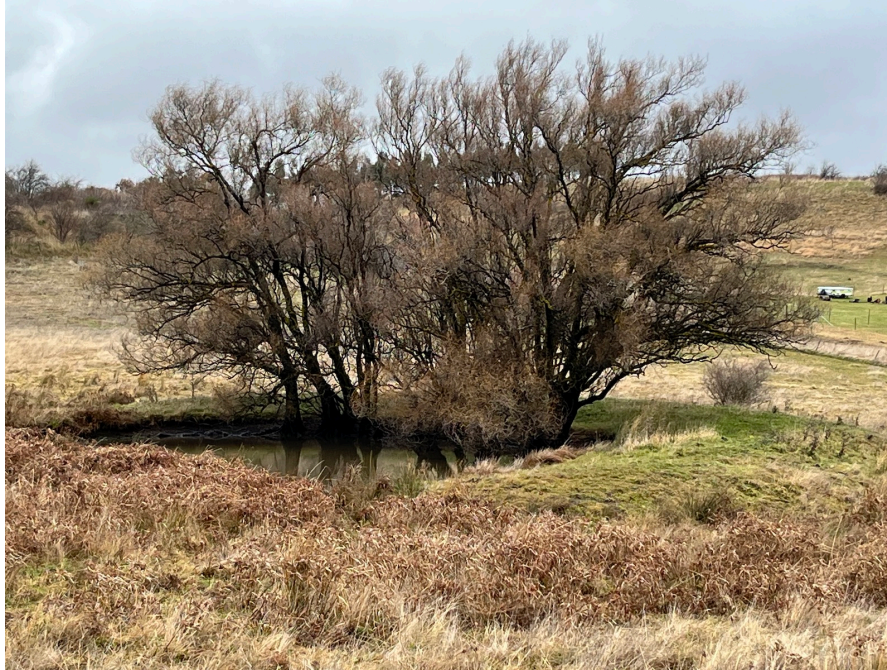
Figure 4 – Existing dam

- An existing drainage depression runs through the site, it is to be realigned centrally within a 20m wide easement. An existing dam with surface area of 140 sq.m. is to be filled in.
- A new pond is to be constructed in the South East corner of the site, with 140 sq.m. of surface area, 100mm of extended detention & permanent storage capacity of 50 cu.m.
- The driveway runoff & flows off the site will be directed as overland flow through swales into the pond as above
- Inter allotment drainage is provided with a discharge point on each of the residential lots
- The discharge from the pond & the inter allotment drainage is piped to councils drainage cnr. of Hills & Macarthur St.

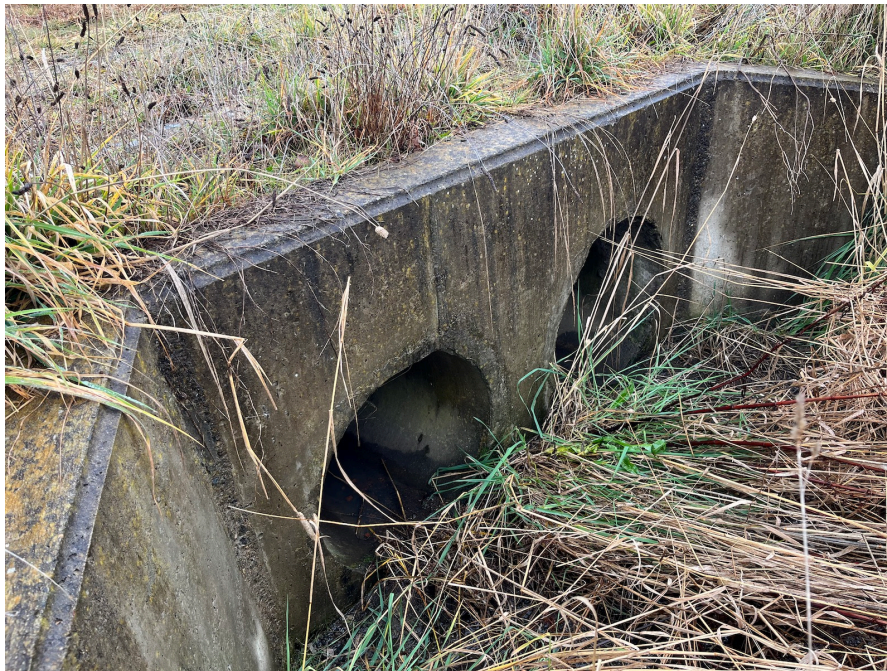
Figure 5 – Existing Discharge
