Bushfire Assessment

Proposed eco-tourist facility

Lot 43 DP 263785

851 Wang Wauk Road, Wang Wauk

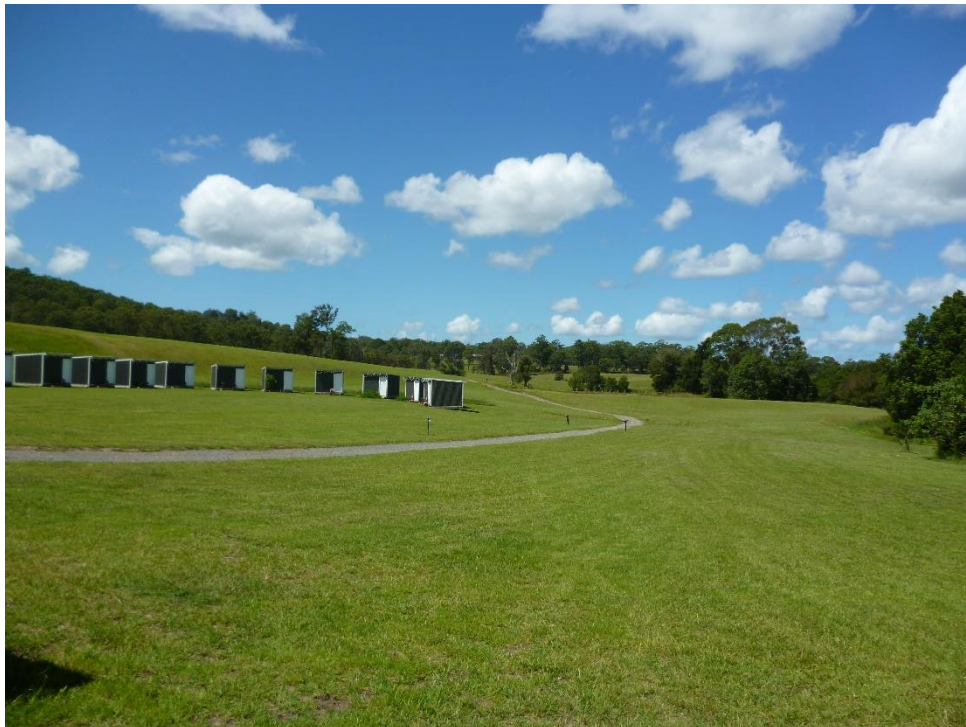
Photo 3.1: Looking south-east through the site showing existing cabins and the condition of land between the cabins and the riparian vegetation in the corridor to Bulby Creek.

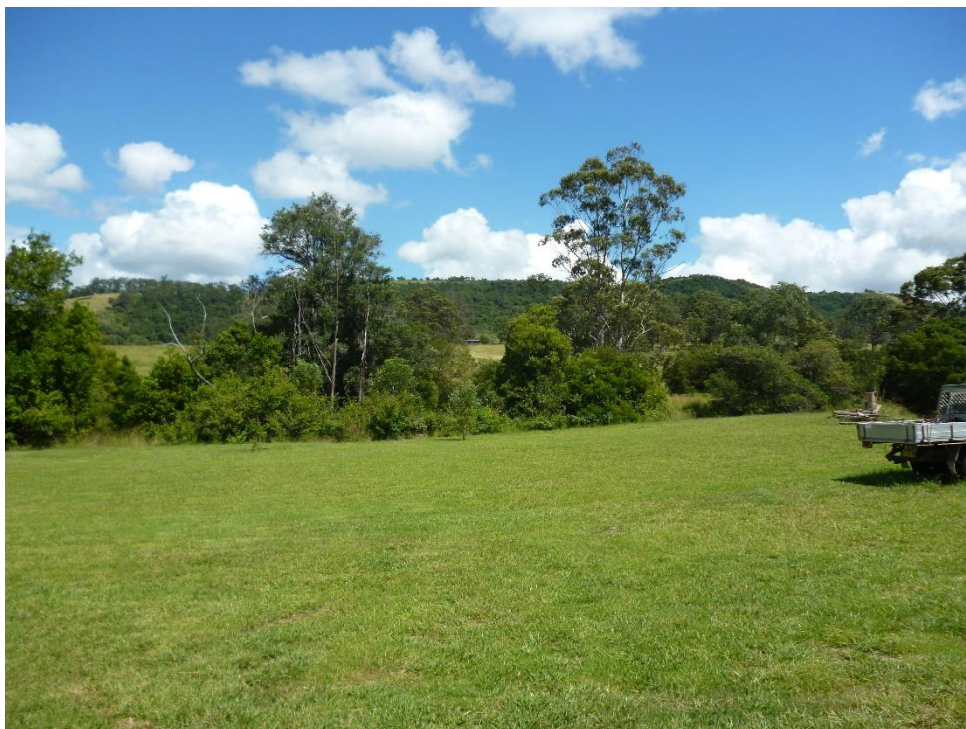
Photo 3.2: Looking south-west from the area adjacent to the shed/refuge building showing the riparian vegetation in the corridor to Bulby Creek.

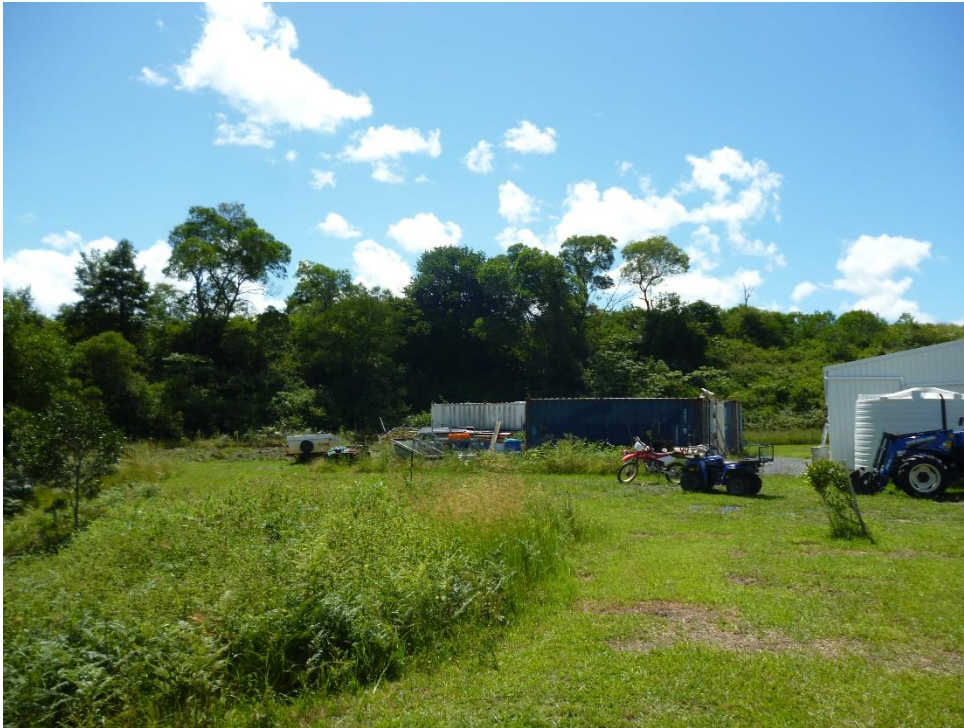
Photo 3.4: Looking generally north/north-east through the area to the west/north-west of the shed/refuge building. This area is to be maintained as an APZ around the shed/refuge building for at least 38 metres from that building.

Direction	APZ (metres) radius
N/NE/NW	38
S/SW	47
Other	36

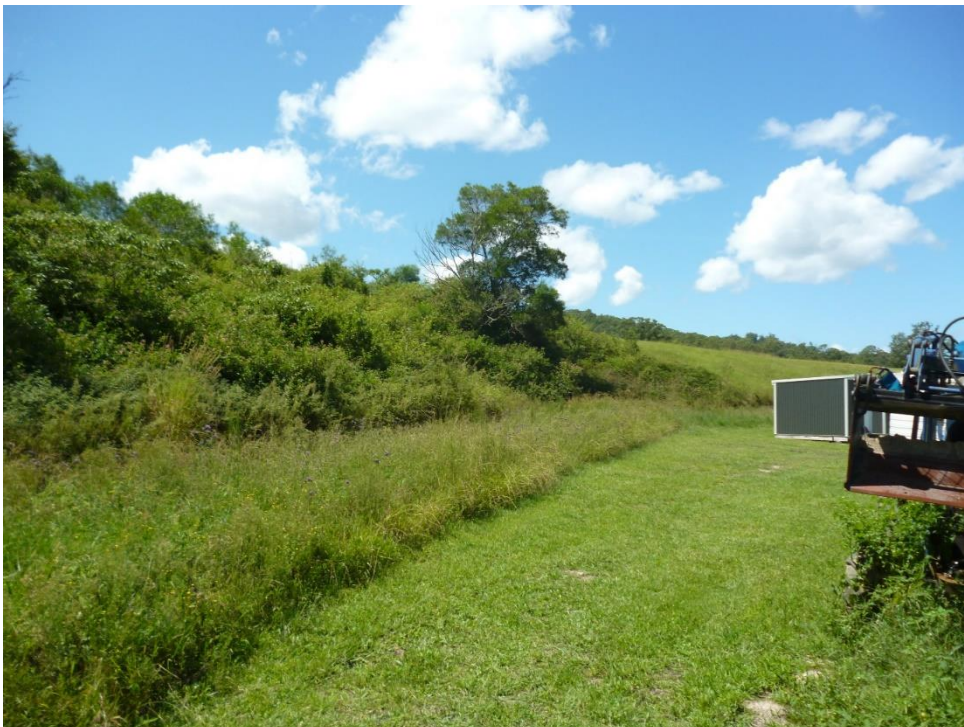
Photo 3.5: Looking generally south-east through the area to the north/north-west of the shed/refuge building. This area is to be maintained as an APZ around the shed/refuge building for at least 38 metres from that building.

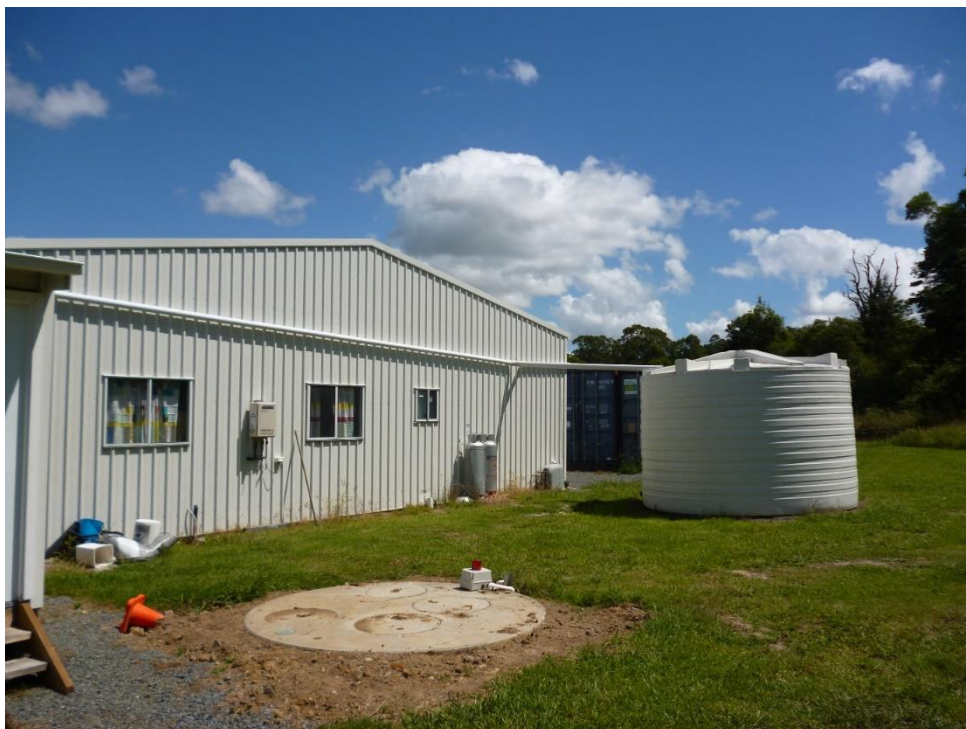
Photo 3.6: Northern part of the shed/refuge building and existing water tank.

- F. A static water supply of not less than 20,000 litres is to be provided at the southern end of the shed/refuge building and be available at all times for firefighting purposes. Access to the static water supply should be clearly identified with an SWS marker supplied by or approved by the RFS.

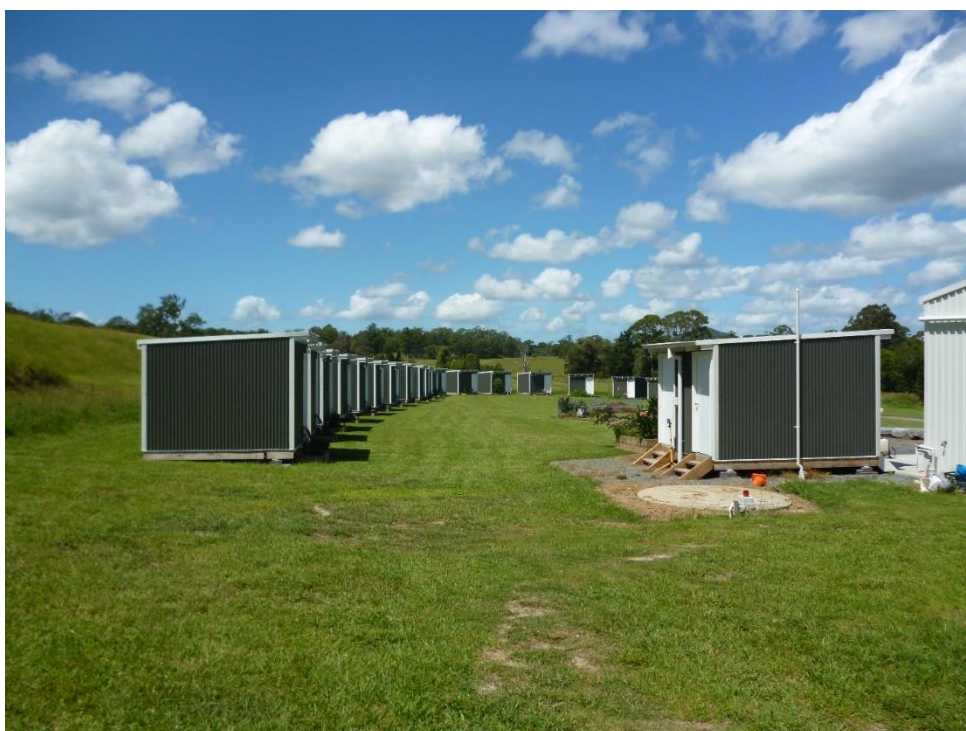
Photo 3.7: Looking generally south-east through the area to the north/north-west of the shed/refuge building showing the existing cabins and condition of the land.

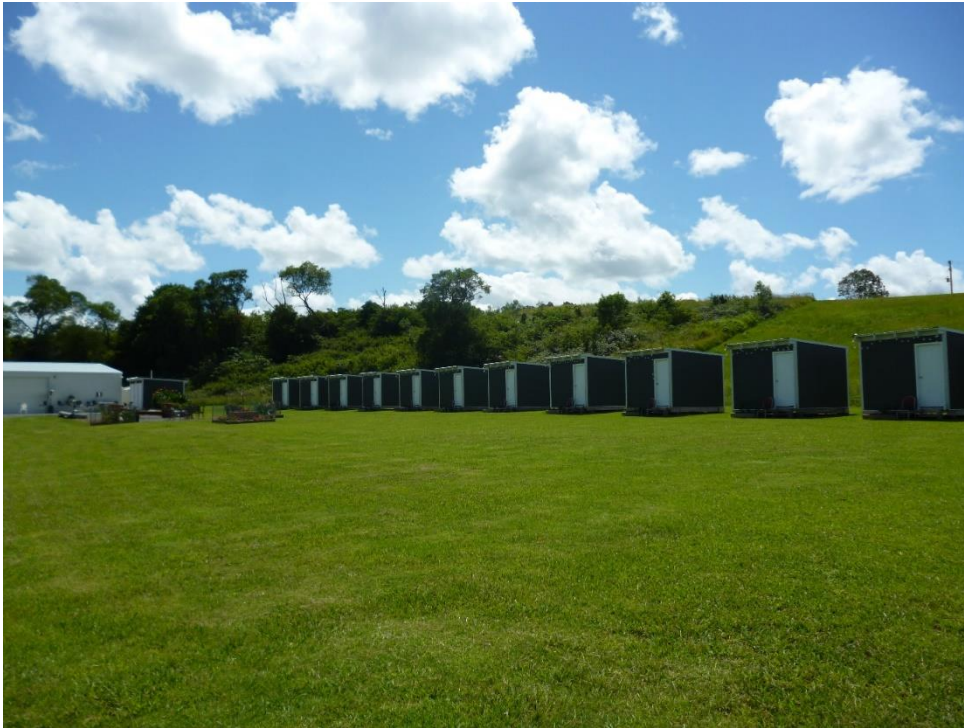
Photo 3.8: Looking generally north-west toward the shed/refuge building and some of the existing cabins.
