Report on
Geotechnical Investigation

Proposed Club and Car Park Upgrade
Dapto Leagues Club, 12 Bong Bong Road, Dapto

Prepared for
Integrated Projects Pty Ltd

Project 221880.00
June 2023

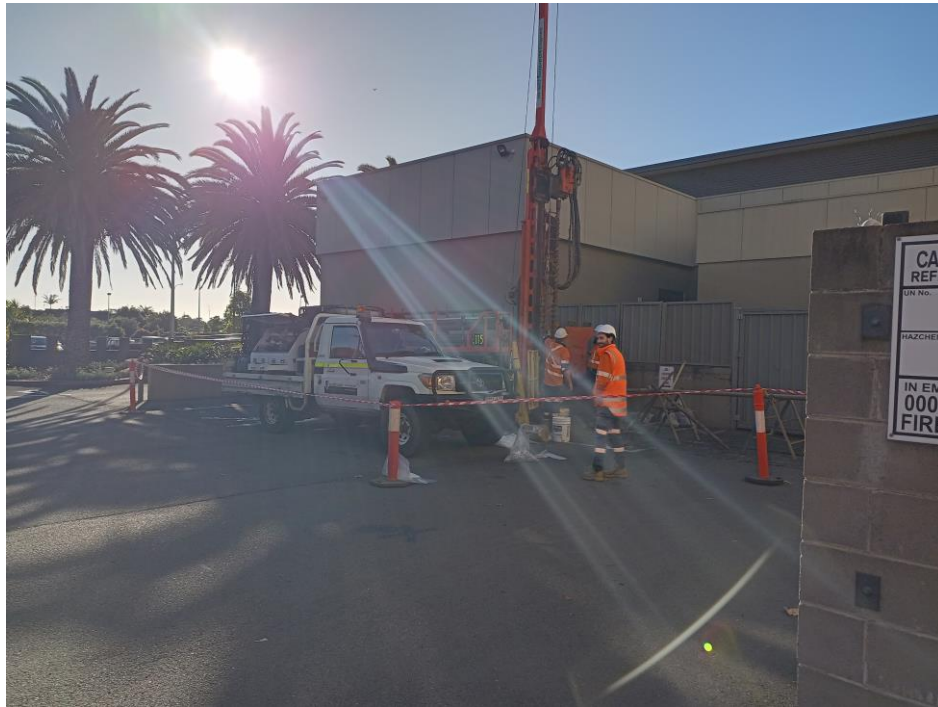
Photo 1 – View north-east at BH 2.

The approximate locations of the field tests are shown on Drawing 1 (Appendix B). Drilling setup at selected borehole locations are shown on attached Photos 1 – 4 in Appendix B. The surface levels to Australian Height Datum (AHD) and the coordinates to Map Grid of Australia (MGA) were determined using a differential GPS receiver, for which a typical accuracy of ± 0.1 m is expected. It is noted that accuracy can be variable depending on choice of GPS, satellite coverage and site conditions. Furthermore, it is important to note that DP is not a registered surveyor, hence the coordinates and elevations are considered approximate.

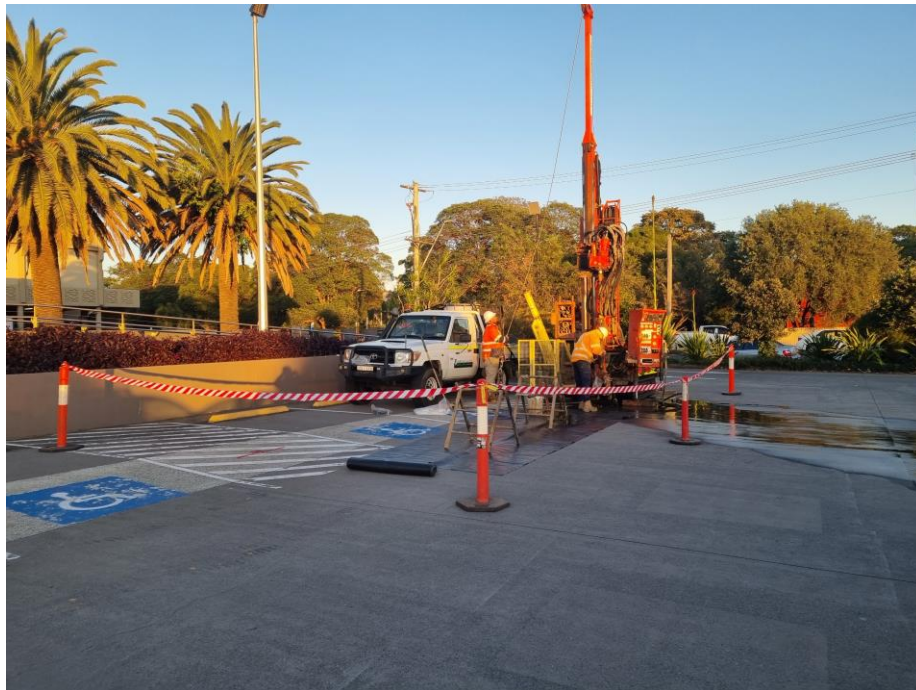
Photo 2 – View south-west at BH 3.

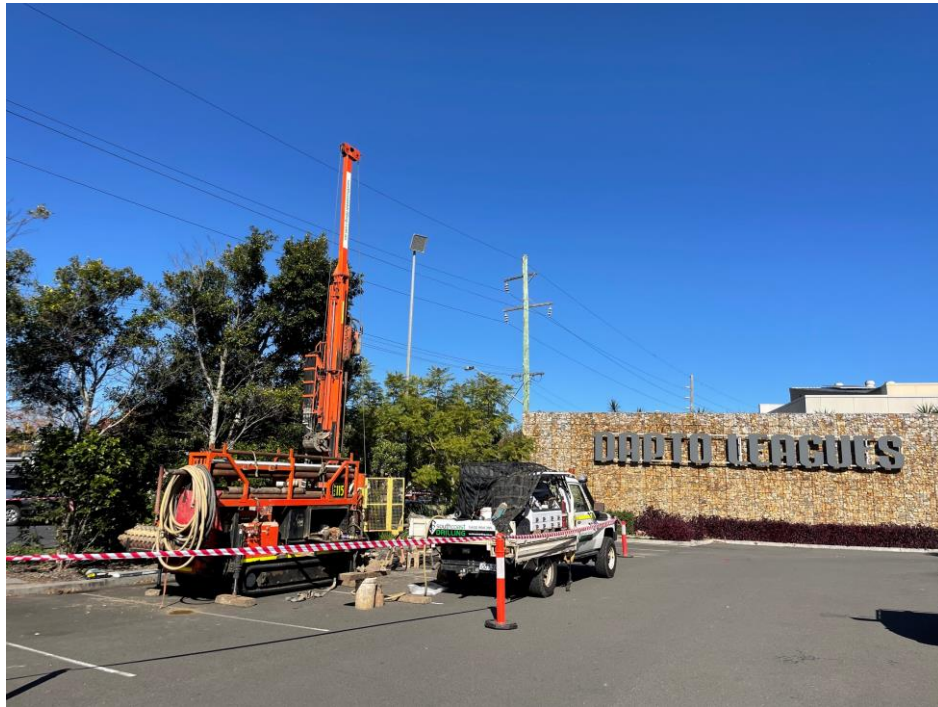
Photo 3 – View south-east at BH 4

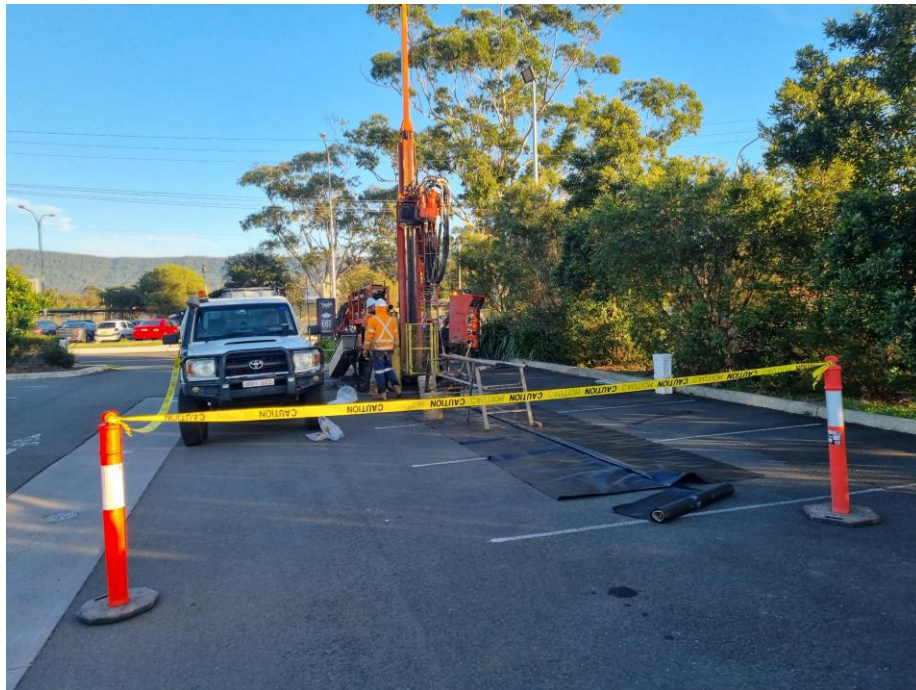
Photo 4 – View west at BH 6.
