Re: Geotechnical Interpretive Report – 120 Poiles Road Bruceedale NSW 2650

Re: Geotechnical Data Report – 120 Poiles Road Brucedale NSW 2650

Geotechnical Investigation

Report No. 9890

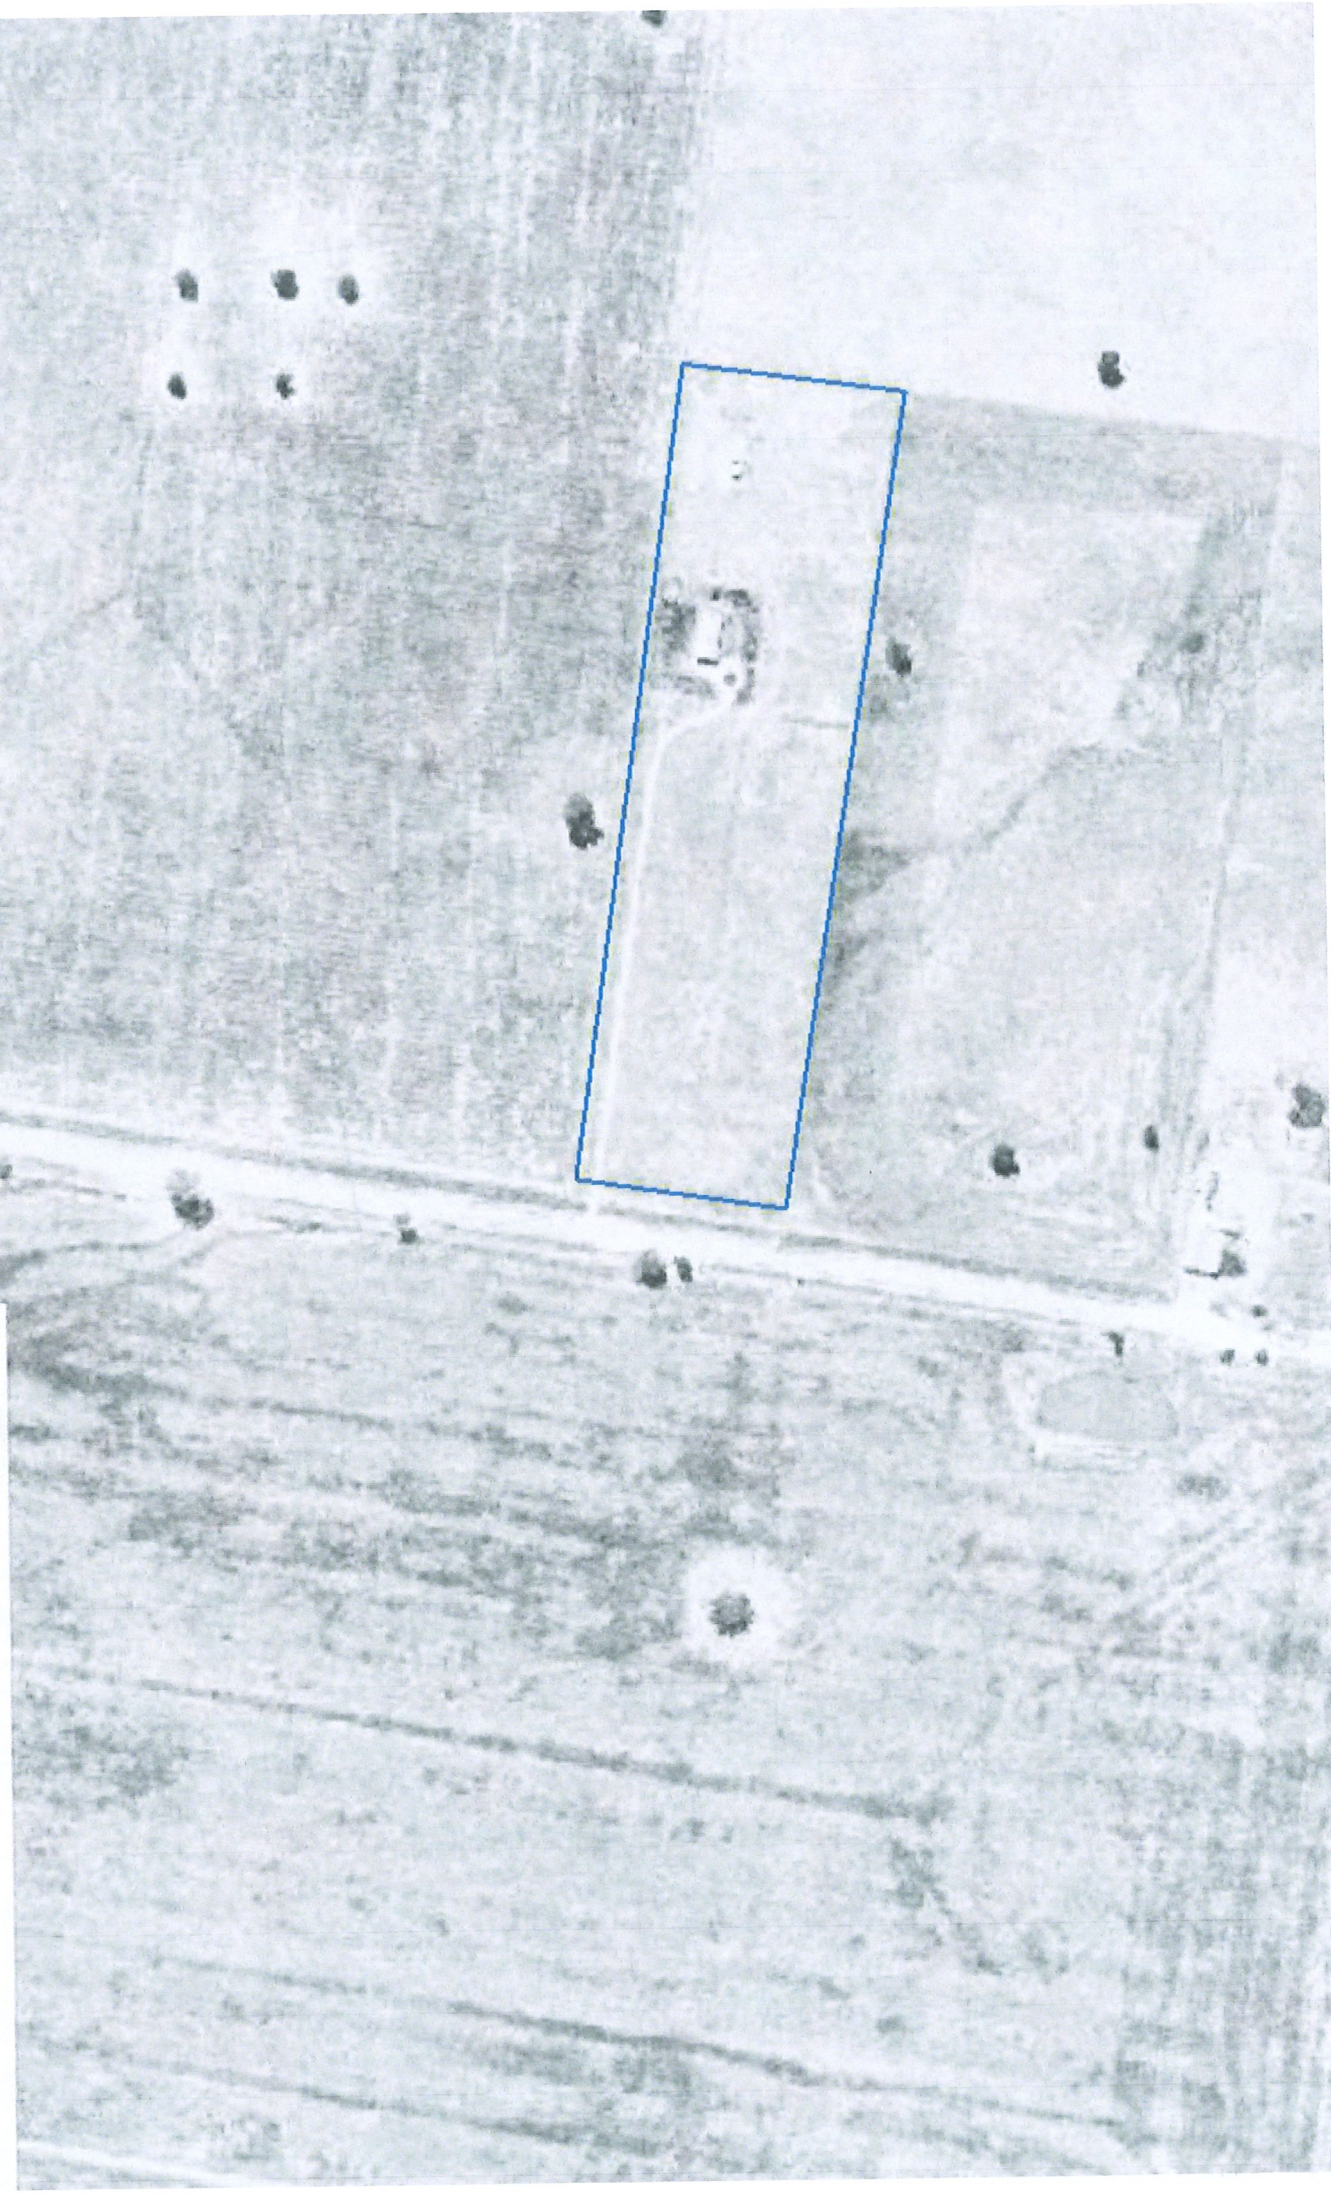
Geotechnical Investigation
Report No. 9890
Historical Imagery 1966

The project site is a 2.83ha (approx.) land parcel with a real property description of Lot 1 DP 214337. From a review of available historical aerial photography and satellite imagery (1966-2022), the existing dwelling has been on site since at least 1966, an addition shed was added between 1998 and 2009 to the south of the existing dwelling. Minimal changes can be seen since that time. (**Attachment B**).

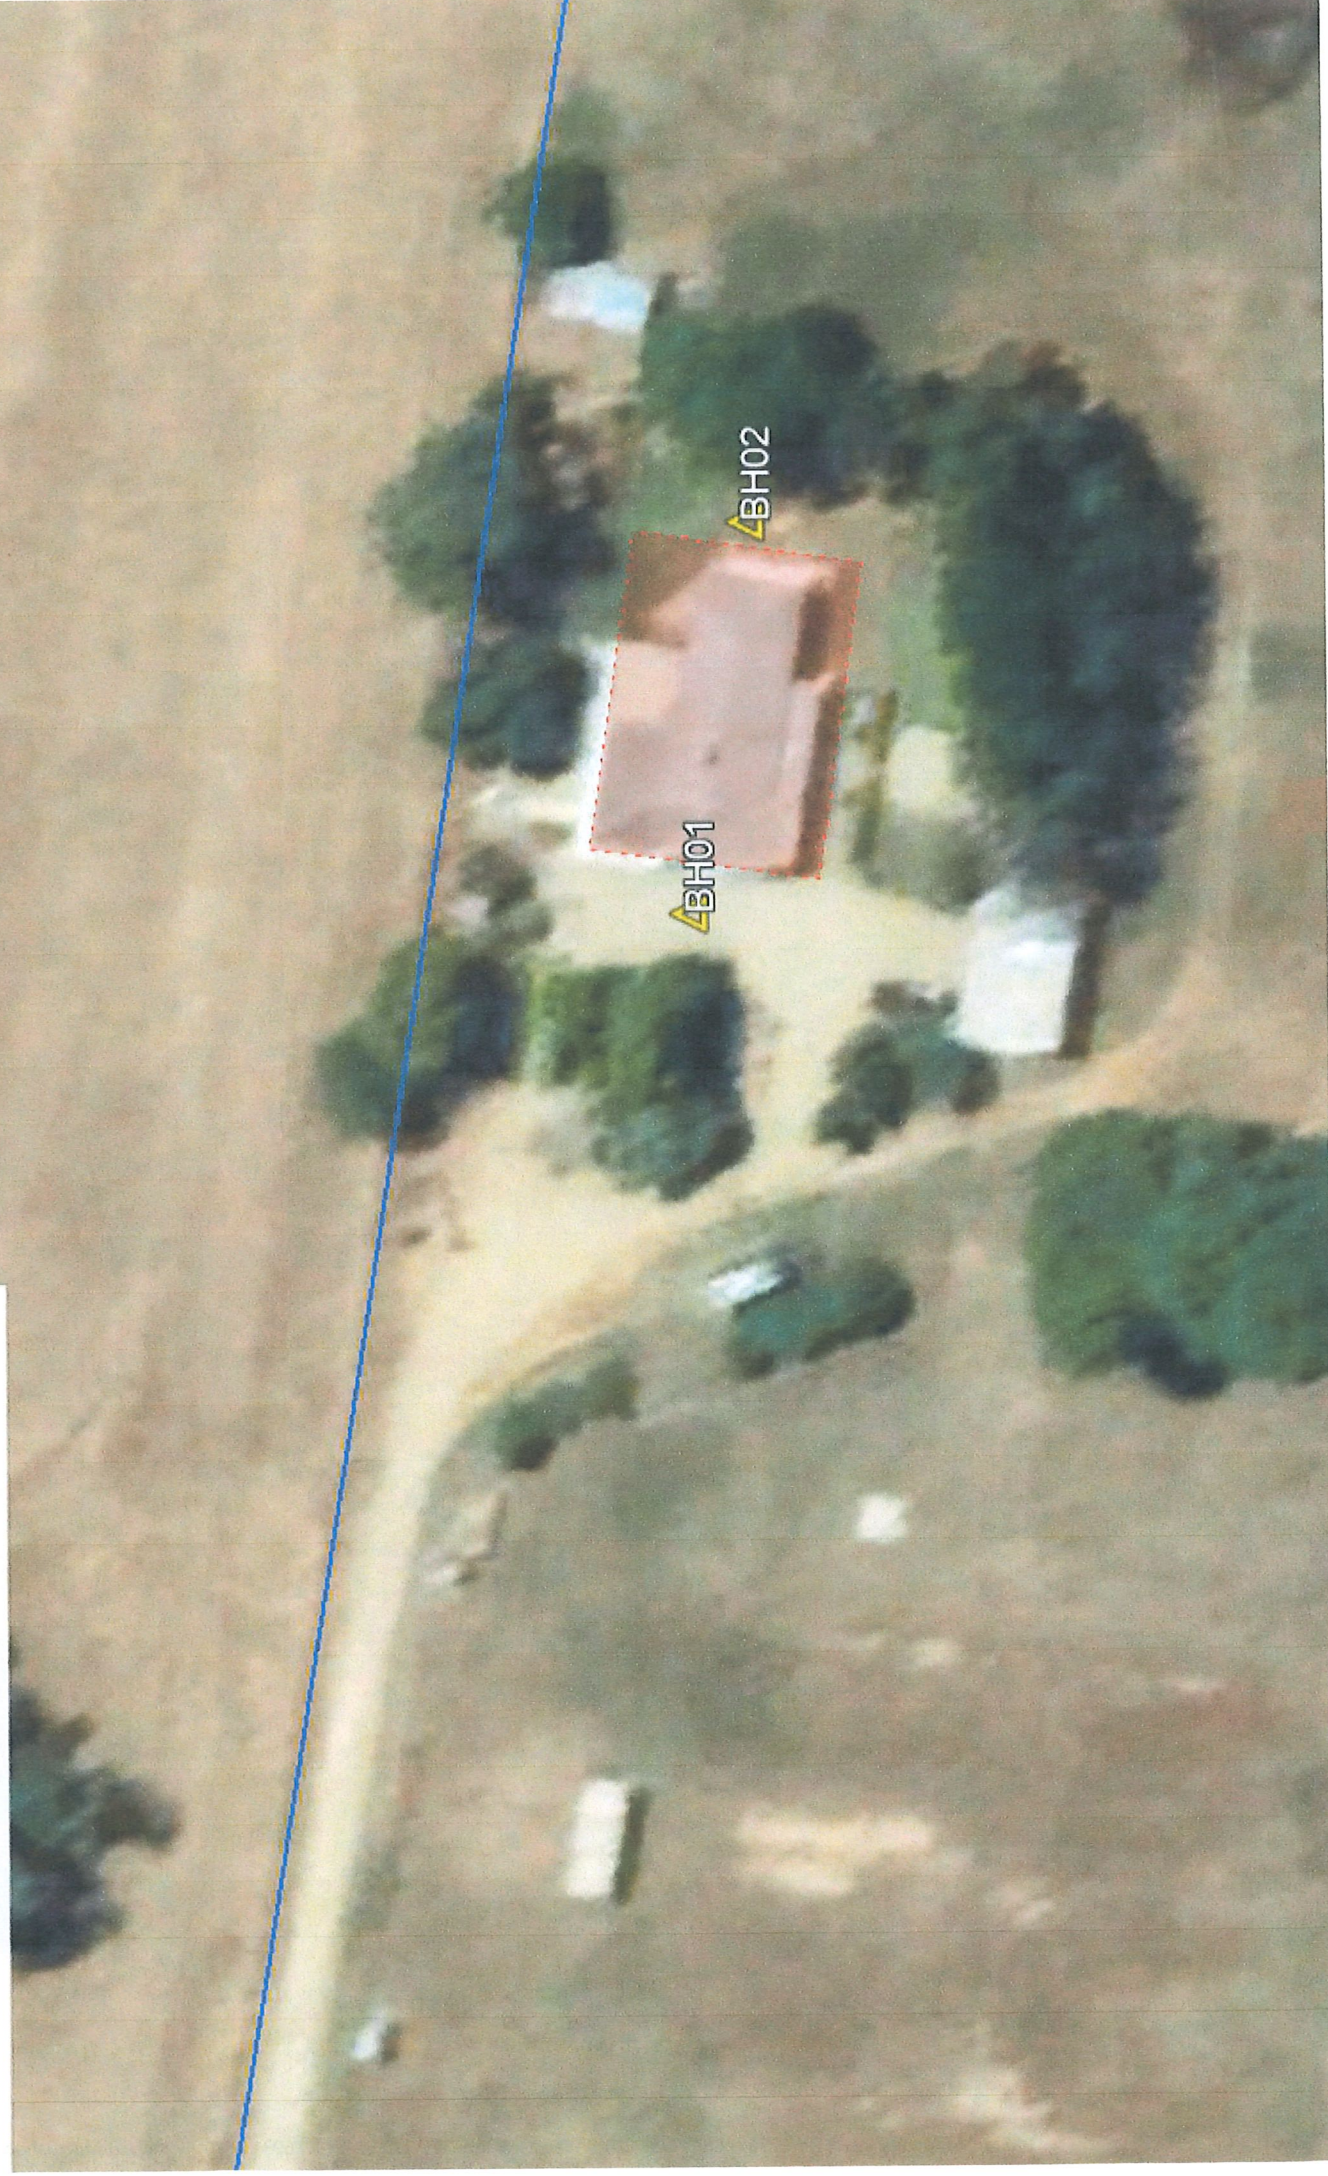
Attachment C : *Plan of the investigation locations*

A plan of the investigation locations can be seen in **Attachment C**.

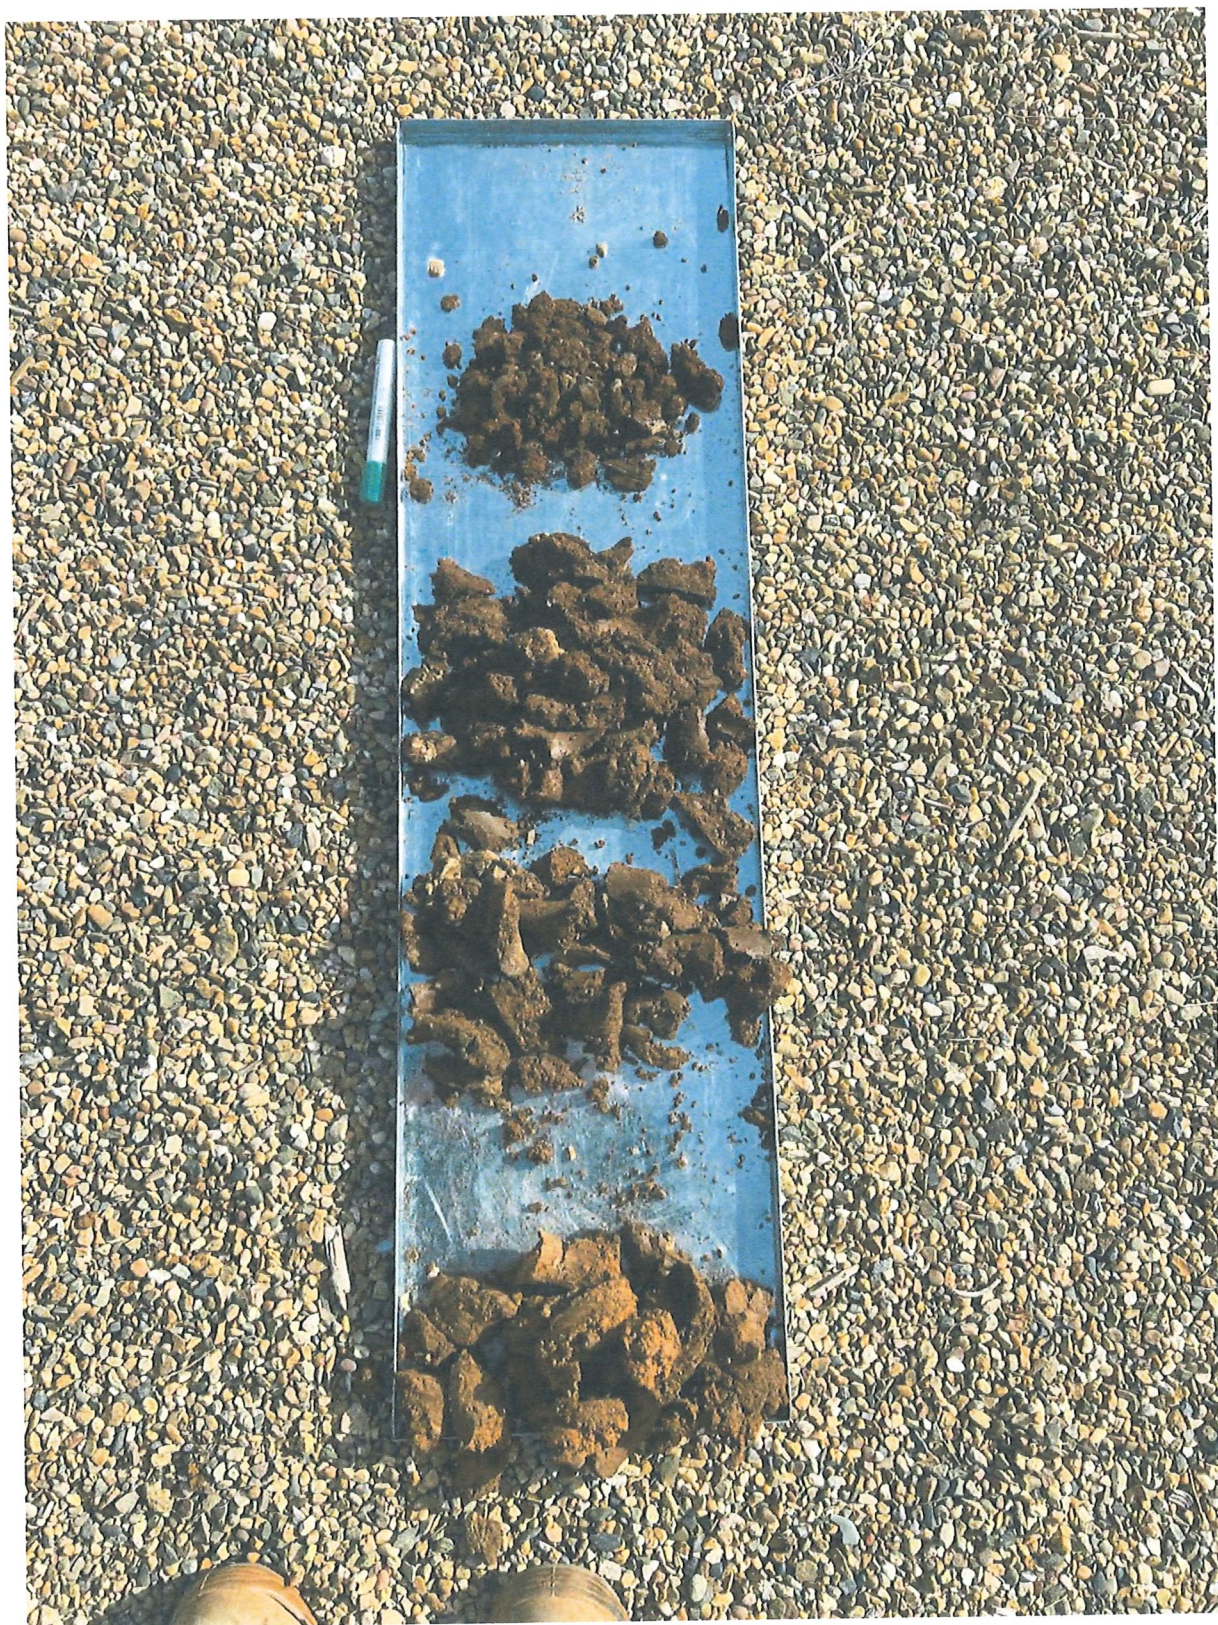
- A dry white non-plastic coarse sized gravel uncontrolled fill.
- A moist brown low to medium plasticity sandy clay
- A colluvial moist brown high plasticity clay.
- A colluvial moist yellow-brown high plasticity clay.
- A residual moist yellow medium to high plasticity clay.

Photograph 4: The general soil profile across the site to 3.0m.
