## **Report on Geotechnical Investigation**

**Proposed Tamworth Regional Aquatic  
Centre**

**Jack Smyth Drive, Hillvue NSW**

**Project 226965.00**

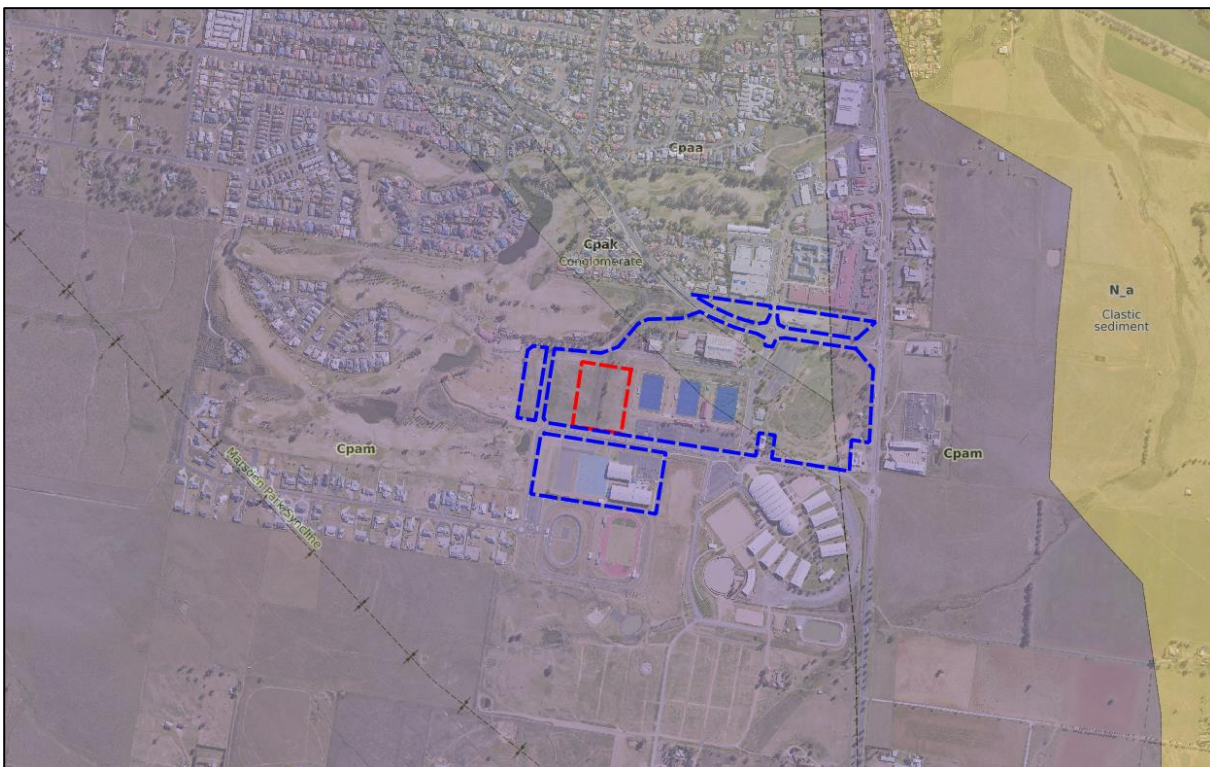
**Figure 10: Seamless geology dataset with approximate sporting precinct (blue outline) and investigation area (red outline)**

Reference to the NSW Seamless Geology dataset (Figure 10) made available by the NSW Government Department of Regional New South Wales, indicates that the site is likely to be underlain by Mandowah Mudstone (purple shading) which typically comprises mudstone with thin siltstone and fine sandstone bands. The site is also mapped within close proximity to areas comprising Keepit Conglomerate (grey shading, which typically comprises conglomerate and sandstone) and Noumea Beds (brown shading, which typically comprises wacke, siltstone and mudstone).

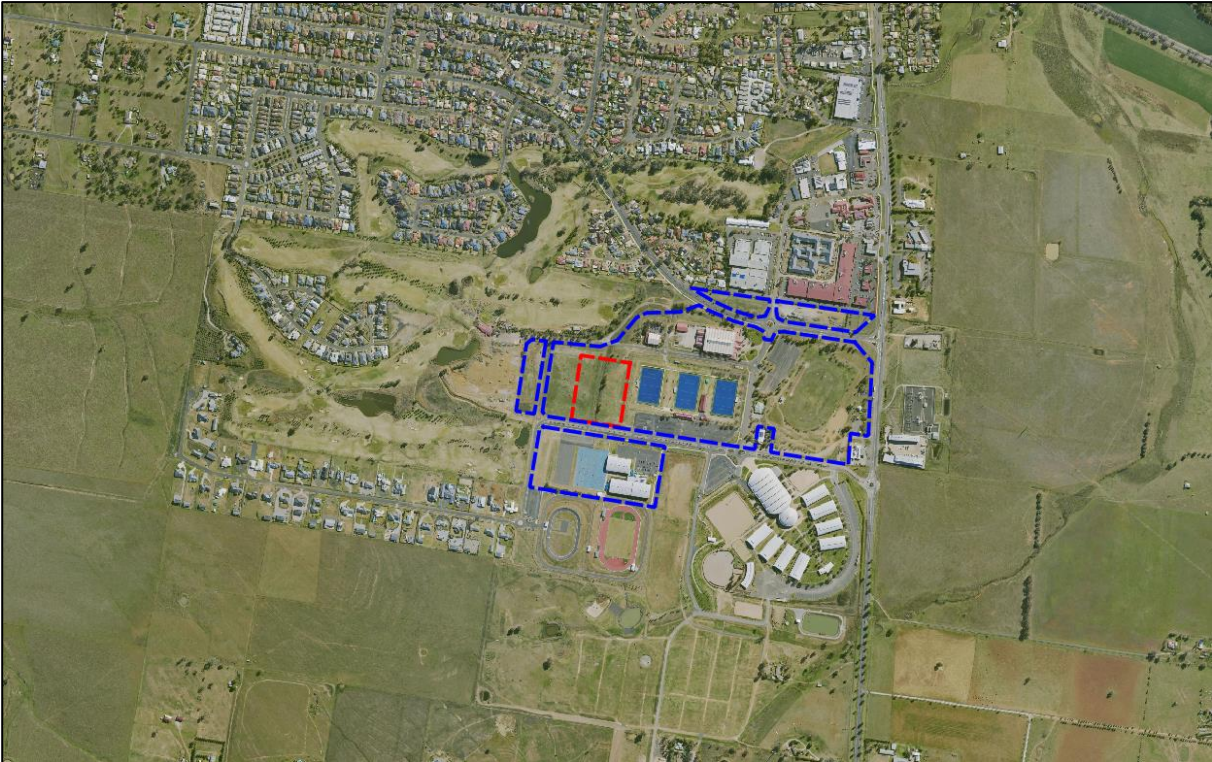
**Figure 12: Acid sulfate soils mapping with approximate sporting precinct (blue outline) and investigation area (red outline)**

Reference to the NSW Acid Sulfate Soil Risk Map (Figure 12) indicates the site is not located within an area of known potential for acid sulfate soils.

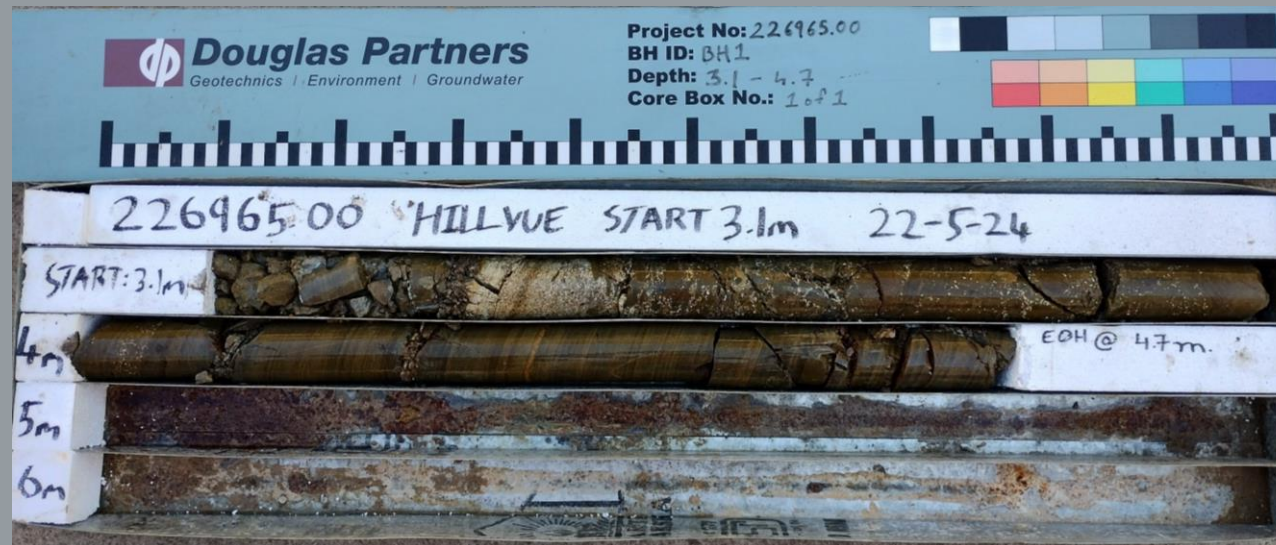
## Bore 1

3.10 m to 4.70 m

- Bedrock described as medium to high strength, highly weathered to slightly weathered siltstone, sandstone or conglomerate was encountered in Bores 1 and 5 only at depths of 3.1 m and 3.05 m respectively. The recovered rock was generally fractured to highly fractured;
