**Report on Preliminary Site Investigation  
for Contamination**

**Proposed Tamworth Regional Aquatic  
Centre**

**Jack Smyth Drive, Hillvue NSW**

**Project 226965.00**

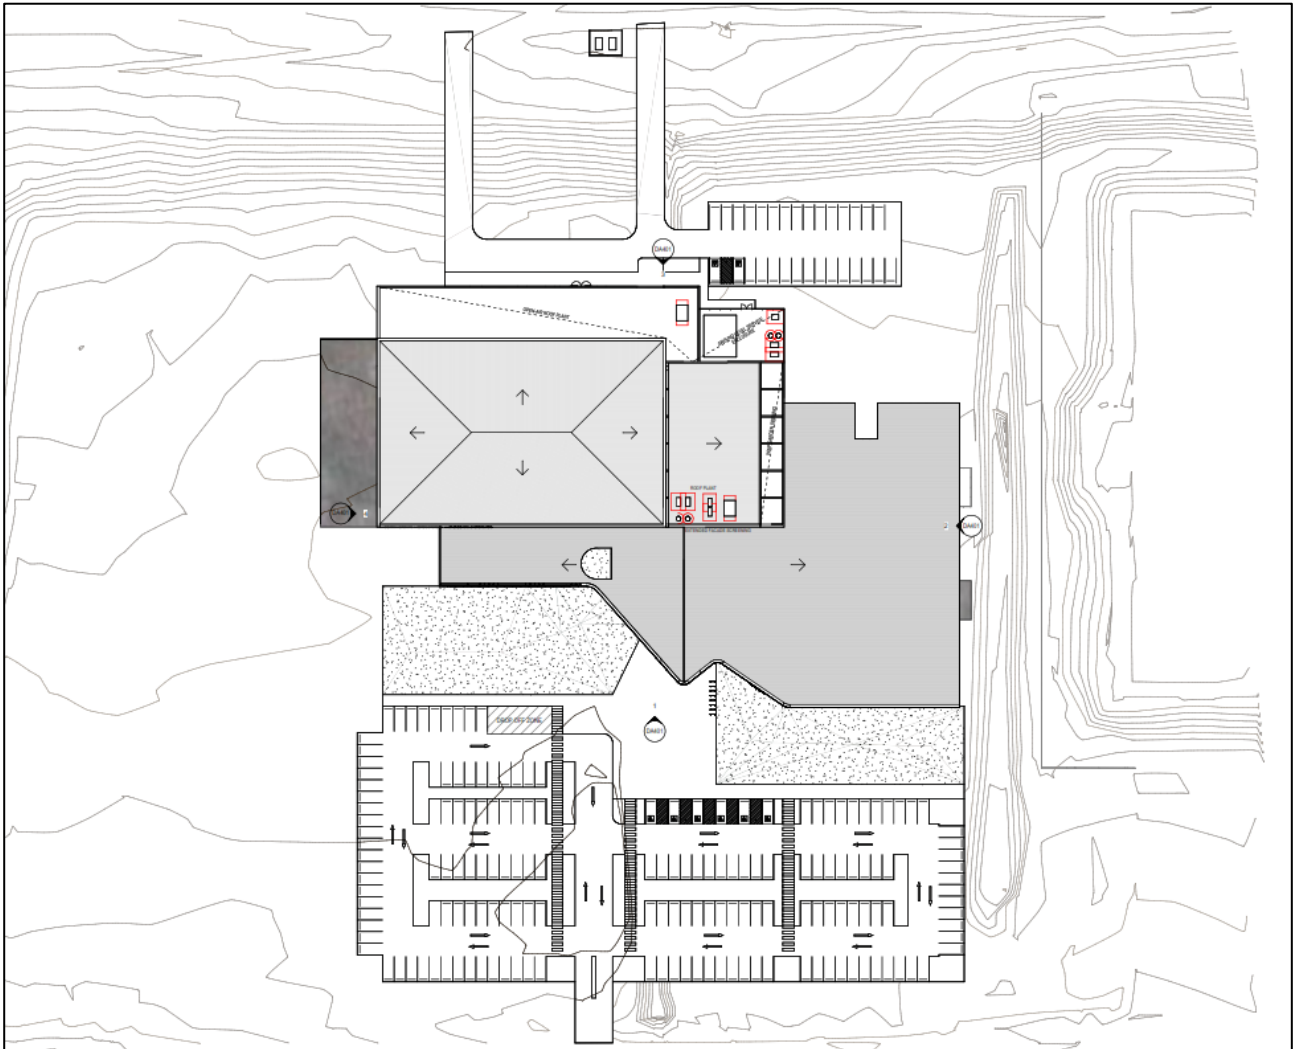
- TRAC facilities:
  - o Ten Lane 50 m indoor pool including spectator seating;
  - o Warm water pool, spa and sauna;
  - o Change rooms and amenities including wet and dry areas;
  - o Administration, offices, store, dry plant rooms and café;
  - o Leisure pool with water play and learn to swim (Stage 2 Extension);
  - o 50 m outdoor swimming pool (Stage 3 Extension);
- NICSH facilities:
  - o Administration, office, teaching and study spaces;
  - o Testing lab and dry amenities;
  - o Strength and conditions gym (Stage 2 Extension); and
  - o Sprint track (Stage 2 Extension).

**Figure 3: Client provided indicative layout of proposed development**

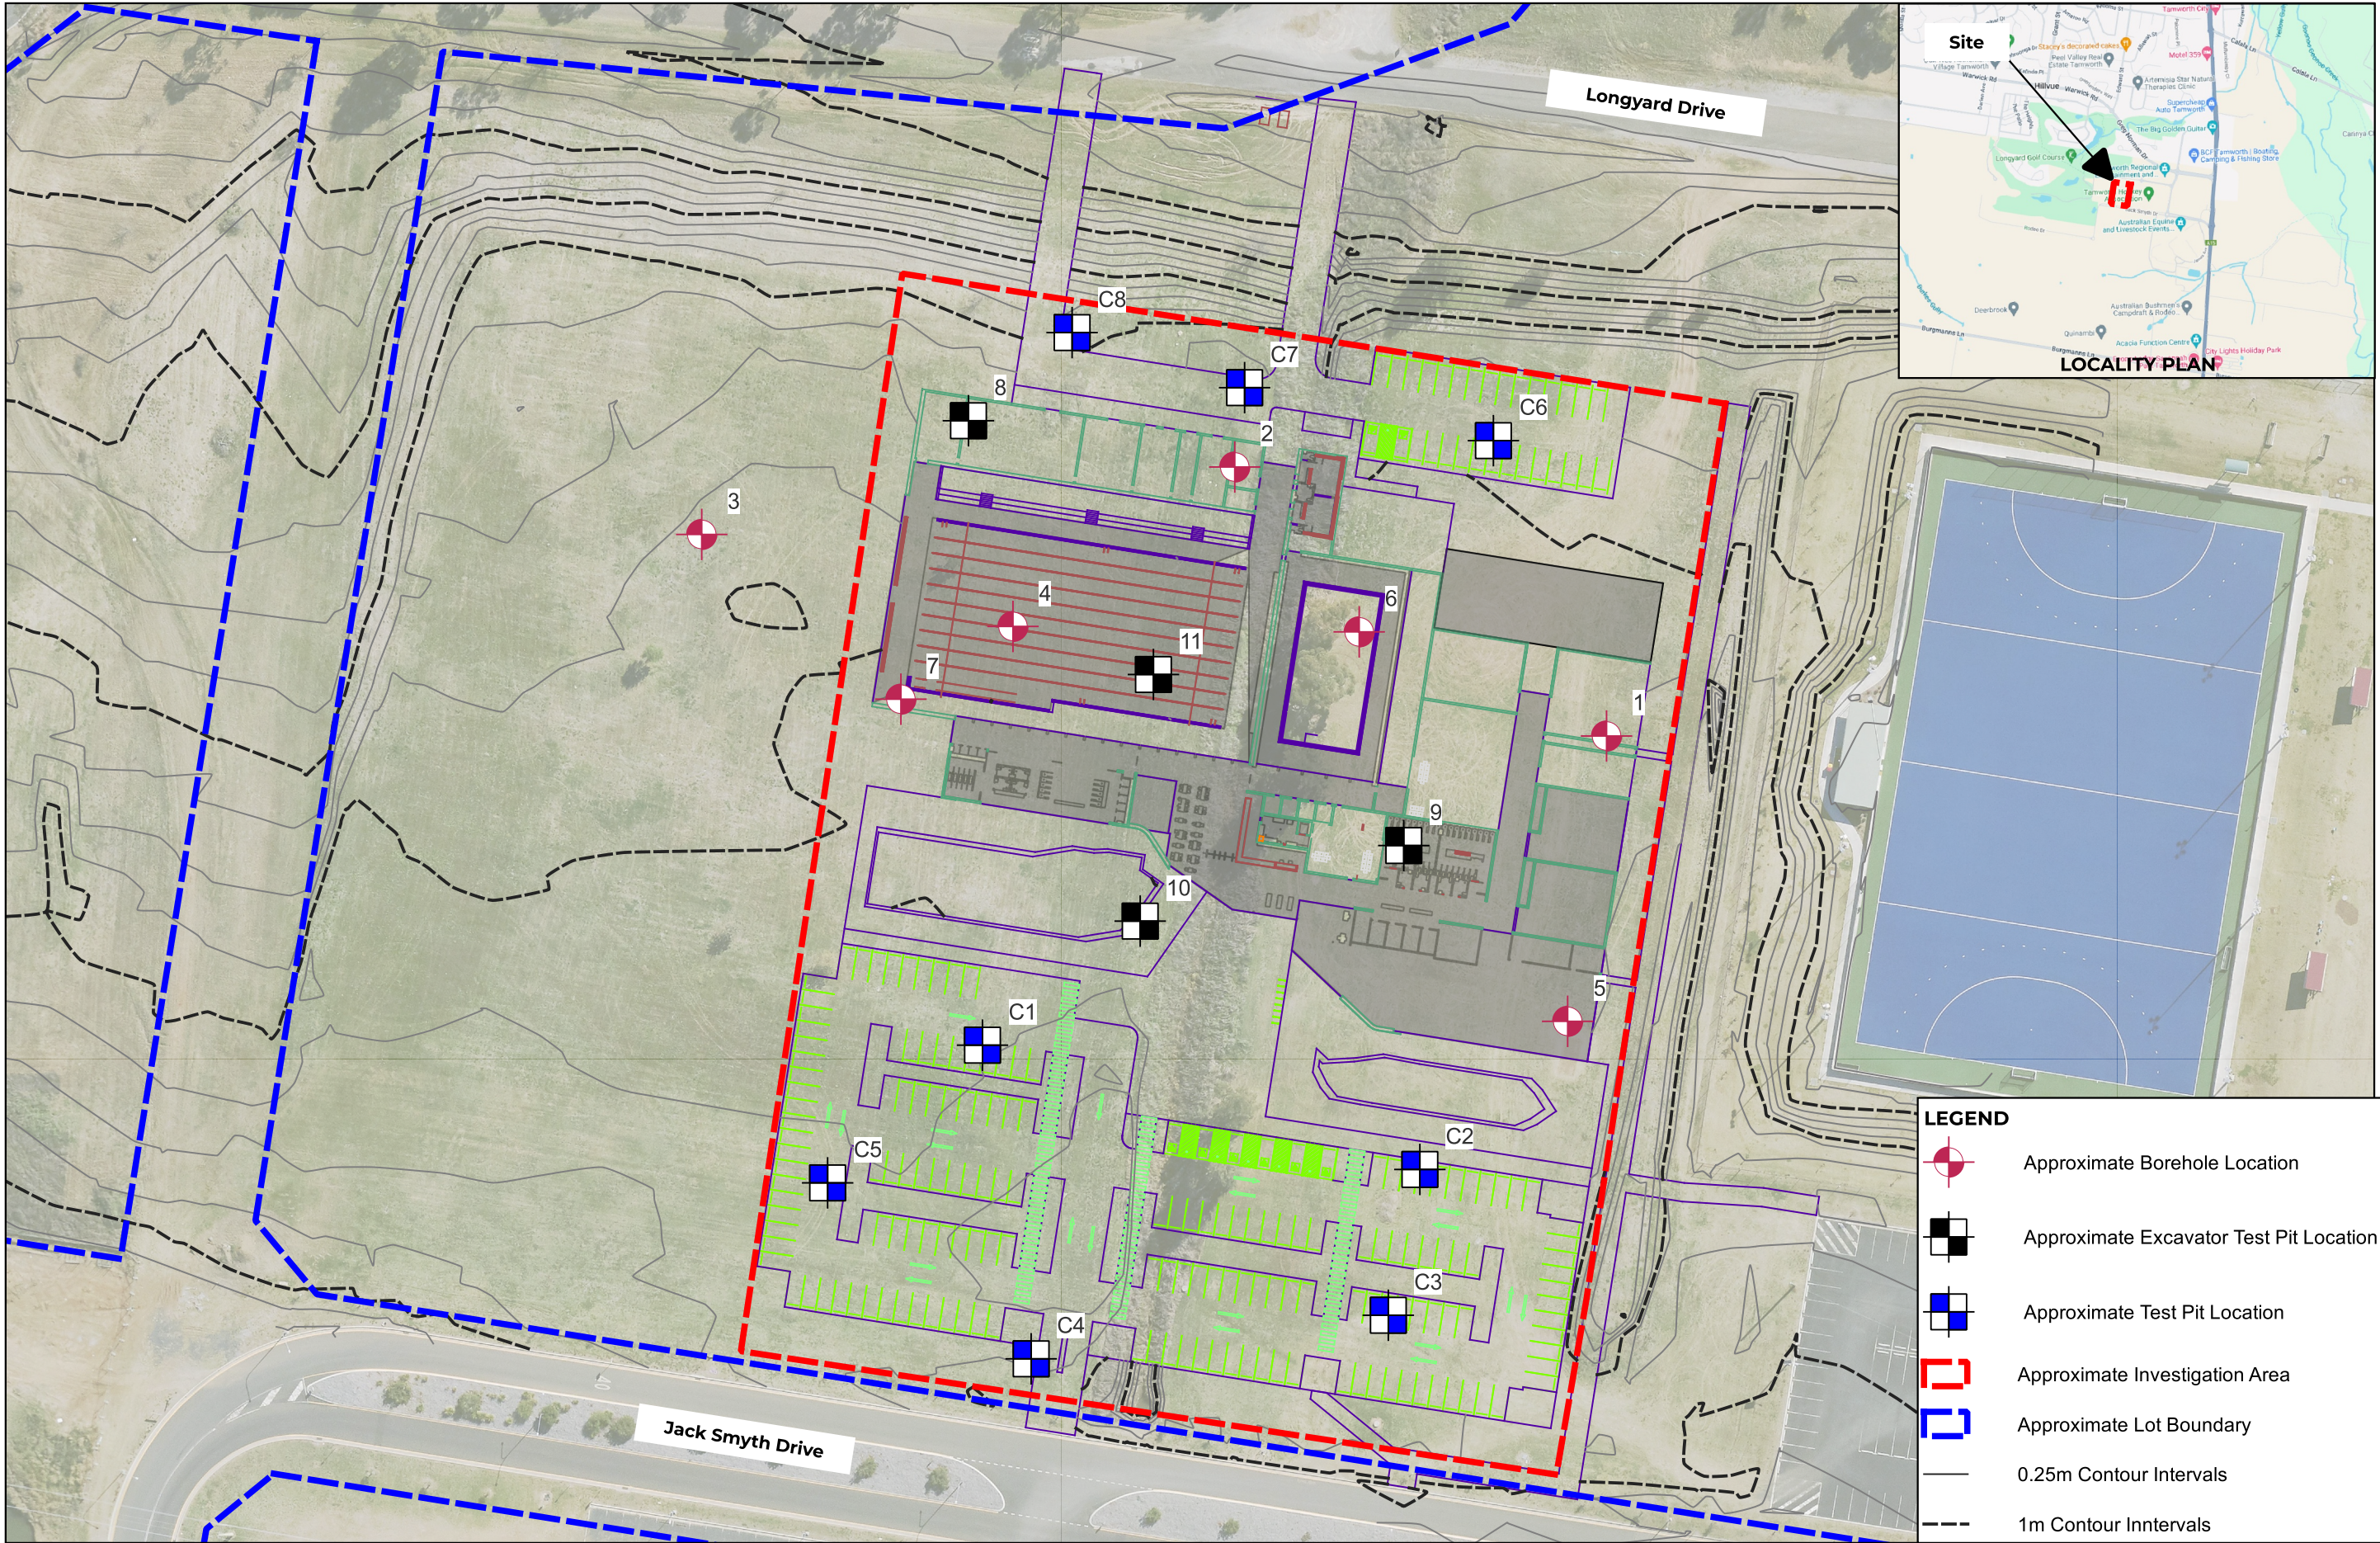
Drawing 1 – Test Location Plan

From the supplied client drawings, which are included in Appendix B with an overlay of the of the ground floor plan shown on Drawing 1, the following features are proposed for the development:

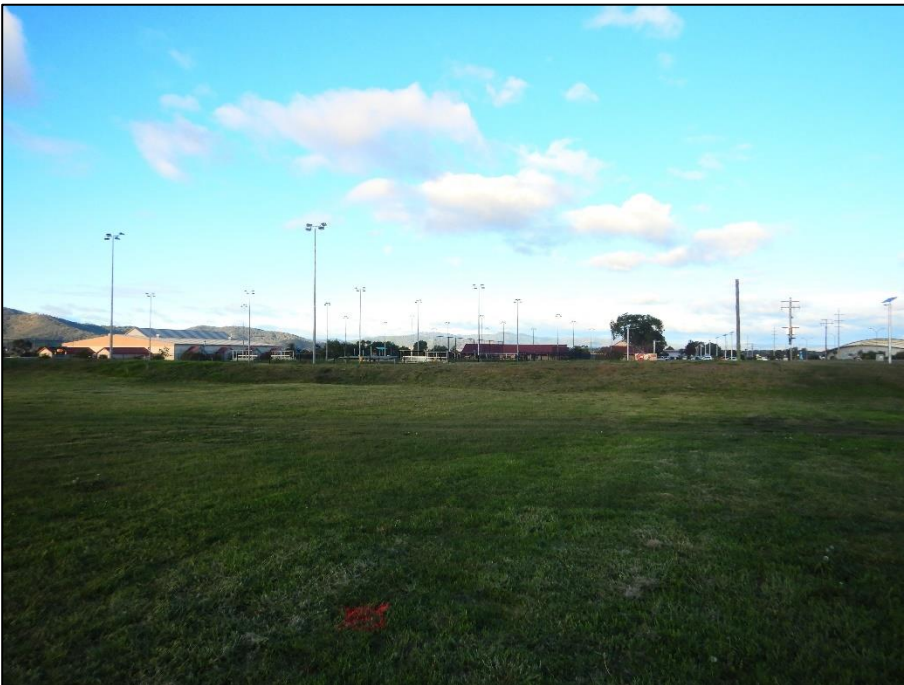
- An existing fill mound was observed outside adjacent to the east of the investigation area adjacent to the hockey fields (Photo B4). The mound was approximately 1 m high and 2 m wide and had a good covering of grass;

**Photo B4: View east towards adjacent mound and hockey fields**

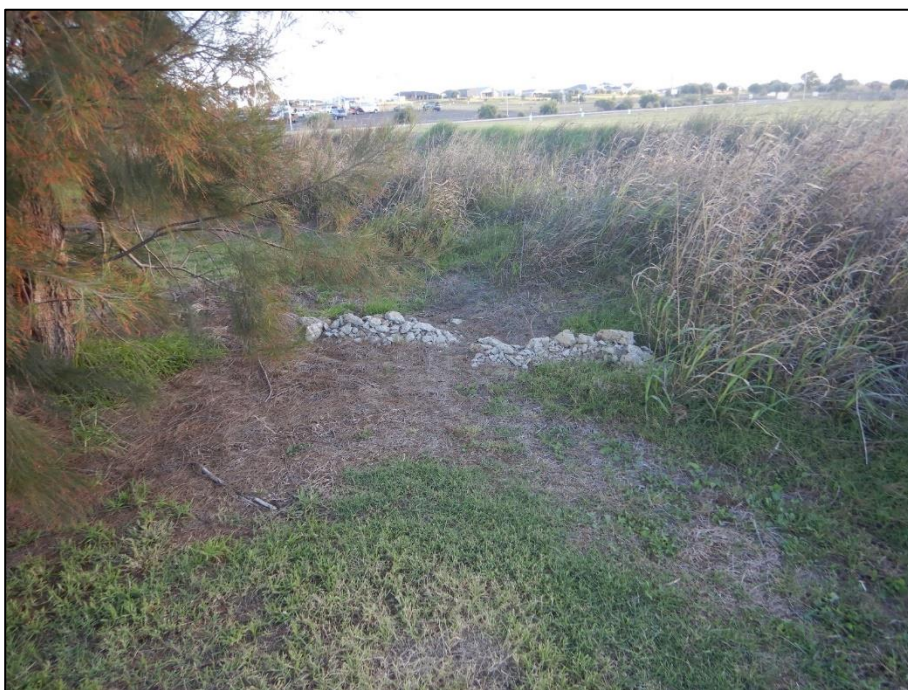
- Stockpiled concrete rubble was observed at the surface near the drainage gully within the southern part of the site (Photo B6);
- Black polypipe and steel temporary fencing panel was observed (Photo B7);

**Photo B6: View of stockpiled concrete rubble adjacent to existing drainage swale**

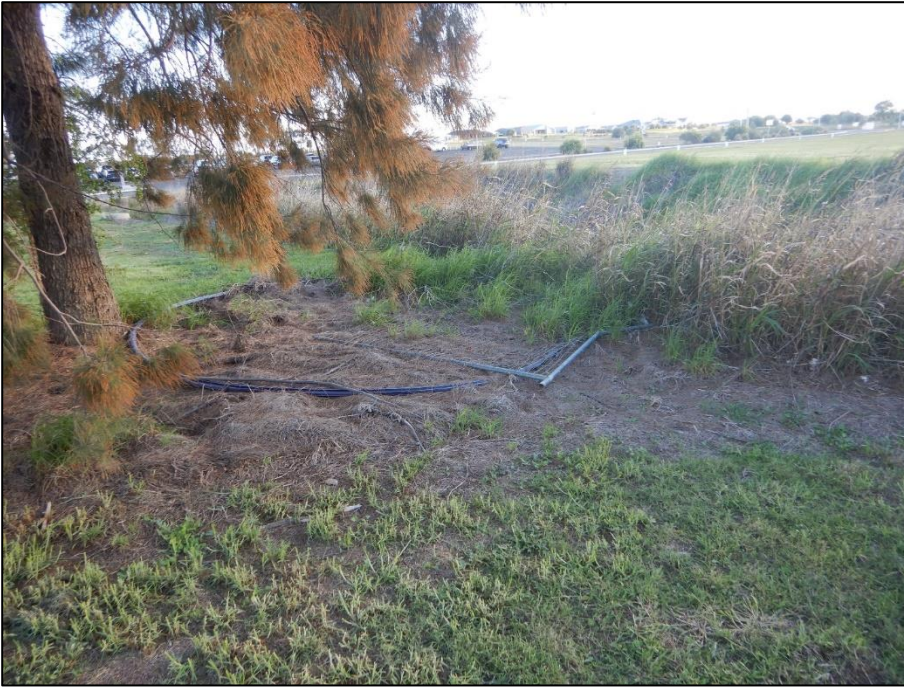
**Photo B7: View of polypipe and steel temporary fence panel adjacent to drainage swale**

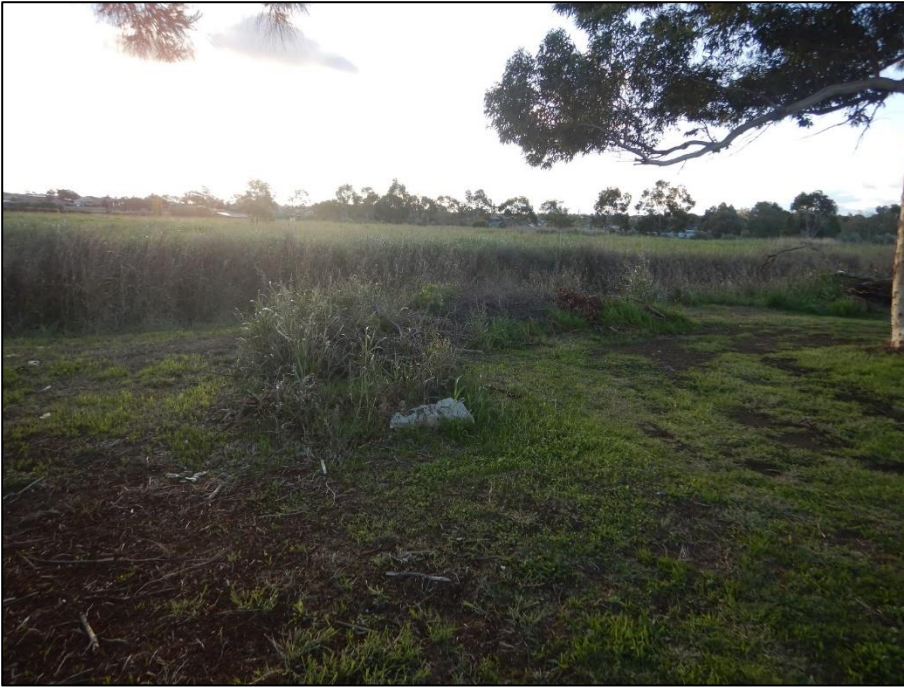
- Stockpiled soil and a piece of concrete were observed near the drainage gully (Photo B9);
- A large tree limb and a number of smaller branches were observed near the drainage gully at the surface (Photos B10 and B13);

**Photo B9: View towards piece of concrete and stockpiled vegetation and tall grass**

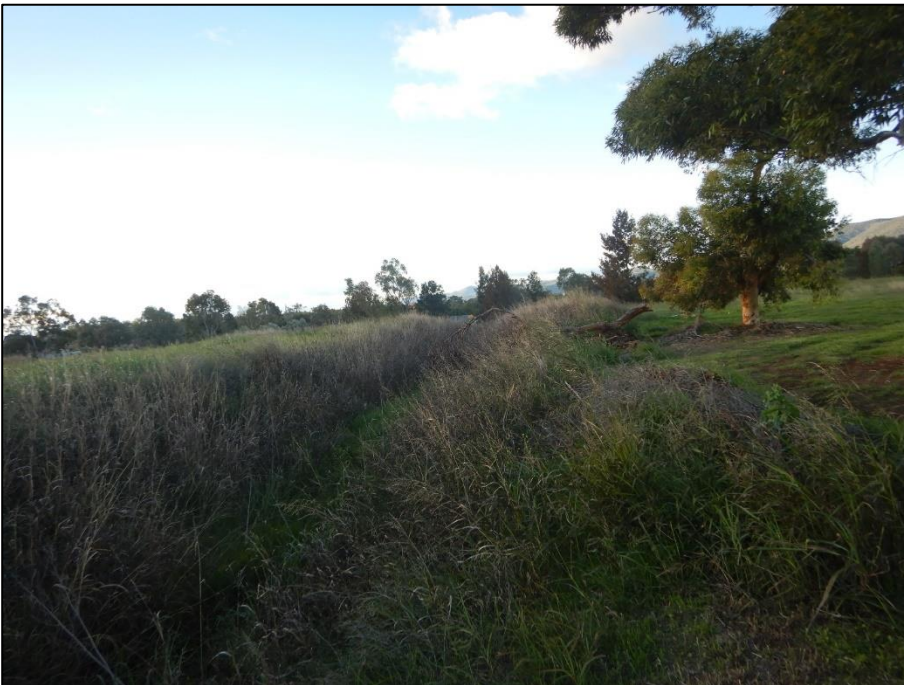
**Photo B10: View north along drainage swale**

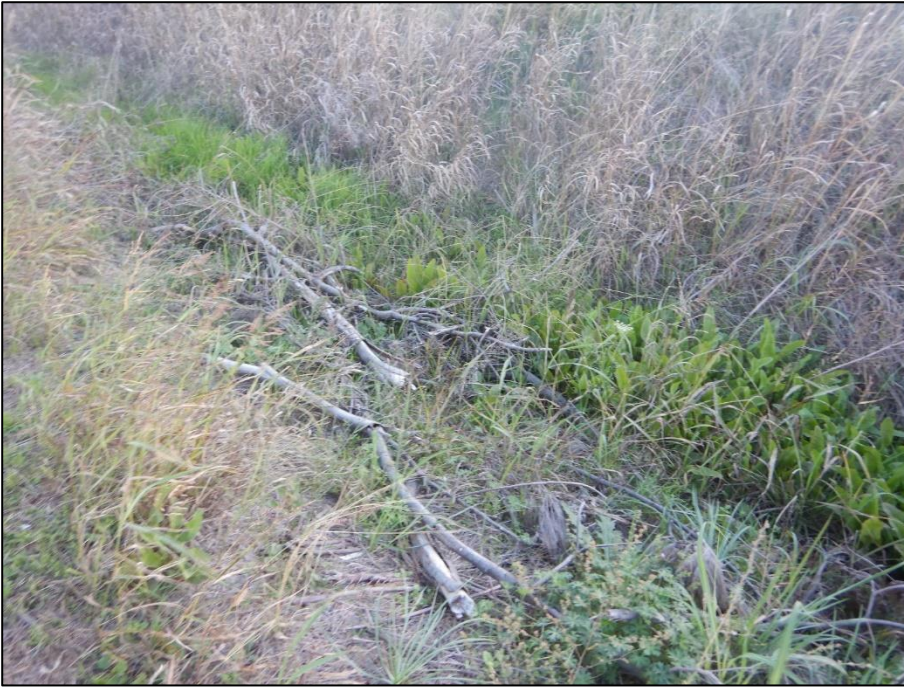
**Photo B13: View of discarded tree branches within drainage swale**

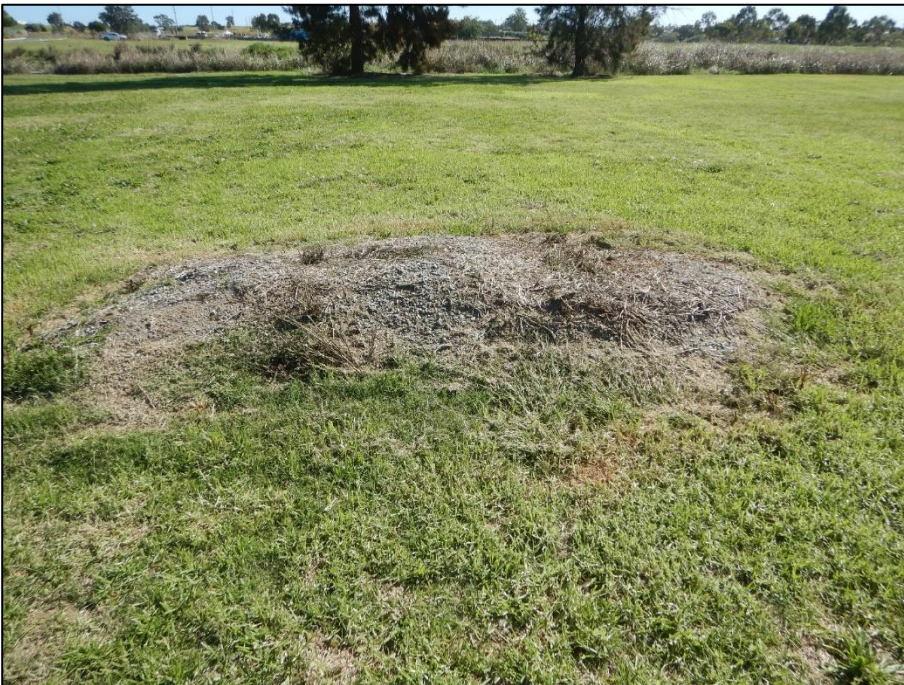
- A number of semi-mature to mature trees were observed along the drainage gully;
- A small fill mound of natural quarry single size gravel was observed within the south eastern portion of the site (Photos B20);

**Photo 20: View of stockpiled gravel material near Test Pit C2**

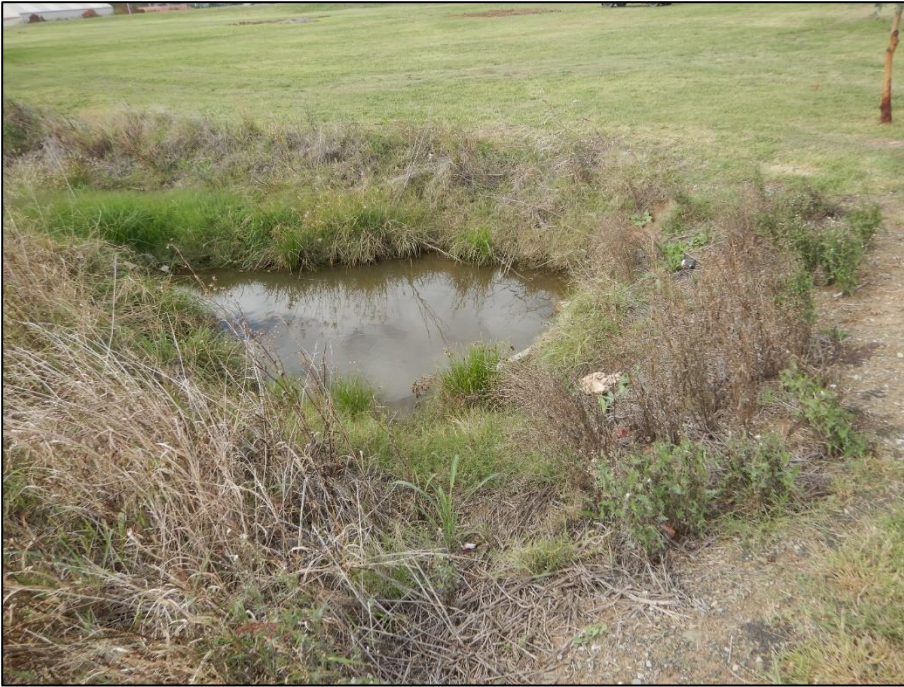
No free groundwater was observed during excavation of test pits or drilling of boreholes. Ponded water was observed within the drainage swale within the southern part of the site. It should be noted that groundwater levels are affected by climatic conditions and soil permeability and will therefore vary with time.

**Photo 21: View of ponded water within southern extent of drainage swale**
