**Preliminary Geotechnical Assessment**

**Proposed Residential Subdivision**

**54 Pullen Street, Woolgoolga**

Report No. RGS33955.1-AB

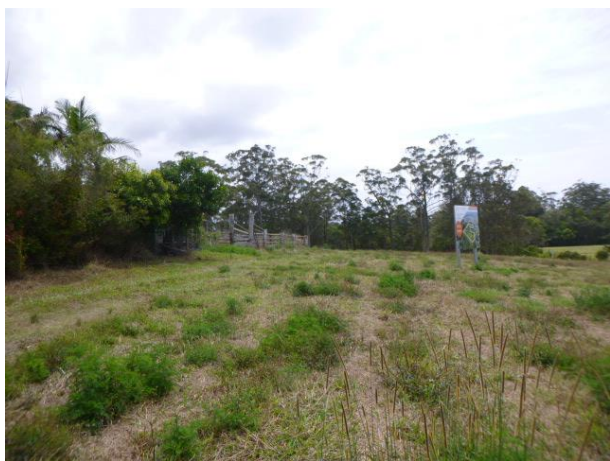
*Looking northwest across the northern portion of the sit. Vacant grazing land with bushland in the background.*

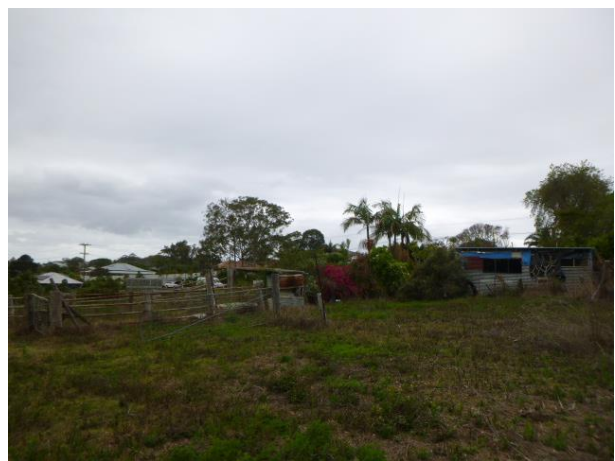
*Looking towards stockyards in proposed Lot 16.*

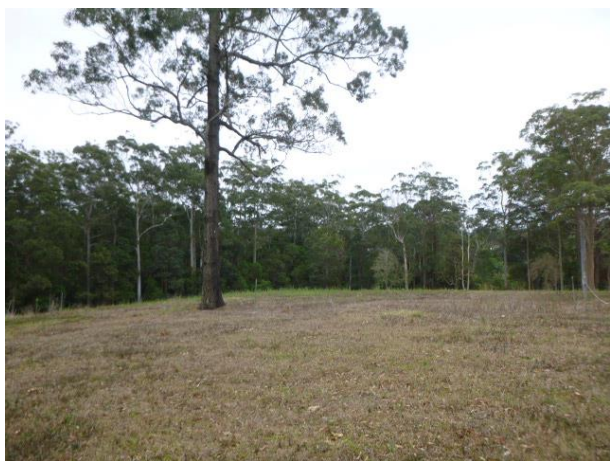
*Looking north from the centre of the site towards Woolgoolga Creek. The site is gently sloping in this area.*

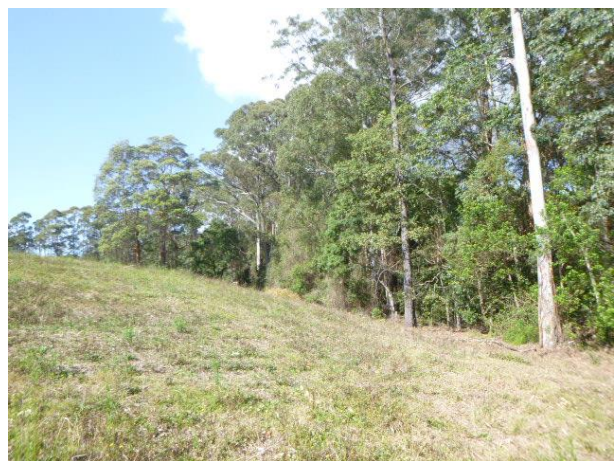
*Looking south from the north western corner of the site. Western portion of the site has steeper slopes.*

The topography comprises undulating residual terrain that falls to the west, north and east with the steepest slopes being along the western side. Slopes are typically less than 12° and no evidence of slope instability was observed during the site assessment. Alluvial terrain is situated to the north.

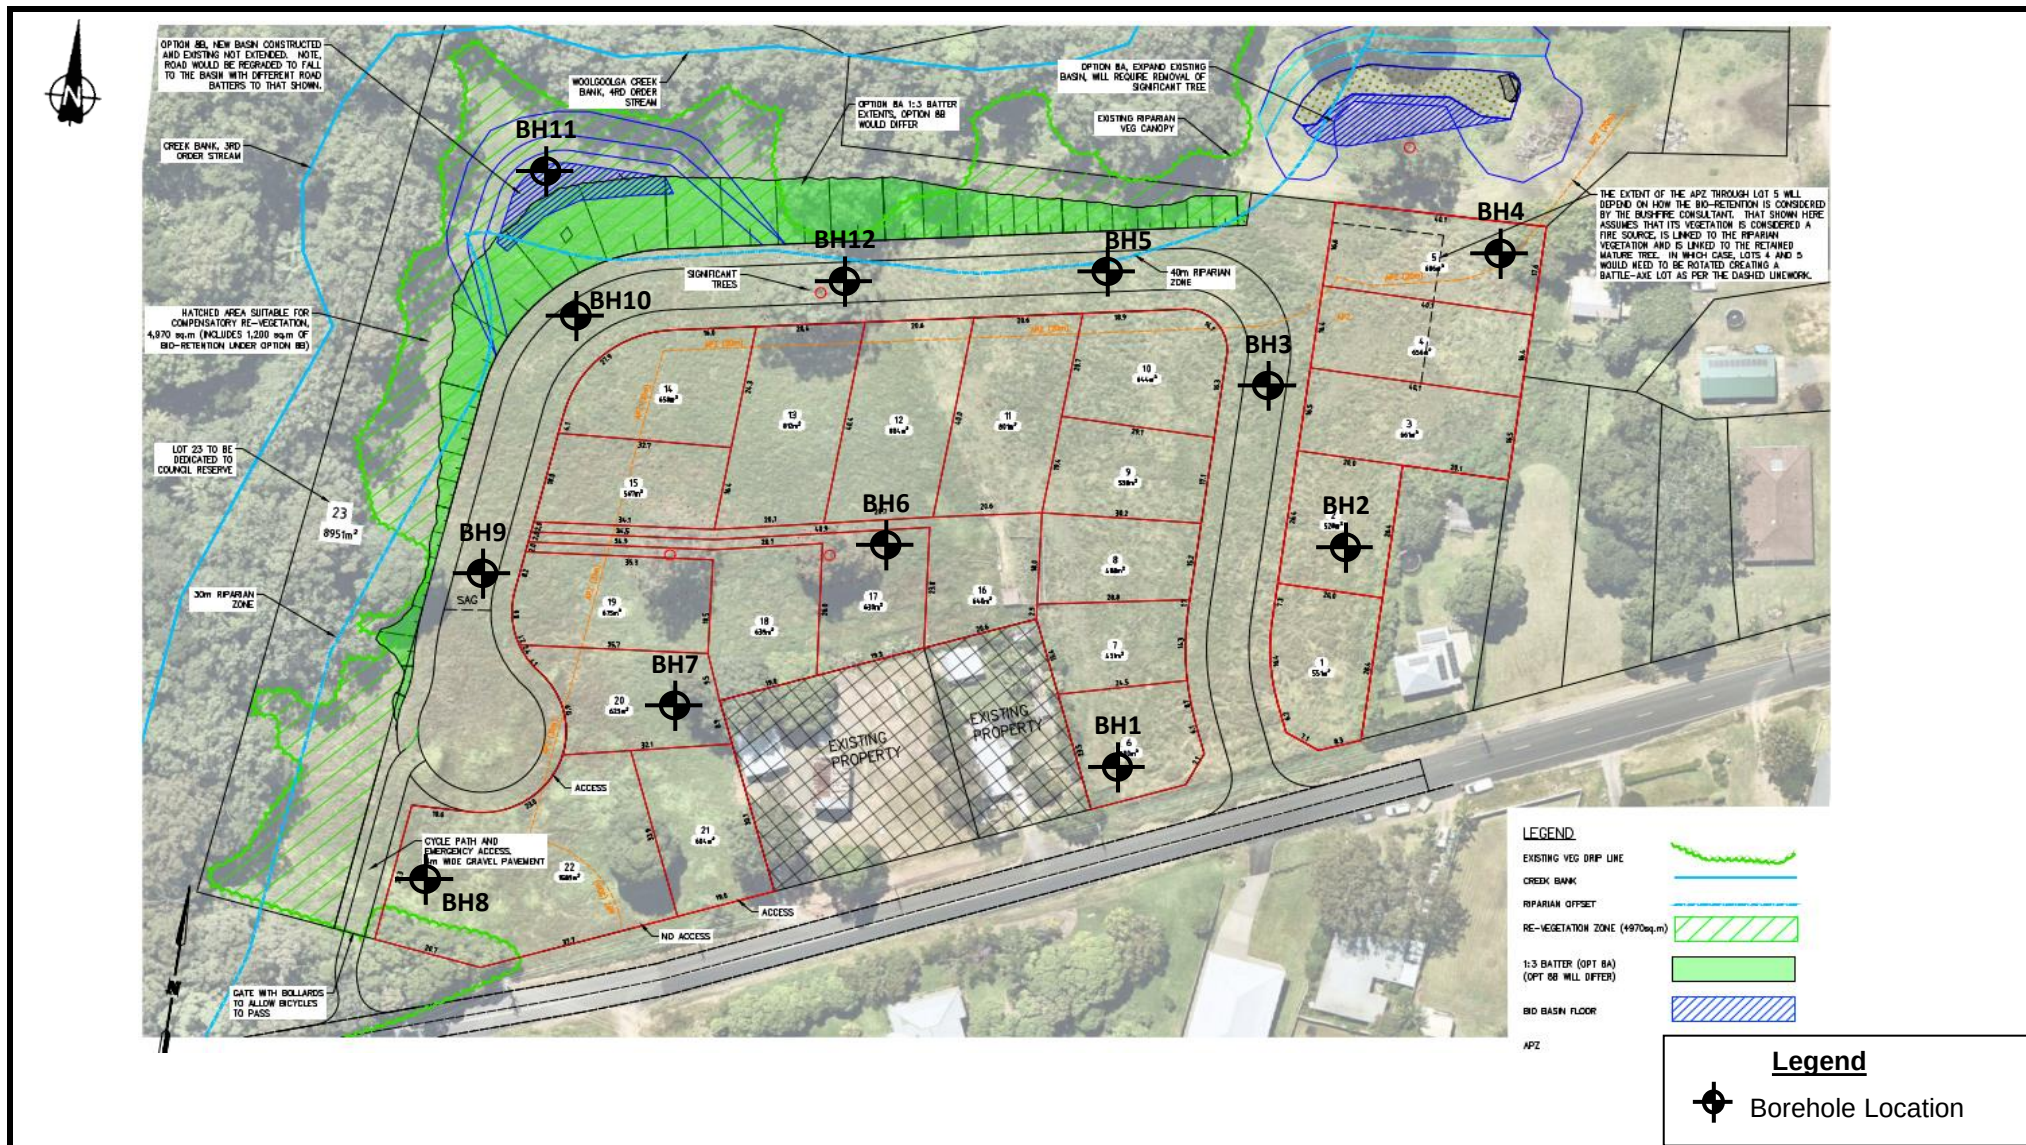
Figure 1          Test Location Plan

Engineering logs of the boreholes are presented in Appendix A. Test locations are shown on the attached Figure 1 and were obtained by measurements to prominent site features.
