# Preliminary Acid Sulfate Soil Assessment - 54 Pullen Street, Woolgoolga

21 June 2024

Ref	Ver	Date	Distribution
2324-178-03	A	21/6/24	Client
	B

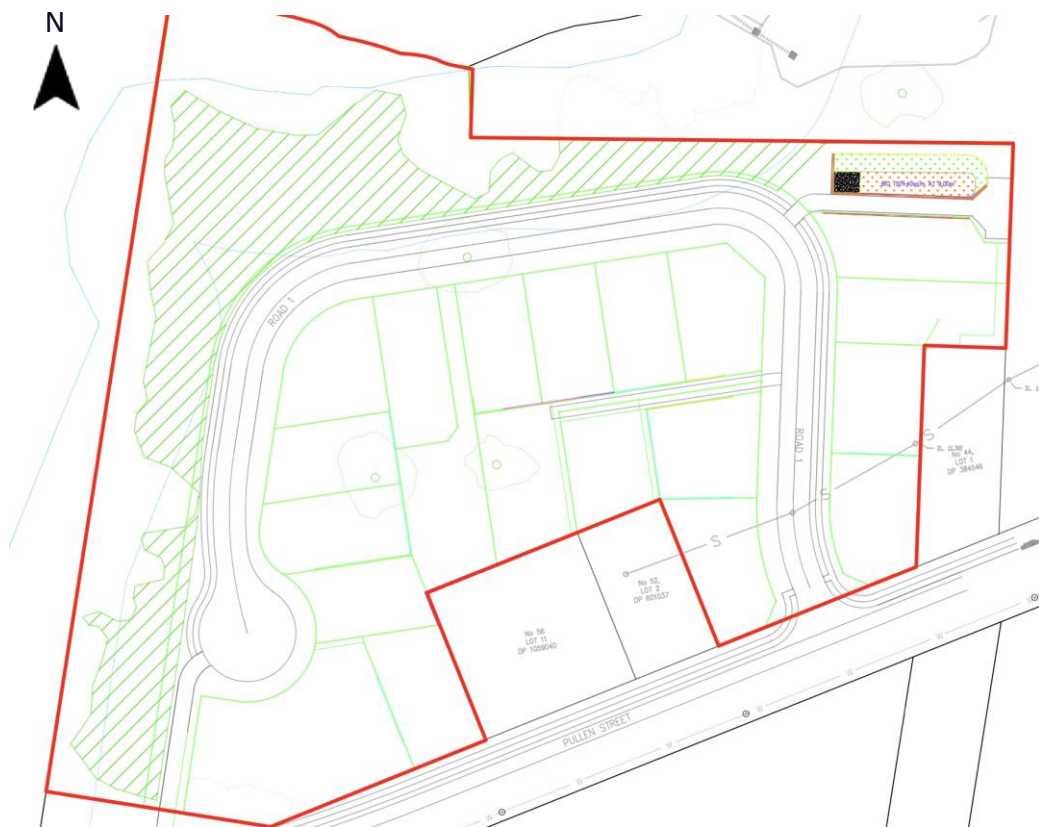
Figure 1.  
Proposed  
Development  
Layout.

Based on plans of the proposed subdivision layout by deGroot & Benson, it is understood that it is proposed to subdivide the subject property into 20 allotments with a bio-retention basin covering 150m<sup>2</sup> basal and 40m<sup>2</sup> bench area in the northeast corner. (Figure 1).

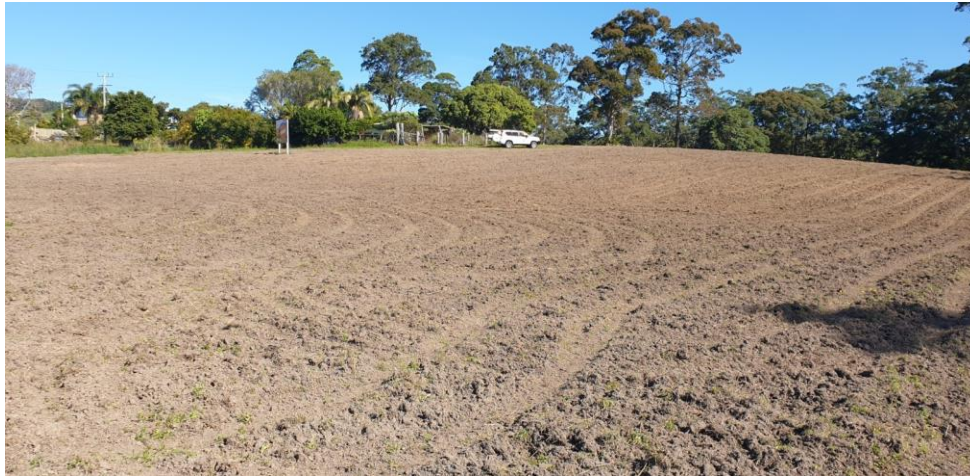
The Site slopes down radially northwards from a central mid slope hill ridge to the north of Pullen Street flanked by gullies draining towards Woolgoolga Creek to the north and alluvial terraces to the northeast (Photographs 1 and 2).

Photograph 1. Looking southwest from the northeast boundary corner towards the hill crest of the southern boundary.

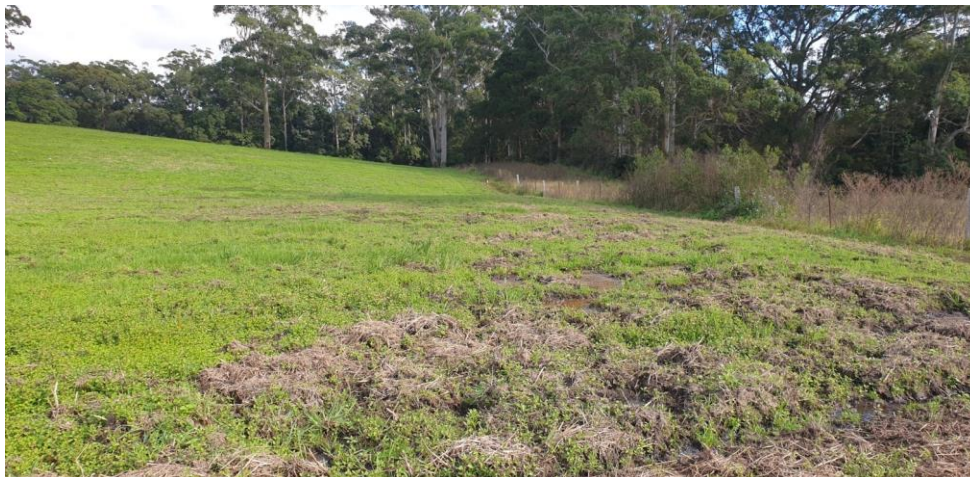
Photograph 2. Looking west along the northern boundary from the northeast boundary at 9.5m AHD.

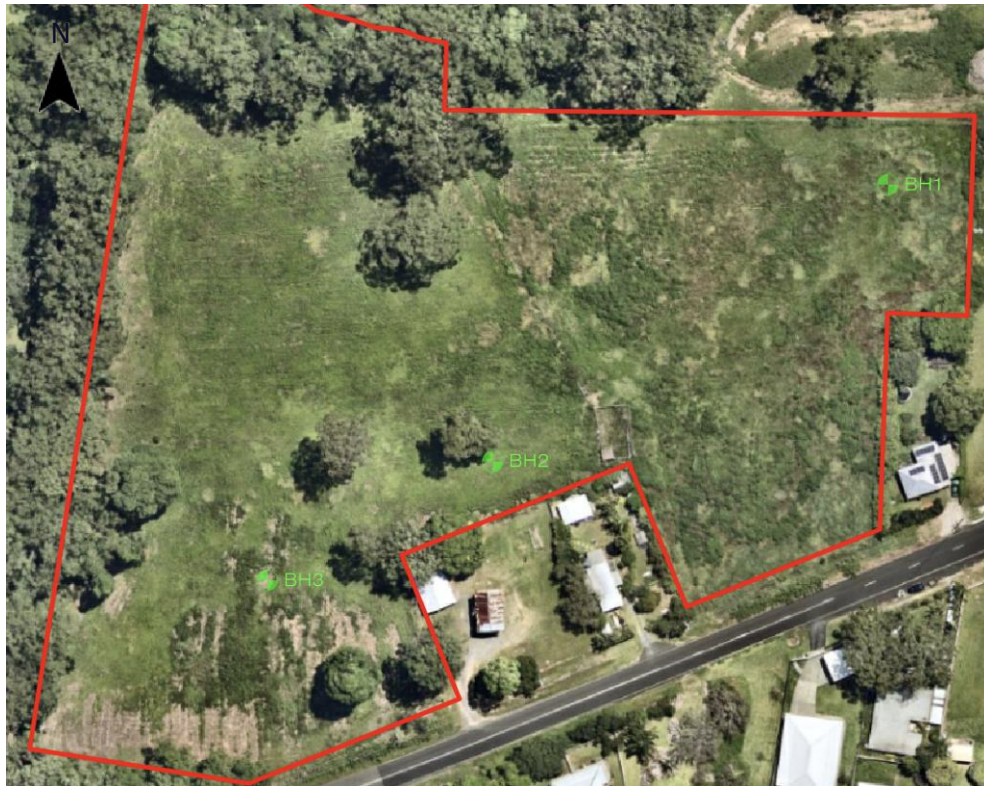
Figure 6. Borehole Locations.

Site soils were observed by drilling three boreholes (BH1-BH3). The boreholes of BH1 and BH3 were drilled to termination at 1.2m depth and BH2 was drilled to refusal at 0.8m depth. The location of the boreholes are shown in Figure 6 and a copy of the borehole logs are presented in Appendix A.

Natural residual clay soil profiles were observed in the boreholes, and were found to be representative of the Megan Soil Landscape, low to mid slope (dry) position. The lithology encountered included a brownish black to dark brown clay loam to 0.3m depth and brown mottled orange and white light clay to 1.2m depth. Extremely weathered bedrock was below the grey mottled white clay in BH2.

No rotten egg odours, shell pieces, dark grey to black anaerobic soils or muds were encountered. No groundwater inflow was observed in the boreholes to the maximum depth drilled.
