Preliminary & Detailed Environmental Site Assessment - 54 Pullen Street, Woolgoolga

12 June 2024

For: Precise Planning

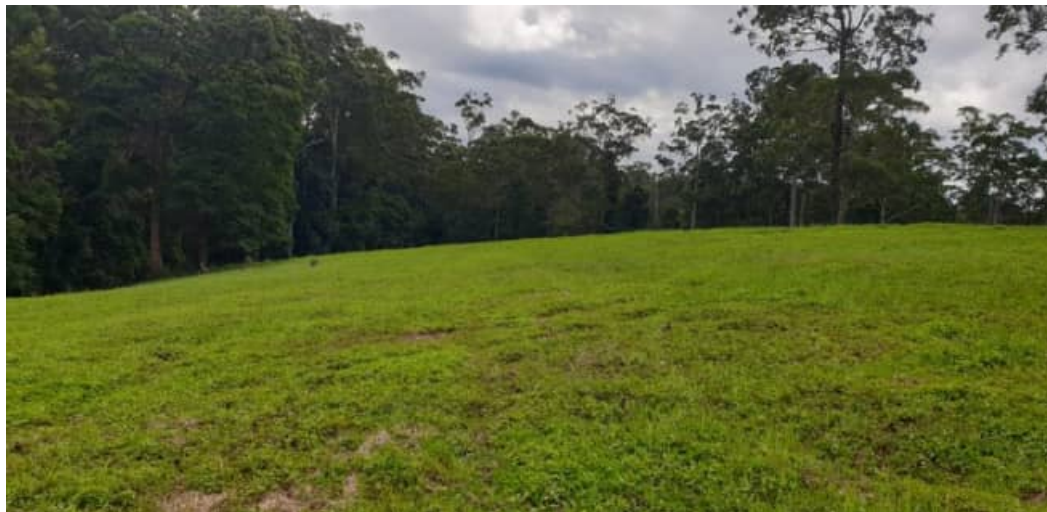
Photograph 1 – Looking north along the western boundary to the left towards the northwestern boundary

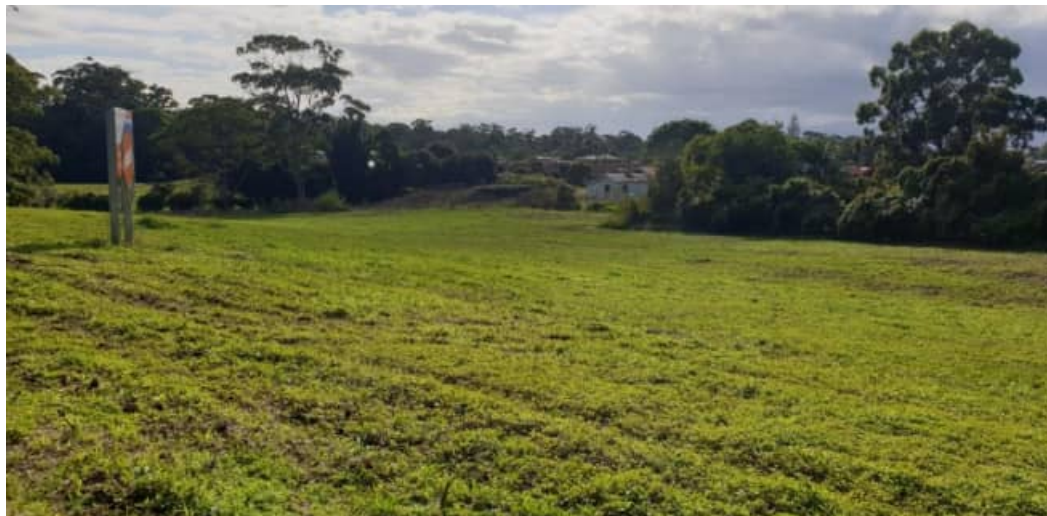
Photograph 2 – Looking northeast from the southern boundary to the northeastern boundary.

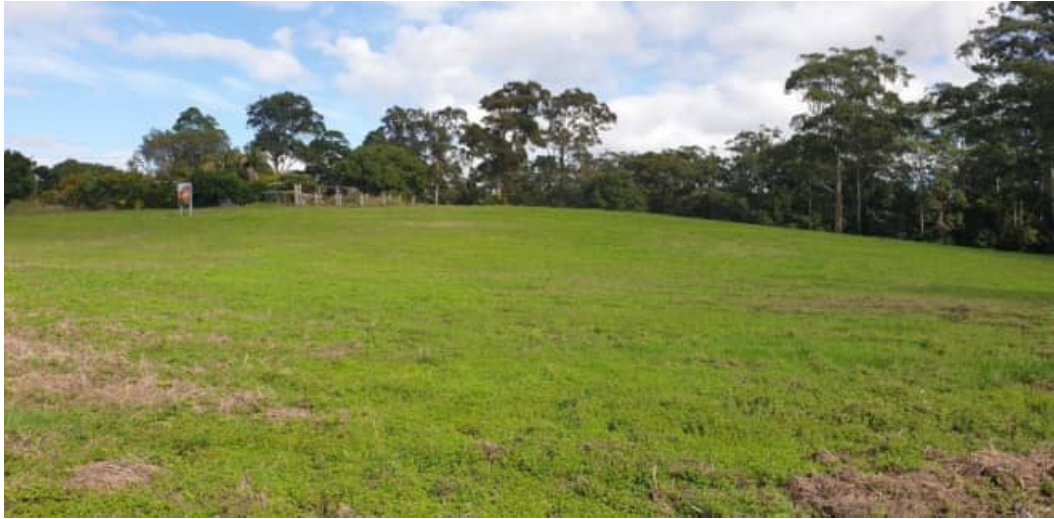
Photograph 3 –
Looking
southwest from
the northeast
boundary corner
towards the
offsite existing
lots affronting
Pullen St.

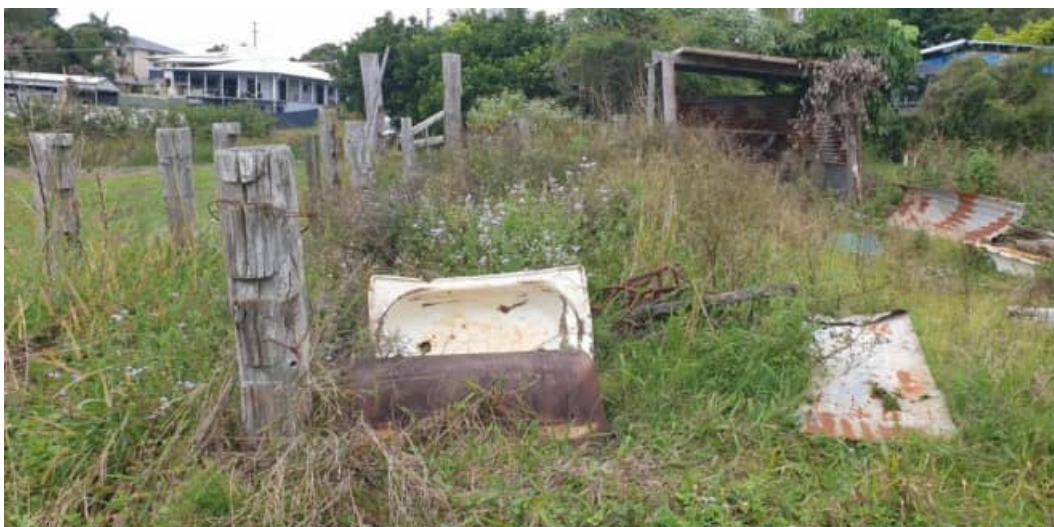
- A small relic cattle yard and Galvanised Iron (GI) roofed shed are located in the upper southern portion of the Site;
- No evidence of past contaminating activities, including chemical odour, staining or asbestos containing material;

Photograph 5 –
Looking south at
the cattle yard,
loading ramp and
small shed.

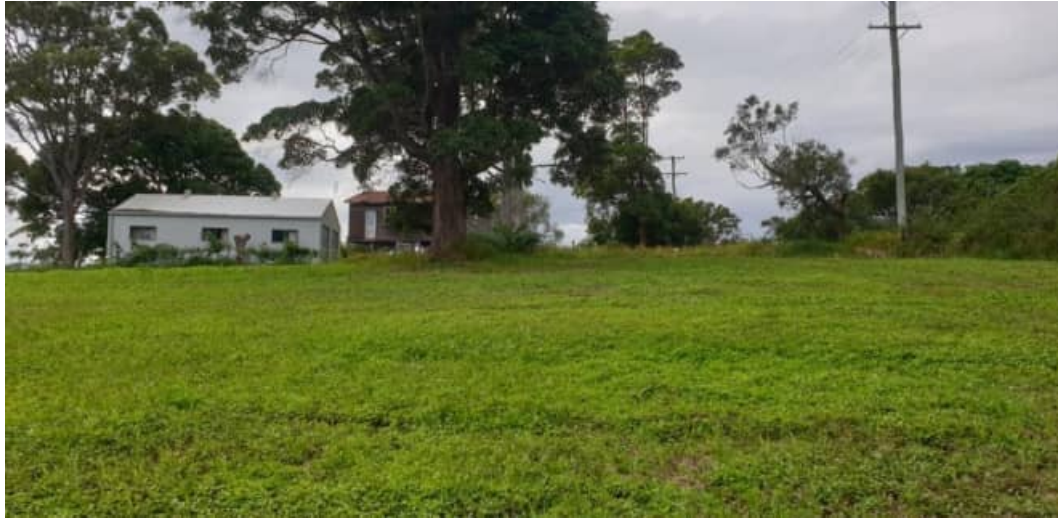
Photograph 6 – Looking east from the southwest corner upslope towards the existing lot offsite affronting Pullen St.

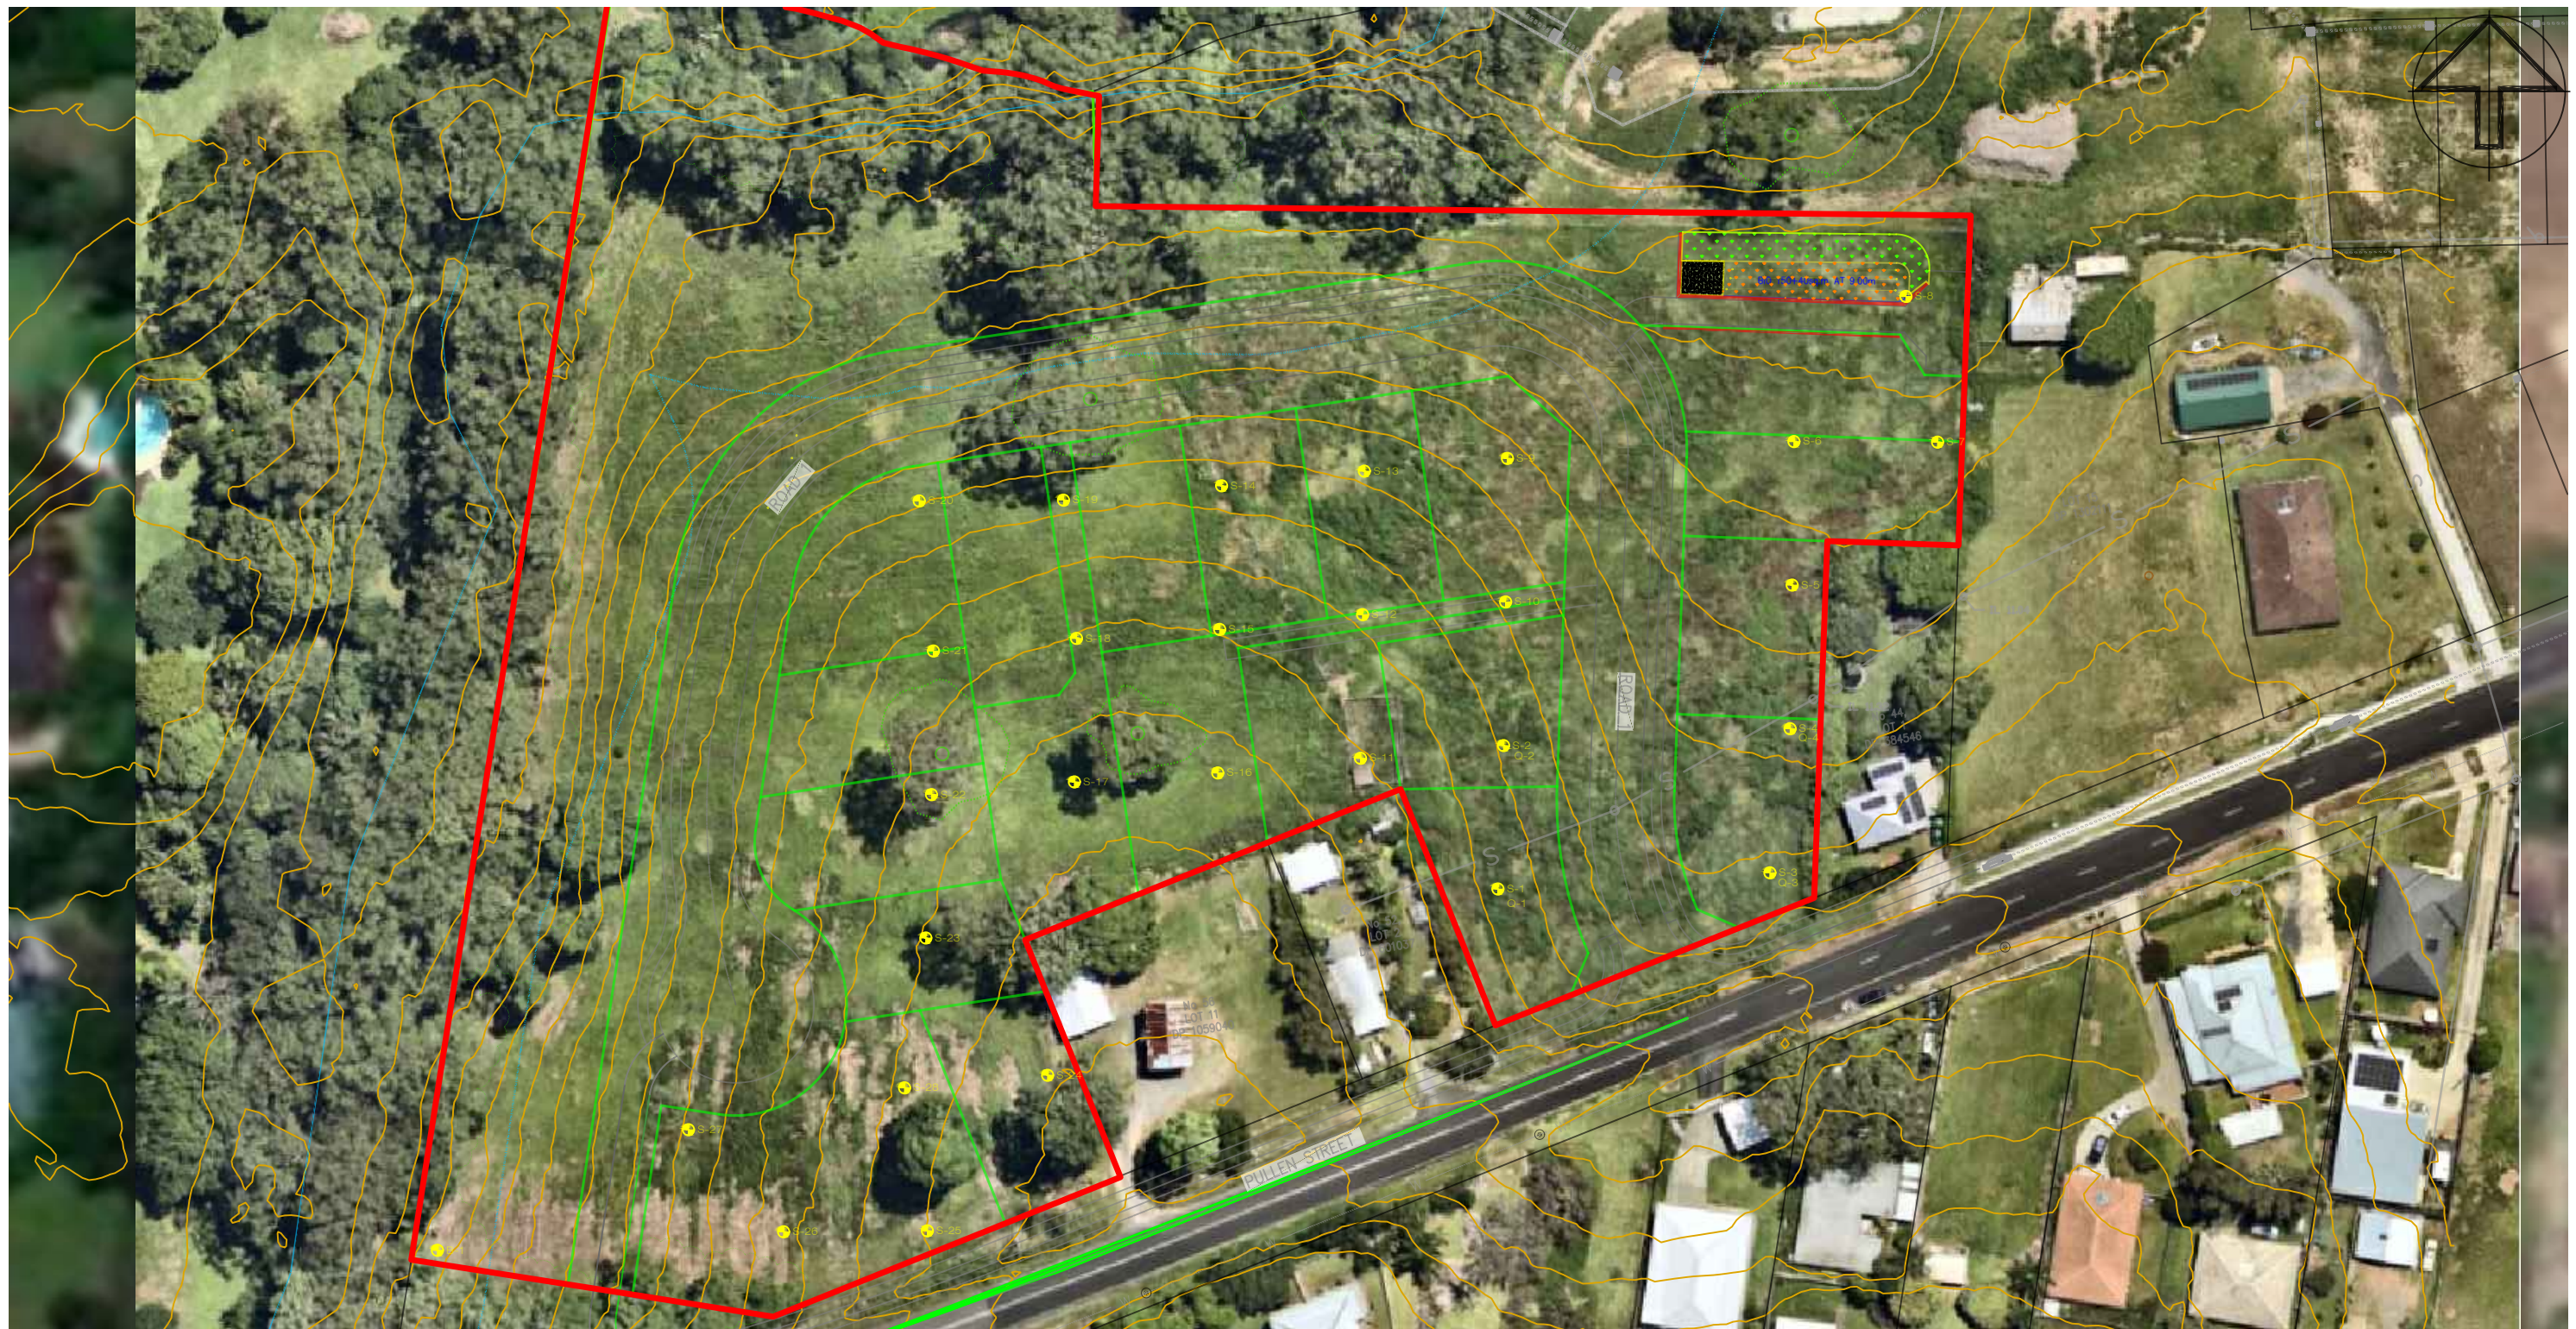
TITLE Site Layout & Sample Locations
