# **Statement of Environmental Effects**

Village Green Stormwater Infrastructure Repairs

Thredbo Alpine Resort  
Kosciuszko National Park, NSW

August 2024

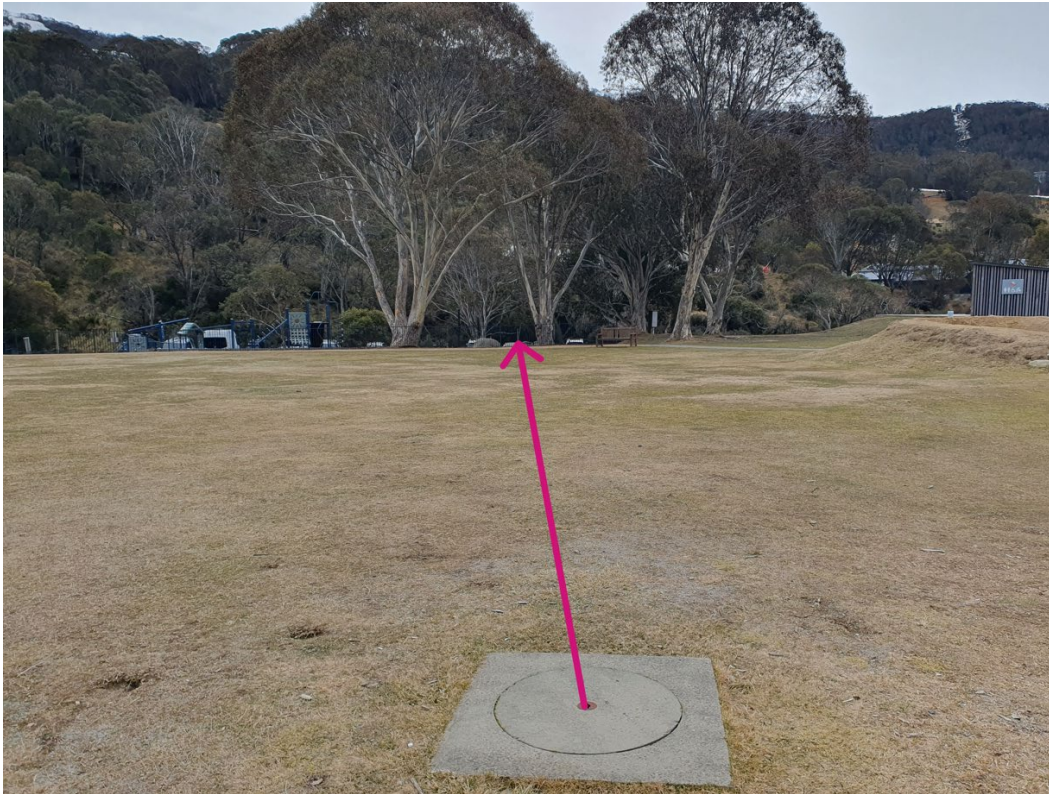
*Figure 3: Upstream pit facing north towards the Playground and Thredbo River*

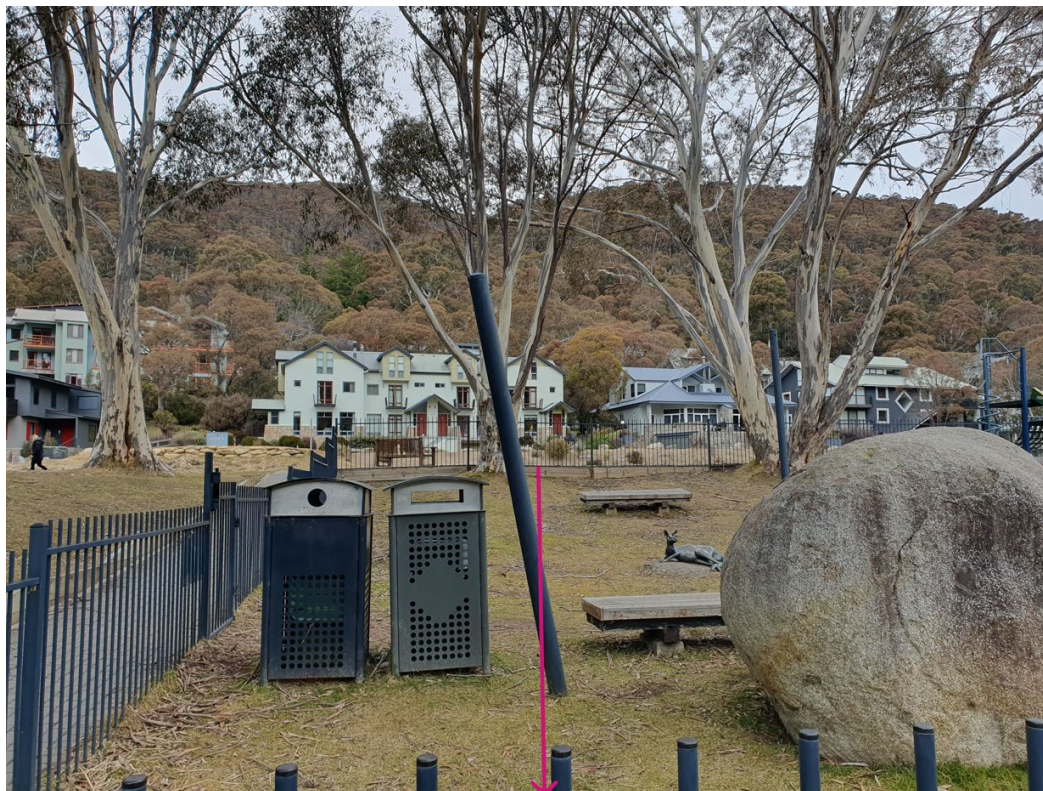
*Figure 4: Standing at the downstream pit looking south towards the upstream pit*

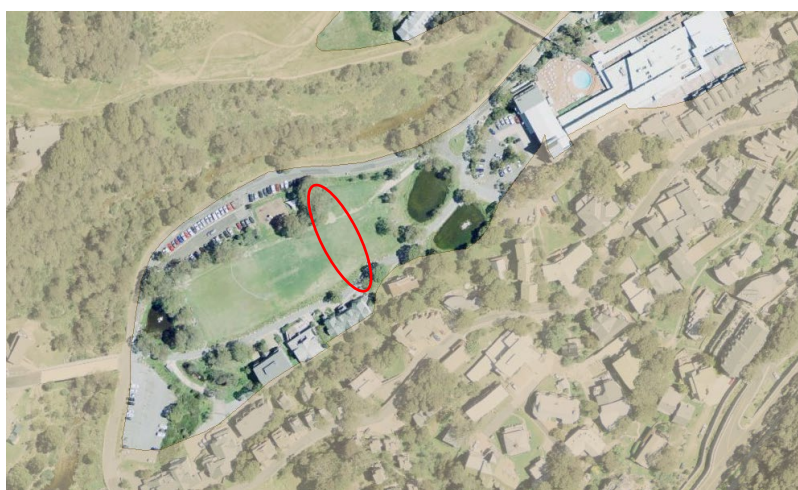
Figure 5: Geotechnical Policy Overlay (NSW Government 2024a)

The Development is not located within the "G" area of the maps accompanying the Geotechnical Policy Kosciuszko Alpine Resorts (DIPNR 2003) (Geotechnical Policy), therefore a geotechnical report is not required. Refer to **Appendix B** for a copy of the Geotechnical Assessment (Assetgeoenviro 2024).

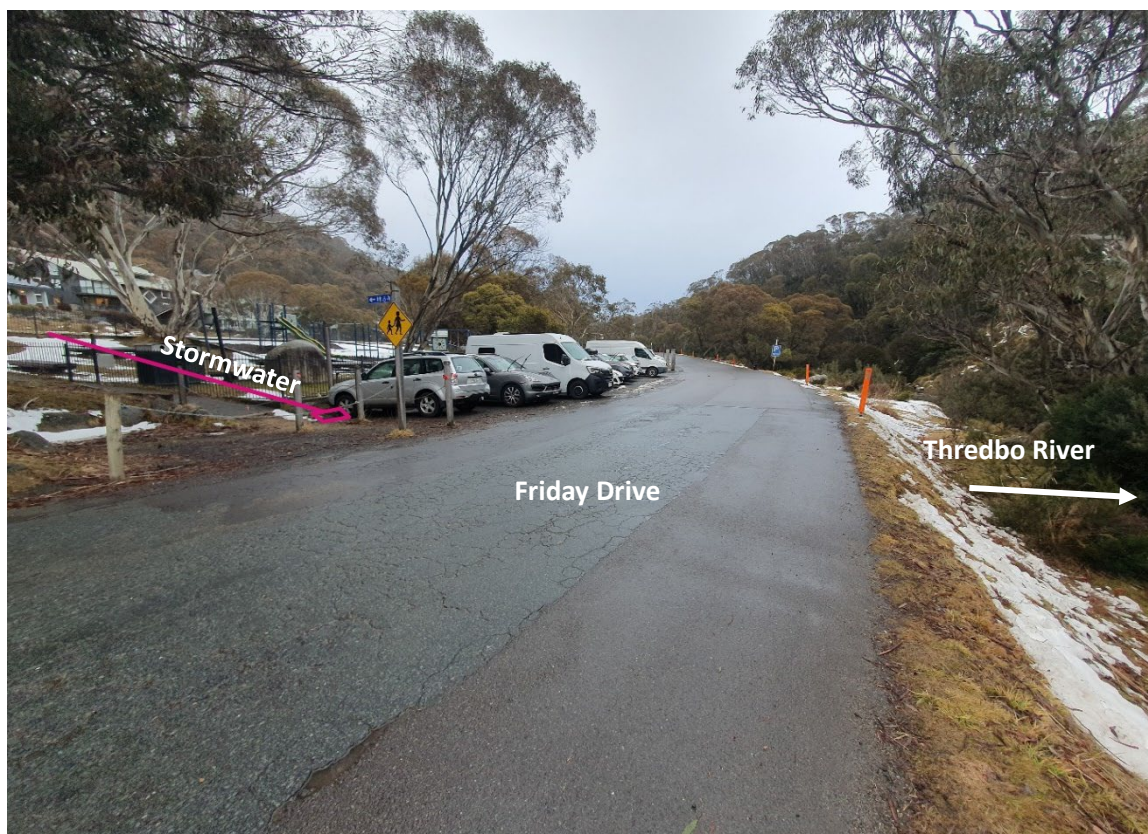
Figure 6: Friday Drive separates Development from Thredbo River

- Thredbo River is separated from the works by Friday Drive, therefore no disturbance within the riparian zone.
- No riparian vegetation removal is required.
- The construction contractor will implement appropriate erosion and sediment control measures during construction to ensure no sediment or uncontrolled surface water runoff leaves the site.
- The trench will be opened in stages and progressively backfilled to limit the amount of disturbance ground at any one time.
- The repair works will ensure the environmental functions of the riparian corridor are maintained by ensuring stormwater run-off is adequately treated before discharging into the river.

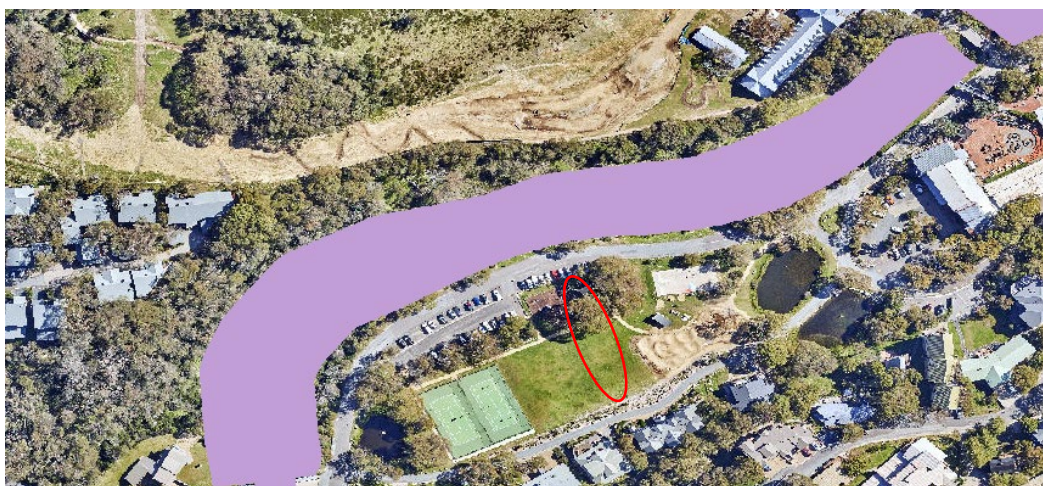
Figure 8: Biodiversity Values Map (NSW Government 2024c)

The Development site is heavily disturbed and not located within an area mapped as containing biodiversity values on the Biodiversity Values Map (**Figure 8**). No vegetation clearing is required for the works.

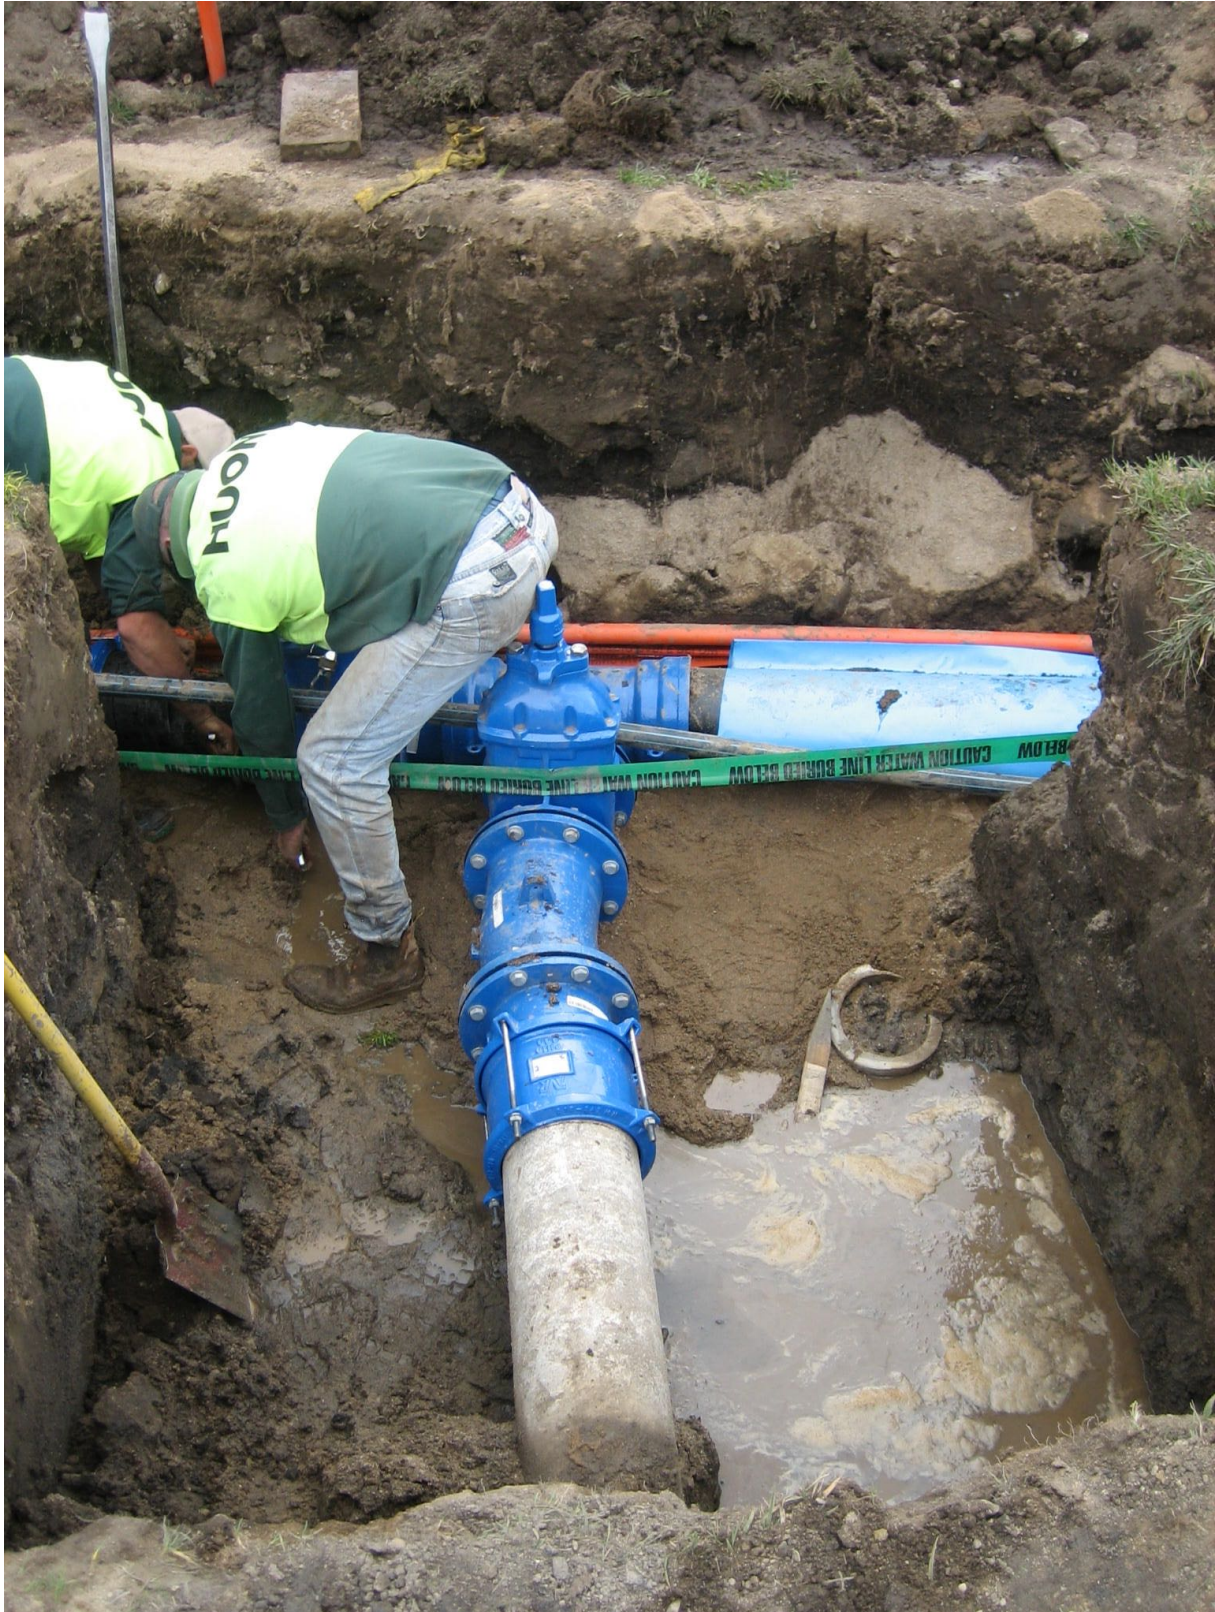
**Photo 1 – view of water main install in Village Green (17 May 2007). Source: Kosciuszko Thredbo Pty Ltd**

It is likely that historic development of the site has involved some filling, more likely within the playground area where a slightly steeper slope is observed, which flanks the level grassed field. Additionally, the pictures provided by the client for the adjacent water mains trench in Village Green support the evidence that the site is filled with Sandy CLAY, dark grey and mottled light grey.

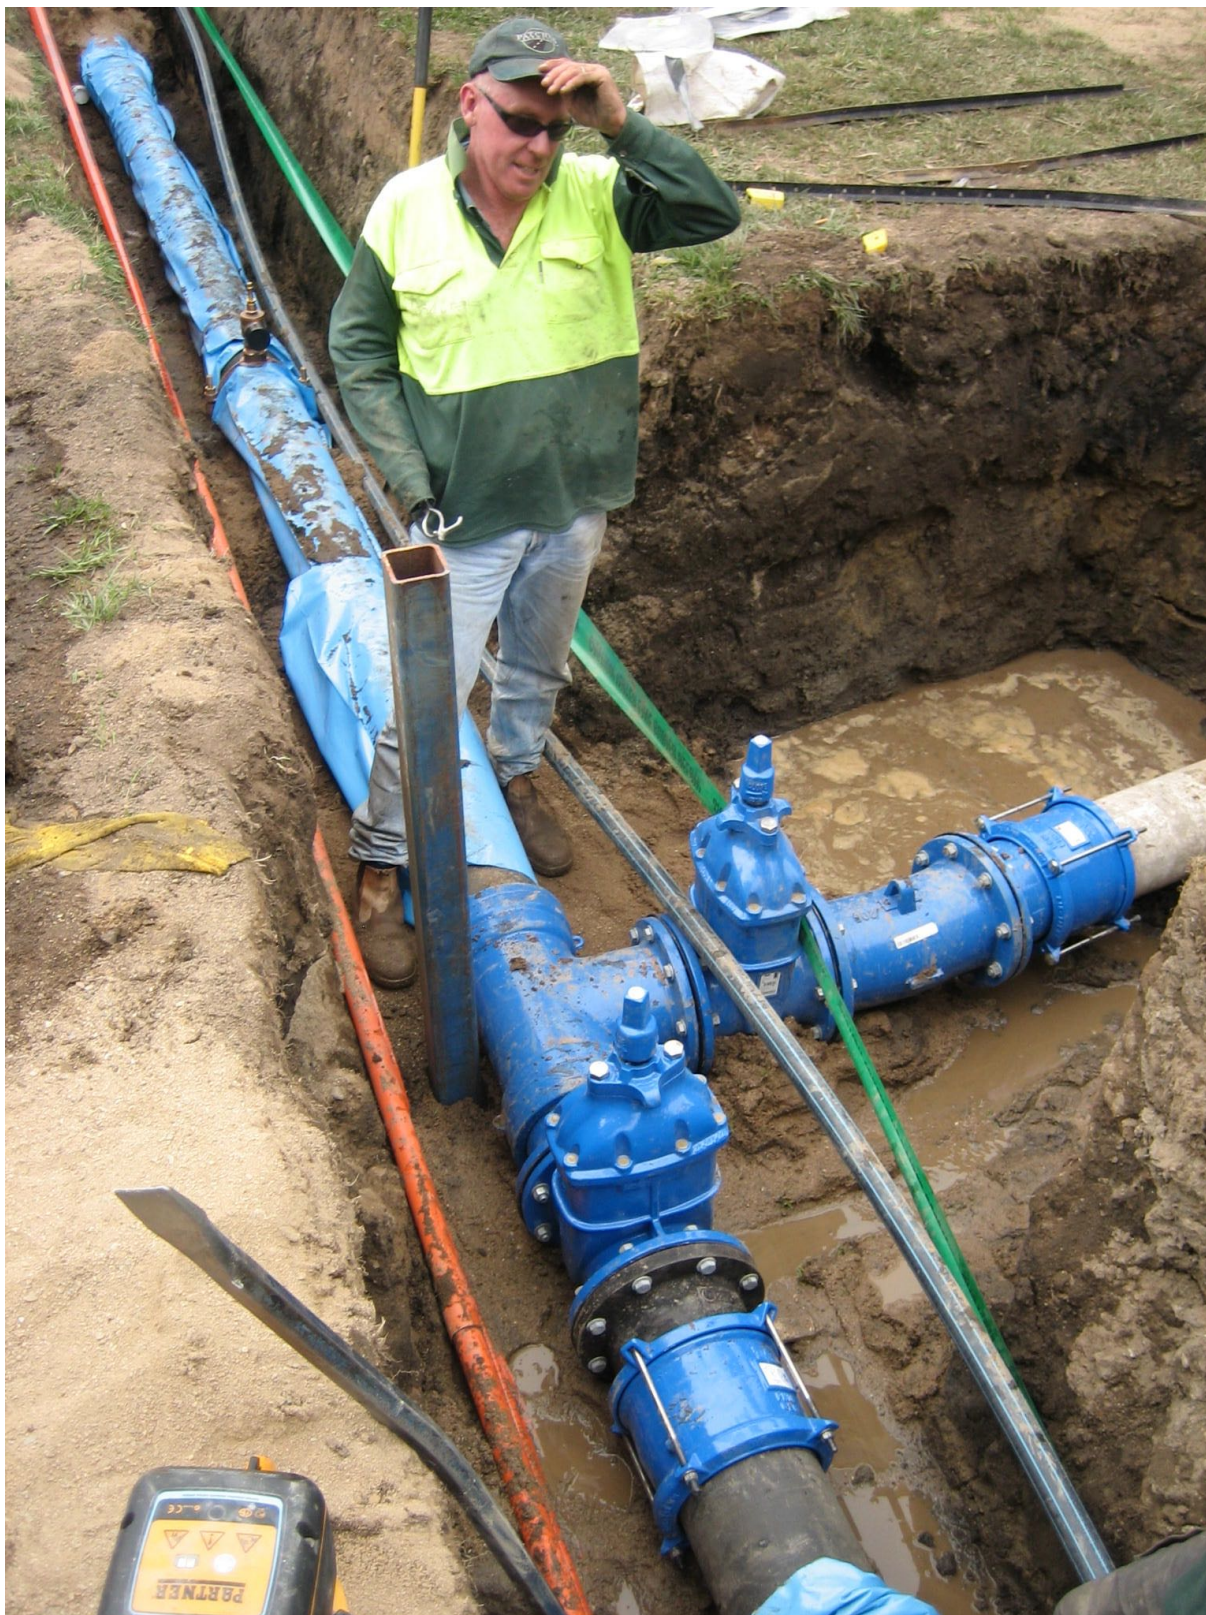
**Photo 2 – view of water main install in Village Green (17 May 2007). Source: Kosciuszko Thredbo Pty Ltd**
