Statement of Environmental Effects

Village Green Stormwater Infrastructure Repairs

Thredbo Alpine Resort
Kosciuszko National Park, NSW

August 2024

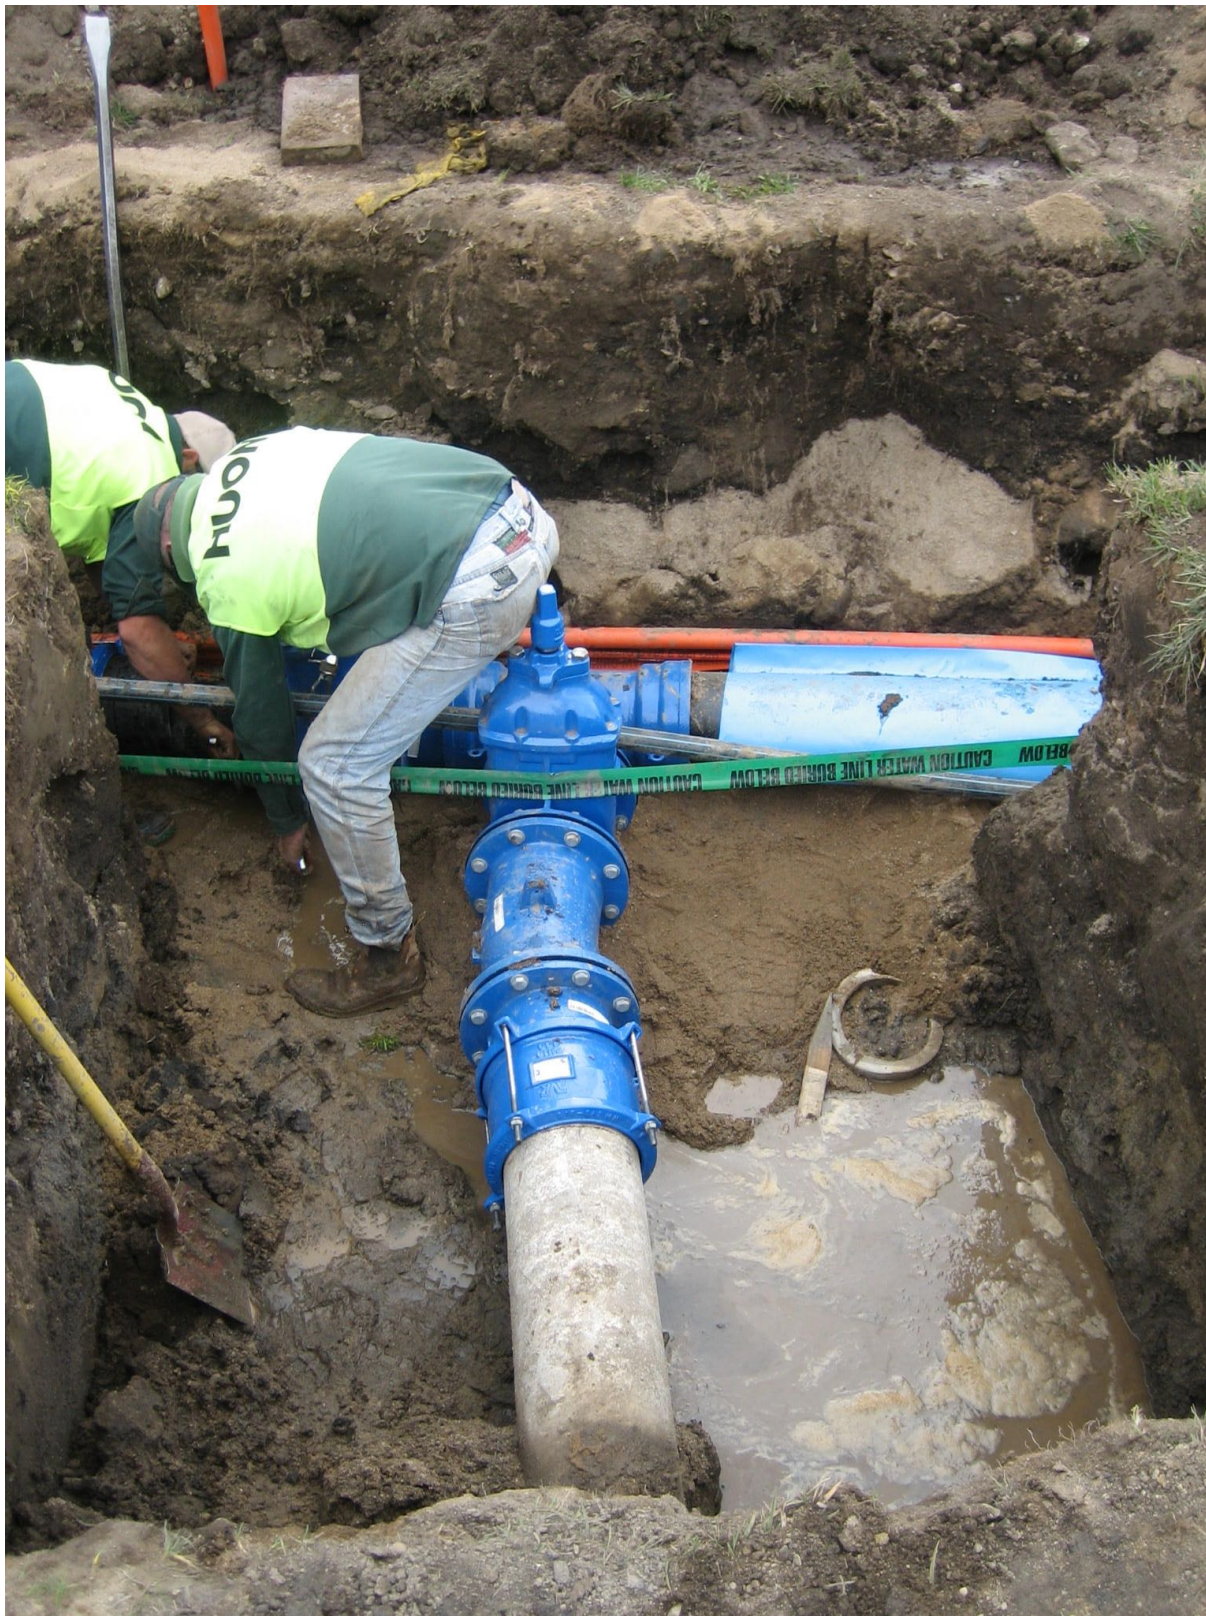
Photo 1 – view of water main install in Village Green (17 May 2007). Source: Kosciuszko Thredbo Pty Ltd

It is likely that historic development of the site has involved some filling, more likely within the playground area where a slightly steeper slope is observed, which flanks the level grassed field. Additionally, the pictures provided by the client for the adjacent water mains trench in Village Green support the evidence that the site is filled with Sandy CLAY, dark grey and mottled light grey.

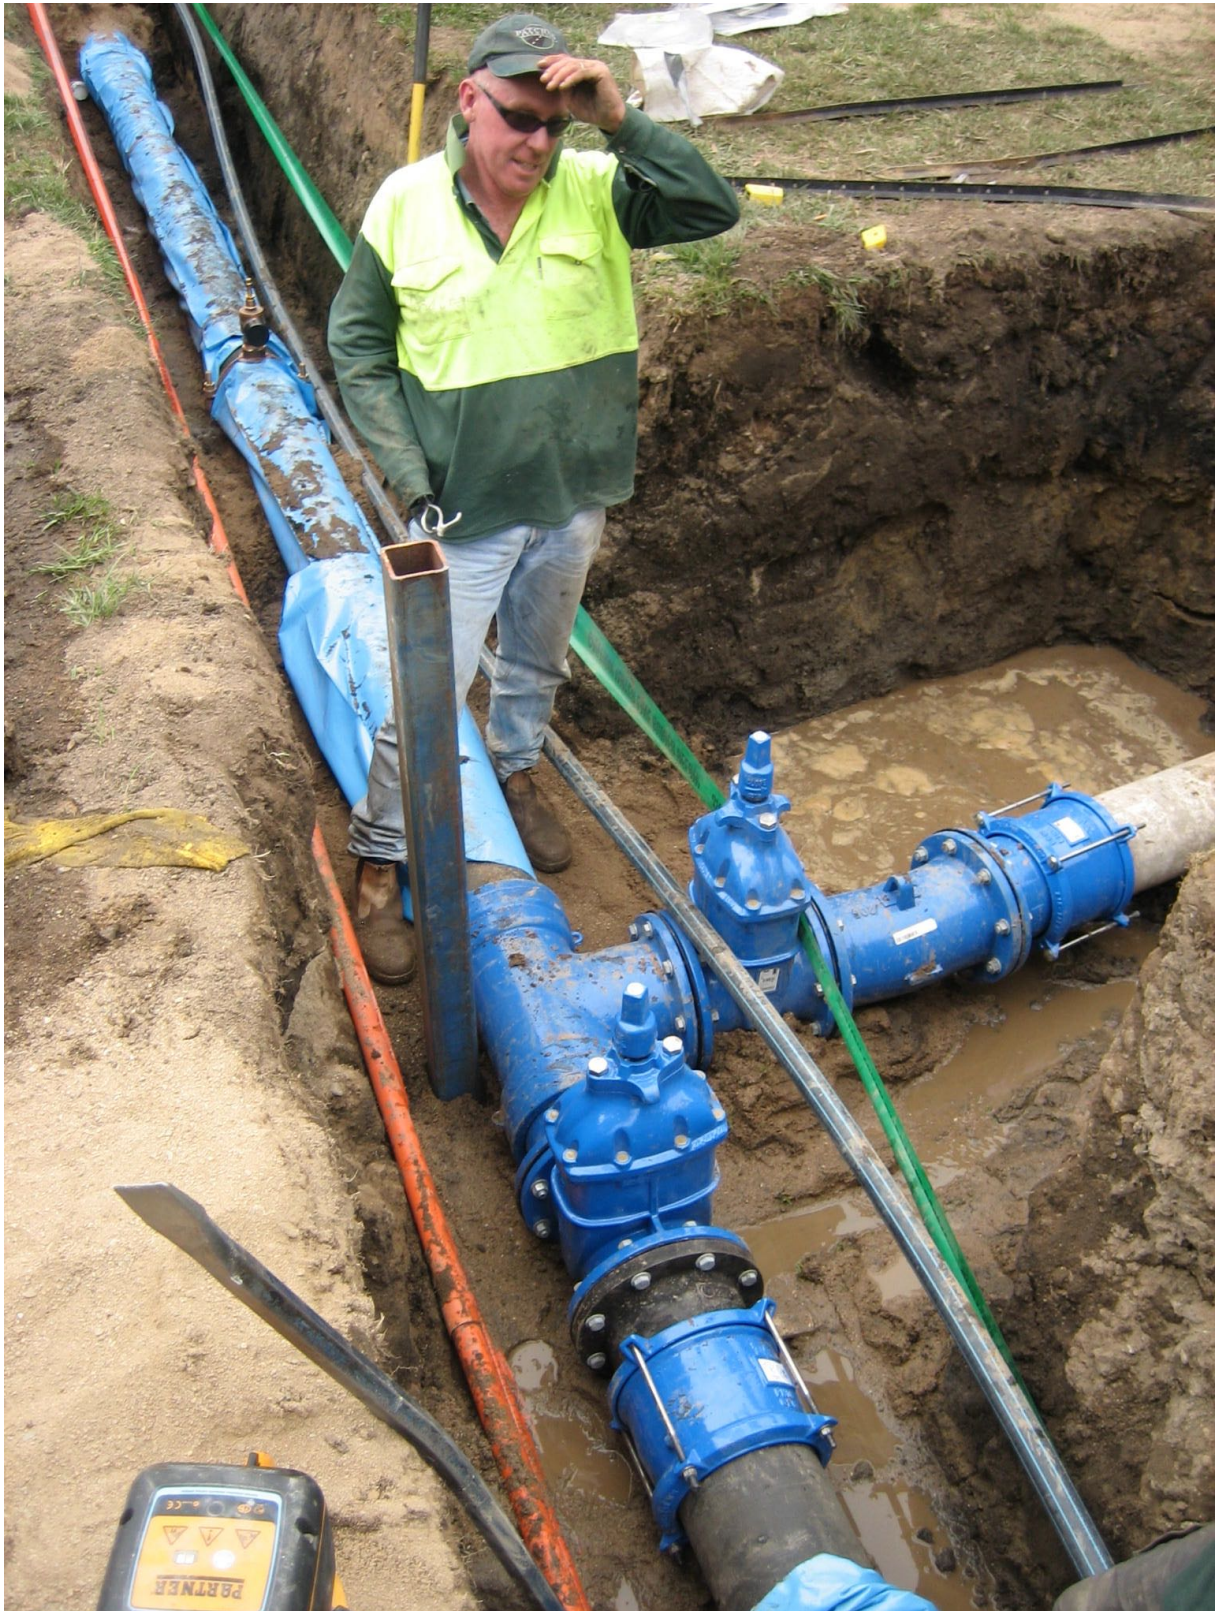
Photo 2 – view of water main install in Village Green (17 May 2007). Source: Kosciuszko Thredbo Pty Ltd

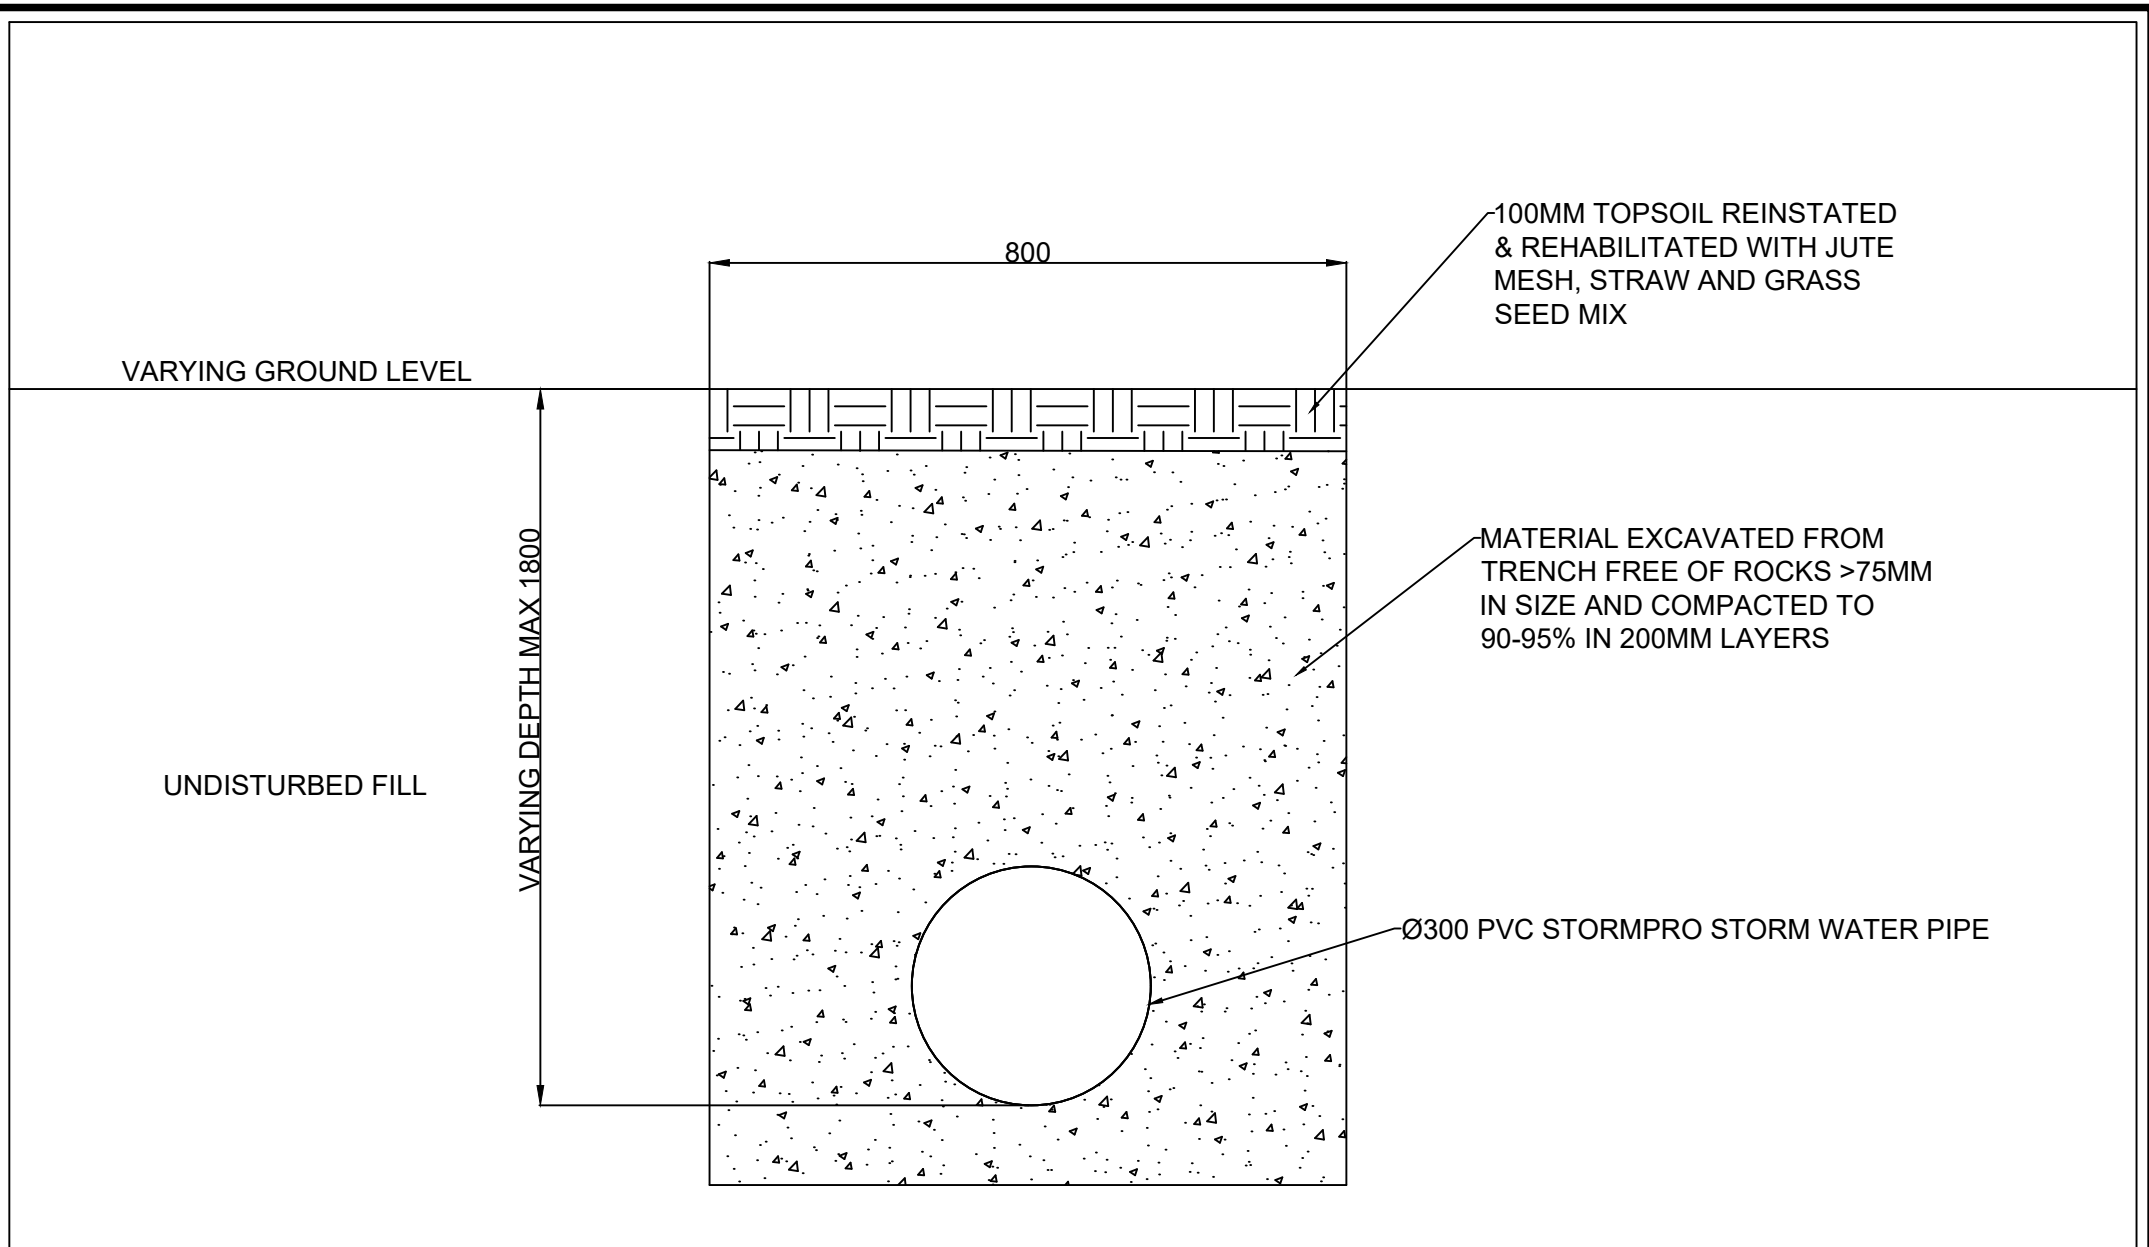
1. Depth will vary to maintain the consistent 4.8% slope of pipe from inlet to outlet
2. Backfill and pipe bedding will meet AS/NZS 3500.3 Plumbing and Drainage - Stormwater drainage
3. If trench section is deeper than 1500mm, then benching must be carried out to achieve a temporary batter slope no deeper than 1H:1V and with max individual bench heights of 1500mm

- Excavation of existing pipeline alignment
 - A trench approximately 800 mm wide x 600-1800 mm in depth is required. Where a trench section deeper than 1500 mm is required, benching will be carried out to achieve a temporary batter slope no deeper than 1H:1V and with maximum individual bench height of 1500 mm.
