Waste Classification and Virgin Excavated Natural Material Report

Report Reference	18587-ER-6-1	Report Date	29/01/2025
Client	The Ice Skating Club of NSW Cooperative Limited		
Client project name	Canterbury Olympic Ice Rink Extension		
Site address	17A Phillips Avenue, Canterbury (refer to Appendix B for a site locality plan).		
Lot & Deposited Plan (DP)	A portion of Lot 1 in DP818459		
Definition of virgin excavated natural material (VENM)	<p>The Protection of the Environment Operations Act 1997 VENM as:</p> <p>'natural material (such as clay, gravel, sand, soil or rock fines):</p> <p>a) that has been excavated or quarried from areas that are not contaminated with manufactured chemicals, or with process residues, as a result of industrial, commercial, mining or agricultural activities, and</p> <p>b) that does not contain any sulfidic ores or soils or any other waste,</p> <p>and includes excavated natural material that meets such criteria for virgin excavated natural material as may be approved for the time being pursuant to an EPA Gazettal notice'.</p>

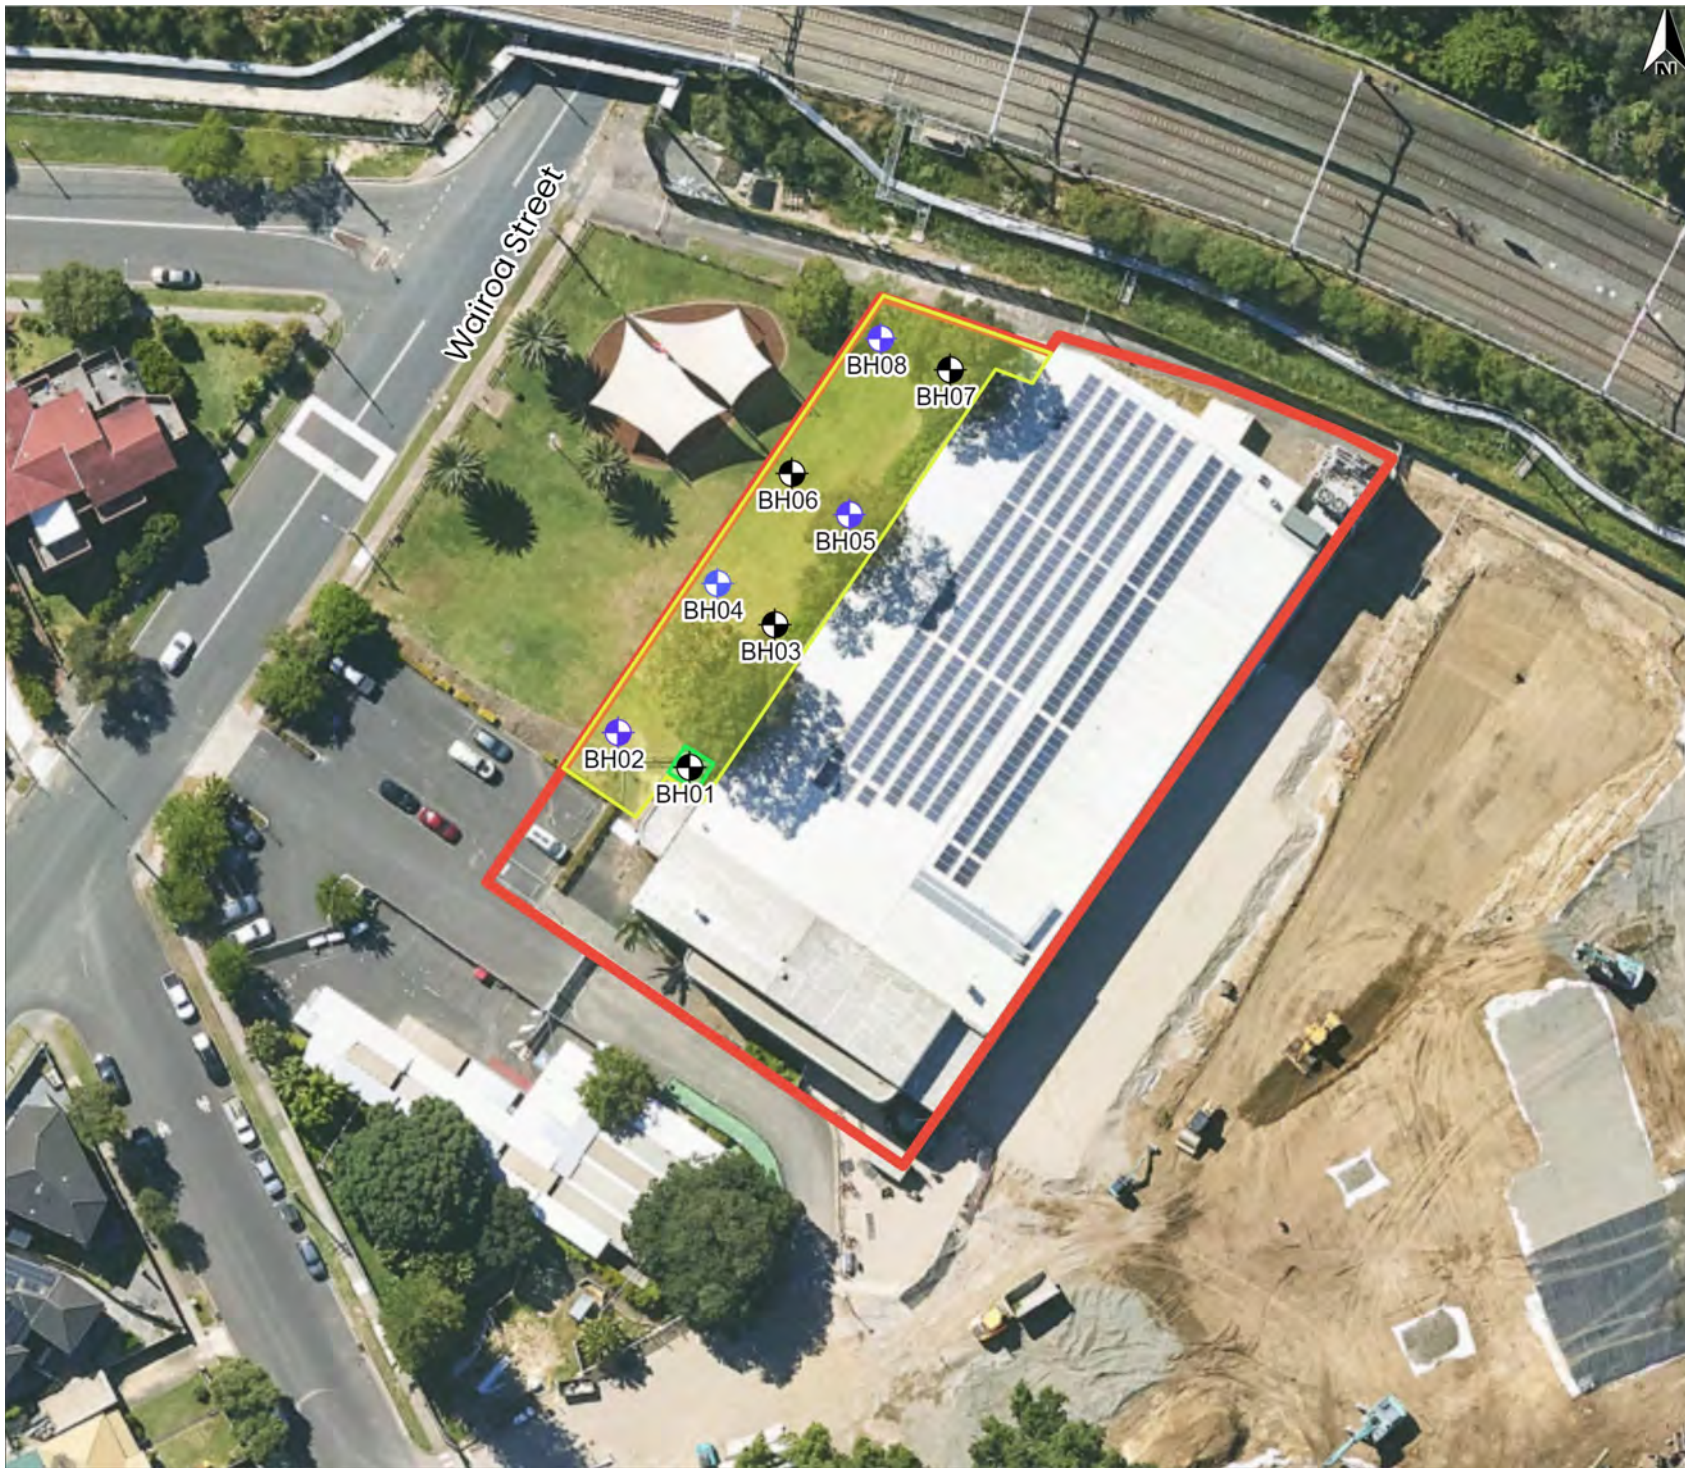
Title: Site Layout and Sampling Plan		
Client: The Ice Skating Club of NSW Cooperative Limited	Drawn: JR	
	Checked: MD	
Project: 17A Phillips Avenue, Canterbury NSW, Australia	Site: Canterbury Olympic Ice Rink	
Date: 14-11-2024	Figure No: 1	
Report Reference: 18587		Scale: 1:810

- Legend**
- Approximate Acid Sulfate and Waste Classification Bore Locations
 - Approximate Waste Classification Bore Locations
 - Approximate Lift Pit Area
 - Approximate Investigation Area
 - Property Boundary
