# Detailed Site Investigation Report

**Project**  
**Canterbury Olympic Ice Rink**  
**Portion of 17A Phillips Avenue, Canterbury, NSW 2193**

**Report No**  
**18587-ER-3-1**

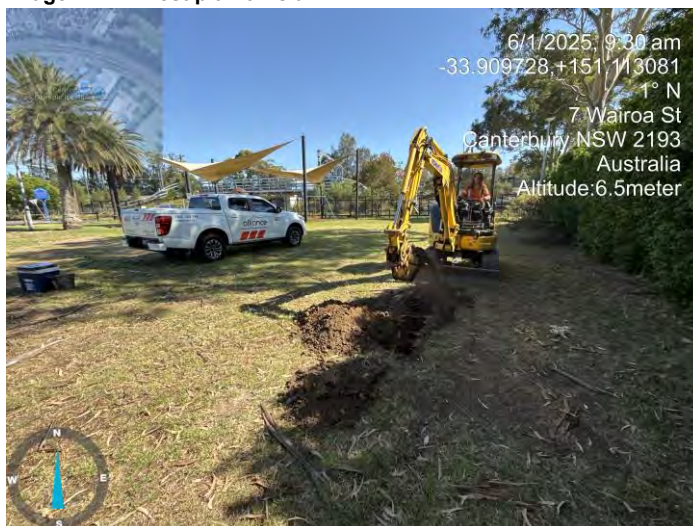
Image 7.1.1.1 Test pit works a

Sampling point locations were confirmed on a site plan. The sampling point location plan is presented in **Figure 5**.

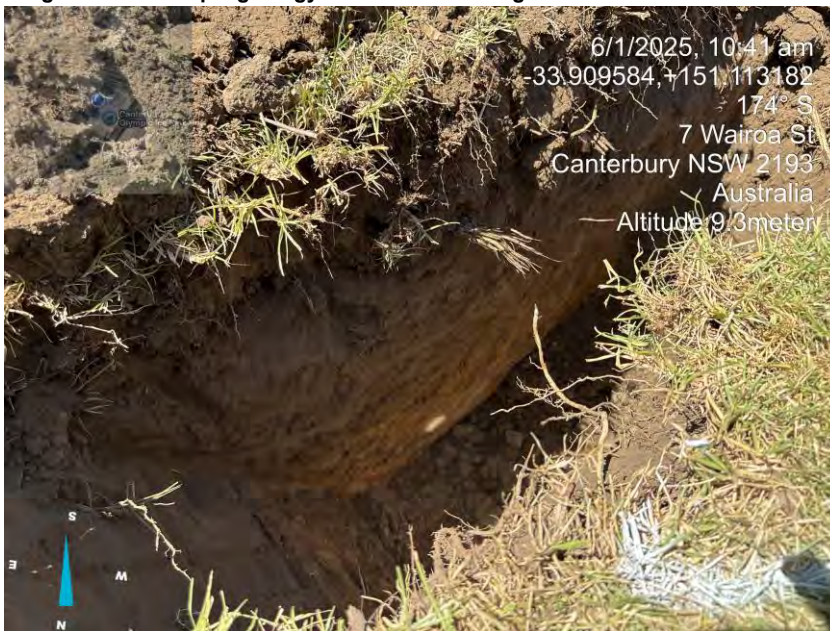
Image 7.1.2.1 Example geology encountered during works

Observations made of the soils encountered during intrusive investigation works on site, were recorded on relevant field logs. A copy of those logs is presented in **Appendix E**.

| Unit | Description | Depth (m bgl) |
|---|---|---|
| Natural | Clayey SAND, fine grained, subrounded, pale grey mottled pale orange | 1-1.3 |

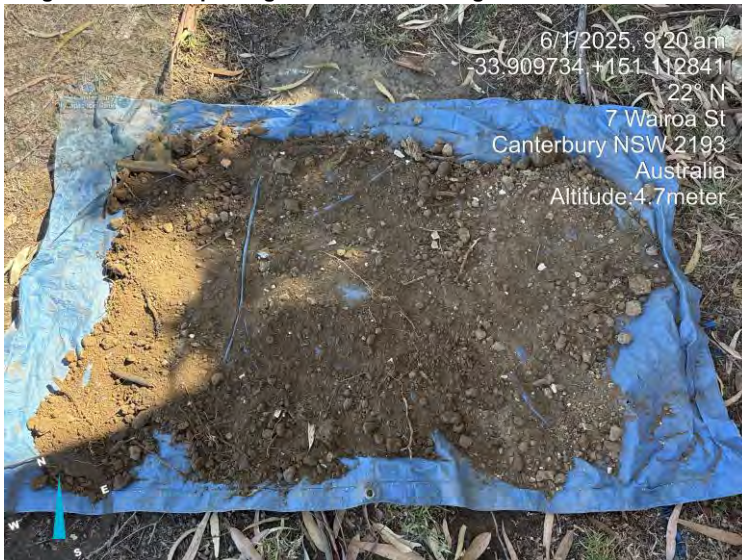
**Image 7.1.5.1 Example of gravimetric screening carried out**

Visual evidence of potential asbestos containing materials (ACM) was not observed in the samples collected.
