# Supplementary Contamination Assessment and Remedial Action Plan

Canterbury Olympic Ice Rink  
Portion of 17A Phillips Avenue, Canterbury, NSW 2193

18587-ER-4-1

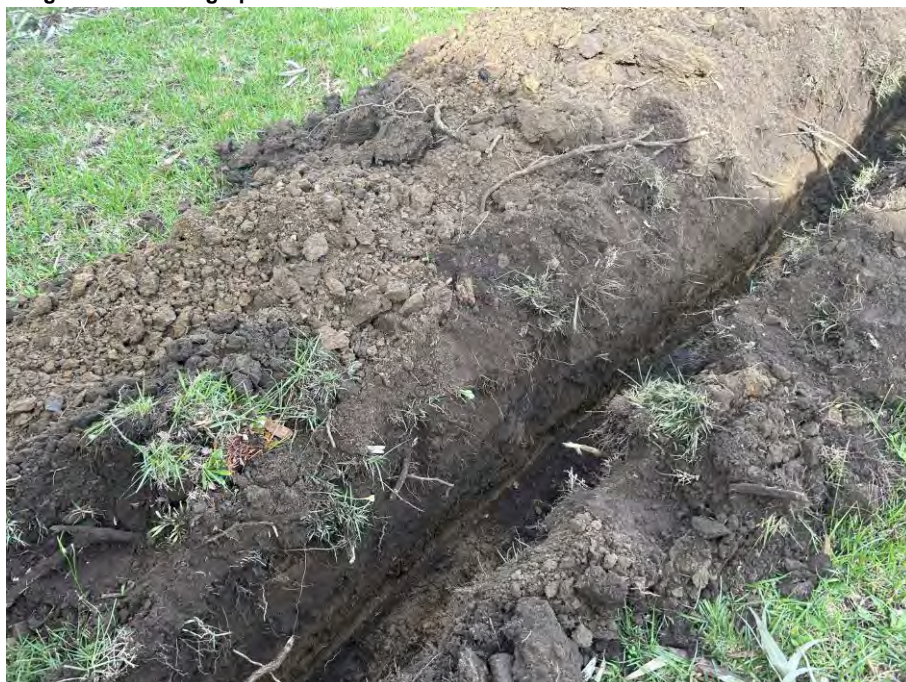
Image 9.1.2.1 Photograph of fill soils from TP12.

Unit	Description	Depth (m bgs)
Fill	Silty SAND, fine to medium, dark brown, with clay, trace gravel of glass, metal and plastic, with trace rootlets, dry.	0.4-0.6
Natural	Silty CLAY, low to medium plasticity, pale brown with slight orange mottling, dry.	0.6-0.9

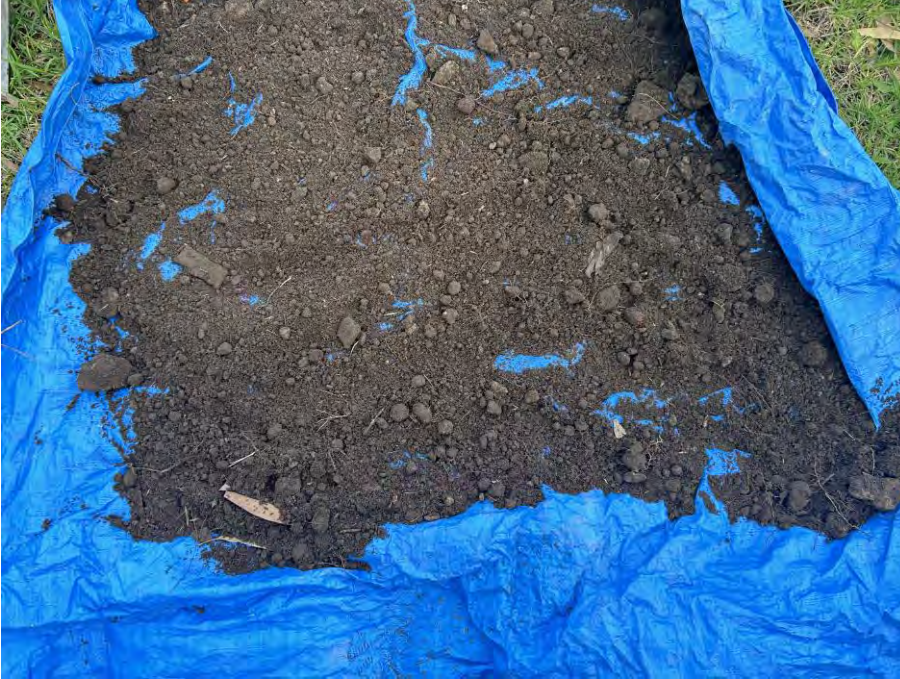
**Image 9.1.4.1 Photograph of gravimetric assessment undertaken at TP12.**

The 10L bulk soil samples were weighed and the weights recorded (to inform assessment of site specific soil densities). The samples were then screened by spreading the material on contrasting plastic. Potential asbestos containing materials (ACM) that would not pass through a 7mm x 7mm sieve that were found during screening, were weighed. The material weights were recorded on the relevant sampling point log, and the potential ACM placed in separate zip lock bags.

Visual evidence of potential asbestos containing materials (ACM) was not observed in the samples collected.

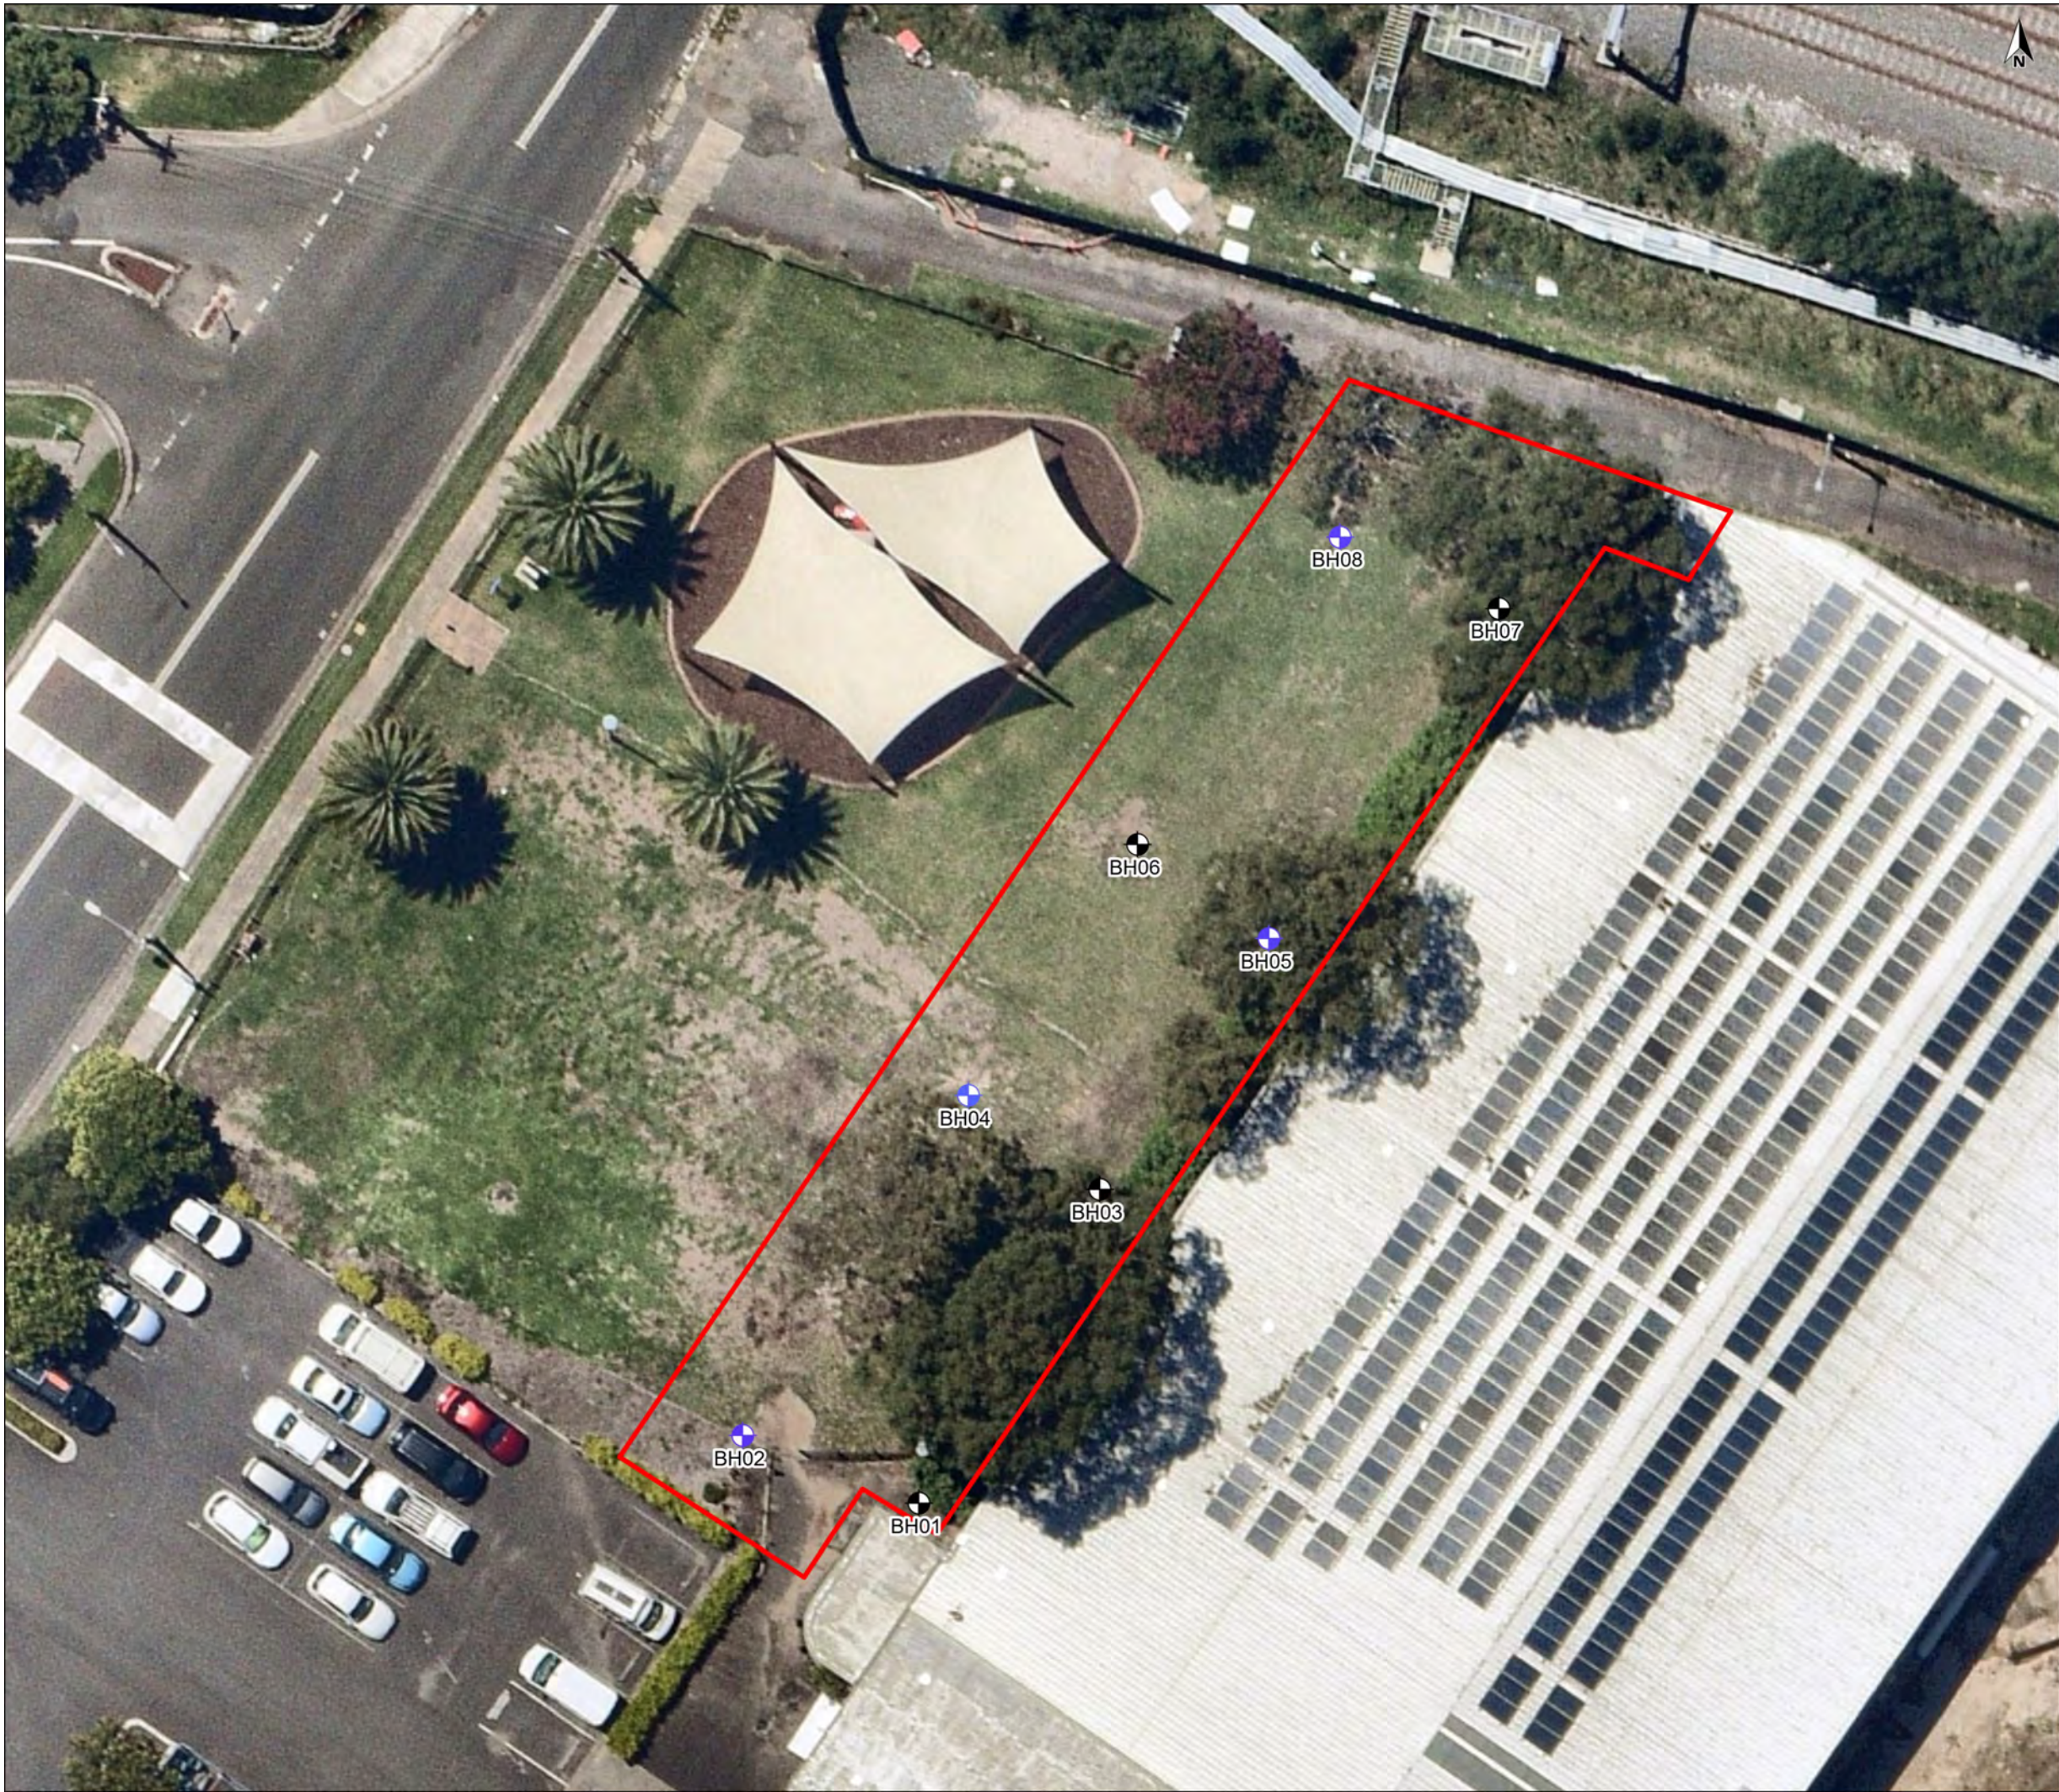
Title: Site Layout Plan		
Client: The Ice Skating Club of NSW Cooperative Limited		Size: A3
Project: Canterbury Olympic Ice Rink	Drawn: DH	Figure No.: 2
Date: 07-01-2025	Checked: SW	
Proj No: 18587	Scale: 1:400	Version: ER-4-1

- Legend**
- Site Boundary
  - Approximate Acid Sulfate and Waste Classification
  - Bore Locations
  - Approximate Waste Classification Bore Locations

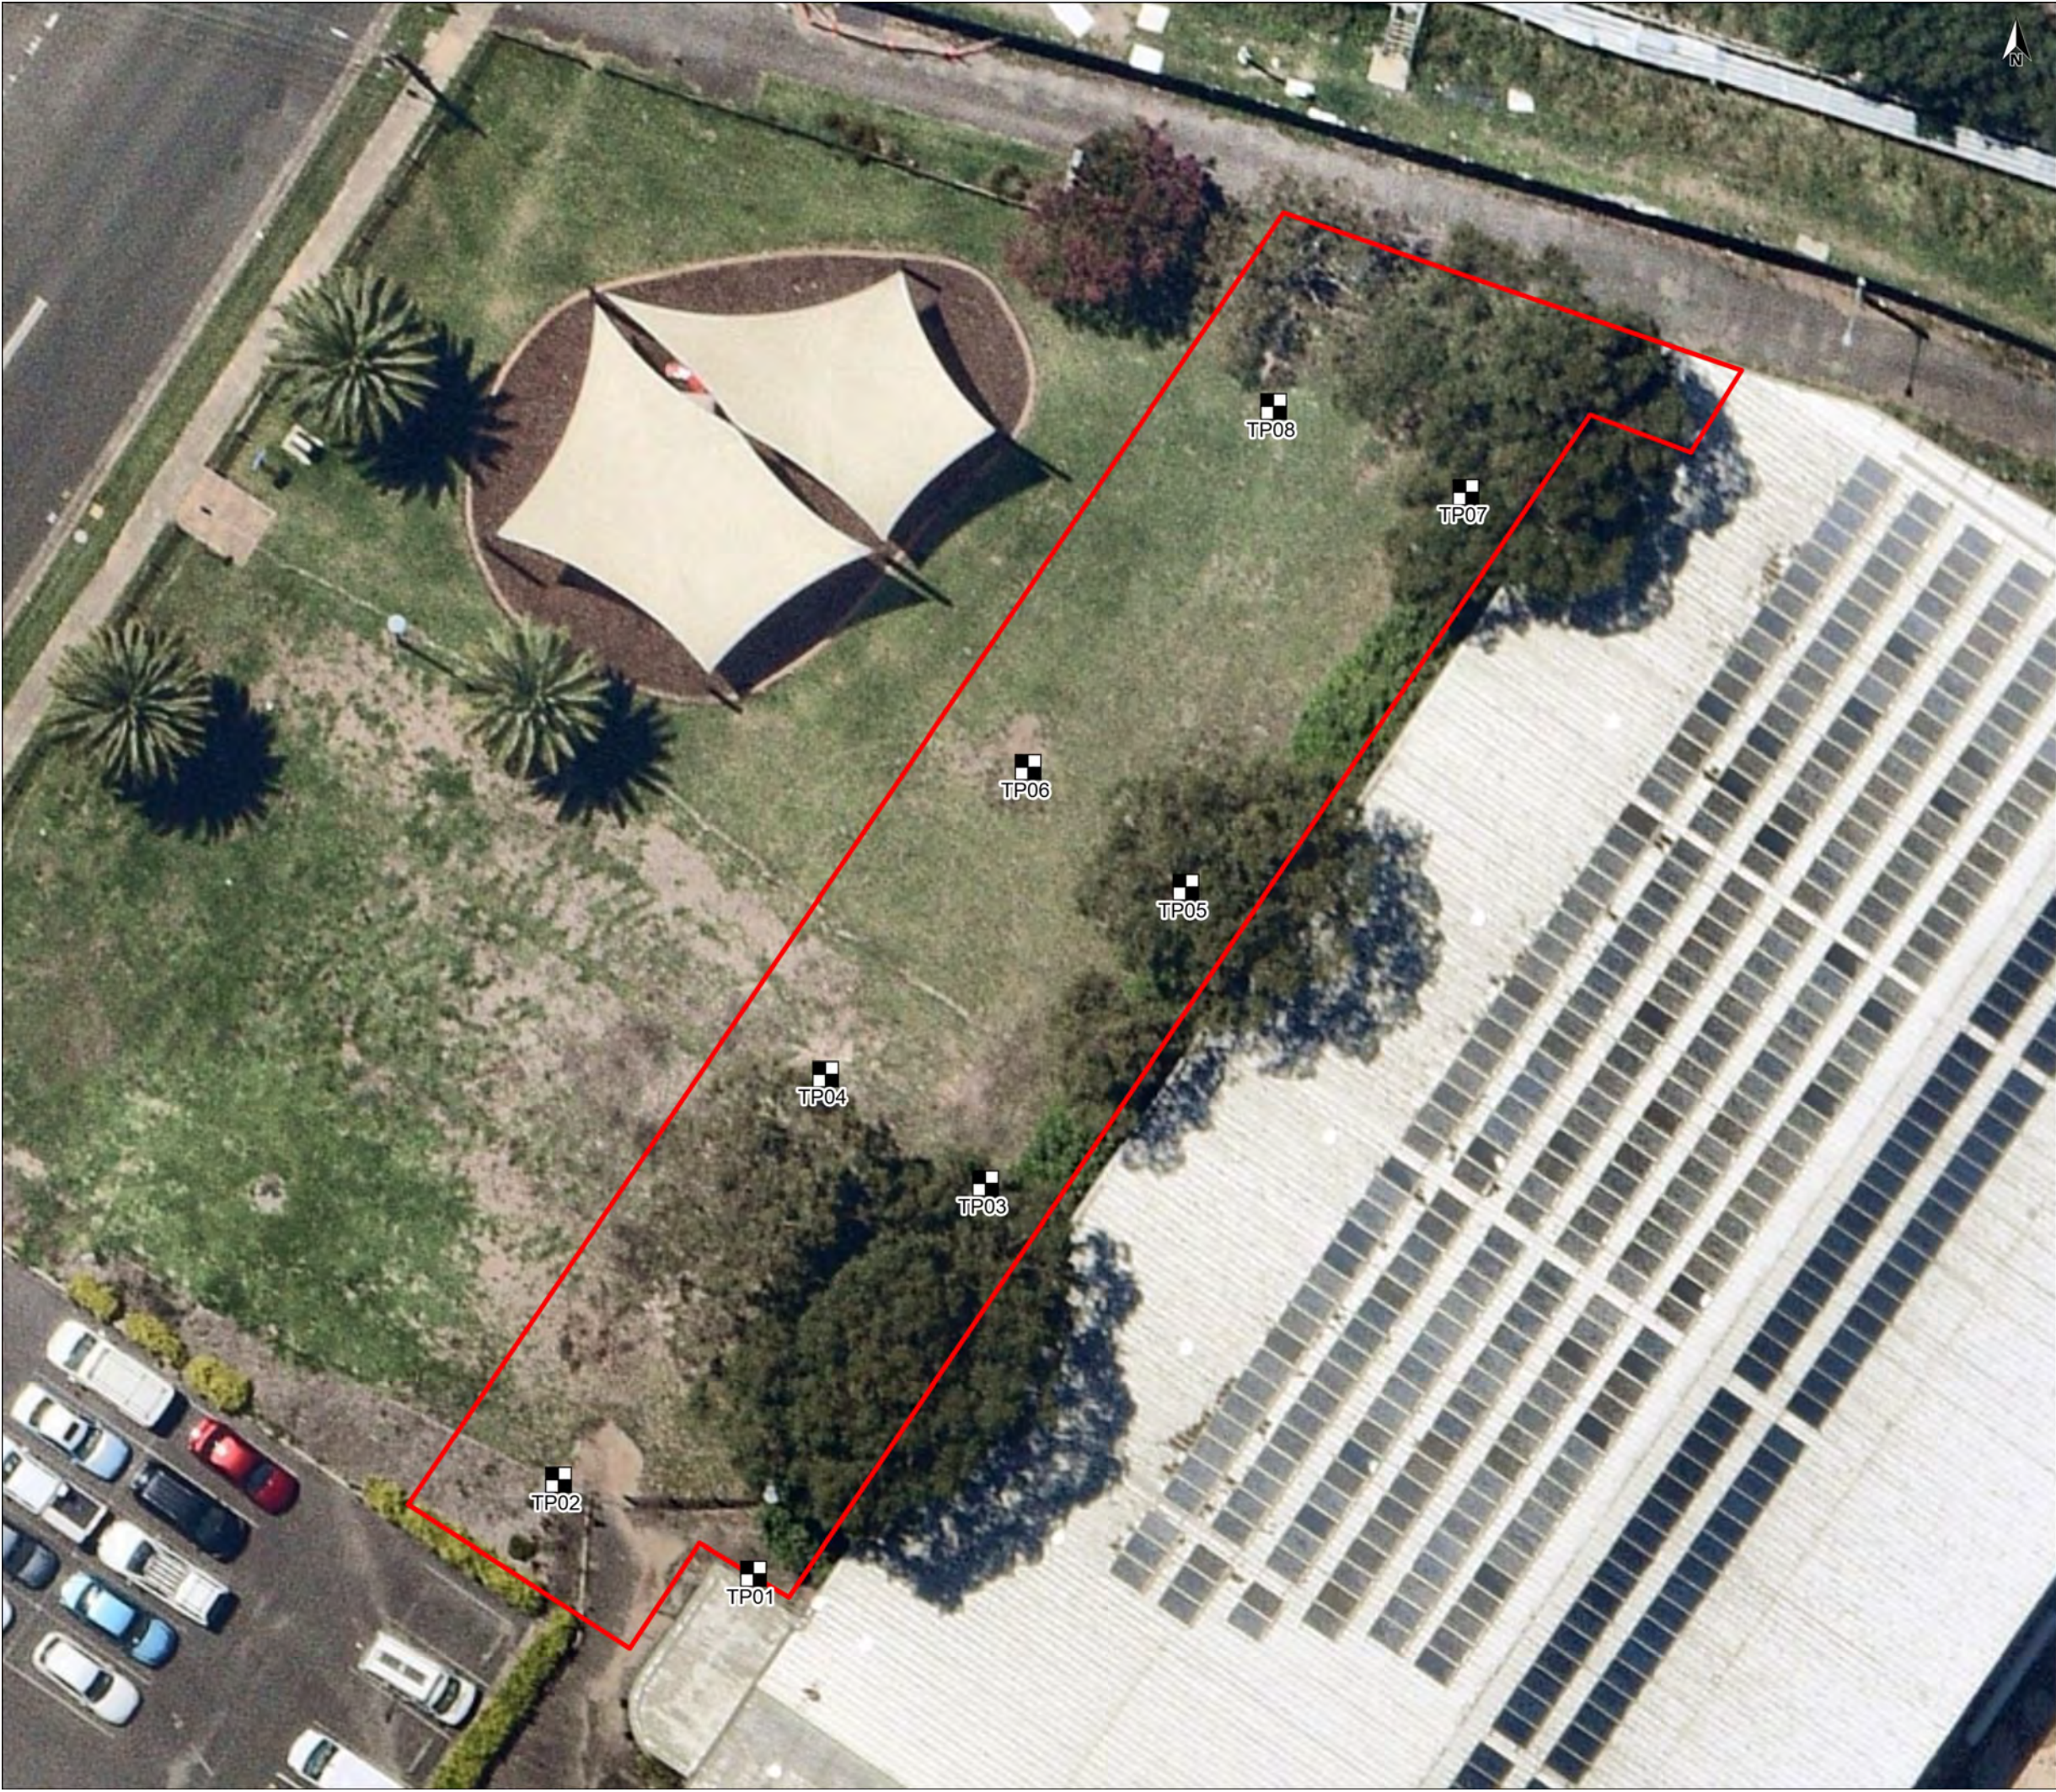
- DSI Test Pit Locations
- Site Boundary

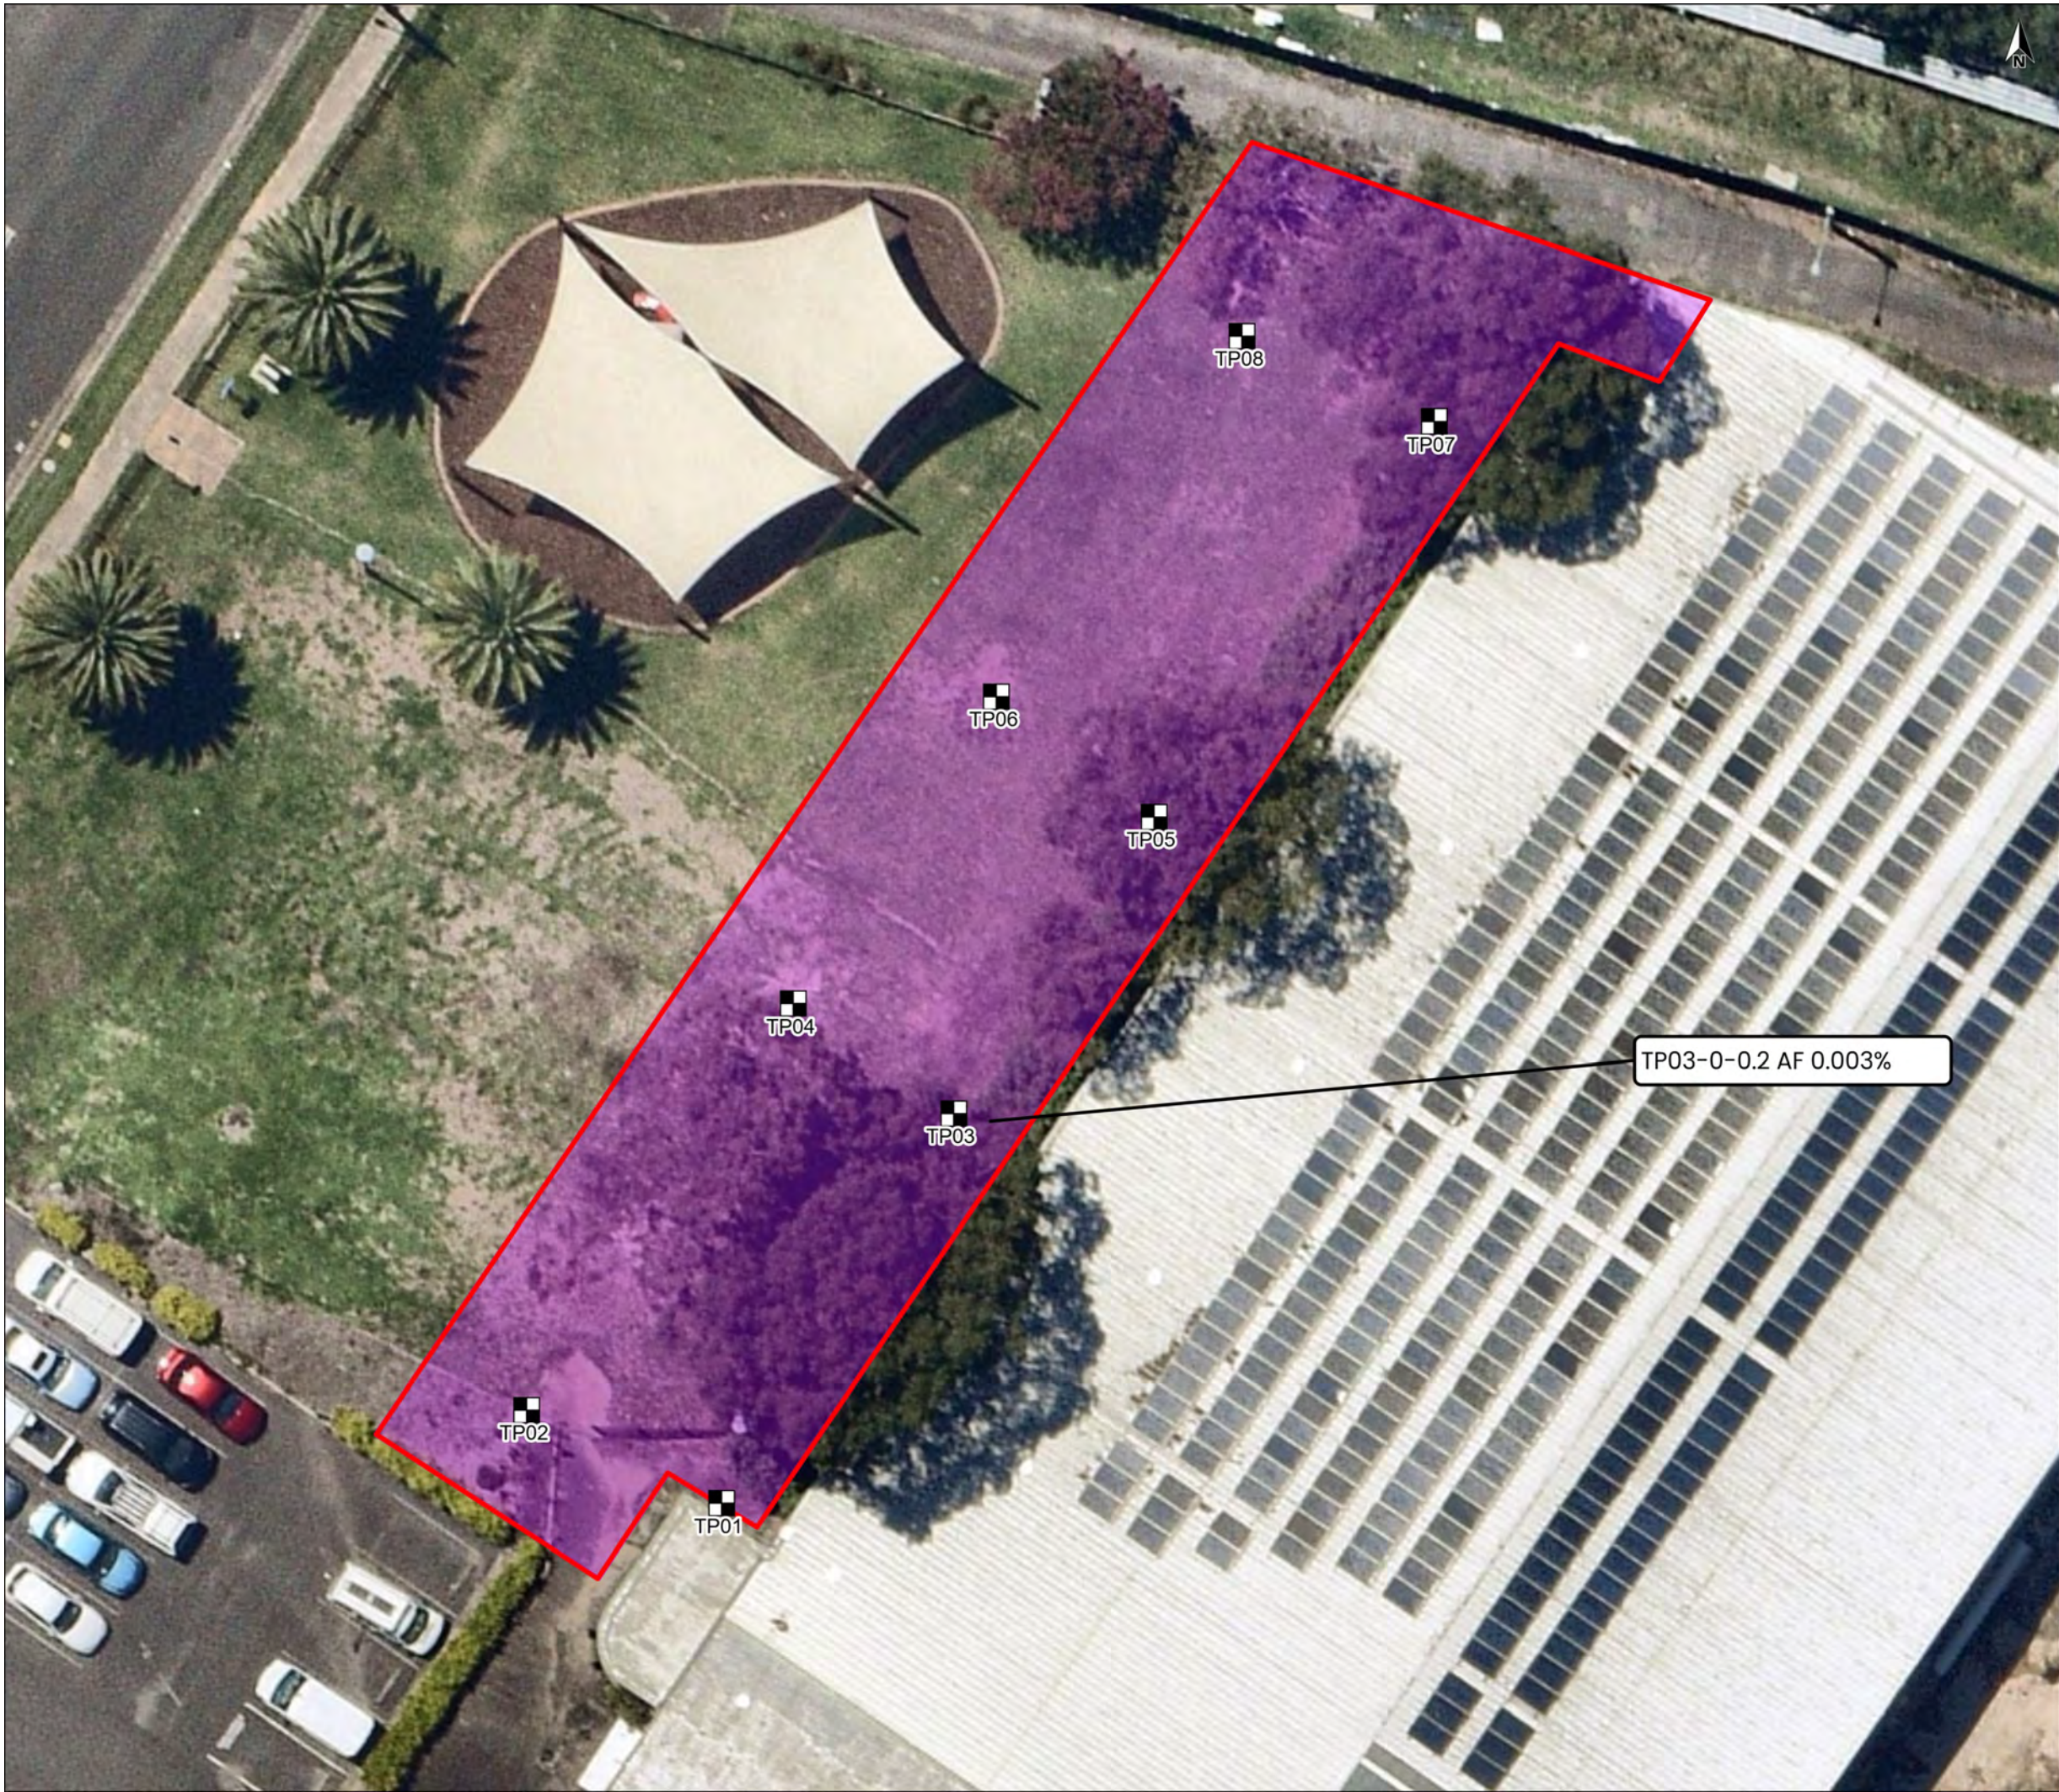
Title: Exceedances - Soils		
Client: The Ice Skating Club of NSW Cooperative Limited		Size: A3
Project: Canterbury Olympic Ice Rink	Drawn: DH	Figure No.: 5
Date: 08-01-2025	Checked: SW	
Proj No: 18587	Scale: 1:250	Version: ER-4-1

- DSI Test Pit Locations
- Site Boundary
- AEC01 - Site Footprint

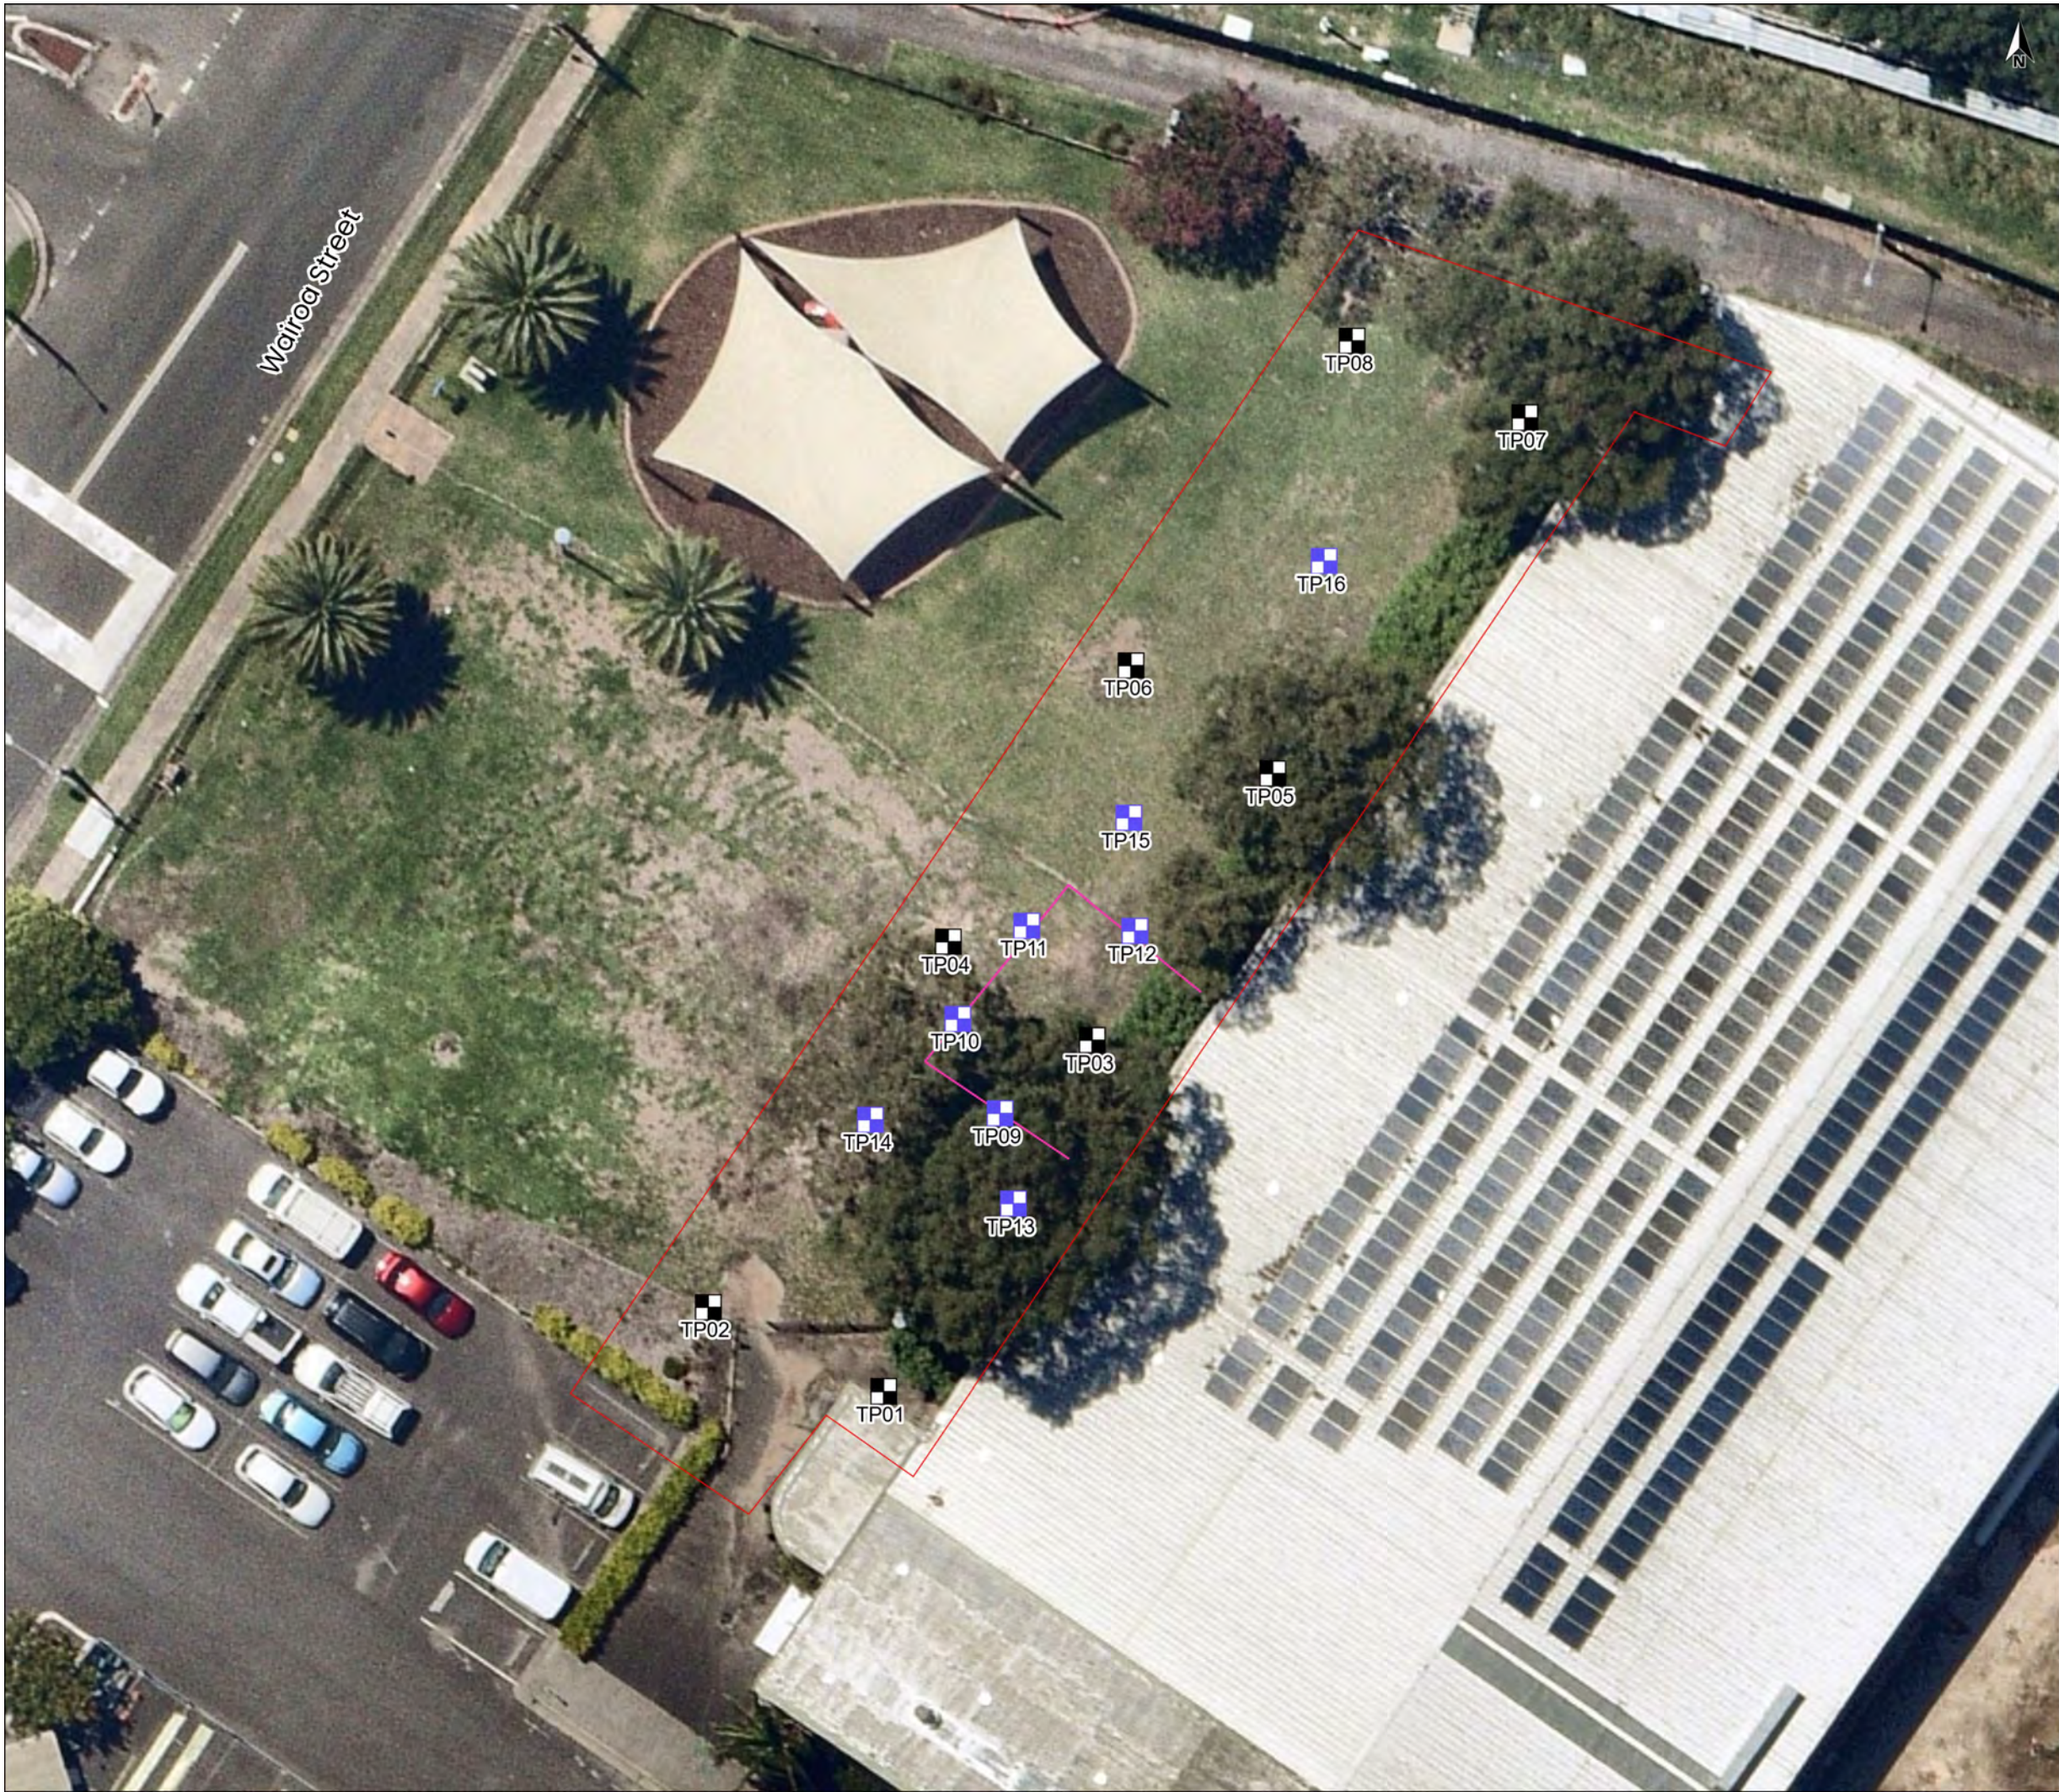
- Legend**
- Approximate location of site boundary
  - Approximate Test Pit Locations
  - Approximate Strip Trench
  - Alliance (2025a) Sampling Point Locations

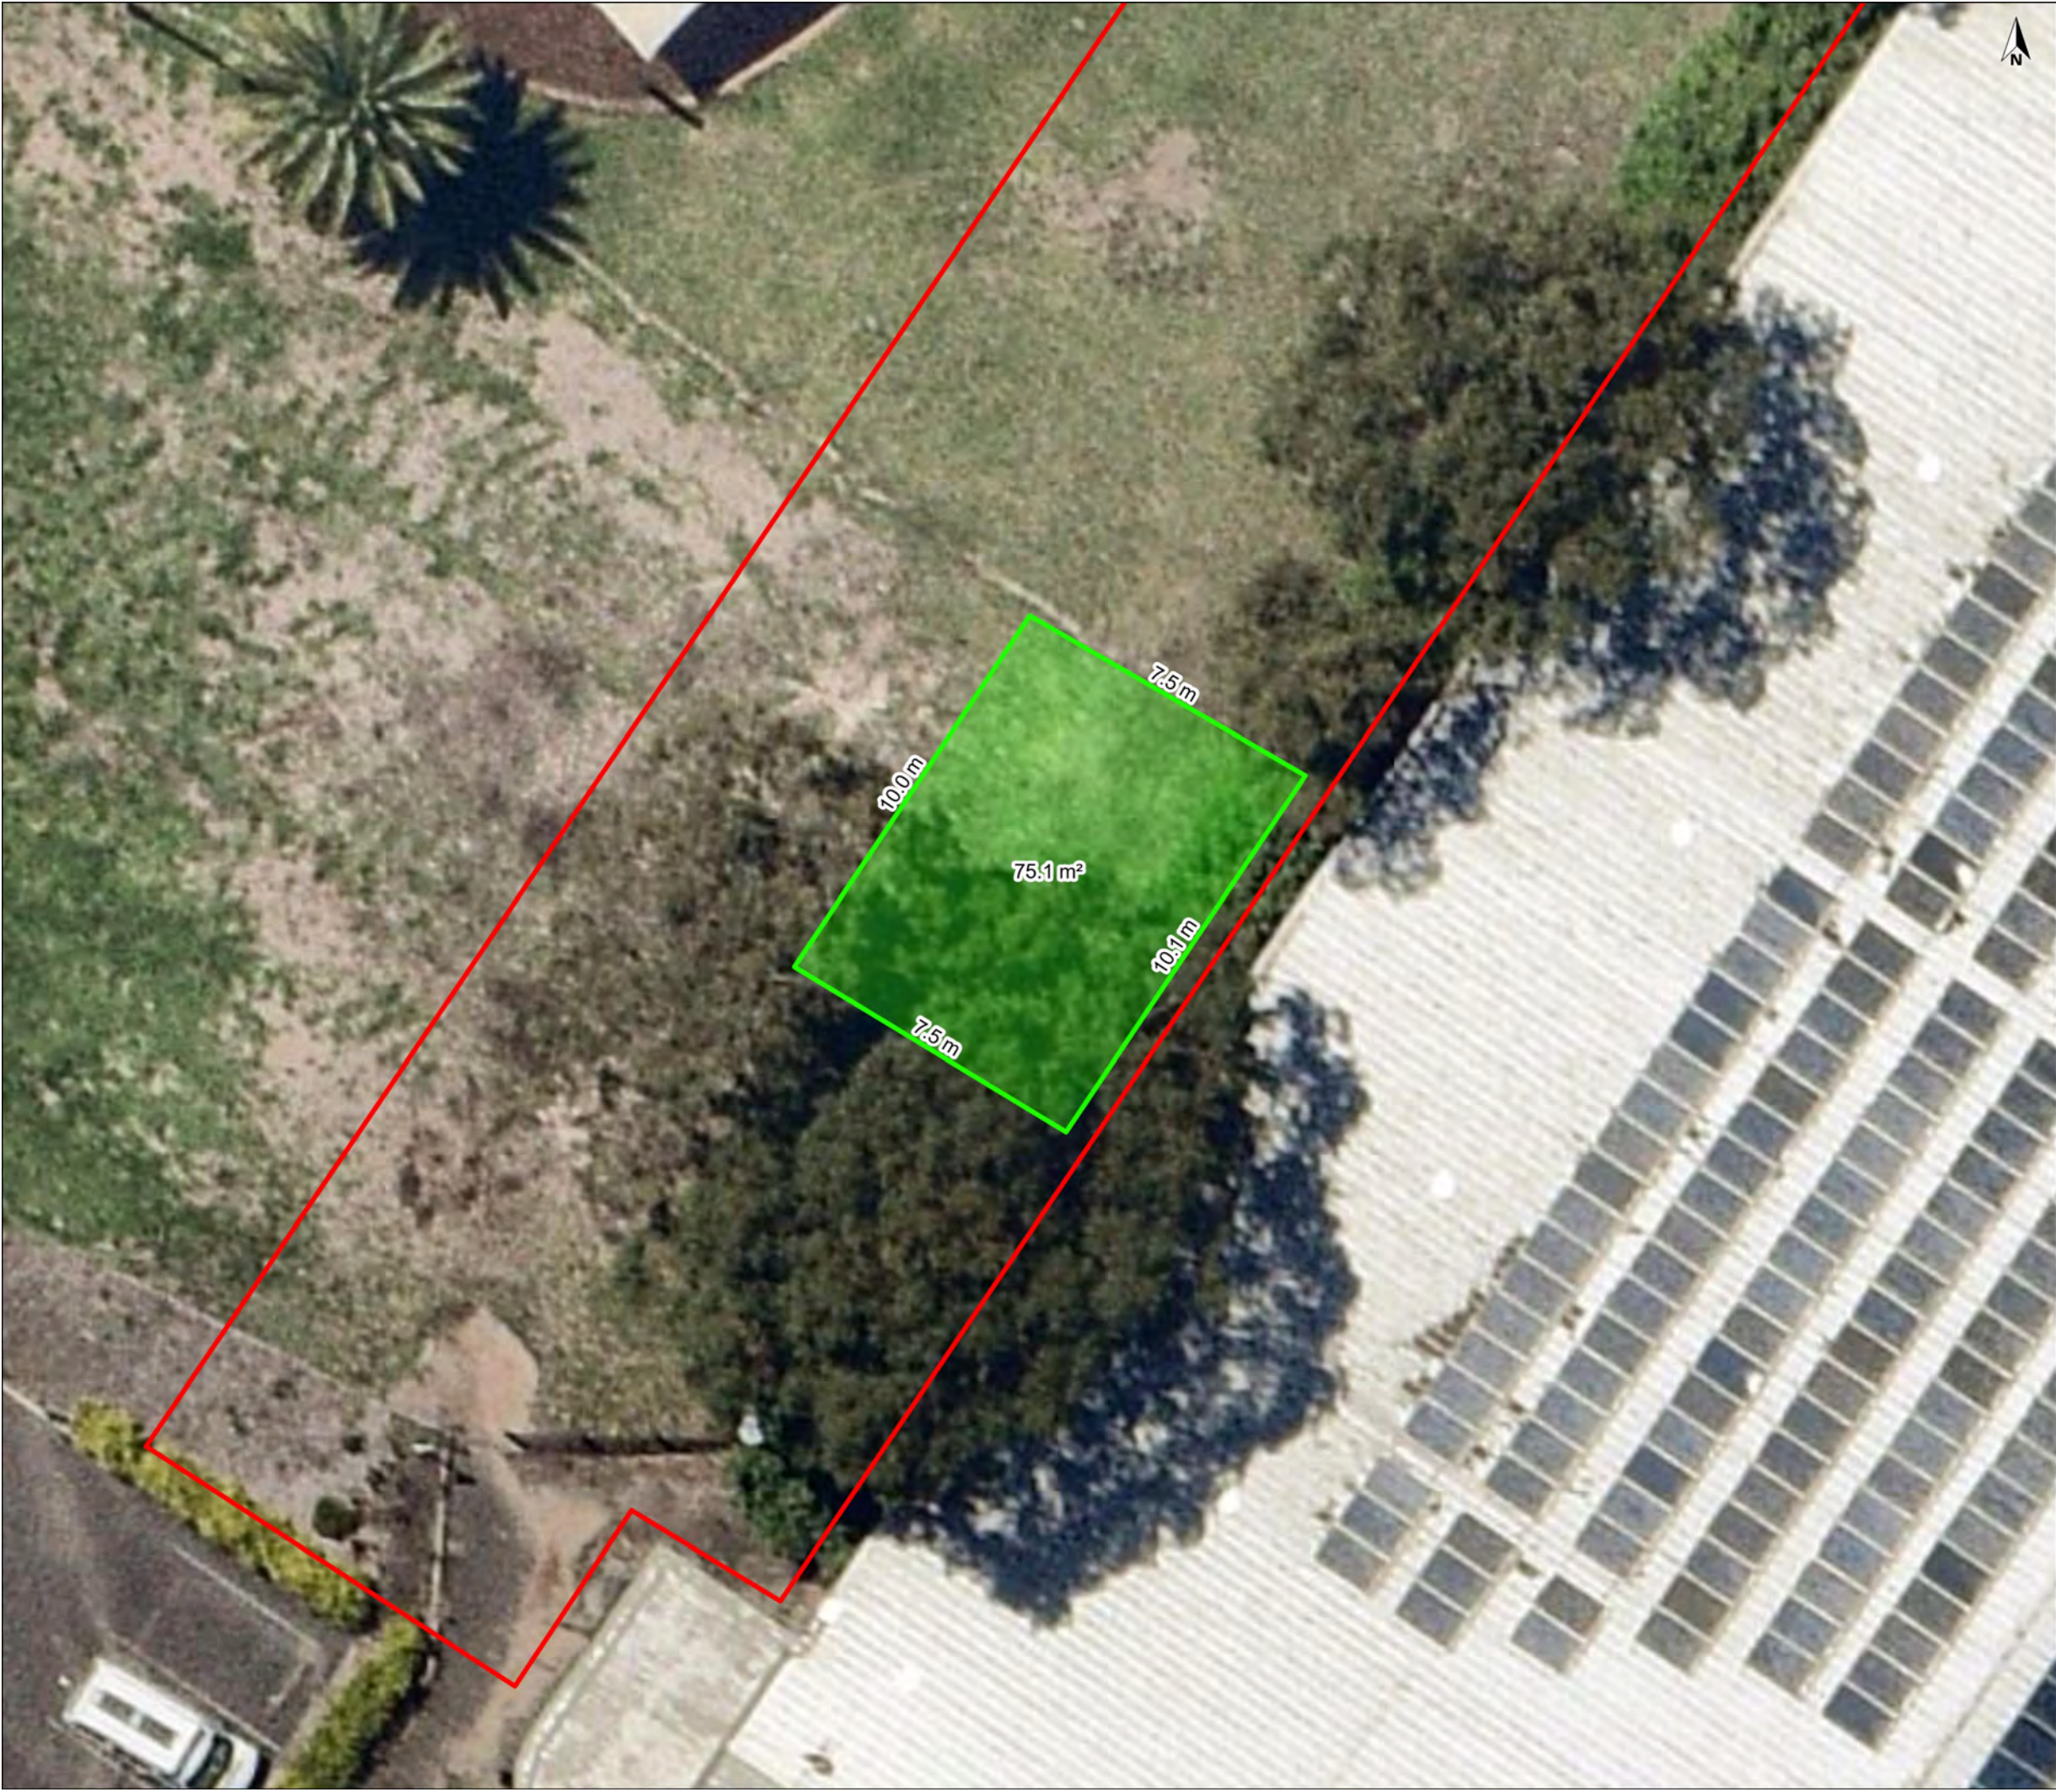
- Legend**
- AEC01a - Approximate area of asbestos fines impacted soils
  - Site Boundary
