# Arboricultural Impact Assessment

171 Weston Street, 2, 4 & 6 Hinemoa St, Panania

Proposed Residential Development

Prepared for Homes NSW

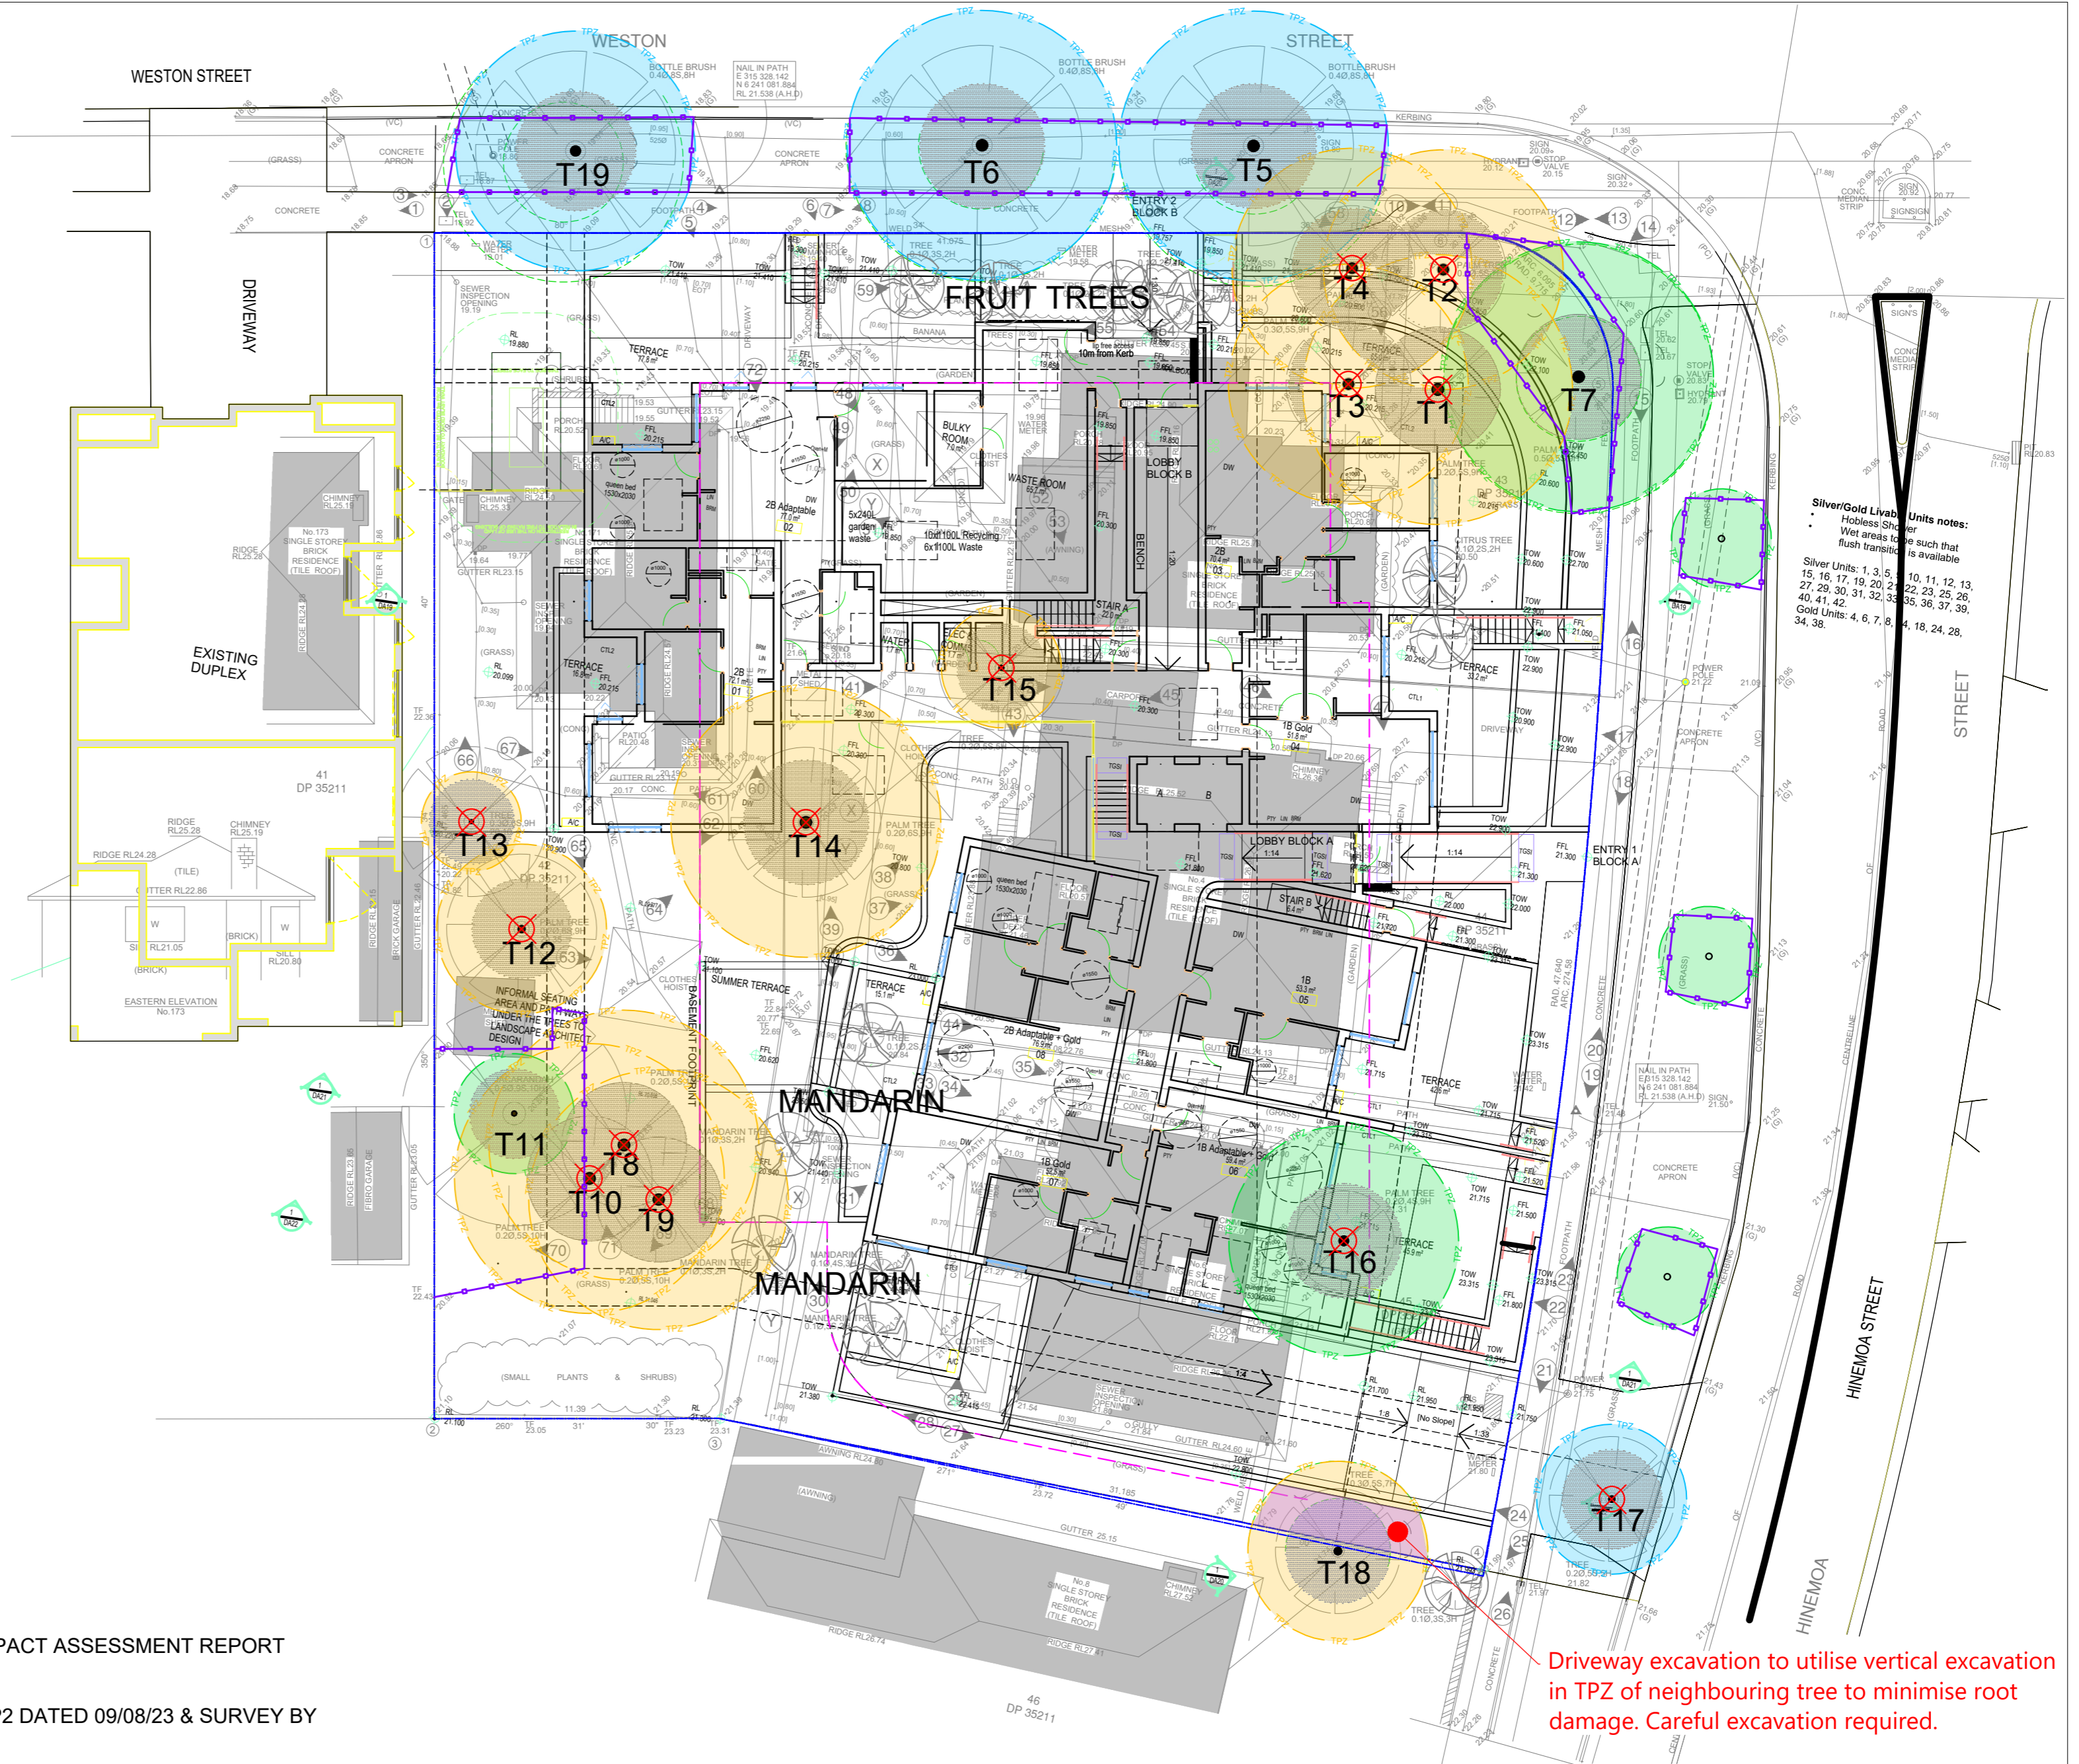
DRAWING: TREE PROTECTION PLAN			
SCALE: 1:200 @ A2	ISSUE: DA	SHEET: T - 01 of 2	
DRAWN: HM	CHECKED: JB	DATE: 05-08-24	REVISION: B

MUST BE READ IN CONJUNCTION WITH ARBORICULTURAL IMPACT ASSESSMENT REPORT

BASED ON GROUND FLOOR PLAN BY MORSON GROUP REV. P2 DATED 09/08/23 & SURVEY BY NORTON SURVEY PARTNERS DATED 23/08/2021

- Install tree protection fencing (1.8m high temporary site fencing with concrete feet, or equivalent, not star pickets) around the TPZ areas as shown on the **Tree Protection Plan**, prior to demolition commencing, to exclude demolition and construction access from tree protection areas. Maintain the fencing in situ throughout all works.

- Install trunk protection to any trees which can't be fenced due to site constraints, or where works access to TPZ areas is likely to occur, and as shown on the **Tree Protection Plan**. Trunk protection should be in the form of jute, thick hessian or other soft/shock absorbing material wrapped loosely around stems and main branches, with timber battens strapped around the stem at 100mm centres. No part of the timber battens should come into contact with tree parts (trunk, branches, roots, buttresses, bark).

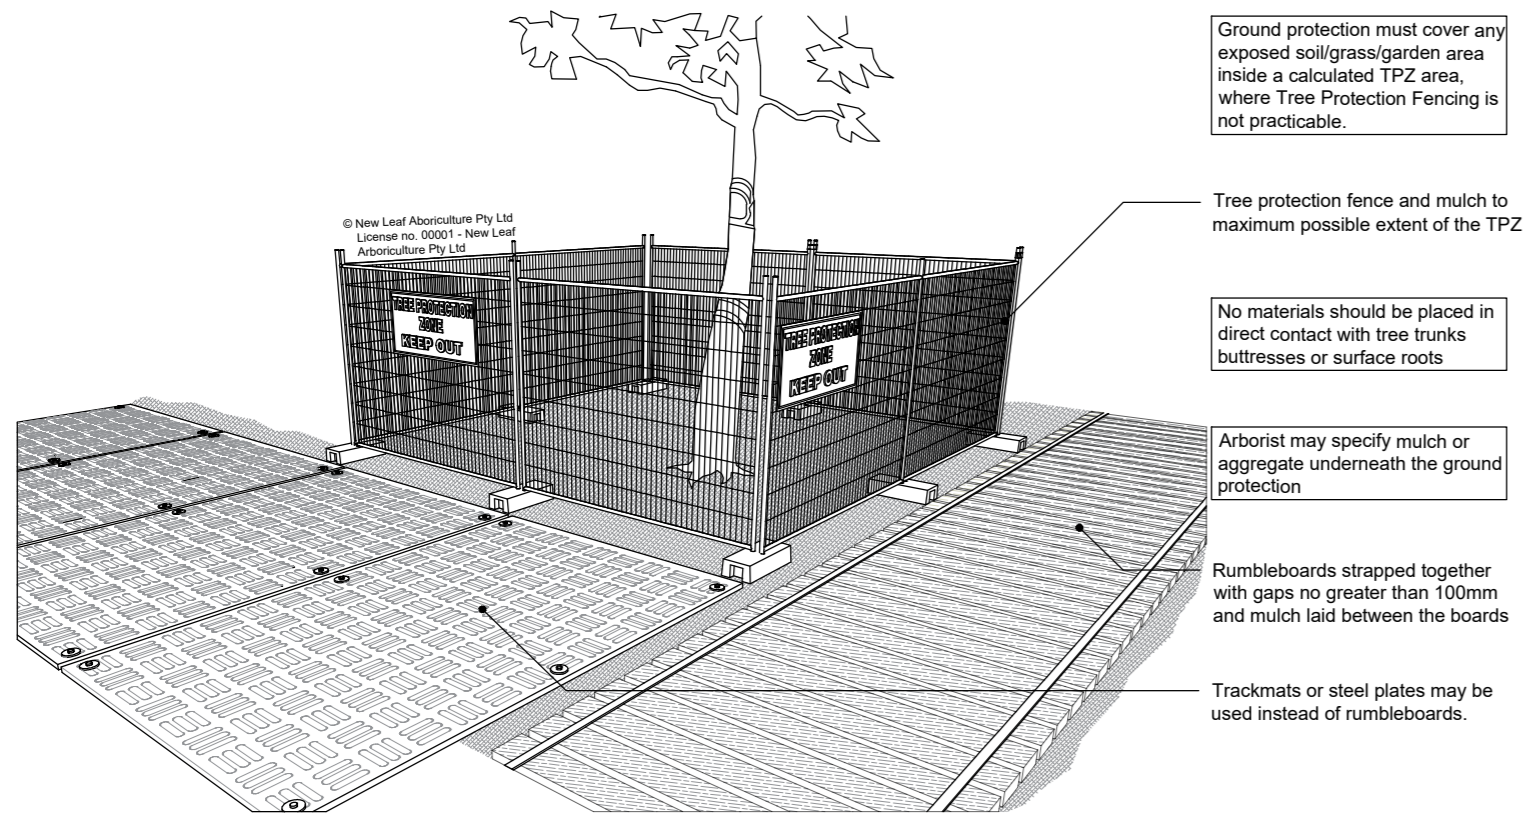
**GROUND PROTECTION DETAIL**

INDICATIVE ONLY - REFER TO ARBORICULTURAL REPORT AND/OR TREE PROTECTION PLAN FOR REQUIRED EXTENTS OF TREE PROTECTION AND TREE SENSITIVE WORK METHODS.

- Install ground protection (100mm depth of mulch overlaid with steel plates, rumbleboards, trackmats or similar to areas requiring ongoing or vehicular access, or materials or waste storage; otherwise, mulch overlaid with plyboard or similar to areas with pedestrian only access) to any area of TPZ which can't be surrounded by fencing and as shown on the **Tree Protection Plan**. Ground protection can be excluded where existing hard surfaces (concrete, paving etc) remain in place over the soil.
