IMPACT ASSESSMENT REPORT

HOMES NSW

171 Weston & 2 to 6 Hinemoa Streets, Panania, NSW (BGYAP)

Report No: 24/1466

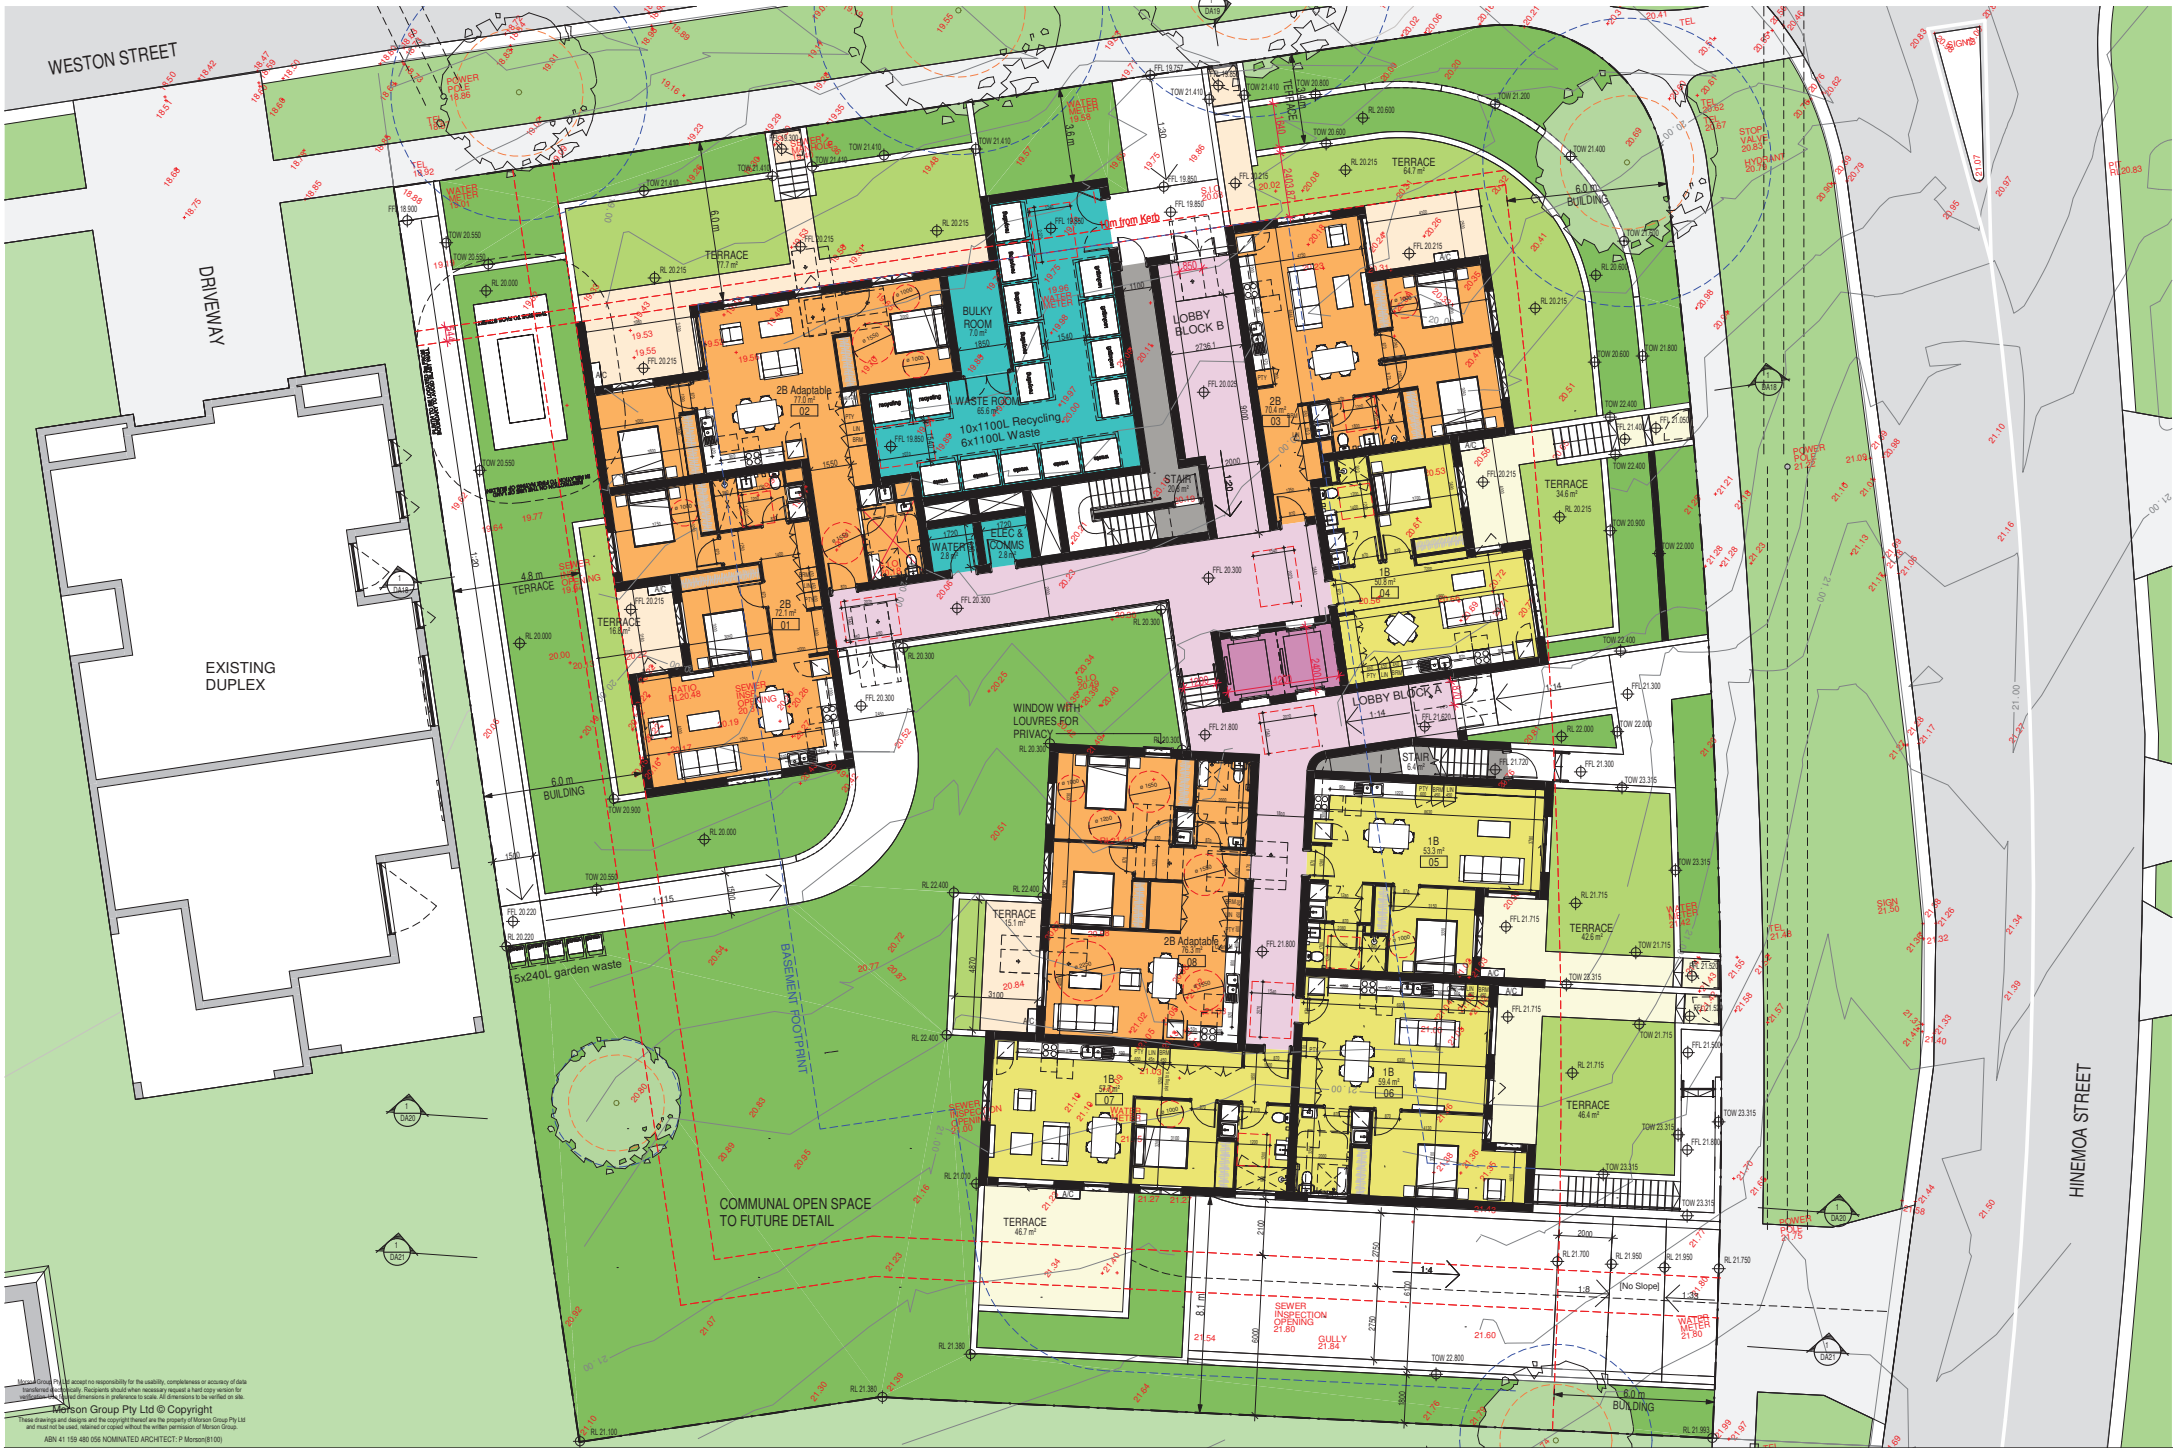
DRAWING No.
DA11
ISSUE No.
P6

SHEET
NAME: GROUND LEVEL
SCALE:
1:100

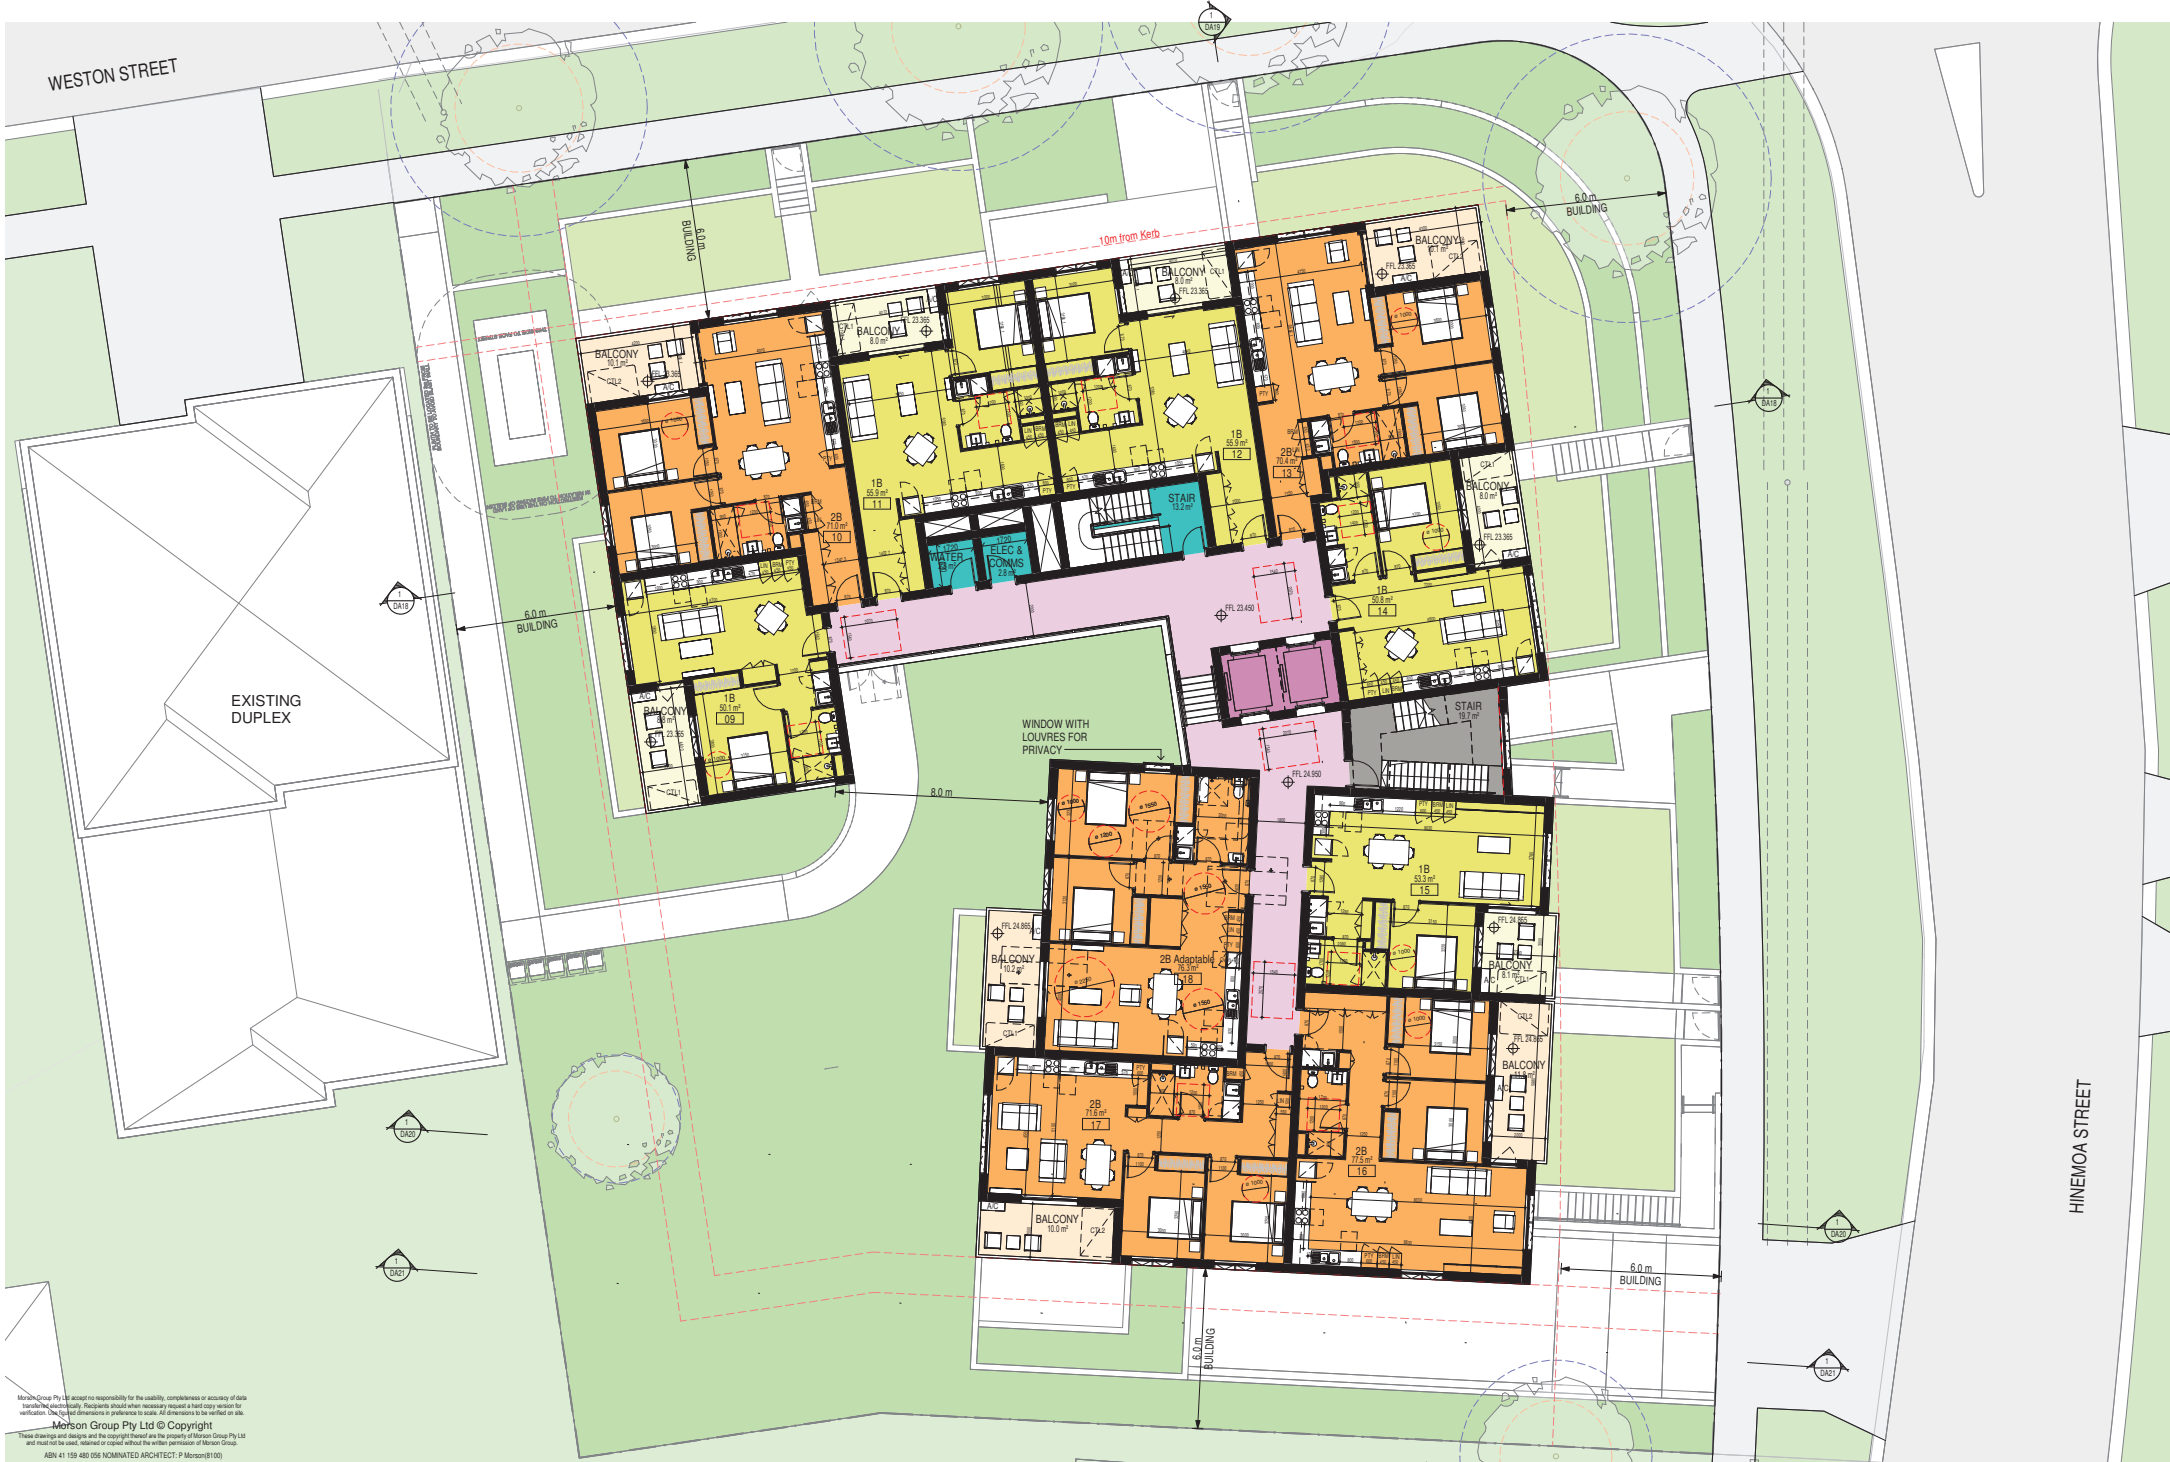
DRAWING No. DA12
ISSUE No. P5

SHEET
SIZE: A1
SHEET
NAME: LEVEL 1
SCALE:
1:100

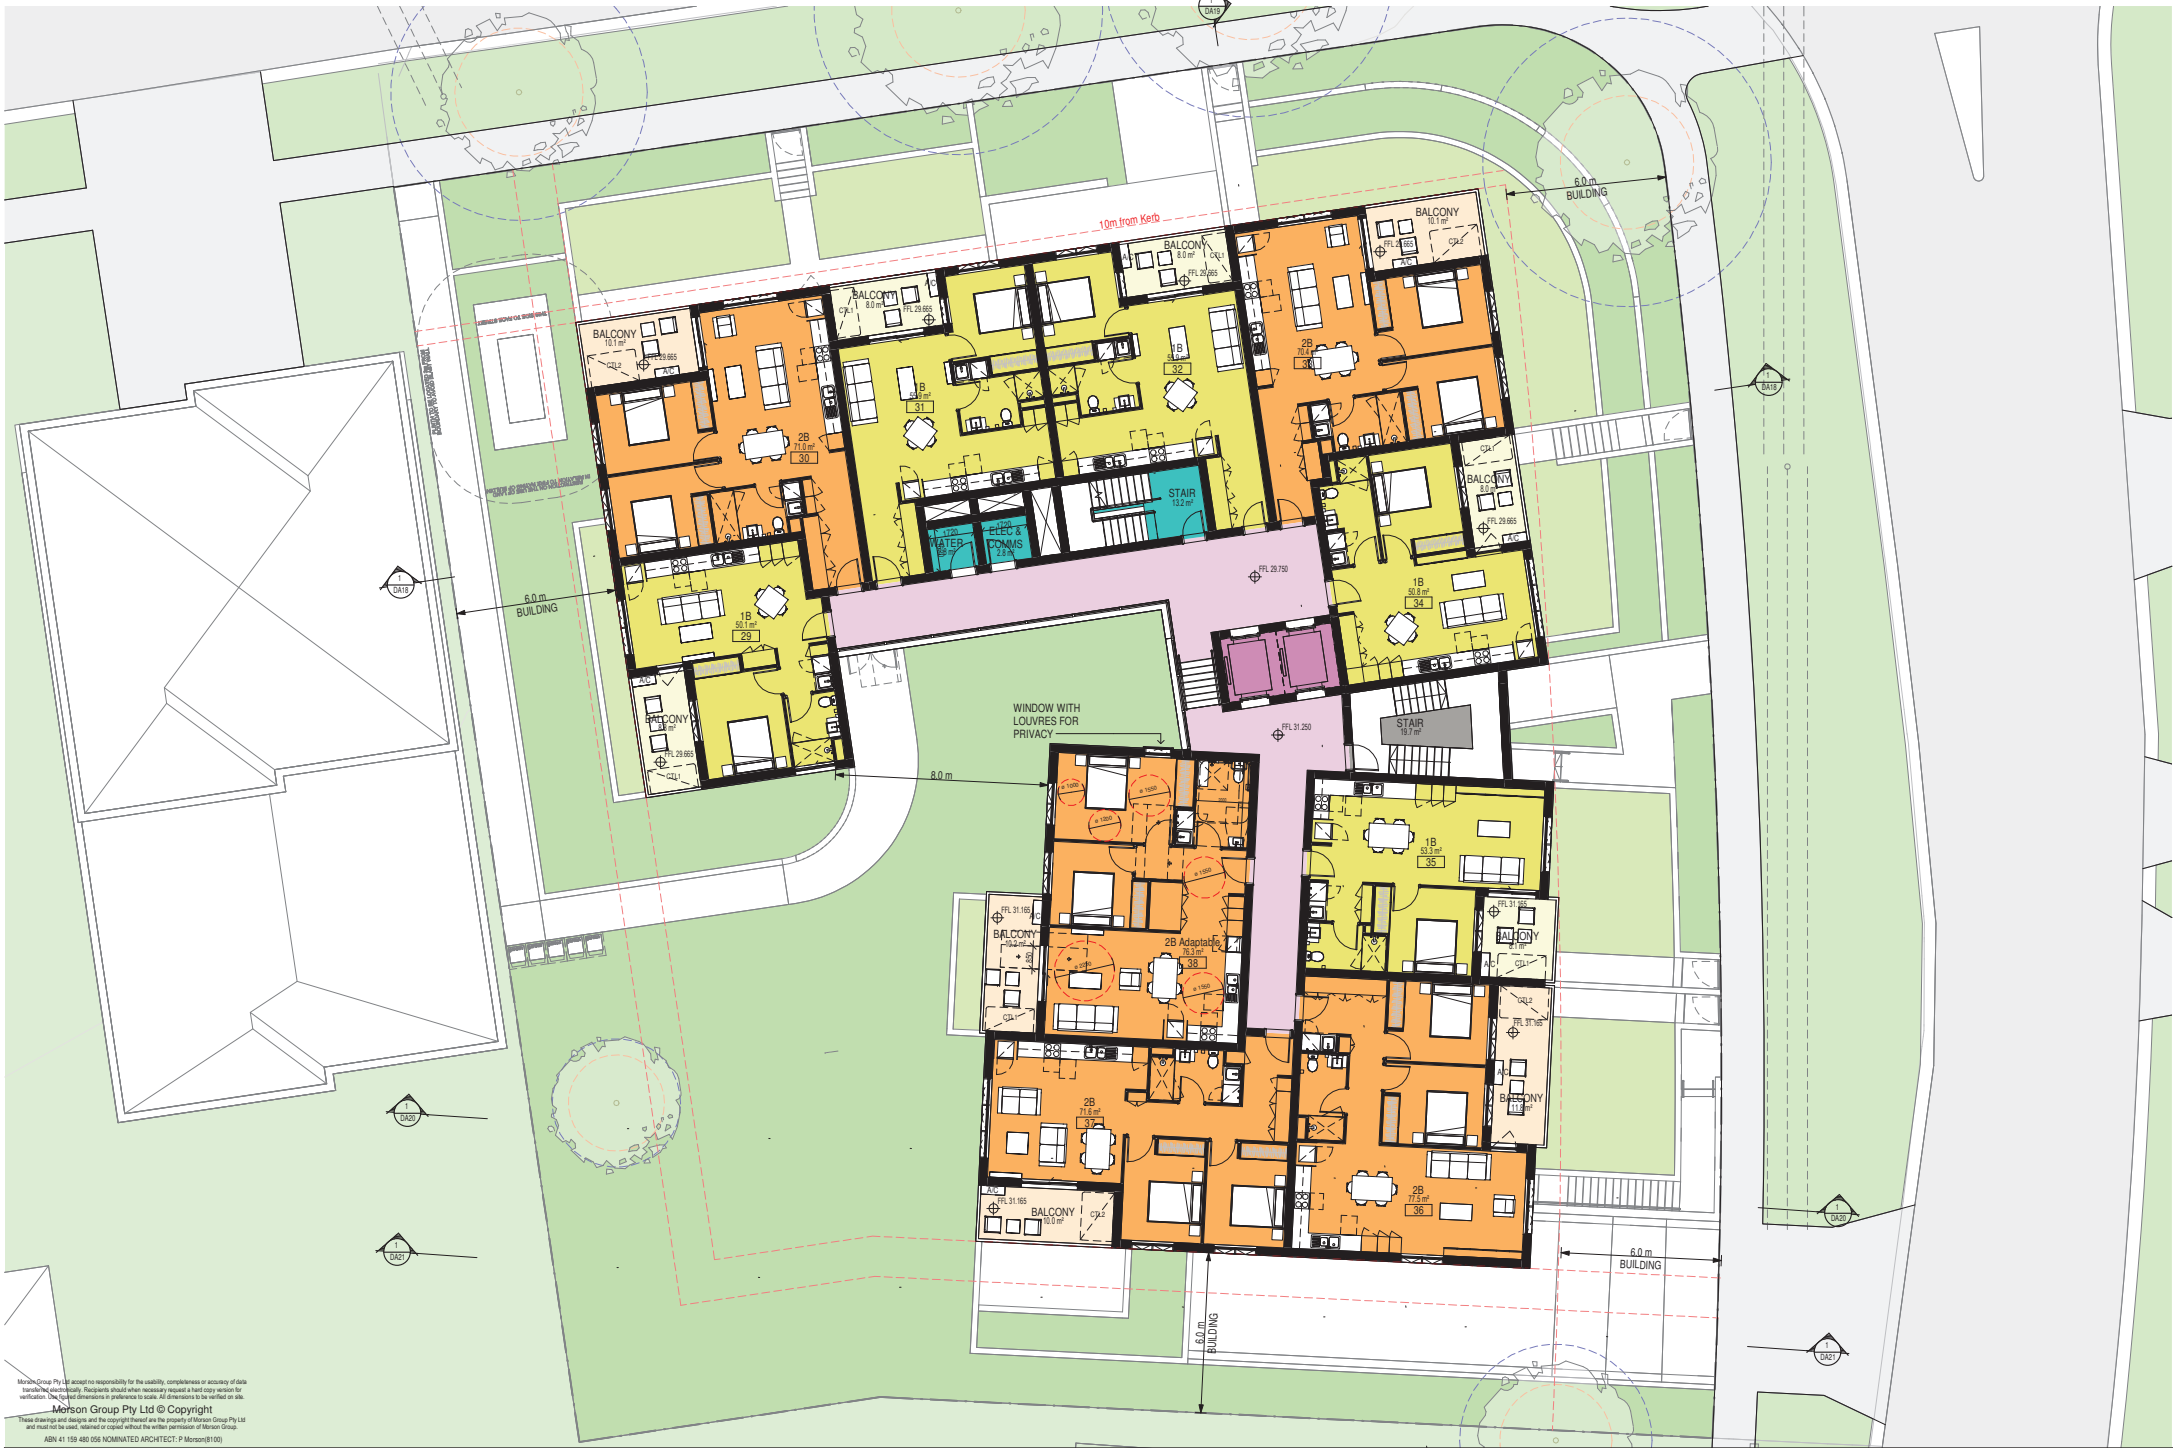
DRAWING No:
DA13
ISSUE No:
P5

SHEET
SIZE: A1
SHEET
NAME: **LEVEL 2 and 3**
SCALE:
1:100

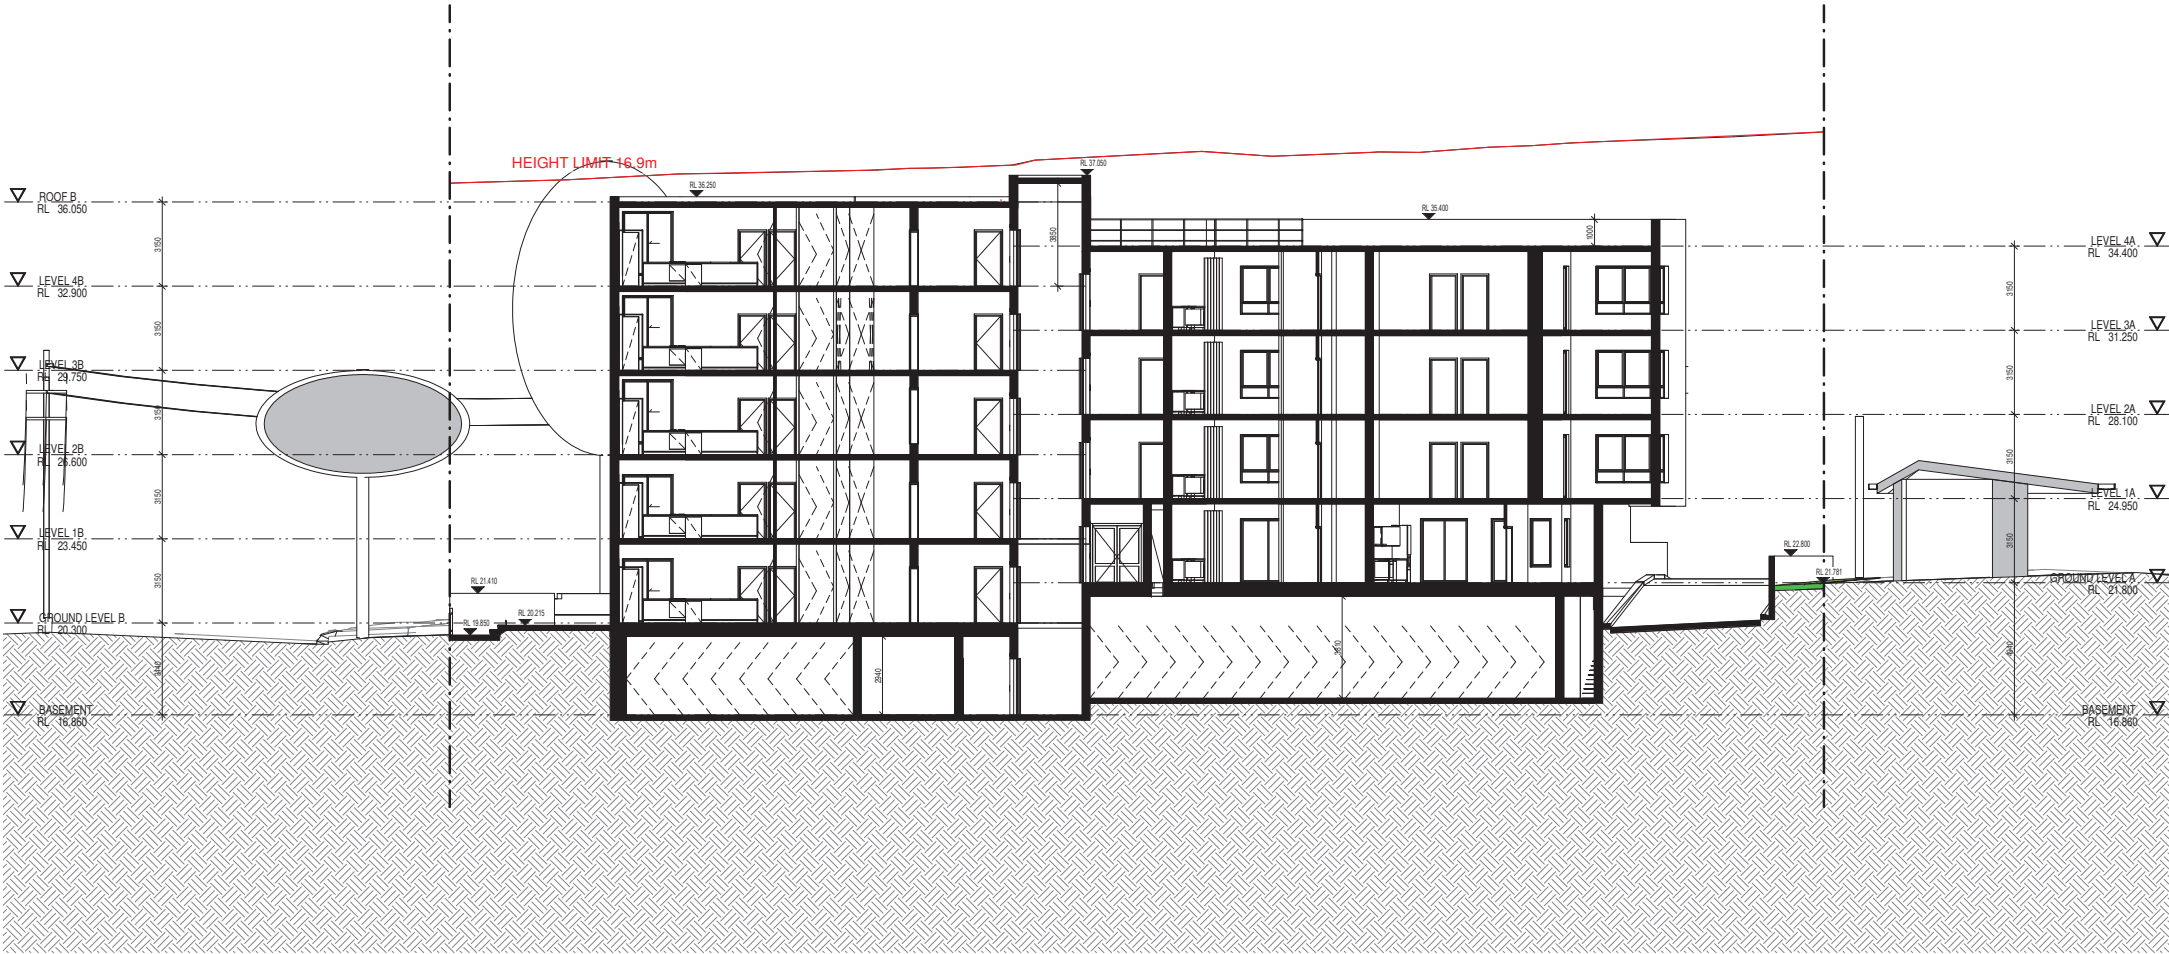
DRAWING No.
DA19
ISSUE No.
P4

SHEET
SIZE: A1
NAME: SECTION 2
SCALE:
1:100
