Our ref: 7406-1-R1  
30 November 2023

## **Eyre Kiosk Wastewater, Perisher NSW Geotechnical Assessment**

This report presents the results of a geotechnical assessment for the proposed Eyre Kiosk Wastewater at Perisher NSW (the Site). The assessment was commissioned on 26 October 2023 by Michael Fearnside of Vail Resorts.

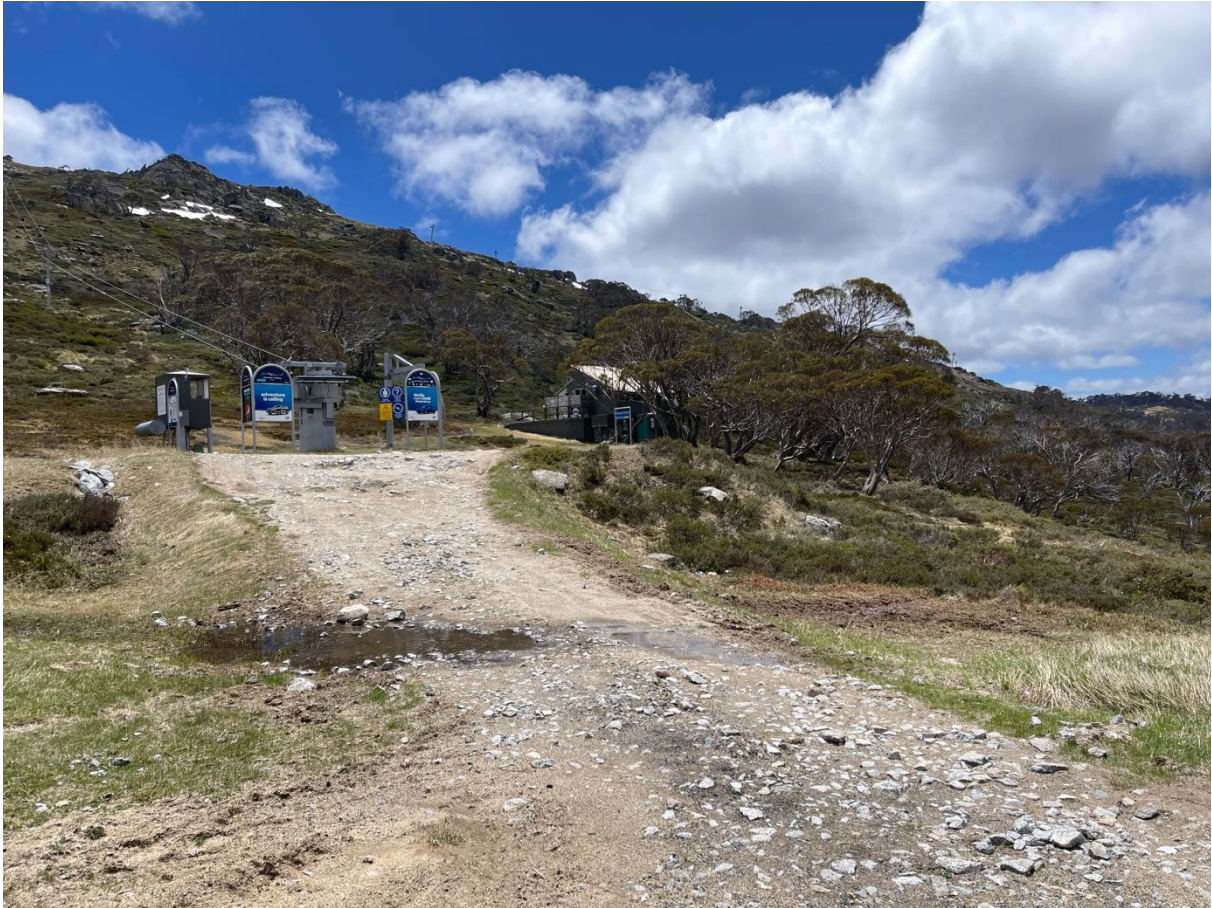
**Photo 1**

General view of Eyre Kiosk showing approach track from Kosciuszko Road. Services to be piped from Kiosk to septic tank on road shoulder (see Photo 2).

Localise seepage was observed to the west of the Kiosk (Photo 4), and local ponded surface was observed in a shallow depression in the northern road shoulder (Photo 1, 2).

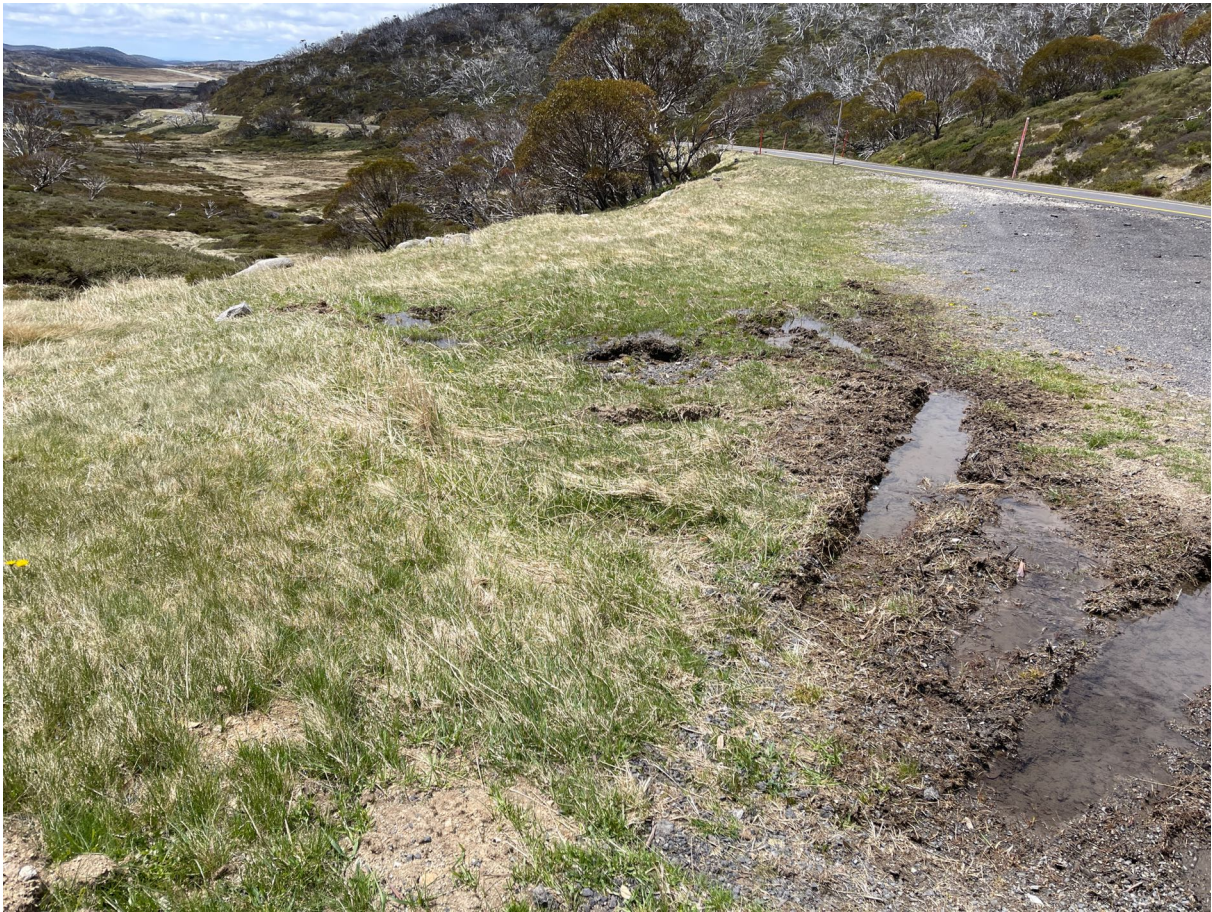
**Photo 2**

View of road shoulder where 3m deep septic tank proposed. Note ponded water in local depression. Road shoulder likely has been filled during construction of Kosciuszko Road.

The septic tank excavation at 3m depth is likely to encounter natural soils or extremely weathered or better granite. Where the foundation material comprises stiff or better natural clays or medium dense or better natural sands or extremely weathered or better bedrock, an allowable bearing pressure of 150kPa should be available.

Shallow excavations (not more than about 1m depth) could be dug with vertical sides. Deeper excavations (e.g., for the septic tank) should be excavated with a temporary batter slope no steeper than 1H:1V, or with 1m wide stepped benching at overall 1H:1V. If extremely weathered or better granite is encountered, this could be cut vertical. Inspection of the cut by a geotechnical engineer is recommended before allowing personnel to enter the excavation to construct the septic tank.

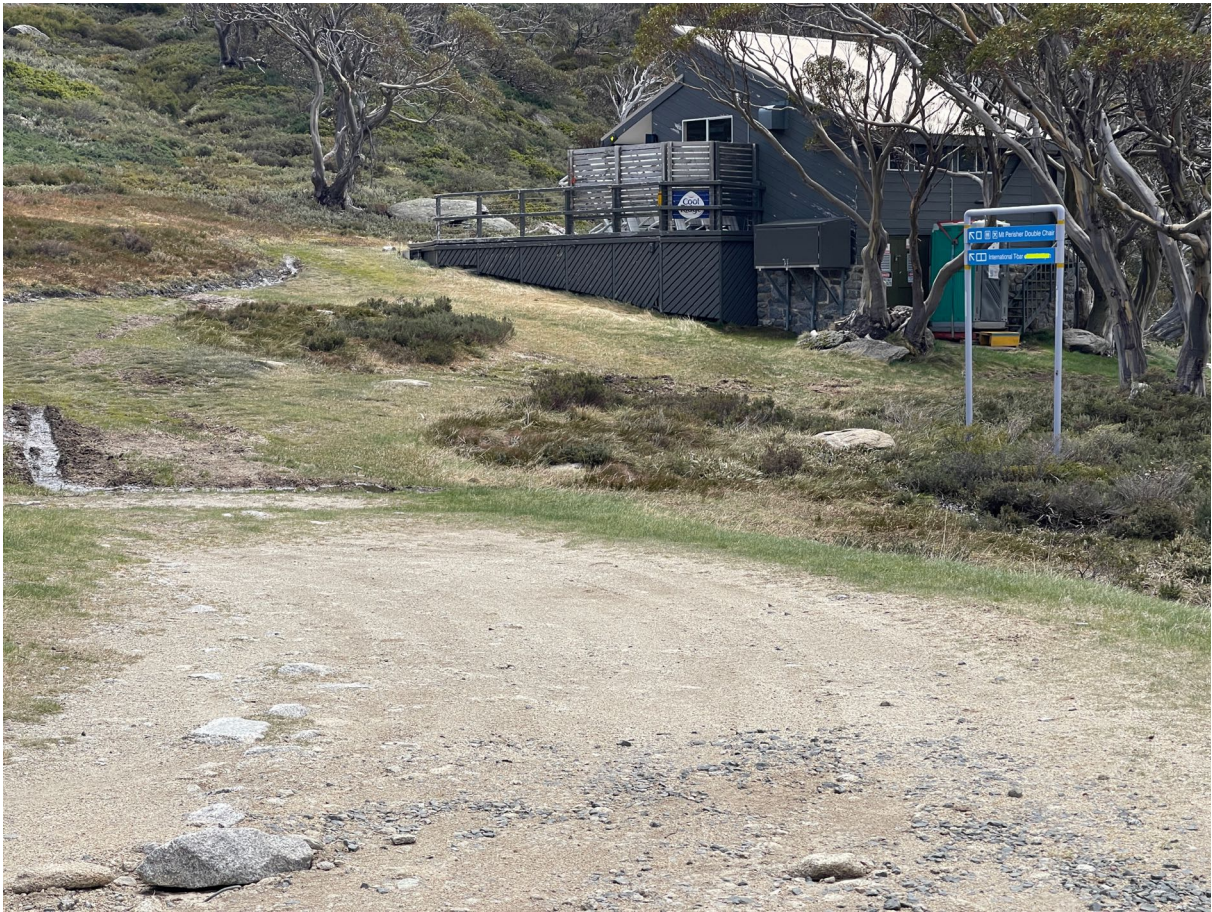
**Photo 3**

Closeup view of Eyre Kiosk. Toilet block proposed to be constructed to left of Kiosk.

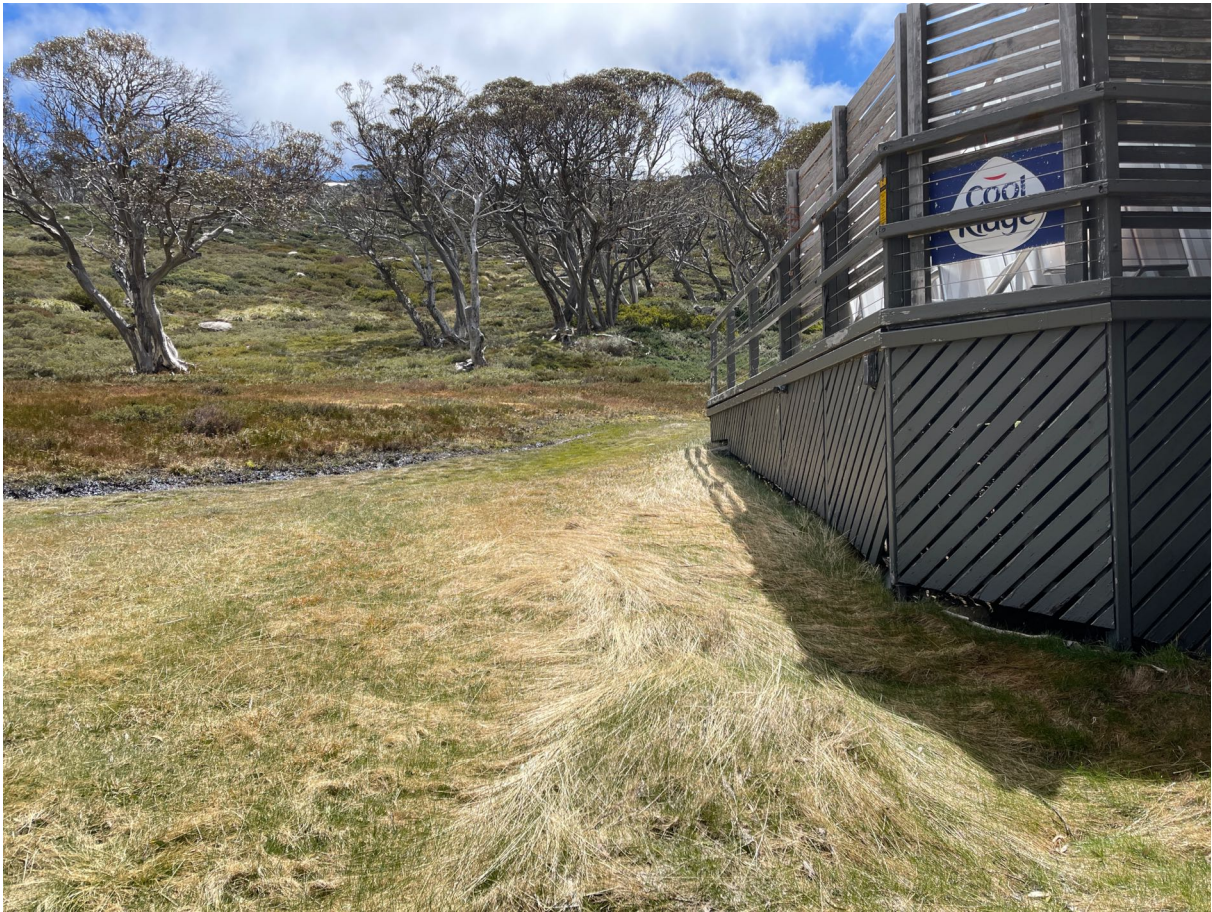
**Photo 4**

Closeup view of area where toilet block is proposed. Note seepage line.

Strip footing excavations for the toilet block are likely to encounter extremely weathered or better granite bedrock at relatively shallow depth, say less than about 1m, which would justify a less severe classification, Class A. It is expected that a conservative allowable bearing pressure of 150kPa would be achievable for footings on extremely weathered granite or very stiff natural clays or dense natural sands.
