# Solar Reflectivity Assessment for Altis Bankstown

Bankstown, Sydney, Australia

CPP 17939

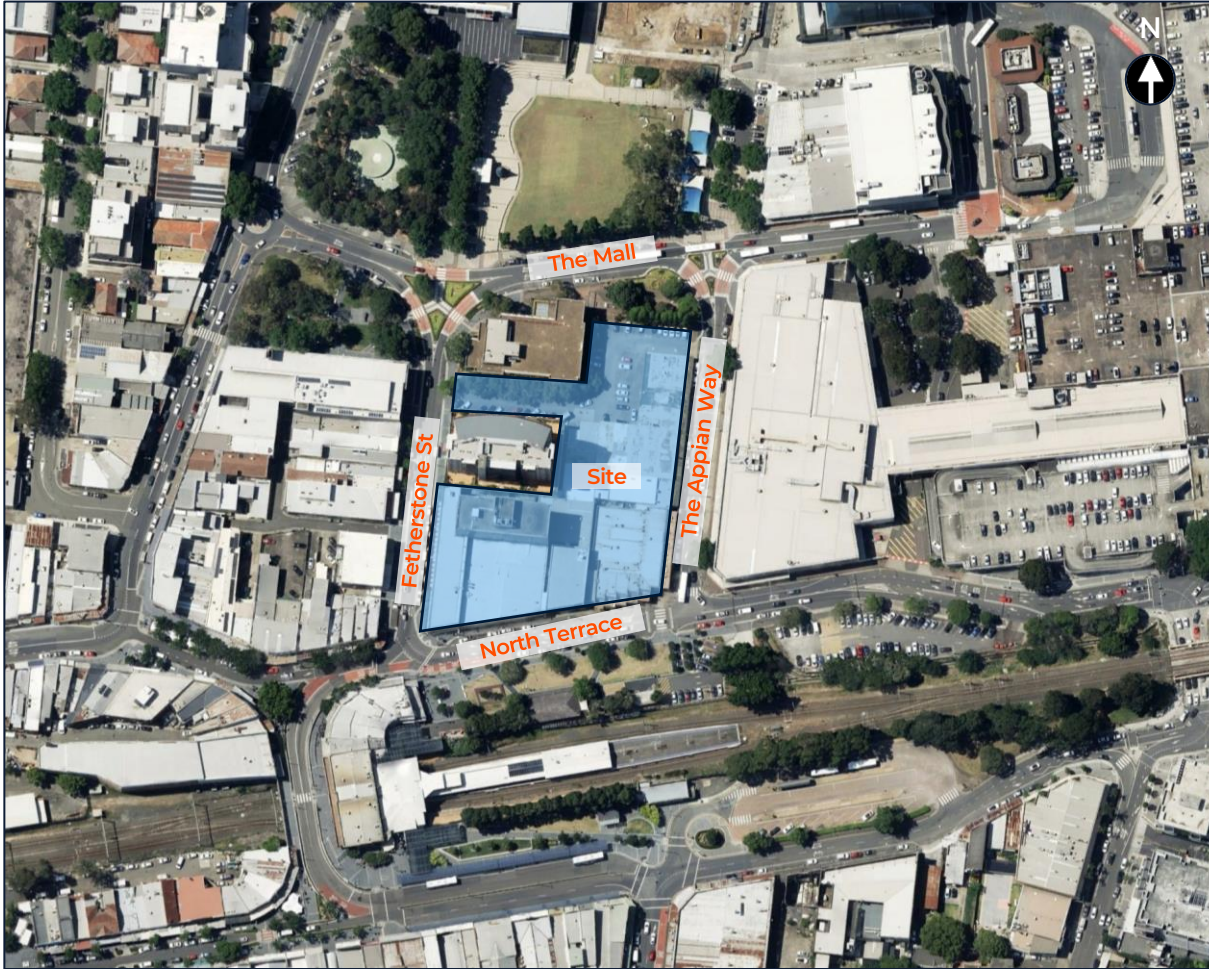
Site relative to the nearest mapped streets

- The proposed development is located in the Bankstown CBD, approximately 100 meters to the north of Bankstown station.
- The site is bounded by The Mall Rd to the north, The Appian Way to the east, North Terrace to the south and Fetherstone St to the west.
- The surrounding terrain is comprised primarily of low-rise suburban development with some larger commercial towers.

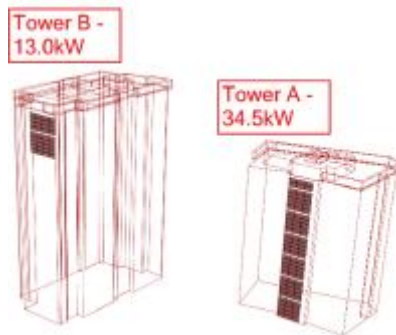
*Solar panels*

- The black region in image 3 is occupied by the solar panels, which did not reveal problems even at conservative 20% reflectance simulation. At the typical **solar panel** reflectance values between 0.5% and 5%, these **are unlikely to cause problems**.

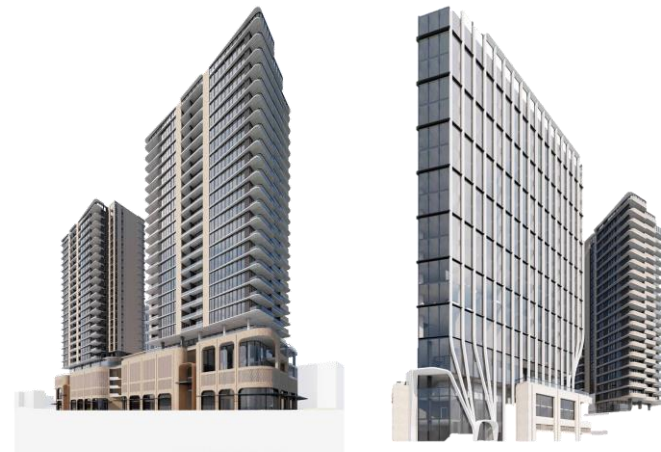
- The proposed project is a mixed-use development located in Bankstown, comprising two 24-storey and single 19-storey tower on a shared podium.
- Windows and railings account for most of the façade glazing. Vertical solar panels on towers A and B also contribute to solar reflection and were considered in the simulation.
- Tower A façade in particular is almost made entirely of glazed elements. However, vertical fins that extrude about 0.5 meters of the façade provide significant protection against solar rays.
- As the project buildings are taller than most of their neighbouring buildings, little blockage of solar rays is provided to the upper levels.

*Facades example*

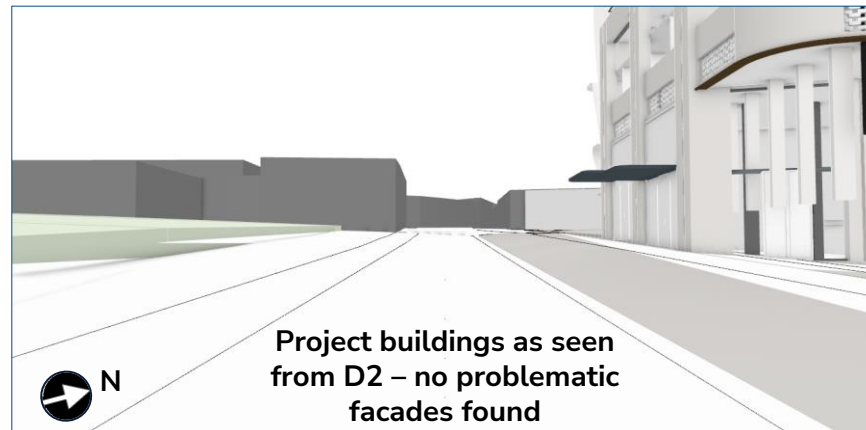
# Solar Reflectivity Results for Receiver D2

- The motorists at this location driving along this road are far more likely to experience visual impairment directly from the sun and not from the reflections off project buildings' facades.
- To identify exceeding levels of glare, all facades that cannot be seen by the driver are automatically rejected

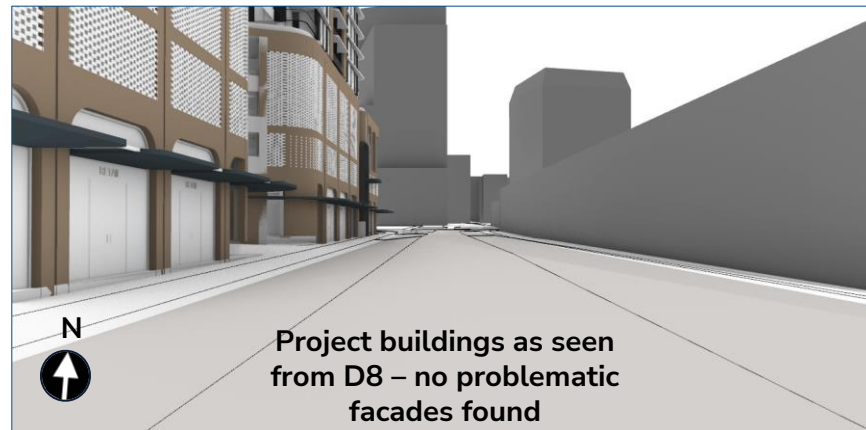
# Solar Reflectivity Results for Receiver D8

- The motorists at this location driving along this road are far more likely to experience visual impairment directly from the sun and not from the reflections off project buildings' facades.
- To identify exceeding levels of glare, all facades that cannot be seen by the driver are automatically rejected

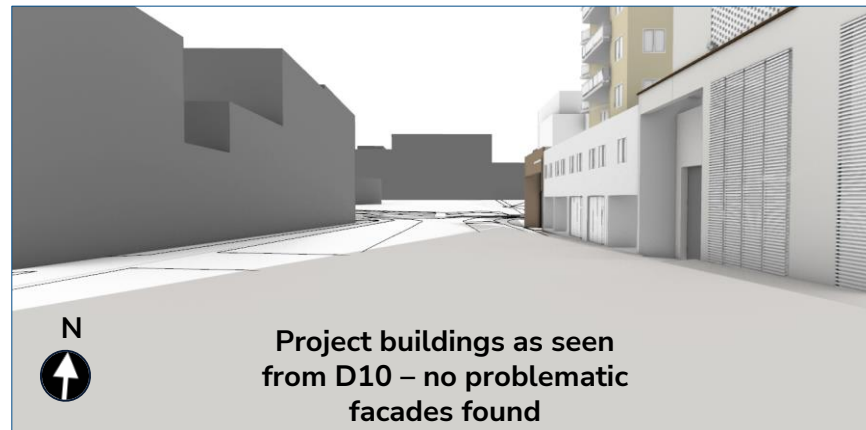
# Solar Reflectivity Results for Receiver D10

- The motorists at this location driving along this road are far more likely to experience visual impairment directly from the sun and not from the reflections off project buildings' facades.
- To identify exceeding levels of glare, all facades that cannot be seen by the driver are automatically rejected
