'MALLAWA' WATER STORAGE

NARROMINE NSW

STATEMENT OF ENVIRONMENTAL EFFECTS

OCTOBER 2024

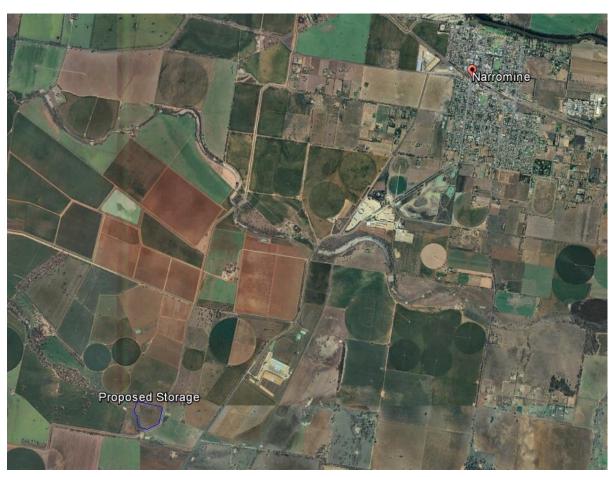
Figure 3.1 Mallawa storage Location, Image Courtesy Google Earth

The proposed storage will be located on the aggregations referred to as Mallawa, within the land parcels LOT 51 DP 595537 and LOT 6 DP 569413. The location of the storage relative to Narromine is shown in **Figure 3.1**. A detailed layout of the proposed storage is shown in **Attachment 1**.

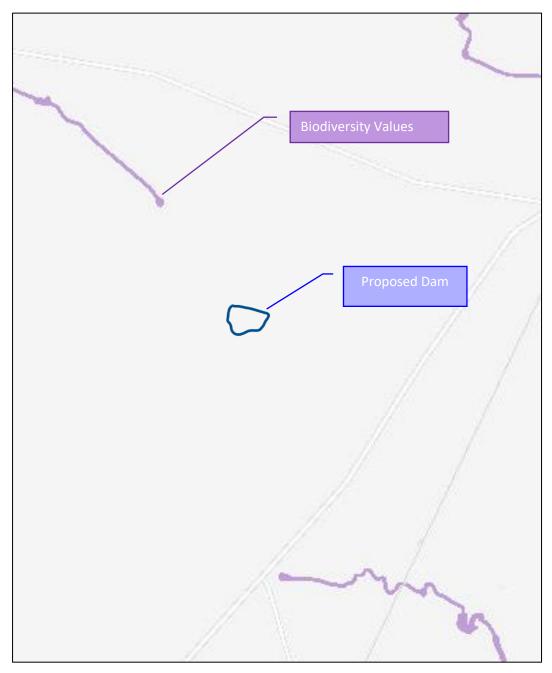
Figure 6.1 NSW Biodiversity Value Map

The construction of the Mallawa storage will not have any negative impacts on local biodiversity. The nature of the existing site & scope of works means that no threatened species of flora or fauna will be impacted by the project. The proposed works are not in an area mapped on the NSW Biodiversity Values Map, **Figure 6.1**.

The storage site has been farmed land since 1996, with regular cultivation occurring, thus vegetation is minimal. There are no trees in need of clearing and the storage project also does not impact upon any endangered ecological communities or areas of outstanding biodiversity value.

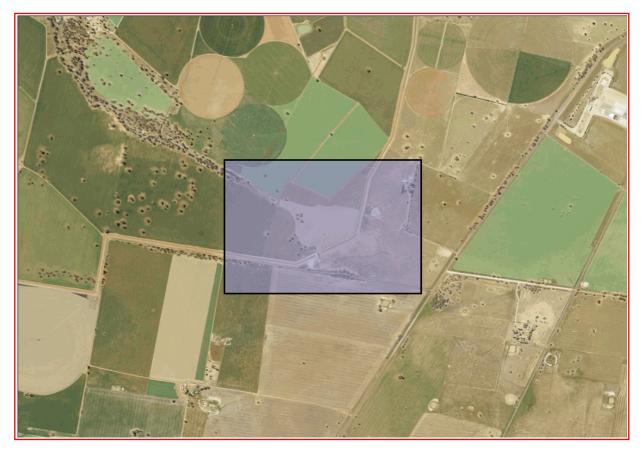
The context area of your search is shown in the map below. Please note that the map does not accurately display the exact boundaries of the search as defined in the paragraph above. The map is to be used for general reference purposes only.

0 Aboriginal sites are recorded in or near the above location. 0 Aboriginal places have been declared in or near the above location. *

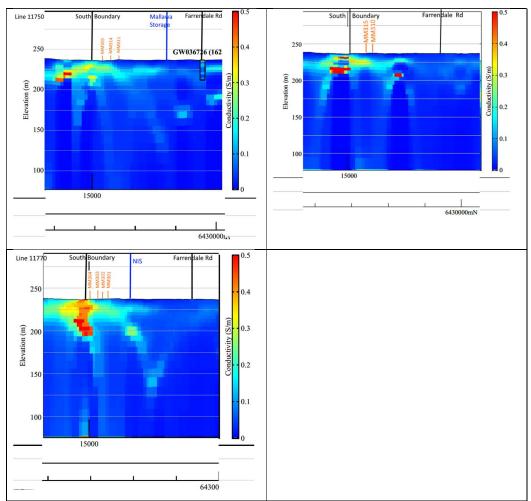
Figure 2.2. Cross sections of apparent electrical conductivity from transects across Mallawa shown in Map 3a. Orange lines represent test holes.

The cross sections in Figure 2.2 show a more precise view of the data in Map 3 (J. Kellett, pers. comm.). These cross sections show a pattern beneath the Proposed Storage of a resistive surface layer over a more conductive layer. The deep (below 200 m above sea level) resistive layer is likely to be rock, and yellowish lines that extend to the bottom of the transect are likely to be artefacts. However, the 10 m thick resistive (blue) zone north of the Proposed Storage indicates a zone of leaky soil.

The airborne EM survey indicates that the Proposed Storage is in an area with moderately low ECa in the 0 to 5 m layer over more conductive (and salty) soil. This pattern indicates that the site of the Proposed Storage should leak slowly. However, the depth of low salinity soil increased rapidly to the north of the Proposed Storage. Test Drilling should be conducted to verify this pattern and locate the boundary between soil that should leak slowly and soil that leaks quicker.
