Site Classification with Foundation Parameters

Proposed Dual Occupancy 68 Head St, Forster

Report Ref: G0667-SCFP-001-Rev0

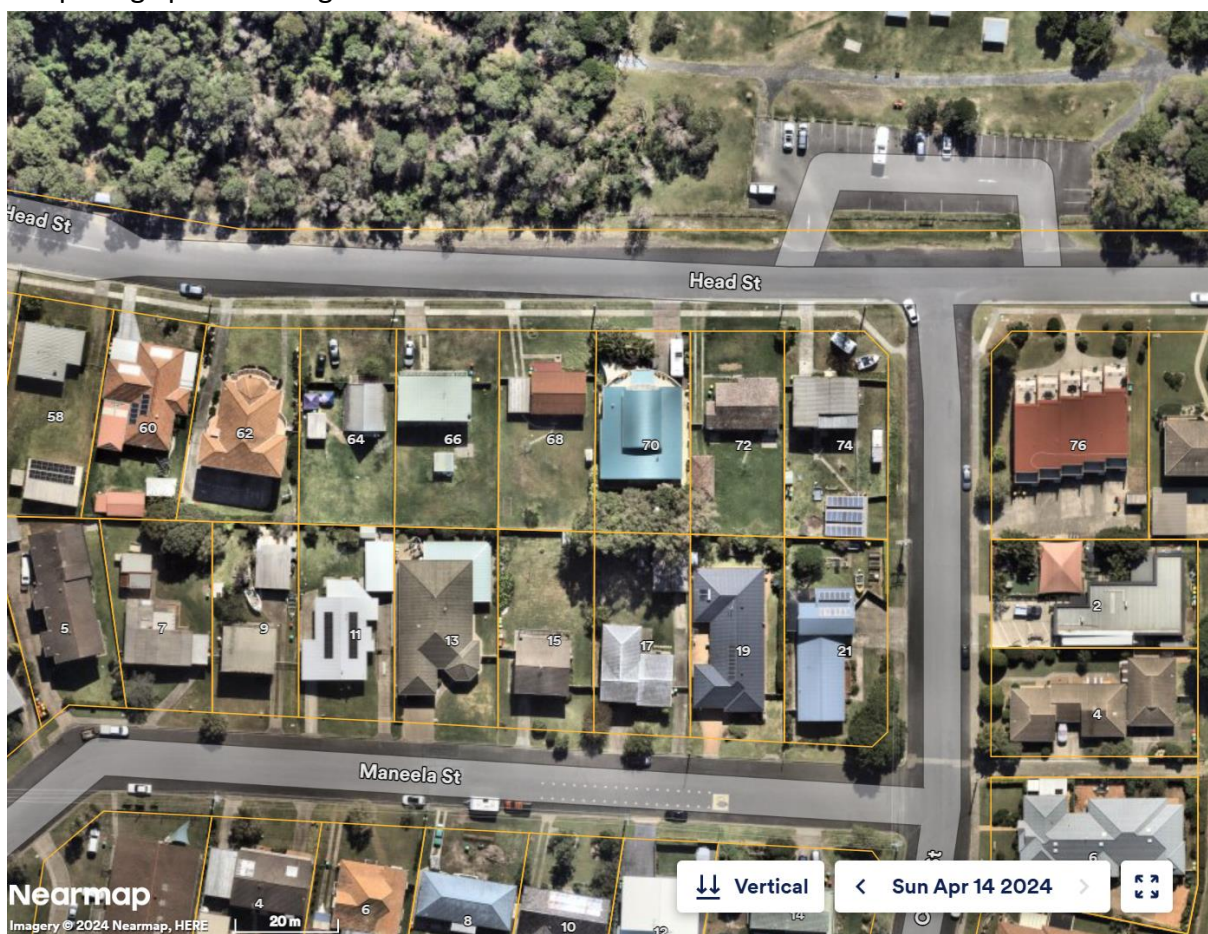
Figure 1.

A photograph showing the surface conditions at the site is shown below in

Figure 1: Aerial image obtained via ‘NearMaps’ depicting the site and site setting

The site is situated on the lower slopes of a westerly plunging ridgeline 20m AHD. Surface slopes fell 1° to the east across the site and had a 5° fill batter to the front of the property that fell to the south. Drainage of the site was a combination of overland flow and surface infiltration into sandy topsoils. Vegetation at the time of the investigation was maintained grasses with no exposed soils and a small citrus tree to the rear.

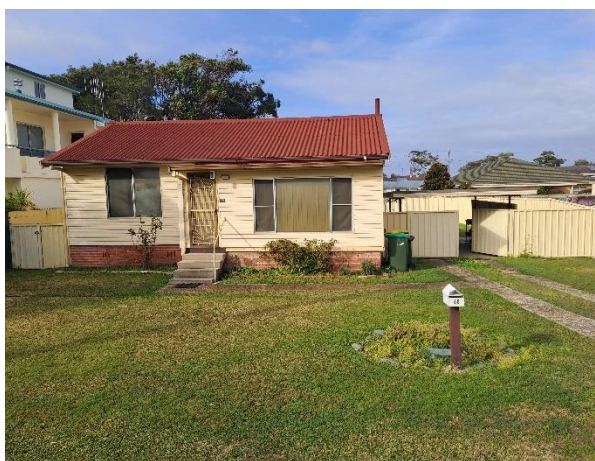
Figure 2: At the front of the property looking south

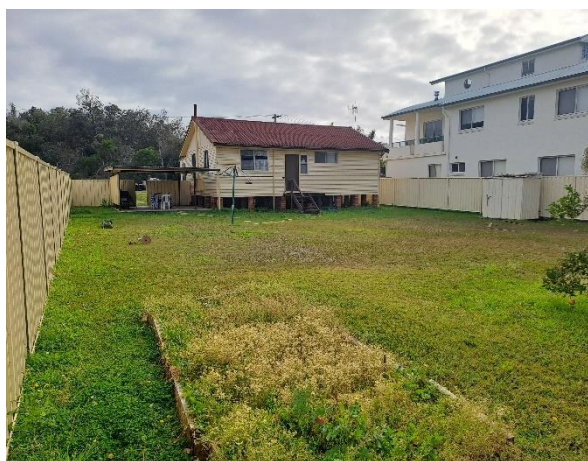
Figure 3: At the rear of the property looking north

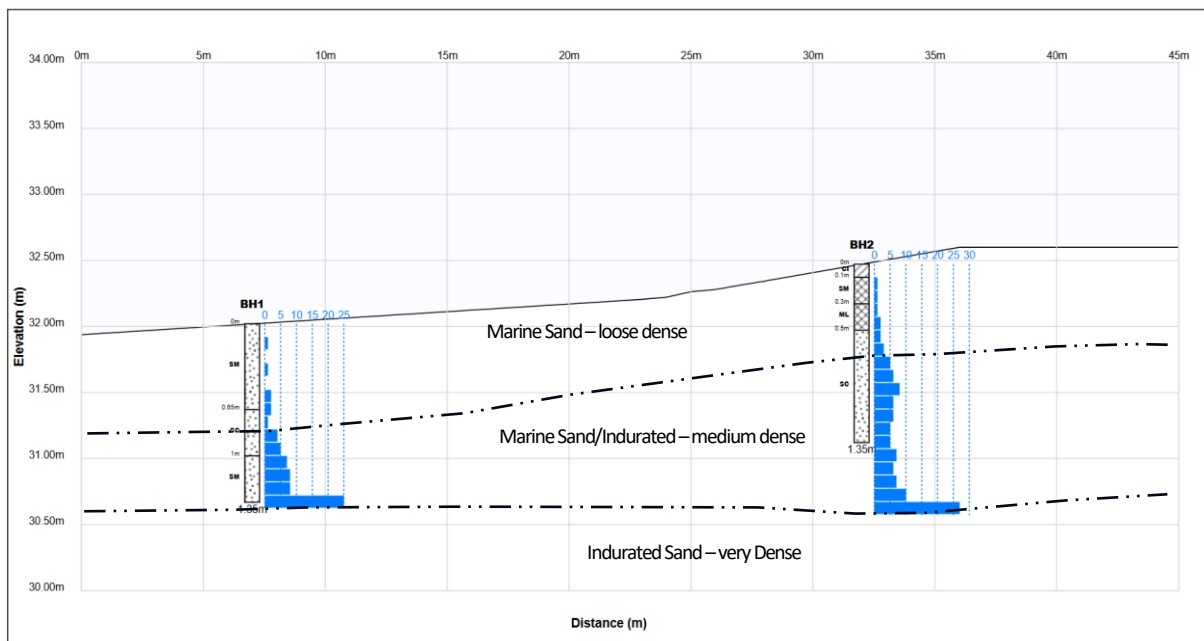
Figure 4. Geological long section of site

Unit	Unit Description	Unit Depth (m)	
		BH1	BH2
Topsoil/Fill	Sandy SILT, low plasticity, dark brown to black	0.05	0.1
Fill	Silty SAND, medium density, brown to grey	-	0.5
Marine Sand	Clayey to Silty SAND, dark brown to black, very loose	0.65	--
Marine Sand	Clayey to Silty SAND, dark brown to black, medium dense, collapsable	1.0	≥1.35
Indurated SAND	Silty SAND, dark brown to black, dense to very dense	≥1.35*	-
Groundwater		0.7	0.5
