Proposed Caravan Park

Lot 2 DP 1015609 (288) Mungo Brush Road Hawks Nest

Geotechnical Assessment

Report No. RGS50057.1 – AB Rev.1

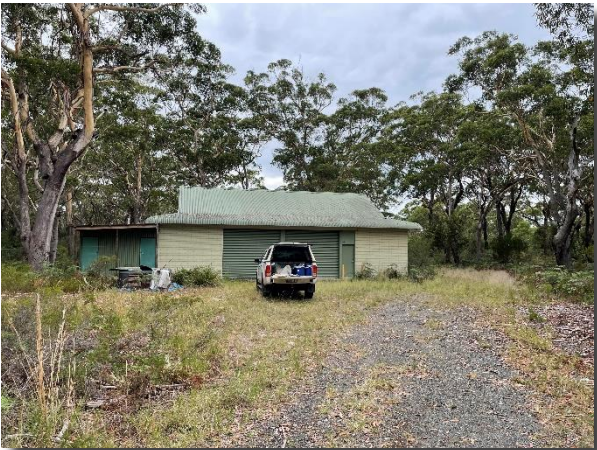
Plate 1: General Site Photographs

<p>1. Gravel access track that extends from the entrance off Mungo Brush Road into the site.</p>	<p>2. Brick shed structure located near the southeast extent of the caravan park footprint.</p>

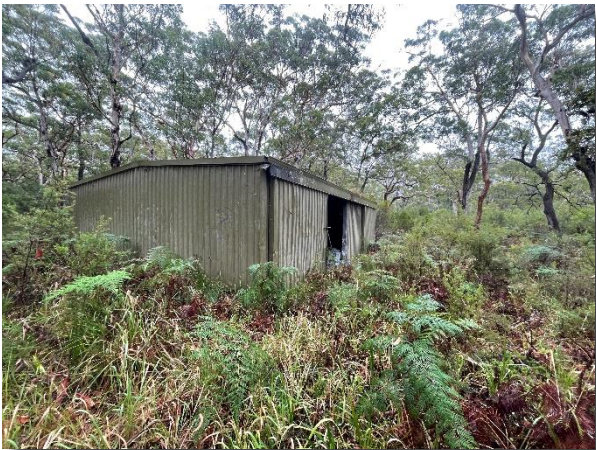
<p>3. Shed located outside the caravan park footprint.</p>	<p>4. Low brick wall located near the centre of the site.</p>

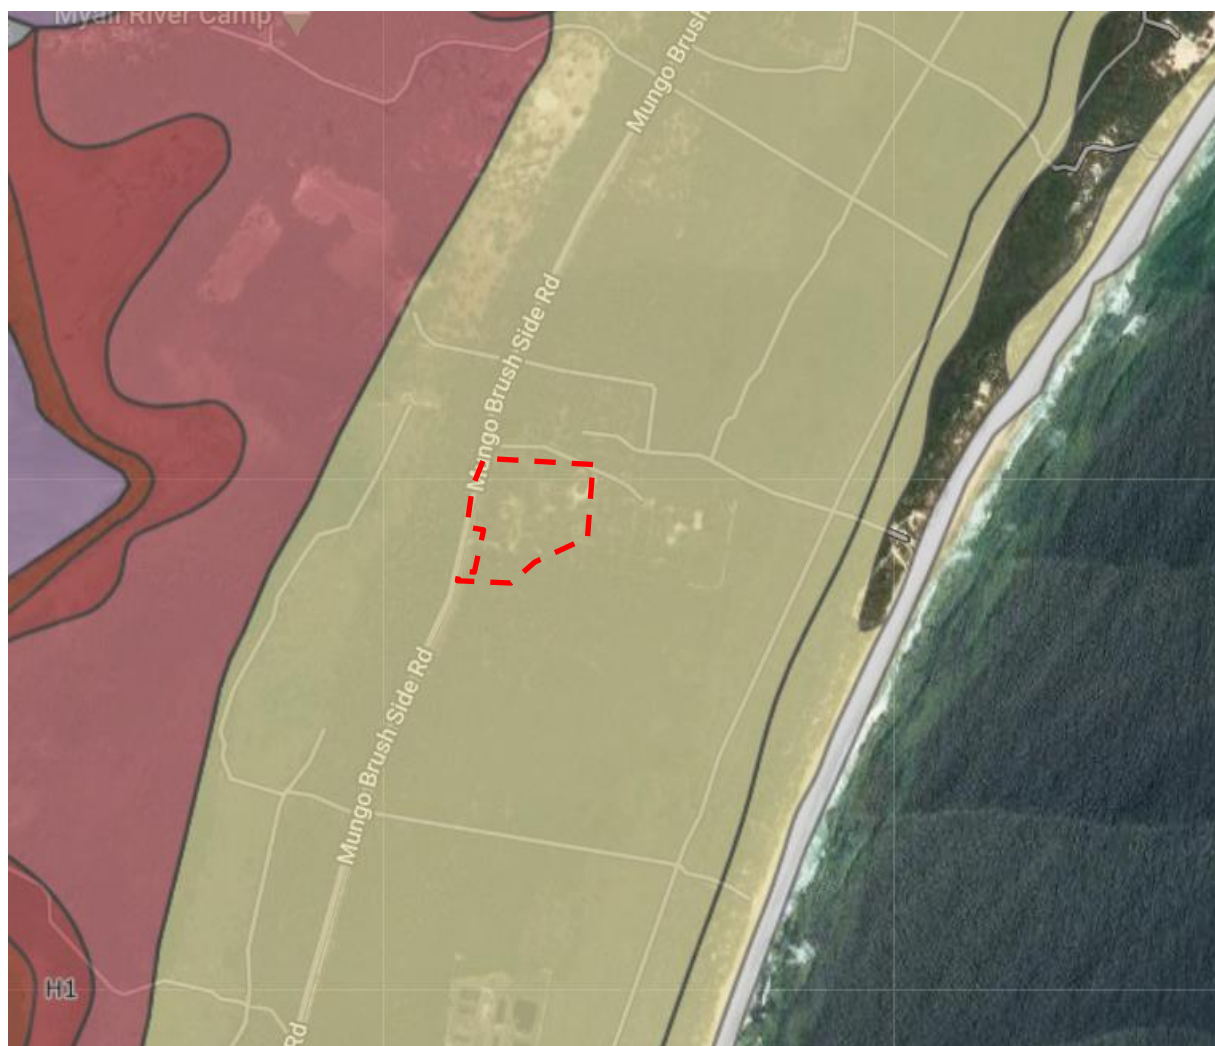
Diagram 3: Acid Sulfate Soils Risk map of the Hawks Nest are reproduced with NSW Government website "Espade v2.2" the caravan park footprint is outlined red.

The Acid Sulfate Soil Risk Mapping of the Hawks Nest area indicates the site to be in an area of low risk of acid sulphate soils greater than 3m below the ground surface (L4). An extract of the map is reproduced below in Diagram 3.

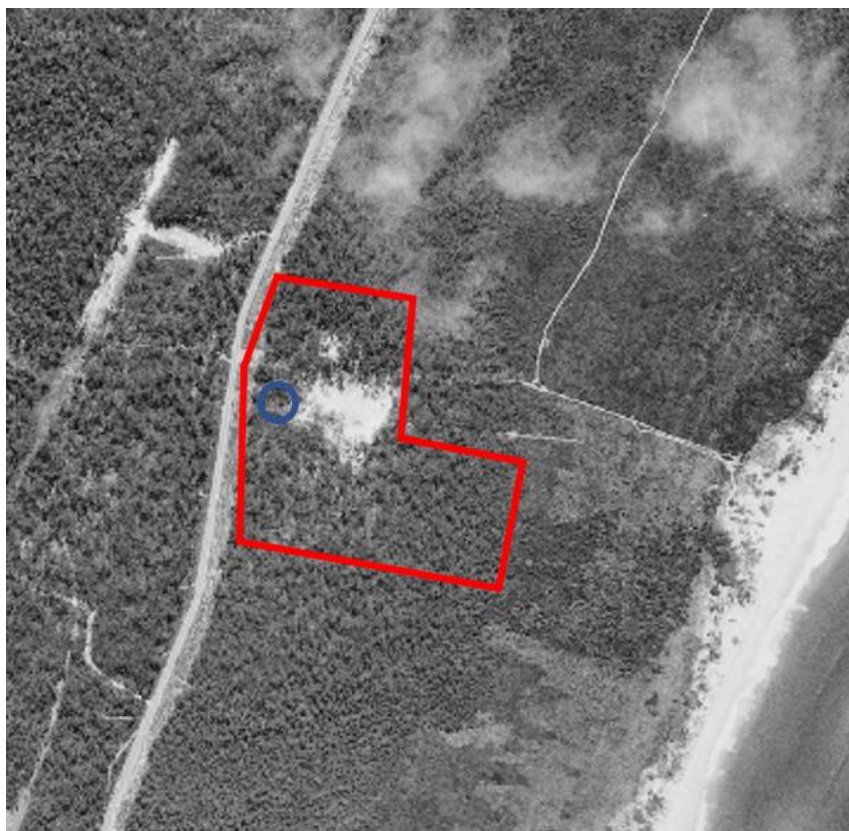
Diagram 3: Historical image from 1973, the approximate site boundaries are outlined red, the approximate location of BH4 is outlined blue.

Based on the depth of the samples from BH4 (up to 2m) and the depth of the groundwater table (6.5m) any PASS should have been oxidated producing actual acid sulfate soils. In consideration of this the soils that have been detected as PASS may be attributed to imported fill such as dredged spoil from the nearby historical sand mining works. It is understood that no sand mining works occurred within the site boundaries, however, there was sand mining to the east and west of the site. With reference to a historical aerial image from 1973 there is evidence of some potential sand mining spoil on the site in the vicinity of BH4, however, the photograph is not clear and the area could also have been a cleared portion of the site. The historical image is reproduced below.

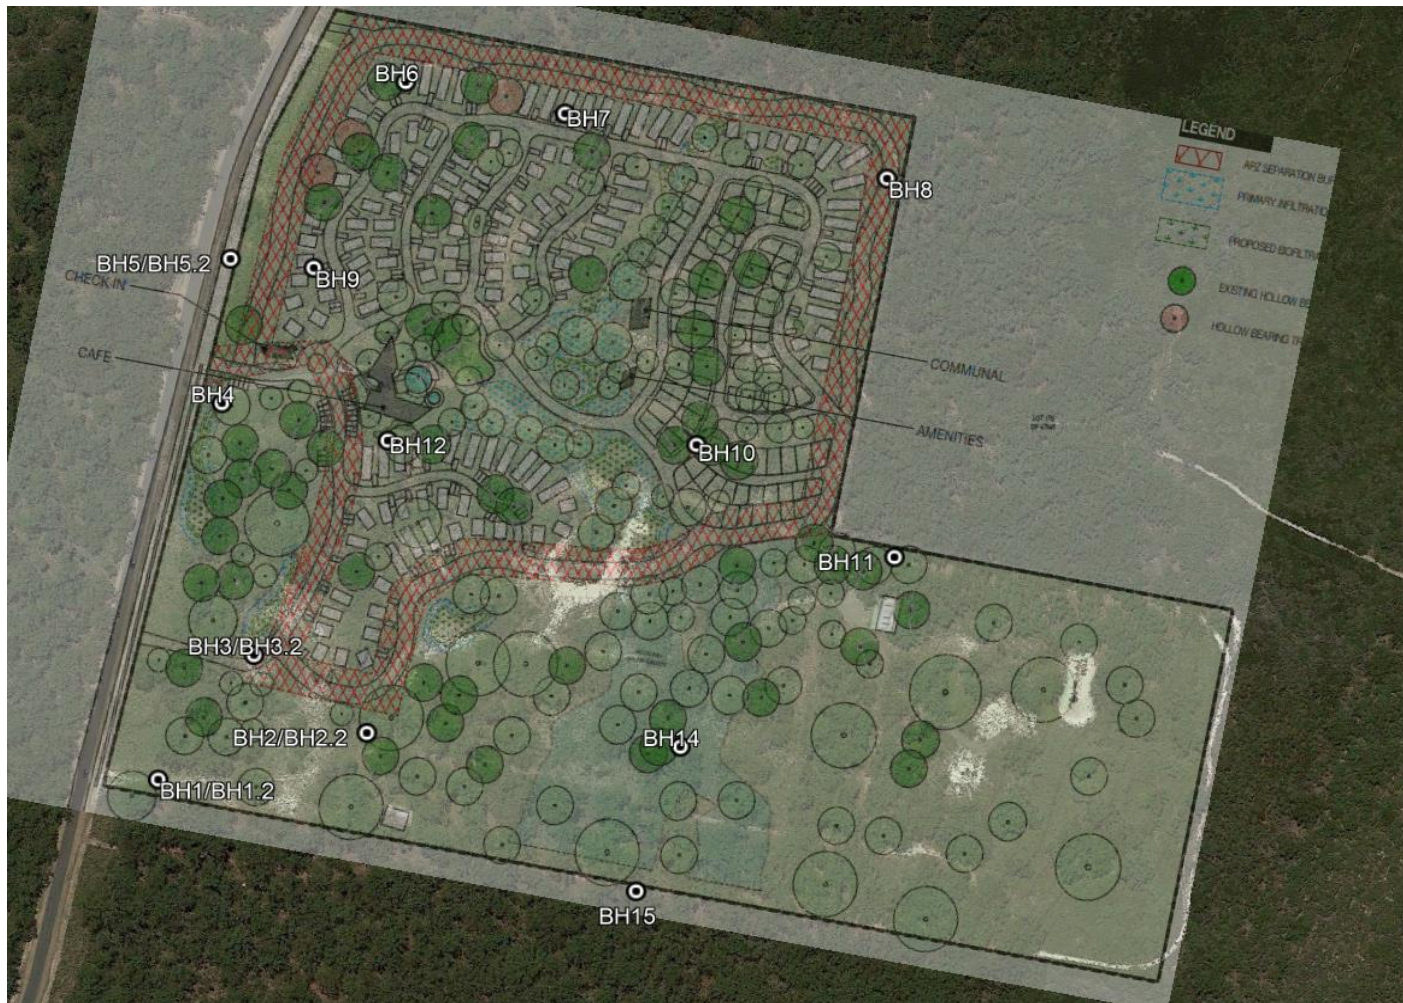
REGIONAL GEOTECHNICAL SOLUTIONS	Client:	Lands Advisory Services Pty Ltd	Job No.	RGS50057.1
	Project:	Proposed Caravan Park 288 Mungo Brush Road Hawks Nest	Drawn By:	LD
	Title:	Borehole Location Plan	Date:	16-Jun-23
			Drawing No.	Figure 1
