Detailed Site Investigation – Contamination Assessment

Proposed Caravan Park

Lot 2 DP 1015609 (288) Mungo Brush Road Hawks Nest

Report No. RGS50057.1-AD

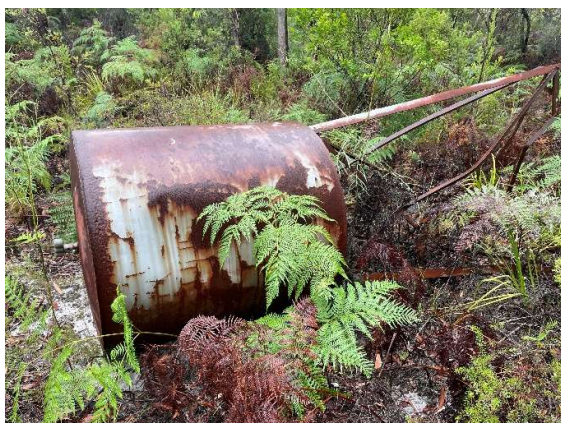
Collapsed AST in-situ prior to its removal. It was located in the south-western part of the site. It had a 2,000L capacity and was used for the storage of diesel fuel.

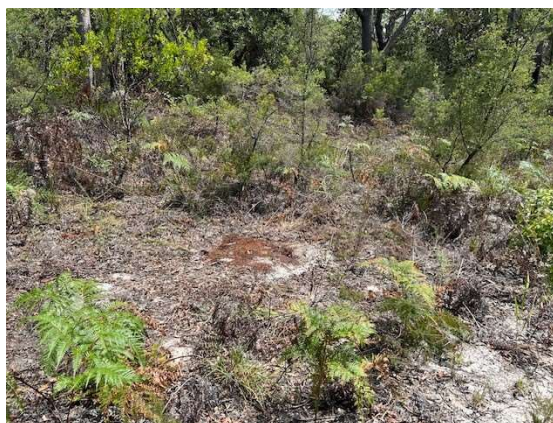
- The AEC2 location is in the south-western part of the and is densely vegetated with tall native trees and smaller shrubs and ferns;
- Some remnant rusted metal flakes were present on the ground surface where the AST was located; and
- No other visual or olfactory evidence of gross hydrocarbon contamination was observed.

Looking north showing the area where the AST was located prior to its removal. Some remnant rusted metal flakes from the AST were present on the ground surface.

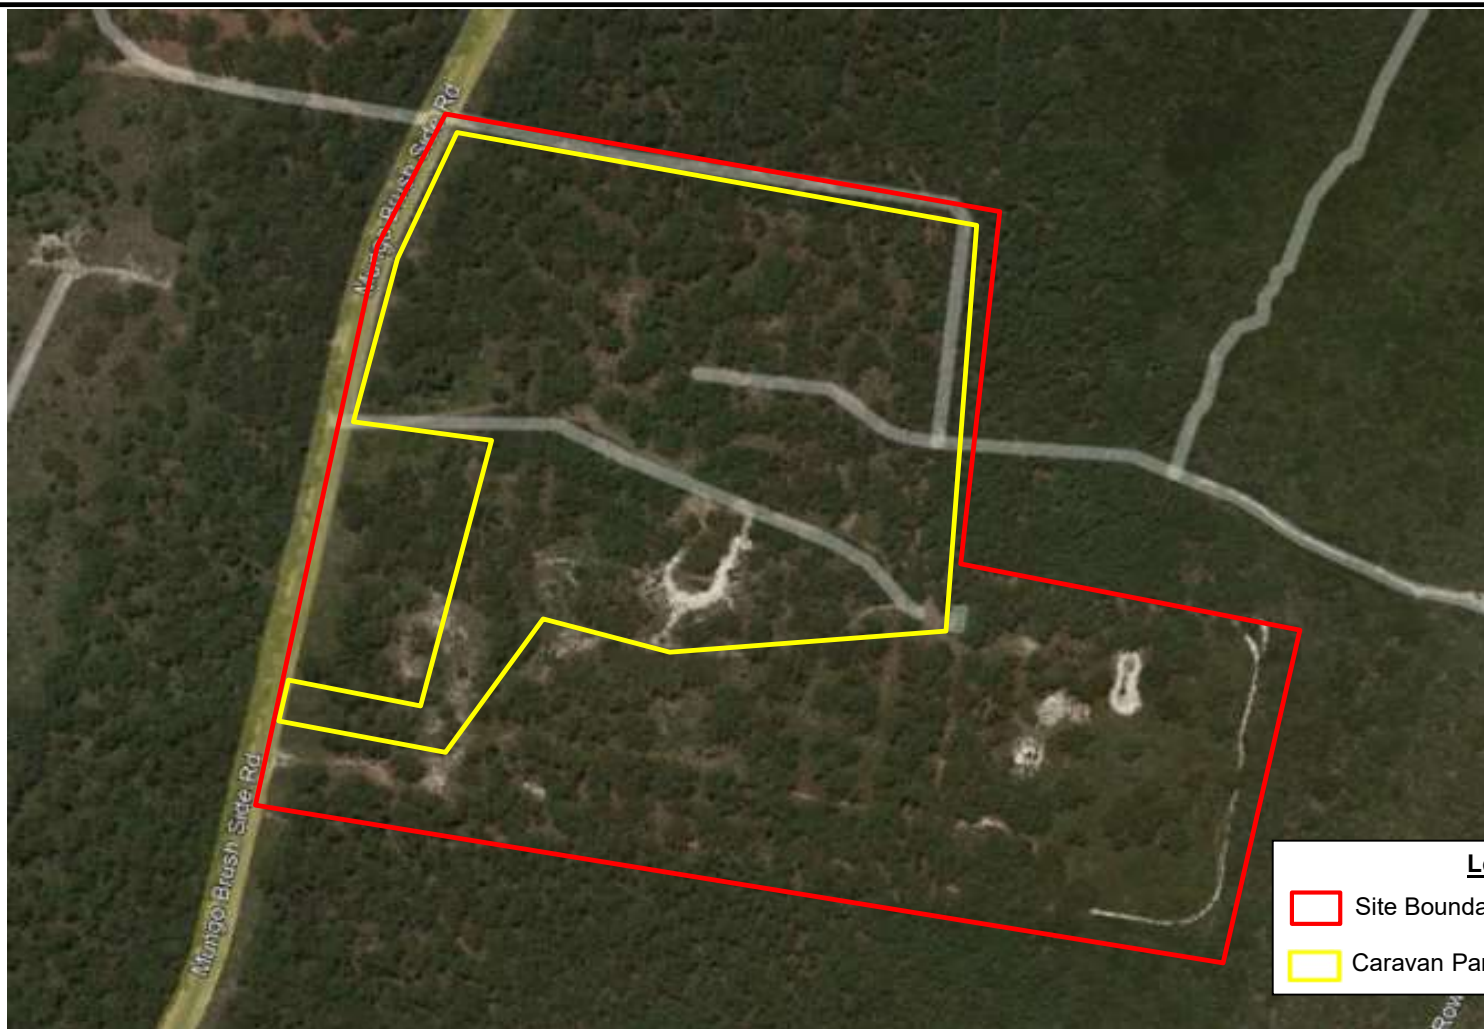
REGIONAL GEOTECHNICAL SOLUTIONS	Client:	Lands Advisory Services Pty Ltd	Job No.	RGS50057.1
	Project:	Proposed Caravan Park	Drawn By:	LD
		Lot 2 DP 1015609 (288) Mungo Brush Road, Hawks Nest	Scale:	NTS
			Date:	21-Mar-23
	Title:	Site Layout Plan	Drawing No.	Figure 2

Legend	
	Site Boundary
	Caravan Park Footprint

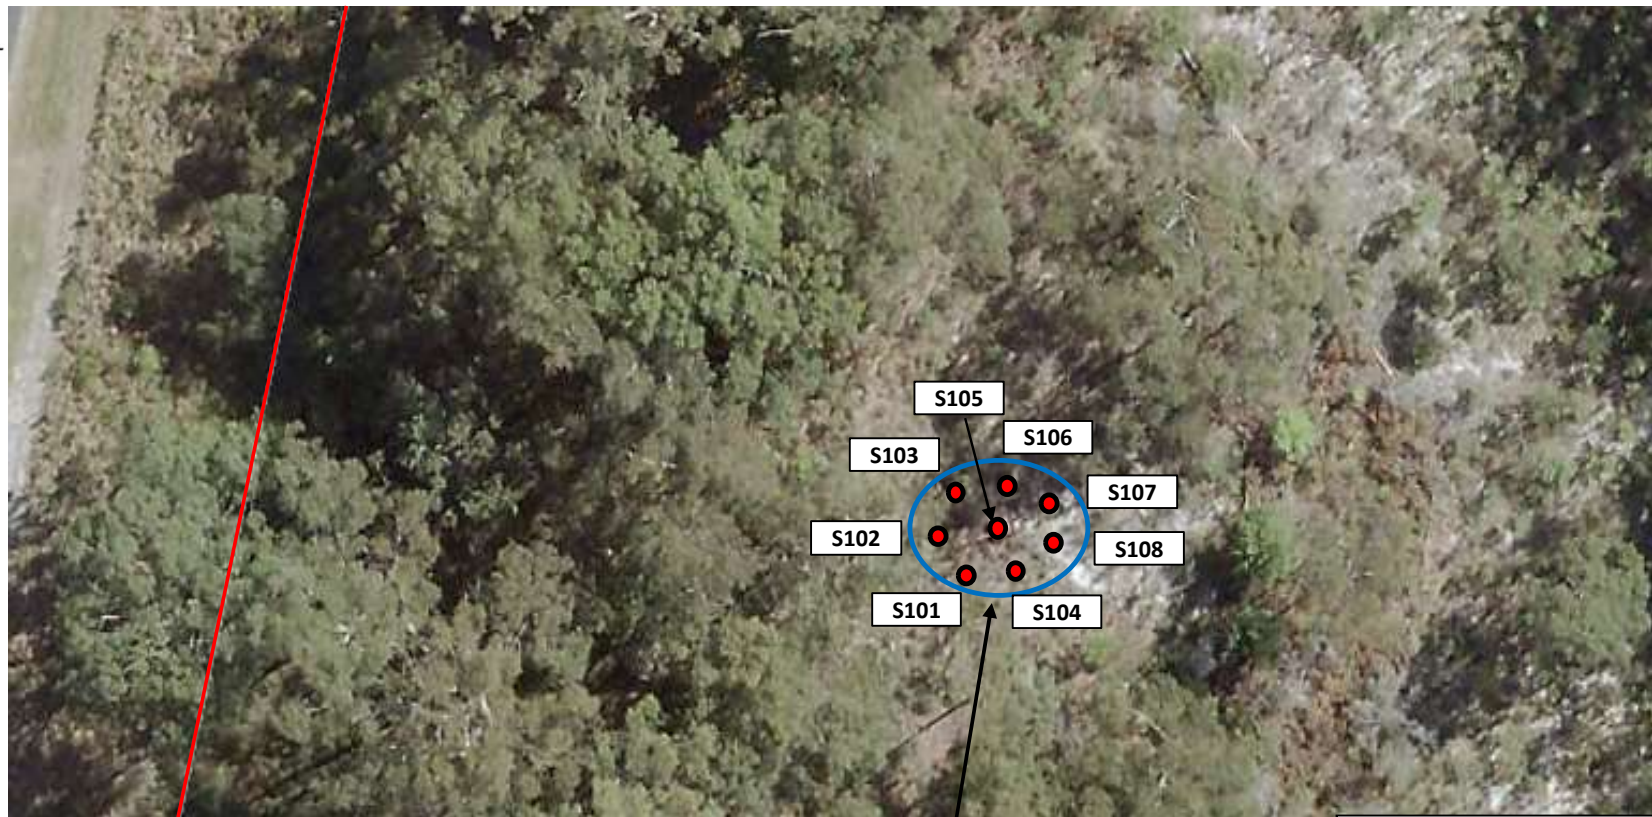
Client:	Lands Advisory Services Pty Ltd	Job No.	RGS50057.1
	Proposed Caravan Park Lot 2 DP 1015609 (288) Mungo Brush Road, Hawks Nest	Drawn By:	AH
		Scale:	NTS
		Date:	7-Mar-24
Title:	Sample Location Plan	Drawing No.	Figure 3

AEC2: Soils in vicinity of
collapsed above ground
fuel storage tank

The location of AEC2 is shown on Figure 3.

The location of where the AST was located is shown on Figure 3.

The approximate location of AEC2 is shown on Figure 3.

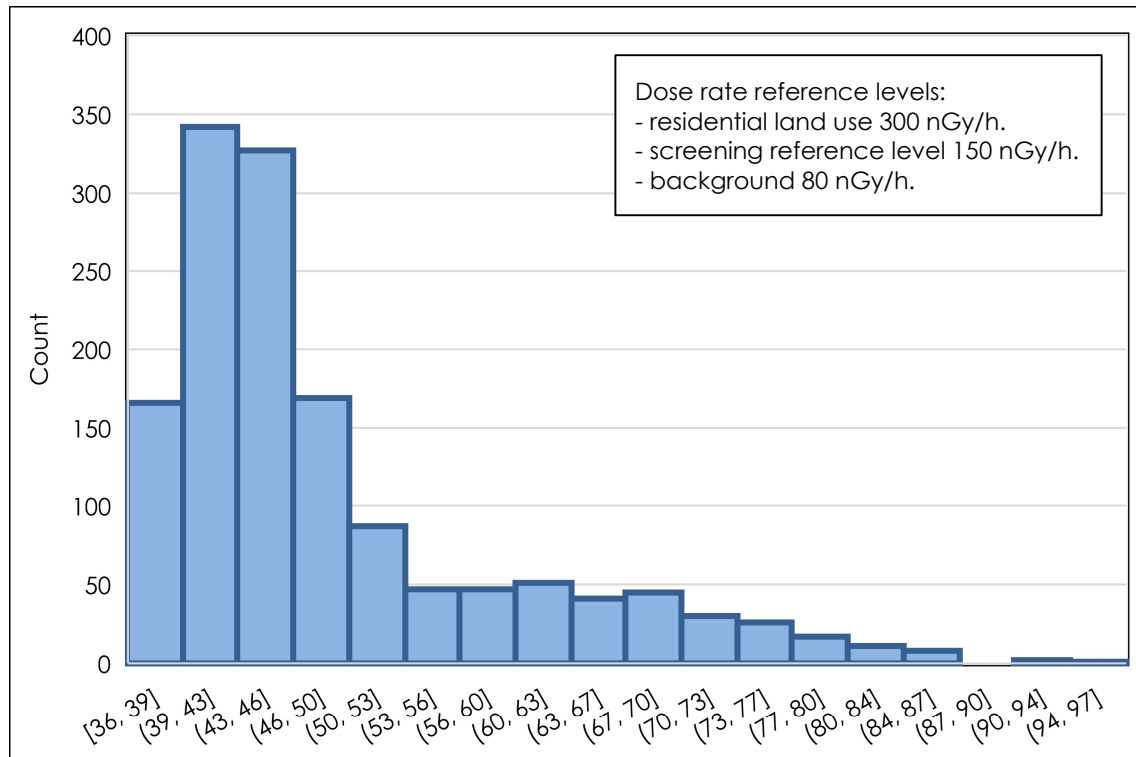
The surface gamma radiation survey results are summarised in Figure 10.1 (overleaf) as a histogram of dose rates, and the dose rates are spatially plotted in Figure 3 (figures section). The recorded dose rates were all below the screening reference level of 150 nGy/h, and were generally below background of 80 nGy/h. The maximum reading was 97 nGy/h, the median was 44.6 nGy/h, and the 3rd quartile of the data set was 51.3 nGy/h; noting that where HMSRs exist, readings are generally in the 100s and 1,000s nGy/h. Where elevated readings were recorded, i.e. > 80 nGy/h, gravel roadbase was noted on the ground surface, and no elevated readings indicative of HMSRs were detected related to the site.

Figure 10.1: Histogram of surface gamma radiation survey (nGy/h), February 2024

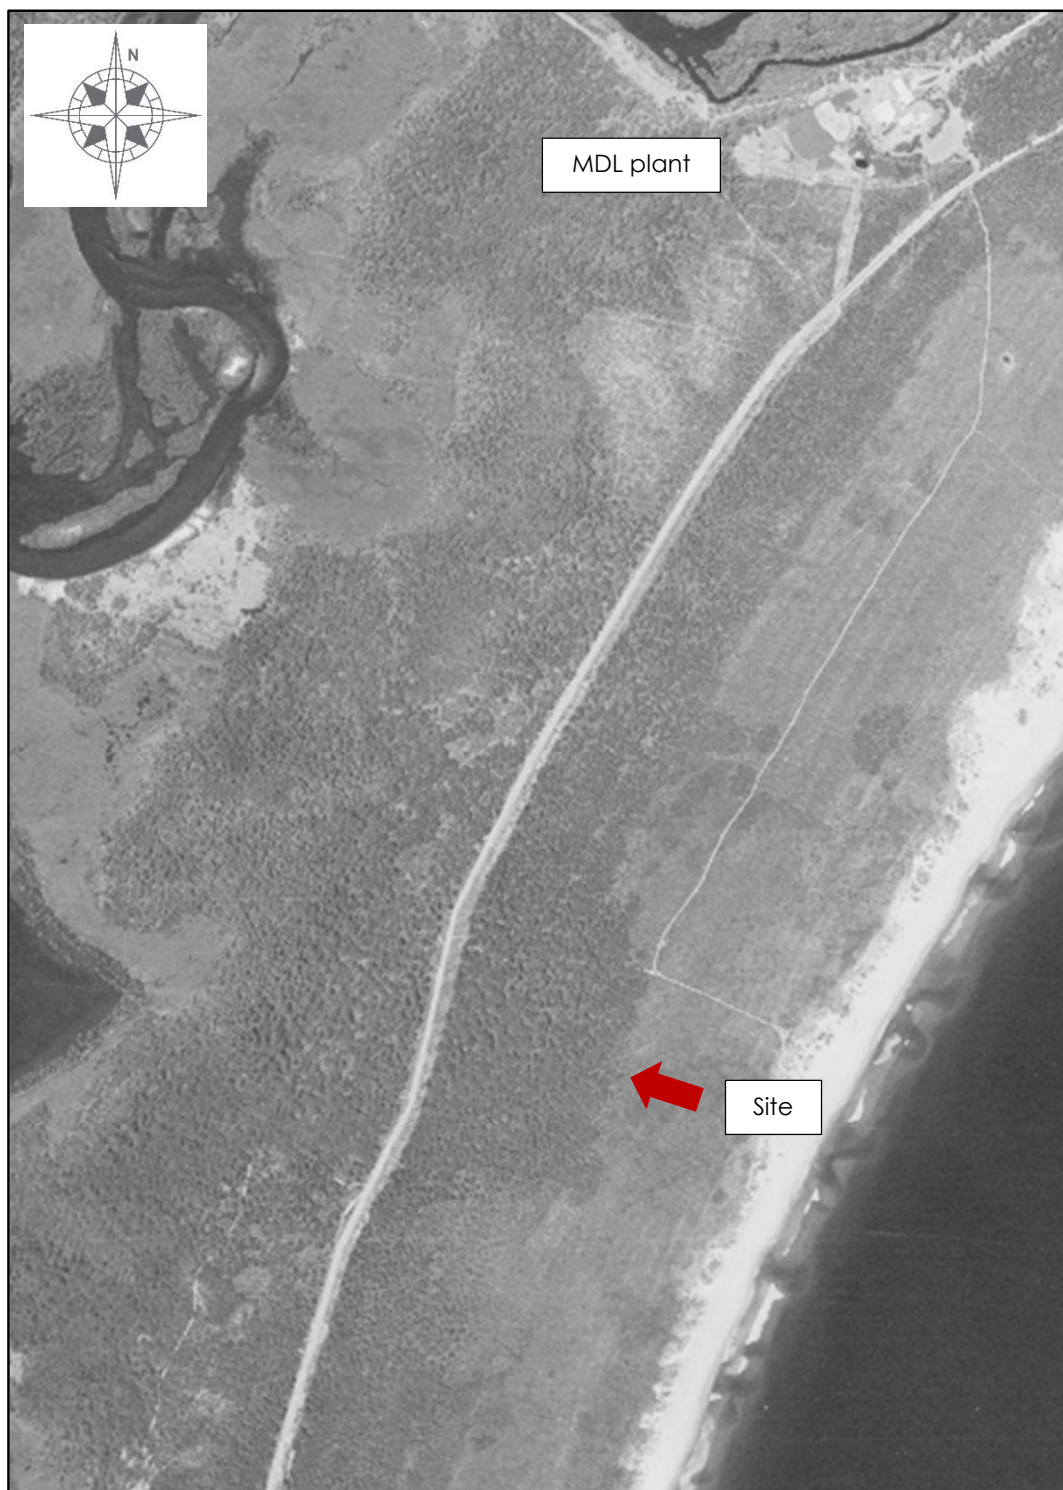
1971 (?) aerial photograph
Source: NSW Spatial Services, 2024

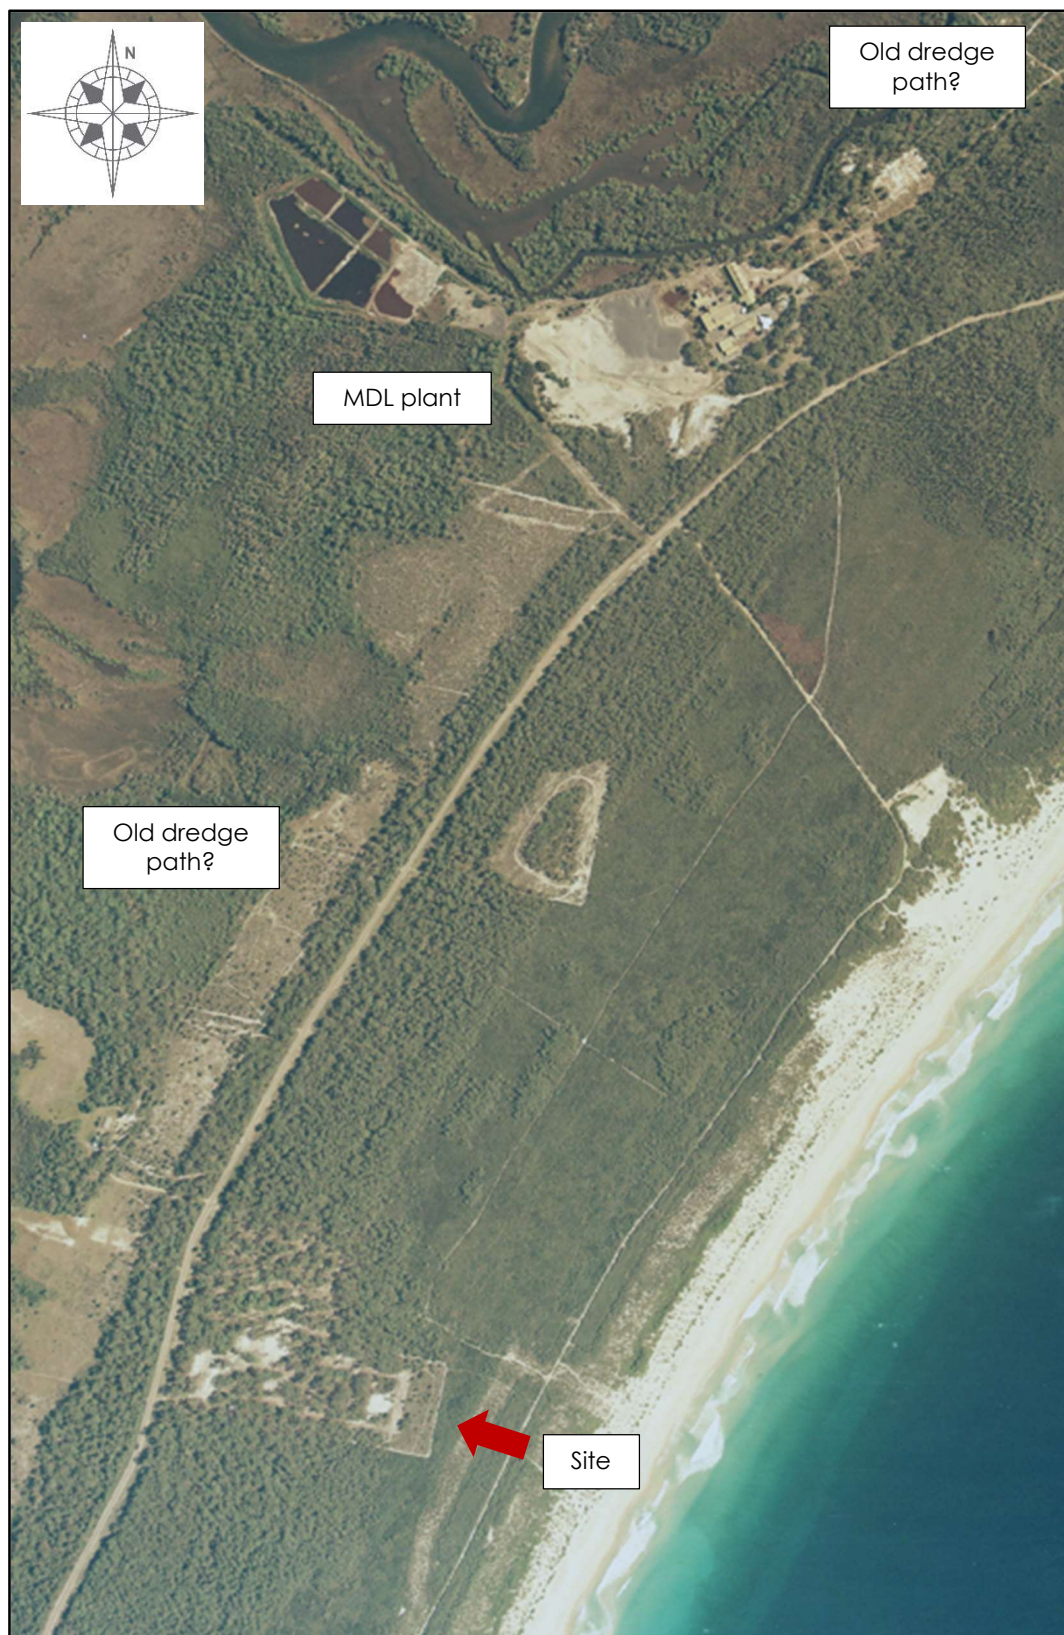
1993 (?) aerial photograph
Source: NSW Spatial Services, 2024

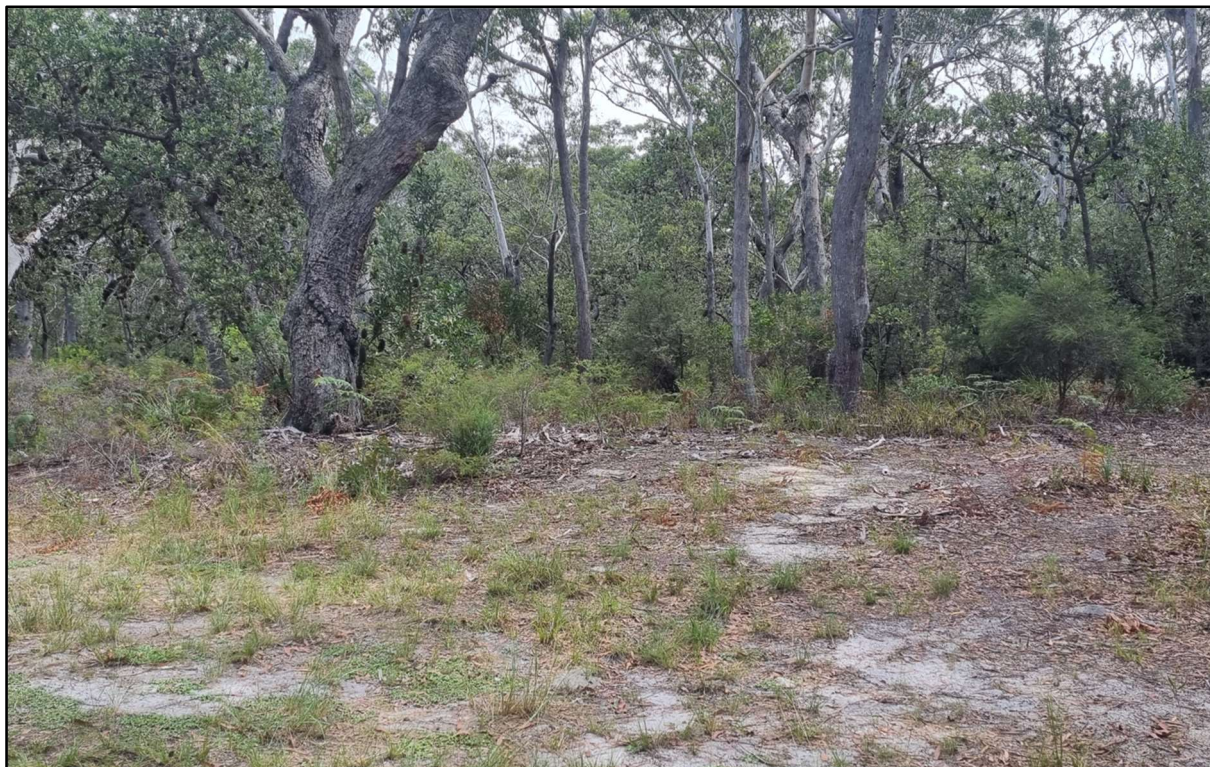
Plate 1: Near on-site building, typical ground surface and vegetation cover

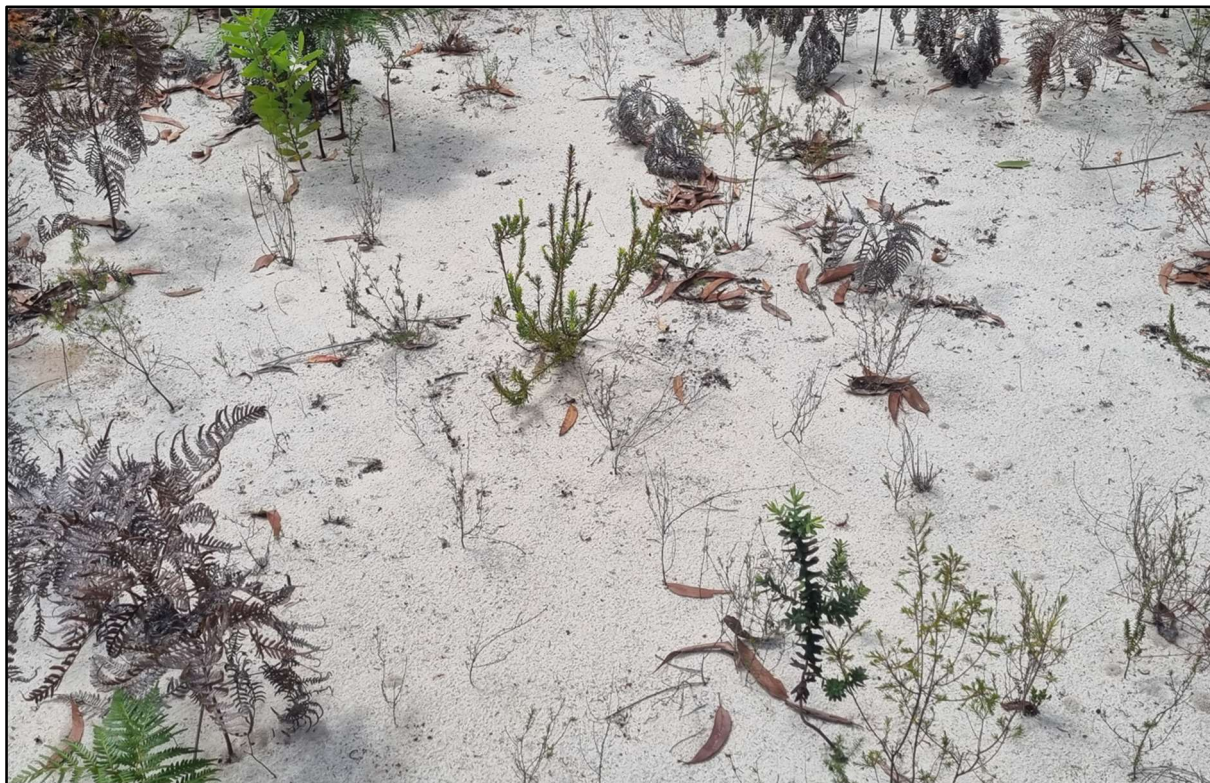
Plate 3: Typical exposed surface of beach sands, with no indications of HMSRs

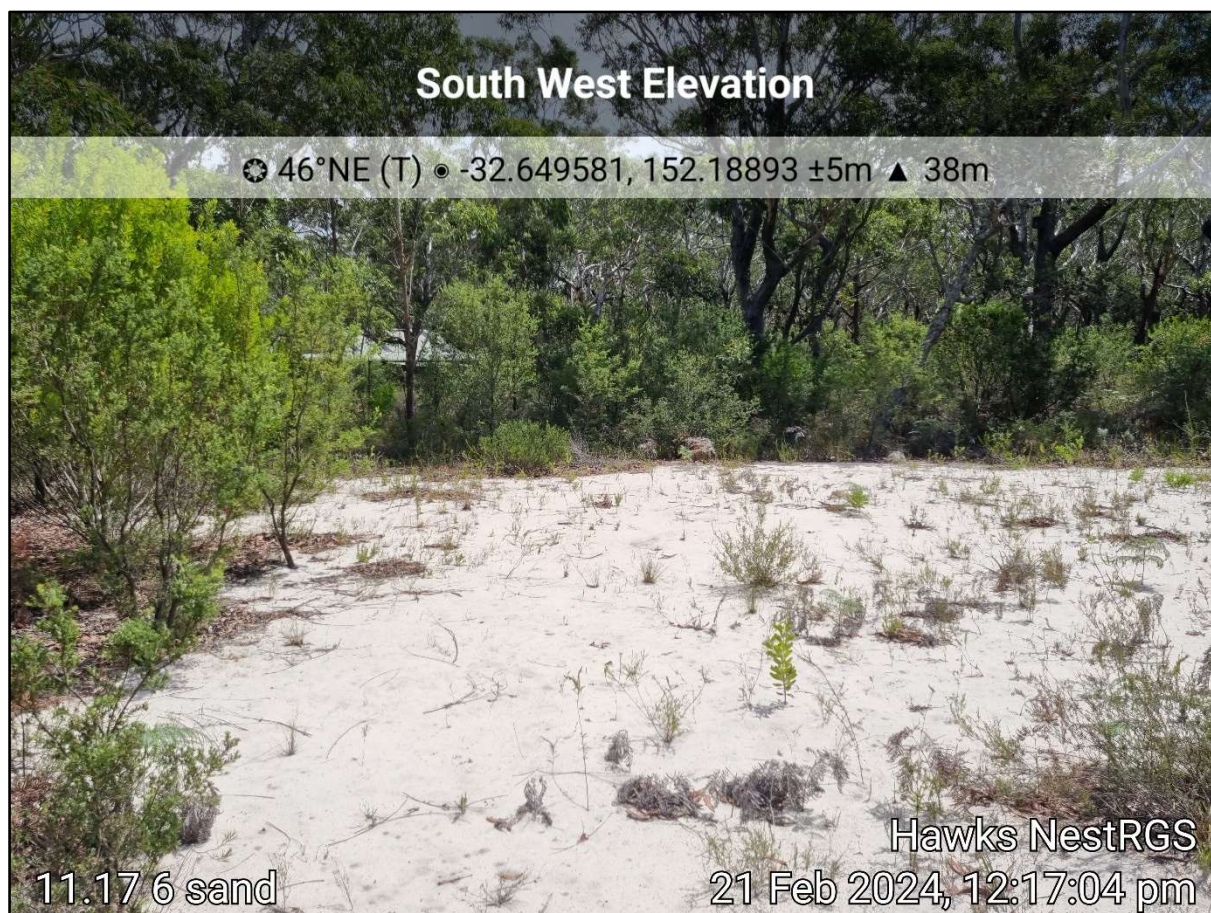
Plate 4: Exposed surface in east of site, beach sands with no indications of HMSRs

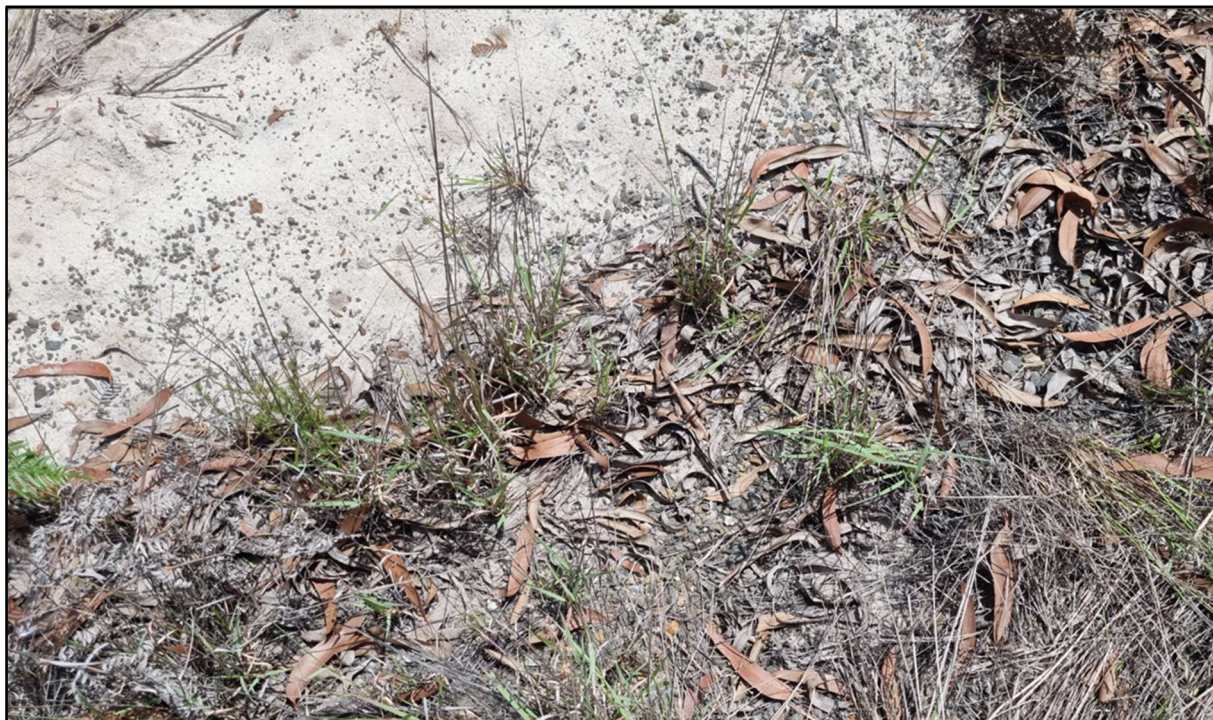
Plate 5: Some roadbase basalt gravel, beach sands with no indications of HMSRs

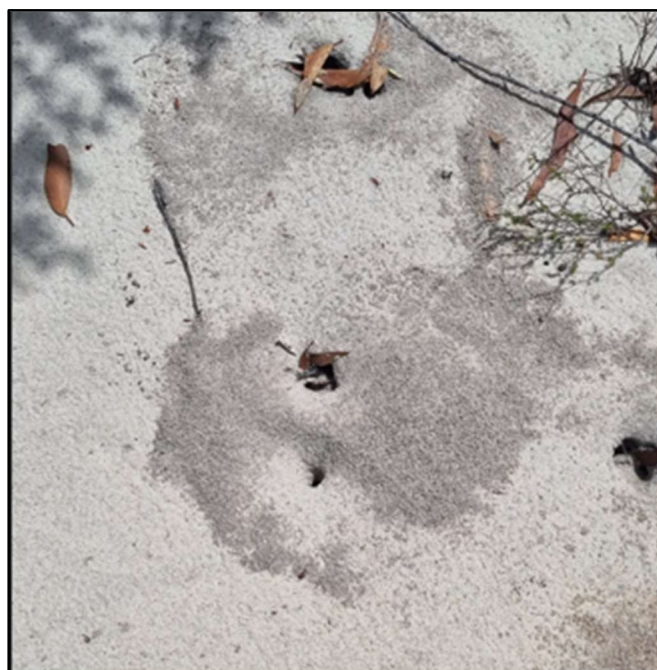
Plate 6: Animal burrows, beach sands with no indications of HMSRs

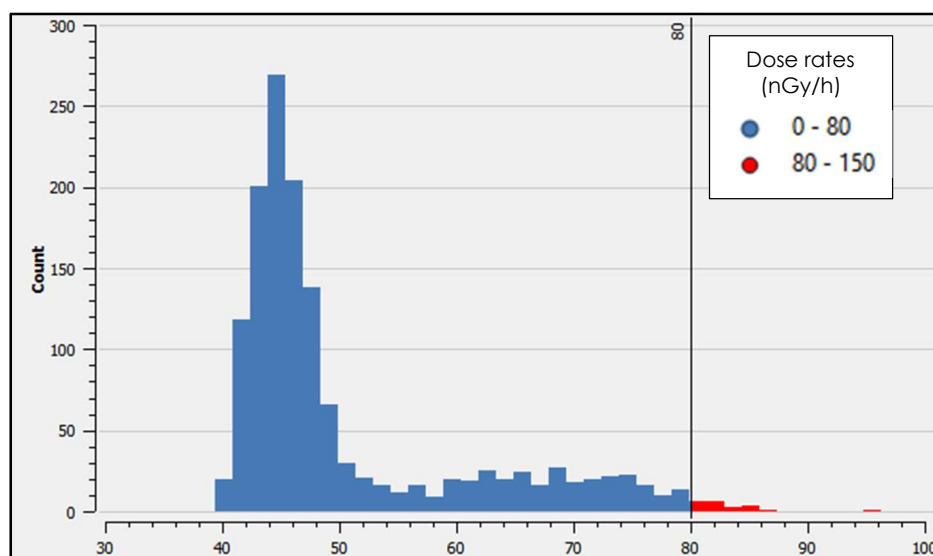
This is further supported by the surface gamma radiation survey results, which are all less than the screening reference level of 150 nanograys per hour (nGy/h), as shown in Figure A.

Figure A: Summary of dose rates (nGy/h)

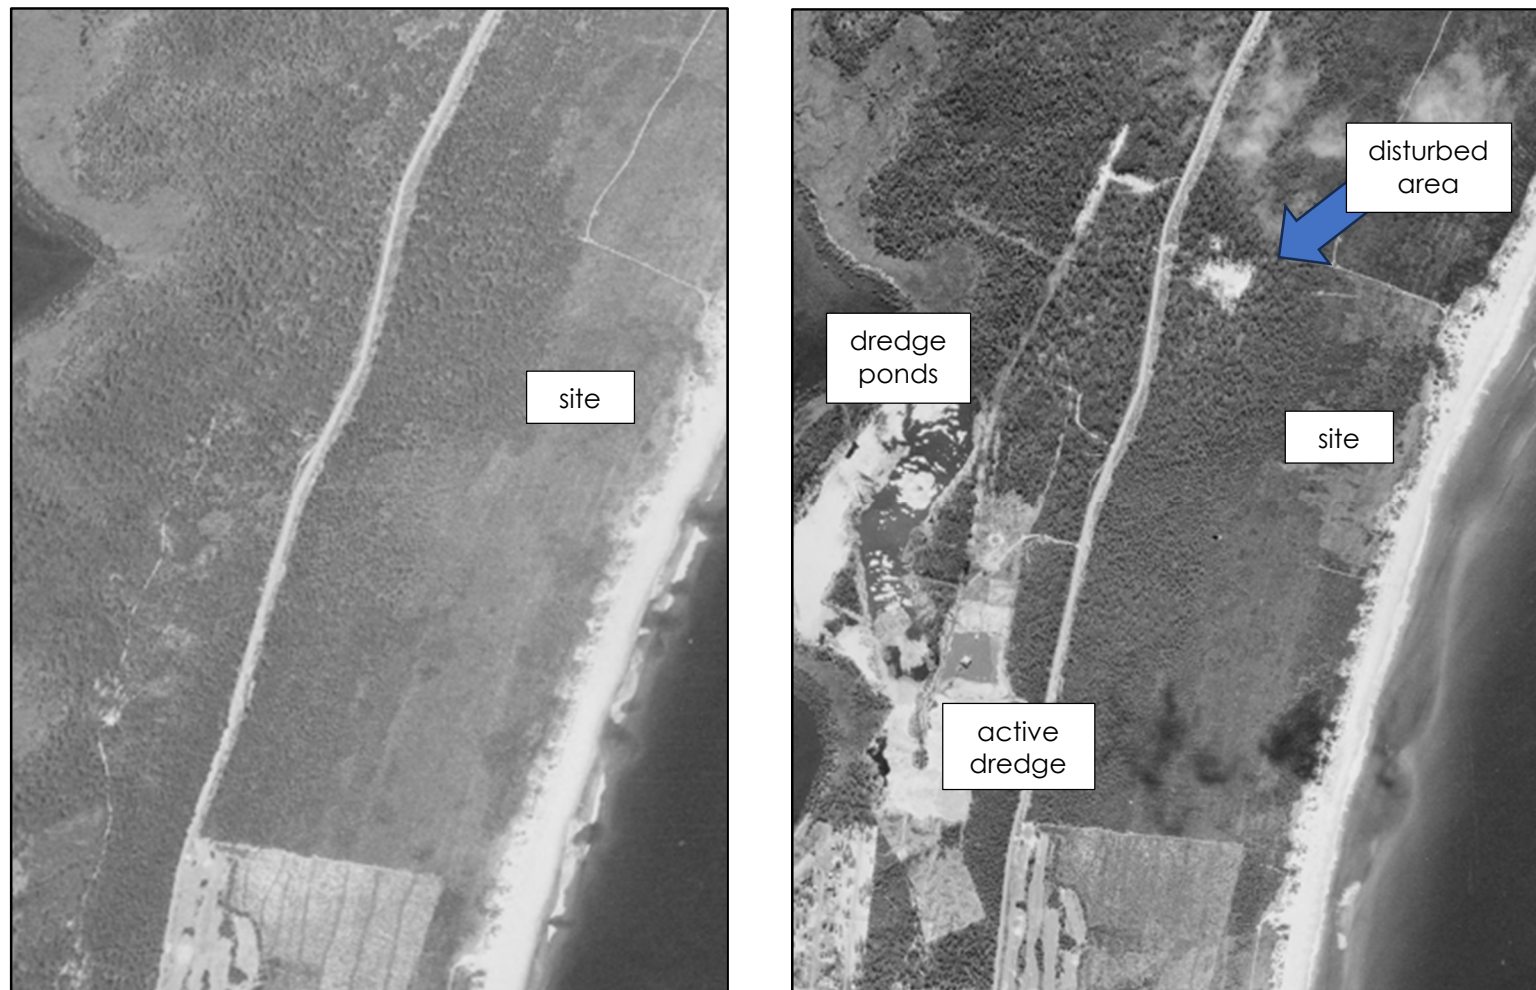
Figure 2: Aerial photographs circa 1970 and circa 1973, showing site and sand mining being conducted off-site to the west
Source: NSW Spatial Services, Historical, Aerial and Satellite Imagery

Whereas an area of disturbed sand is shown in the 1973 photograph in Figure 2, comparison with the area of the active dredge and associated dredge ponds, along with the former dredge paths, and the operations at the MDL plant, including stockpiling of mineral sands, strongly suggests that this area of disturbed sand is unrelated to the mining of mineral sands or the disposal of mineral sands wastes.

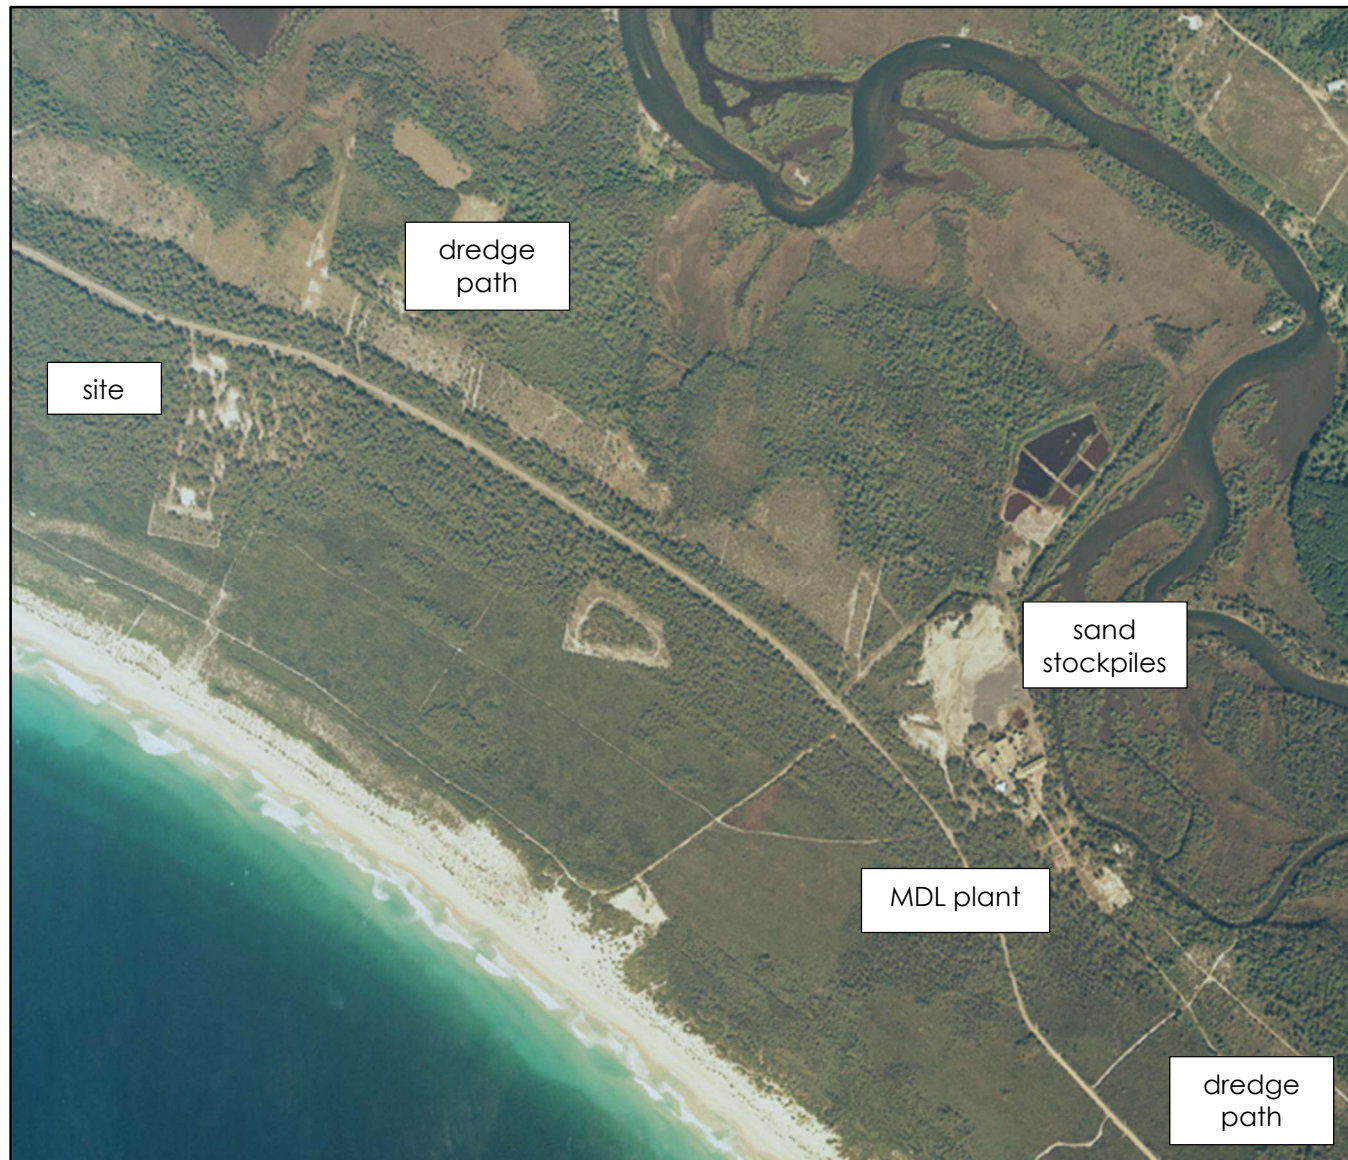
Figure 3: Aerial photograph circa 1993, showing MDL plant and sand stockpiles, and former dredge paths
