Supplementary Stage 2 Detailed Site Investigation

Western Sydney University
Milperra Campus, Milperra NSW

Report No: 2300-DSI-01-220224.v1f

Report Date: 22 February 2024

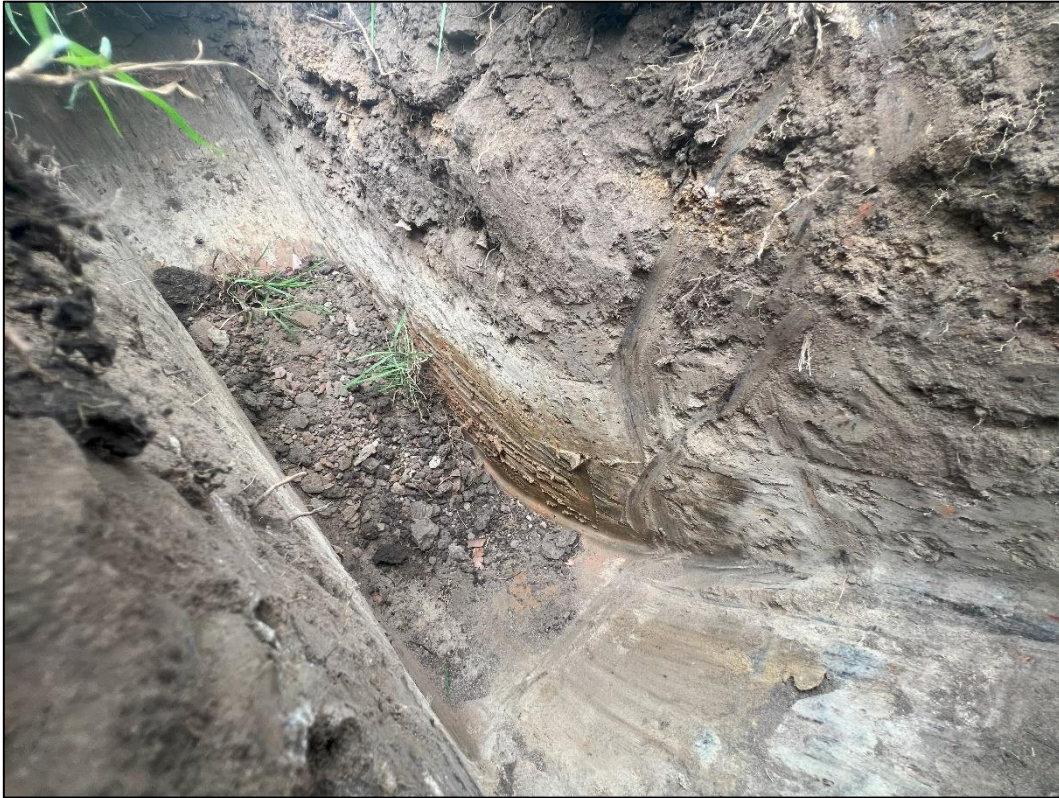
Site Photograph 10.2.1. General soil stratigraphy encountered within AEC02, as observed within 'TP28' on 9 January 2024.

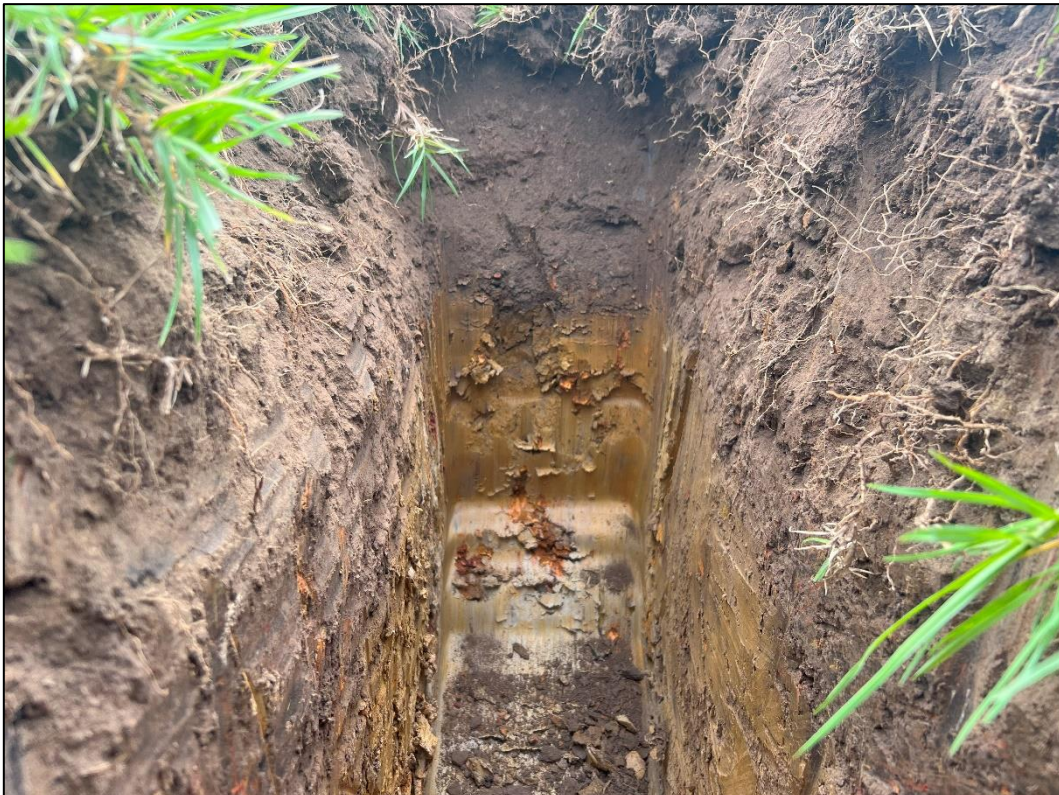
Site Photograph 10.2.2. General soil stratigraphy encountered within AEC02, as observed within 'TP06' on 11 January 2024.

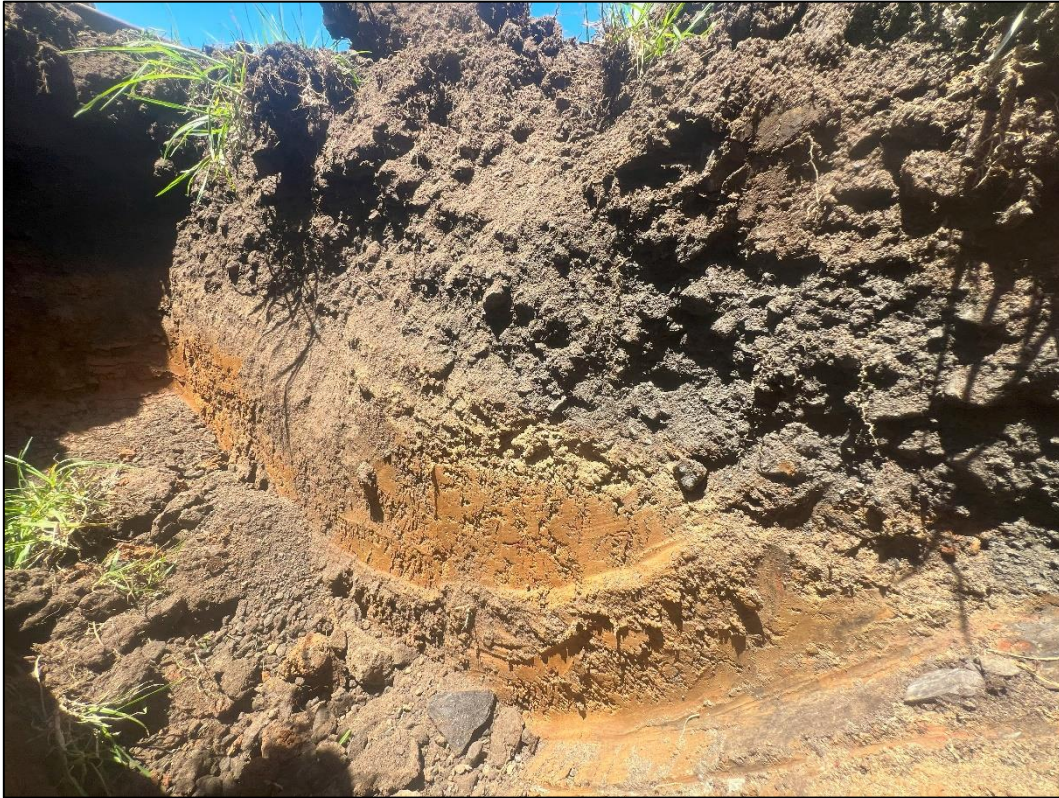
Site Photograph 10.2.3. General soil stratigraphy encountered within AEC03, as observed within 'TP06' on 11 January 2024.

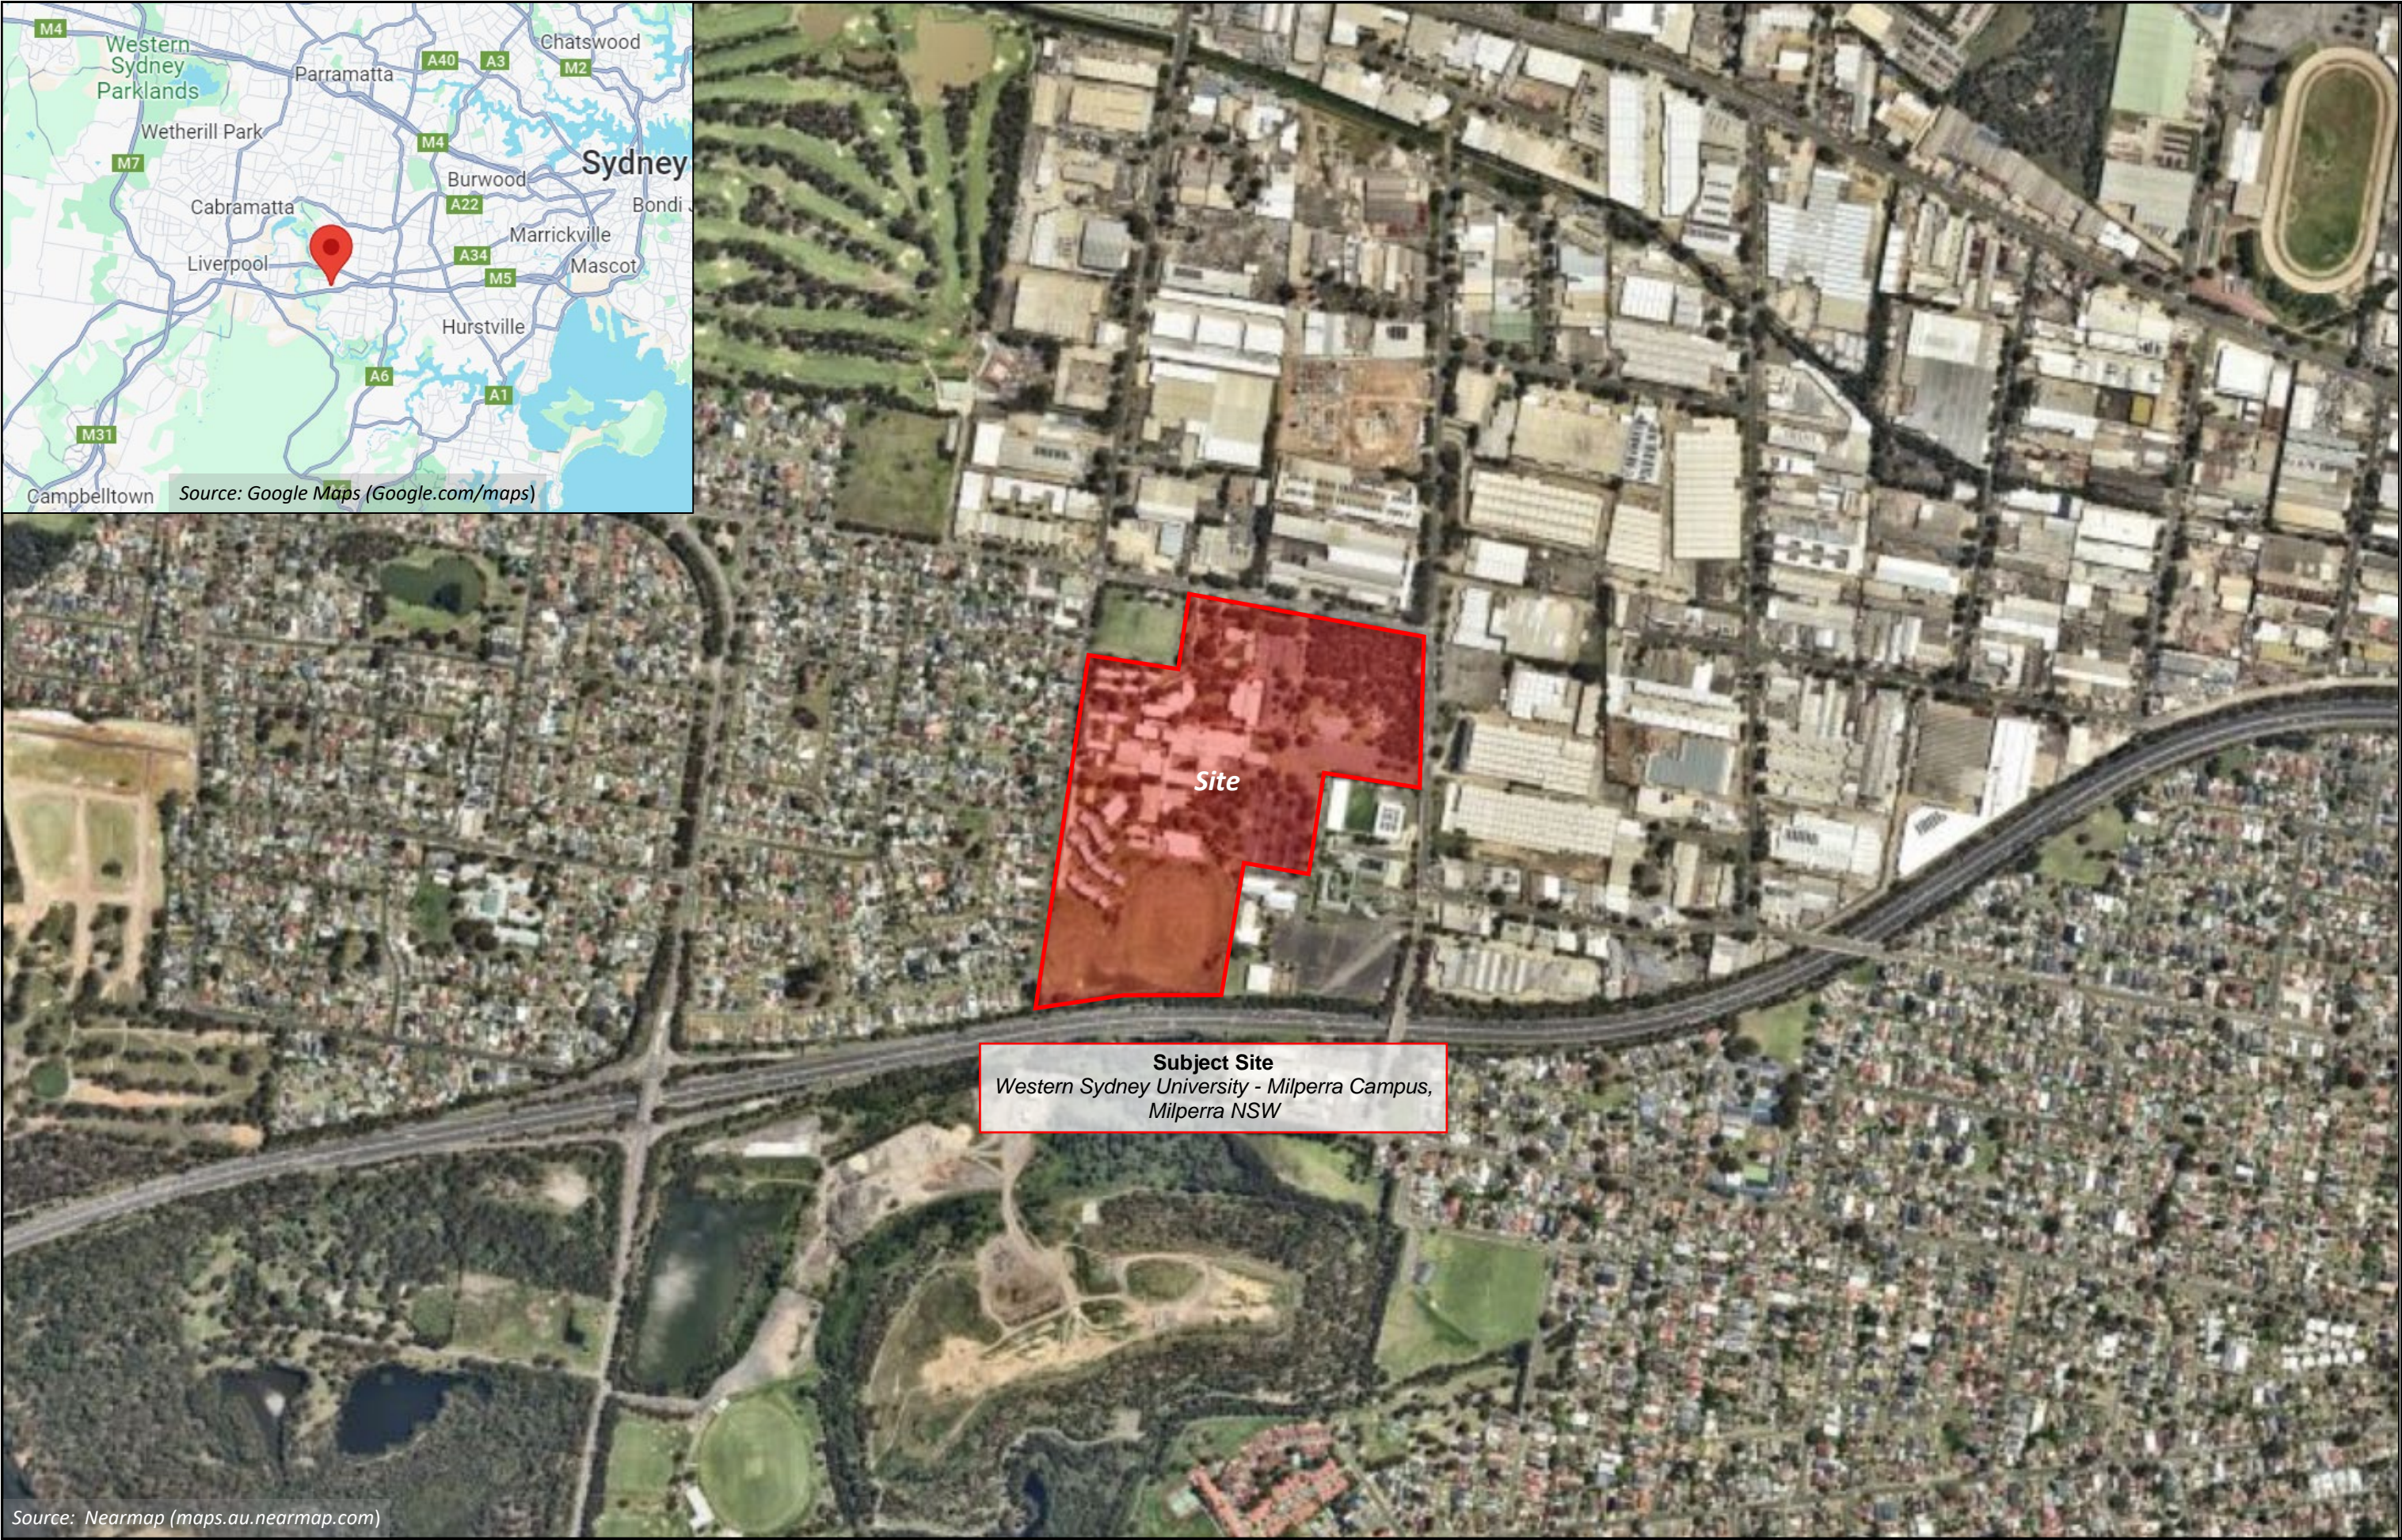
Figure Number:	2
	Project Name:	Supplementary Detailed Site Investigation				Figure Date:	22 February 2024
	Project Location:	Western Sydney University – Milperra Campus, Milperra NSW				Report Number:	2300-DSI-01-220224.v1d

<div>Sydney Environmental Group</div>	Site Locality						
	Client Name:	Mirvac Pty Ltd

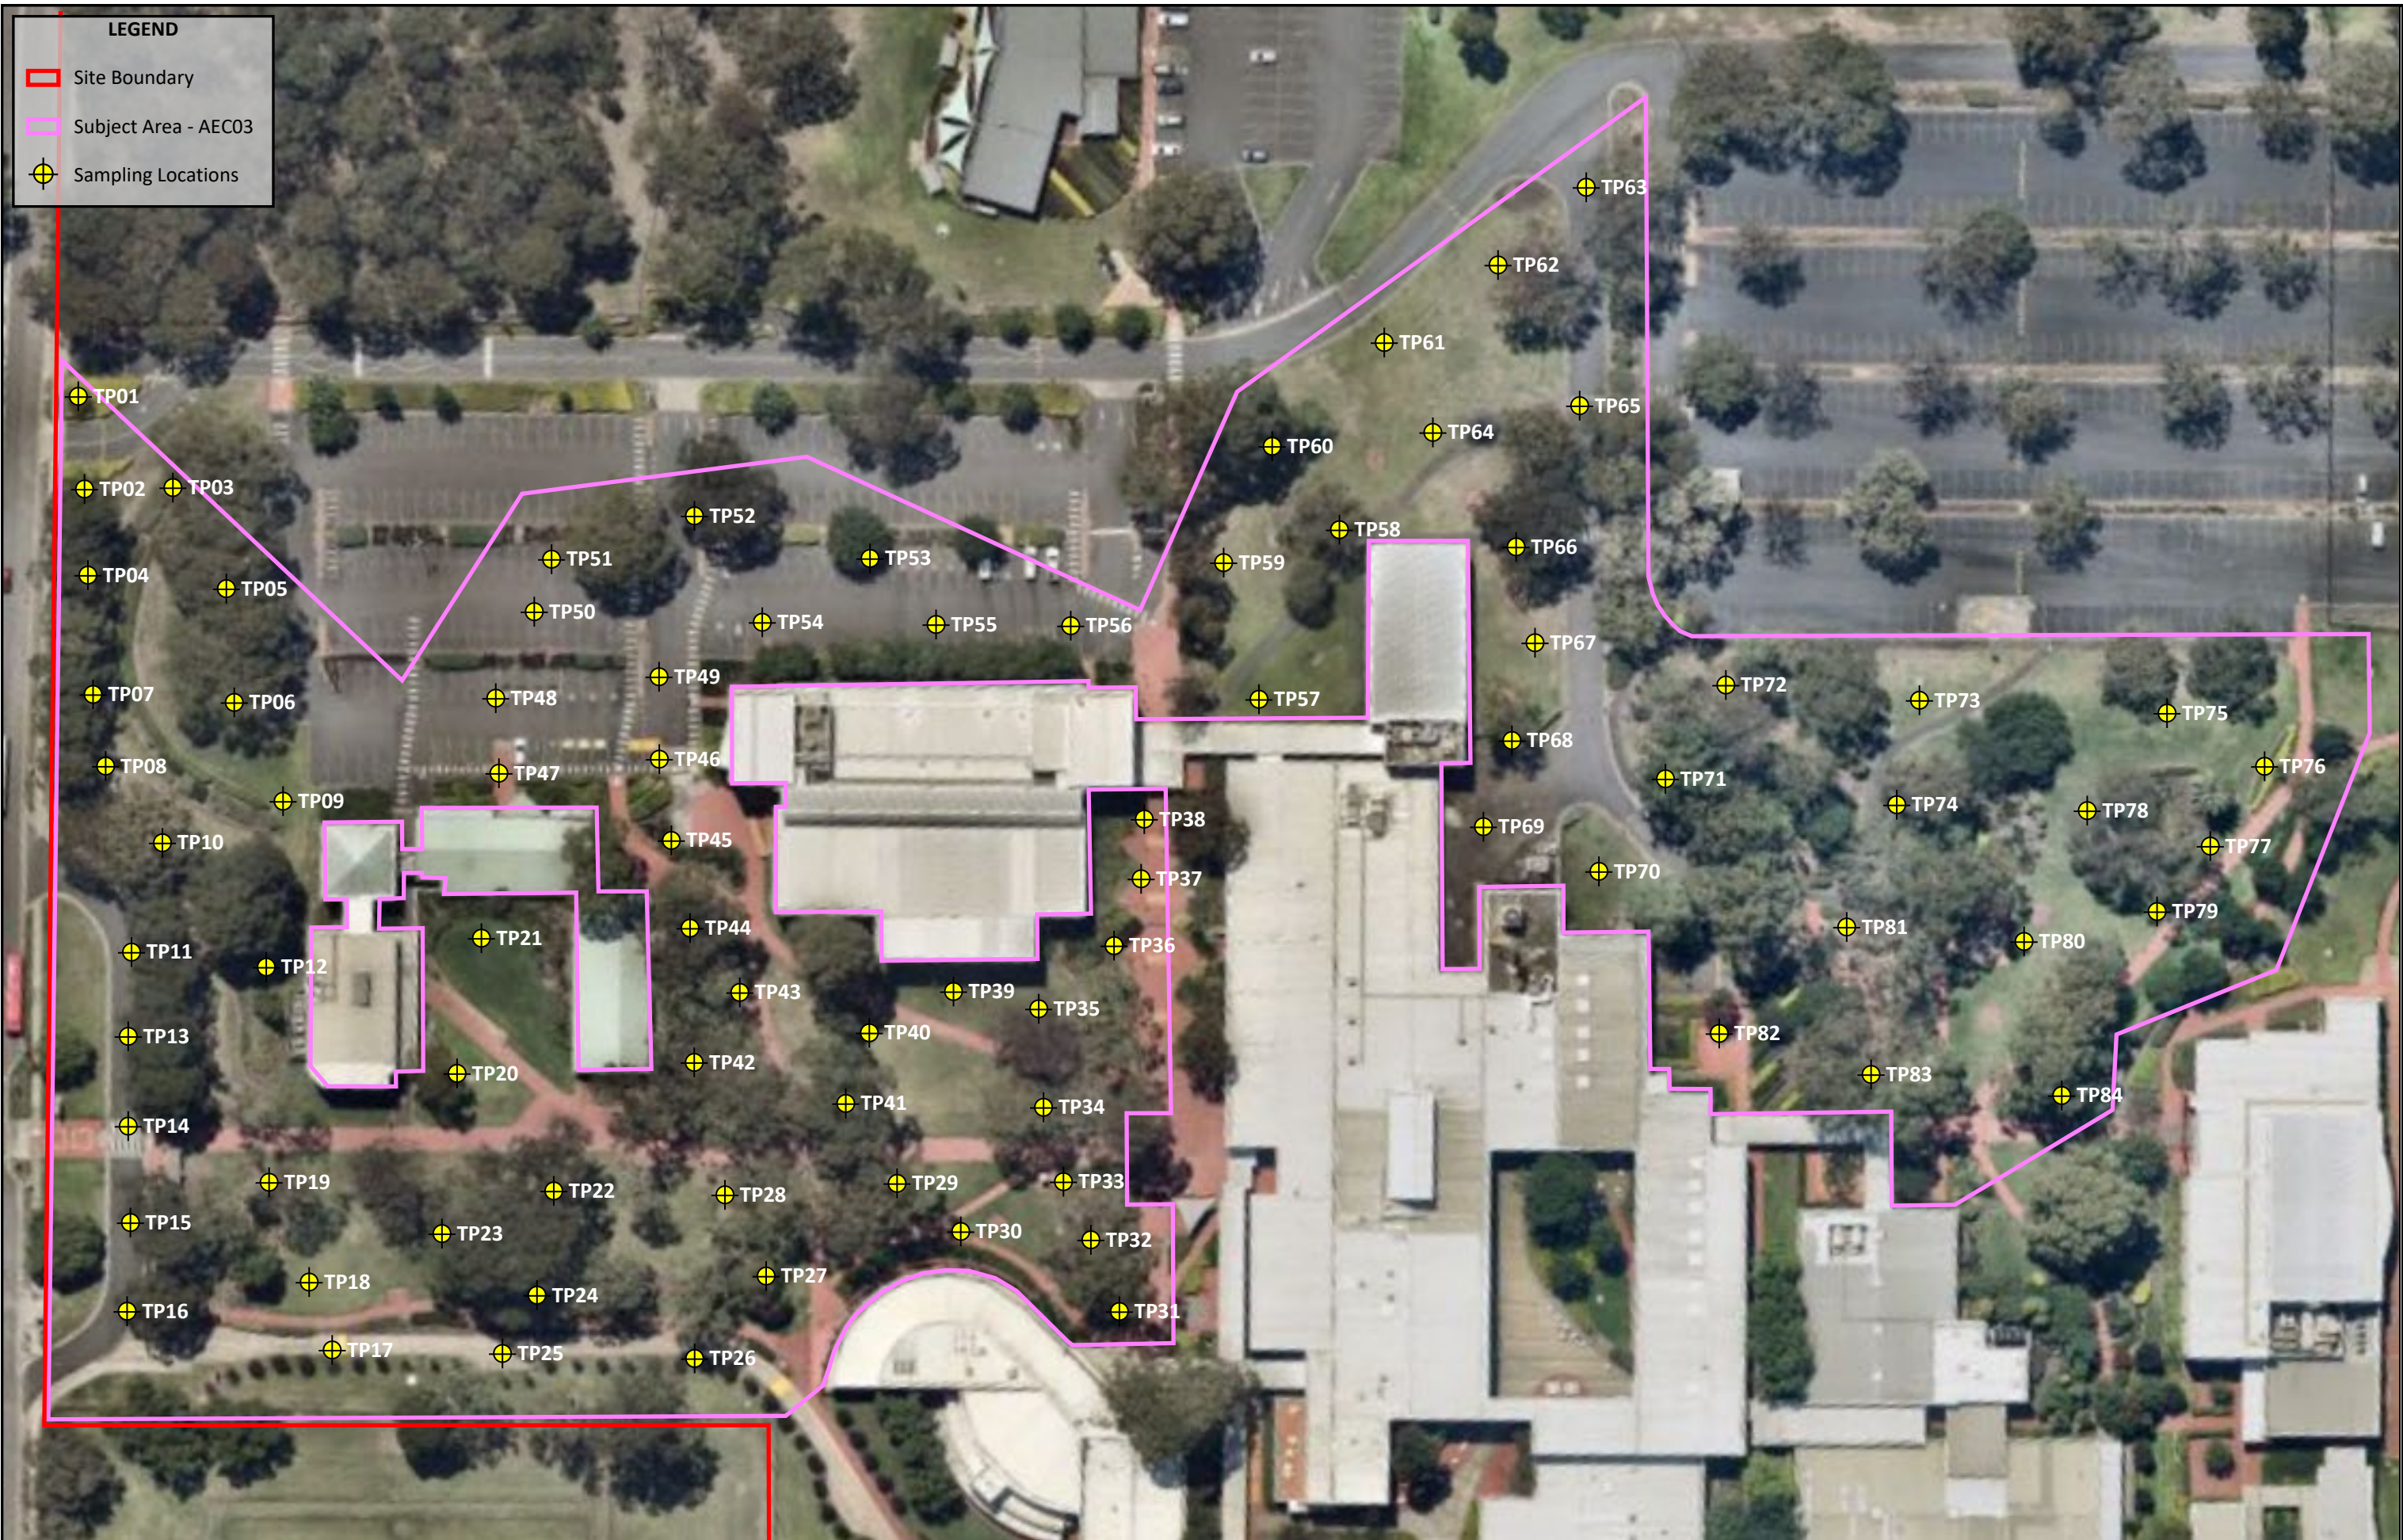
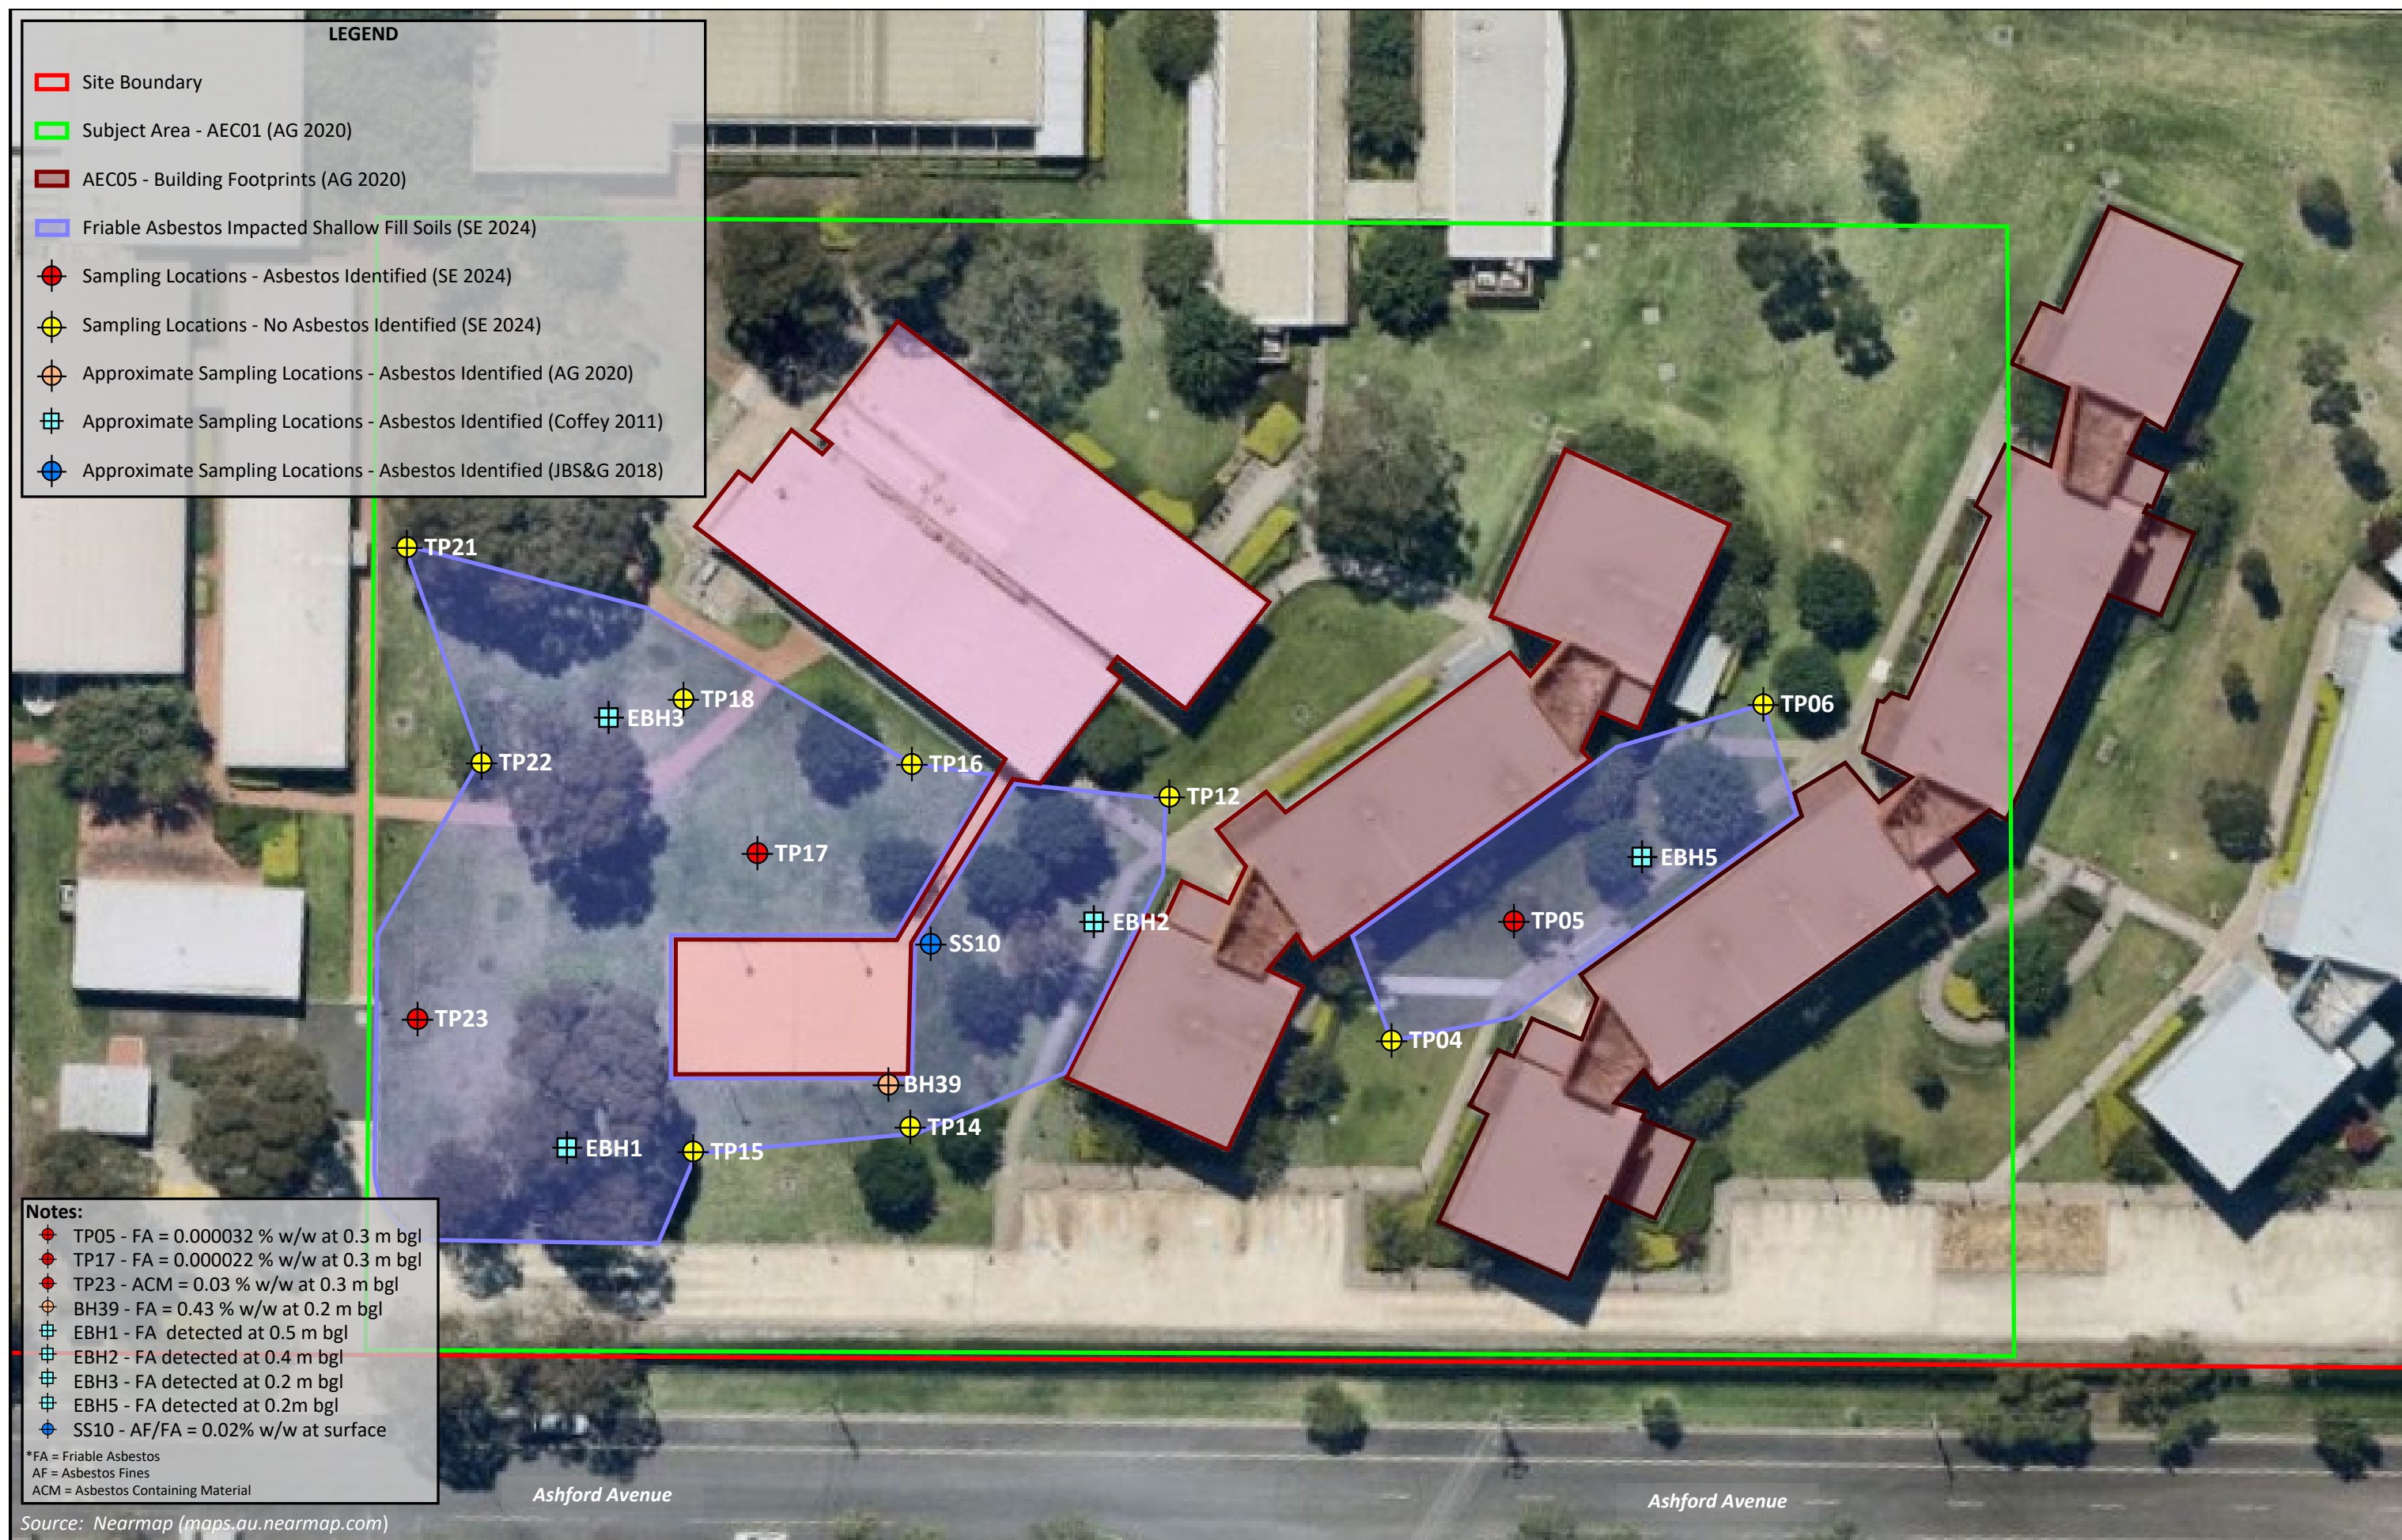
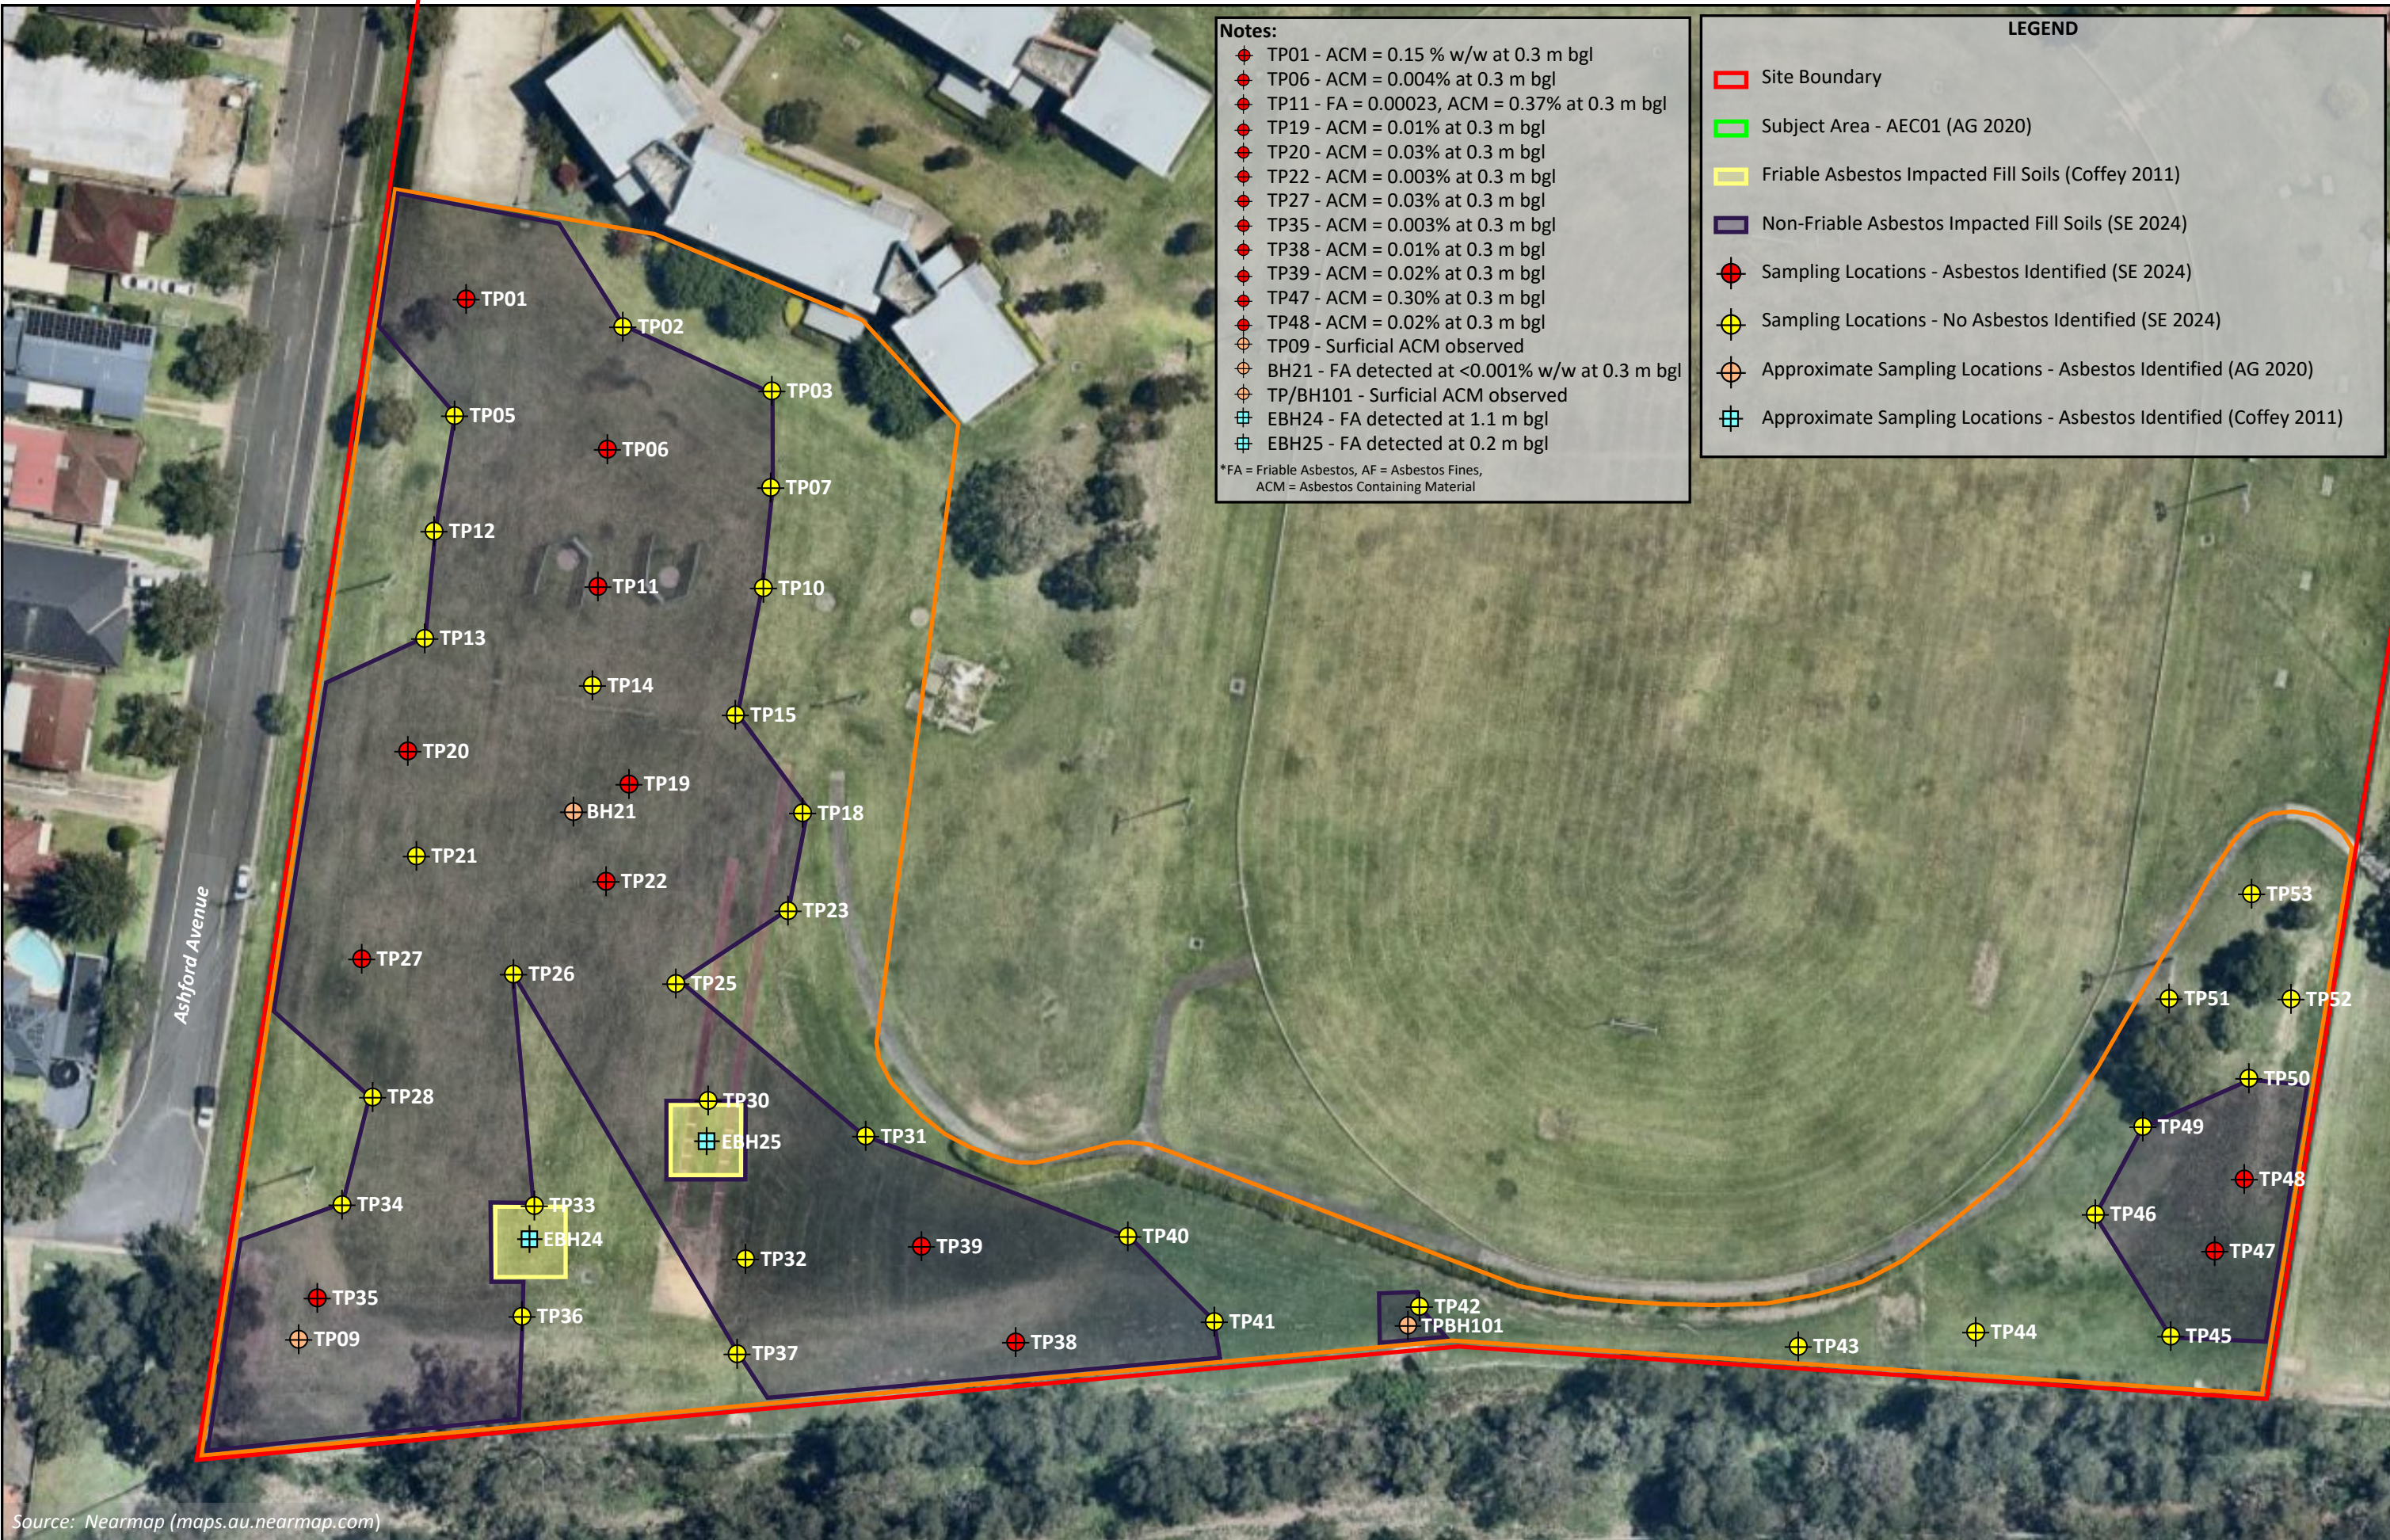
- TP01 - ACM = 0.15 % w/w at 0.3 m bgl
- TP06 - ACM = 0.004% at 0.3 m bgl
- TP11 - FA = 0.00023, ACM = 0.37% at 0.3 m bgl
- TP19 - ACM = 0.01% at 0.3 m bgl
- TP20 - ACM = 0.03% at 0.3 m bgl
- TP22 - ACM = 0.003% at 0.3 m bgl
- TP27 - ACM = 0.03% at 0.3 m bgl
- TP35 - ACM = 0.003% at 0.3 m bgl
- TP38 - ACM = 0.01% at 0.3 m bgl
- TP39 - ACM = 0.02% at 0.3 m bgl
- TP47 - ACM = 0.30% at 0.3 m bgl
- TP48 - ACM = 0.02% at 0.3 m bgl
- TP09 - Surficial ACM observed
- BH21 - FA detected at <0.001% w/w at 0.3 m bgl
- TP/BH101 - Surficial ACM observed
- EBH24 - FA detected at 1.1 m bgl
- EBH25 - FA detected at 0.2 m bgl

- TP19 - ACM = 0.085 % w/w at 0.3 m bgl
- TP28 - ACM = 0.191 % w/w at 0.3 m bgl
- TP42 - ACM = 0.006 % w/w at 0.3 m bgl
- TP57 - ACM = 0.053 % w/w at 0.3 m bgl
- TP68 - ACM = 0.344 % w/w at 0.3 m bgl
- TP70 - ACM = 0.156 % w/w at 0.3 m bgl
- TP71 - ACM = 0.002 % w/w at 0.3 m bgl
- TP53 - ACM = > 0.01 % w/w at 0.3 m bgl
- TP56 - ACM = > 0.01 % w/w at 0.3 m bgl
- BH59 - Surficial ACM observed

- An addendum to the existing Remedial Action Plan prepared by AG (2022) is required to outline the remediation methodologies required to remediate the newly identified extents of asbestos contamination identified.
- Following removal of hazardous building materials (if identified) and subsequent demolition of the onsite structures, a clearance inspection should be carried out by an appropriately qualified occupational hygienist / NSW LAA;
- A supplementary contamination assessment is required within AEC01a prior to the start of remedial works at the site;
- Additional contamination assessments are required to be undertaken per the site RAP (AG 2022) prior to the start of remediation works at the site; and
- A waste classification assessment should be carried out on any soil materials proposed for disposal off-site as per the NSW EPA Waste Classification Guidelines (2014).

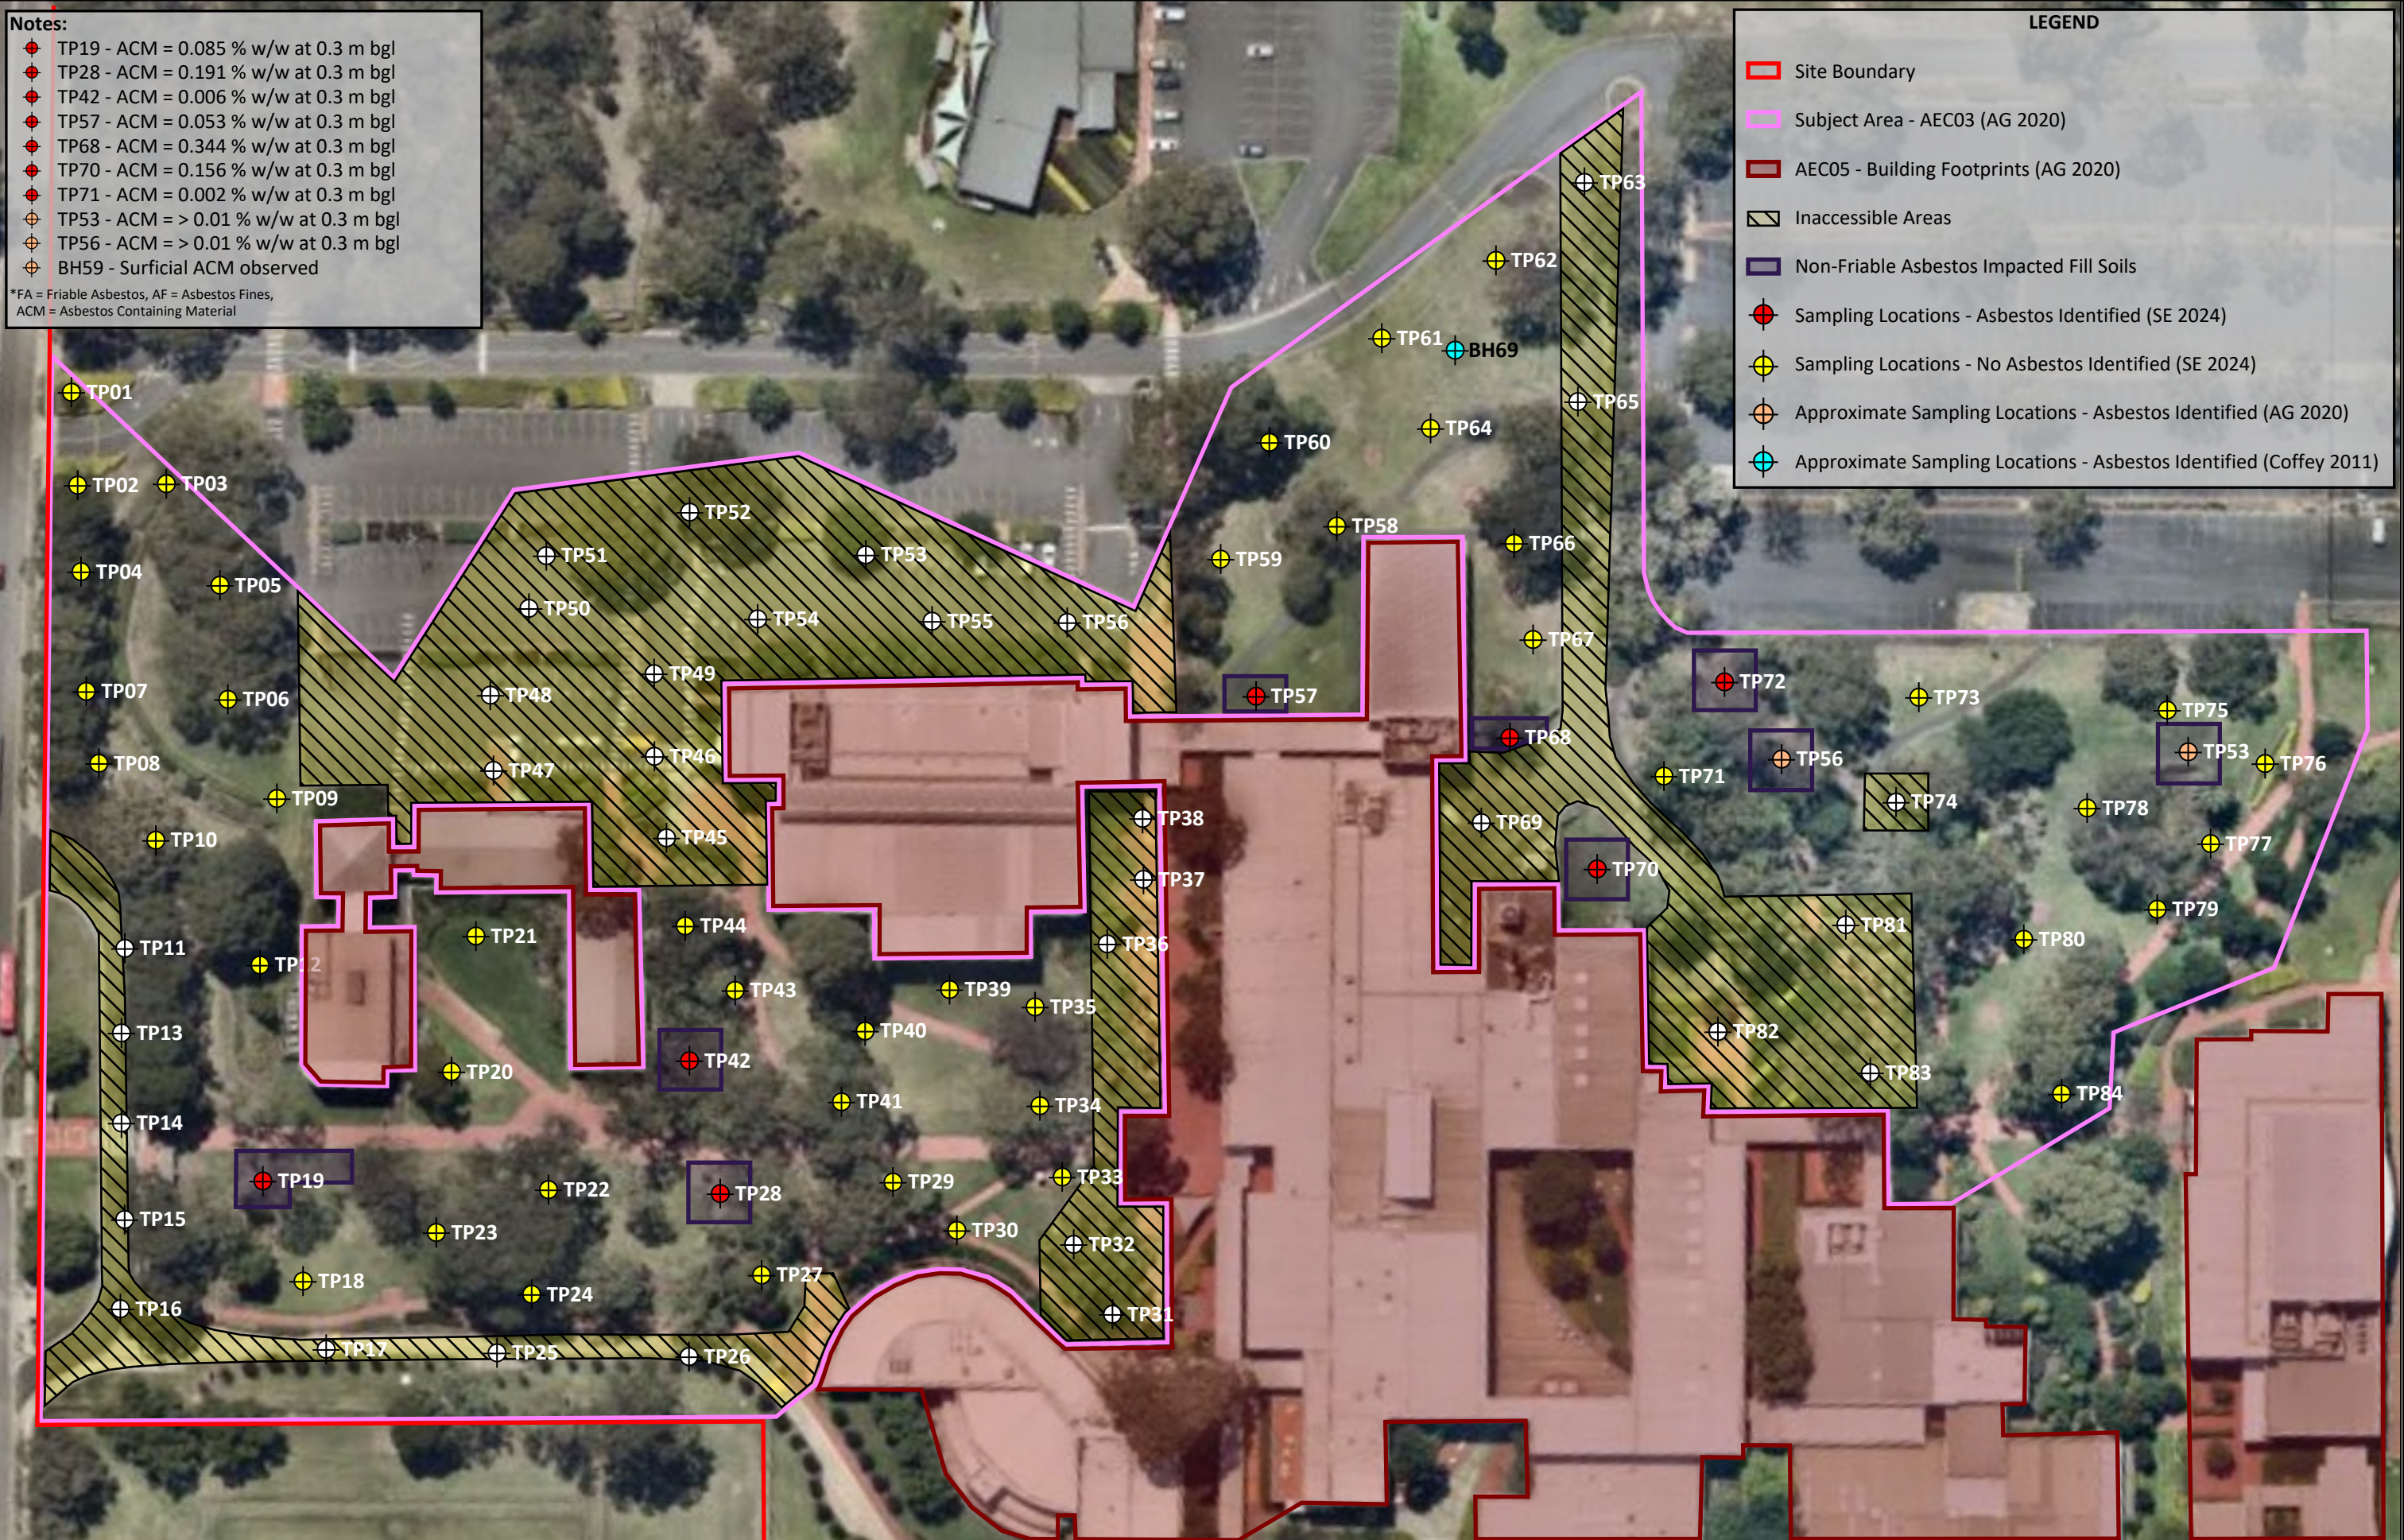
- Site Boundary
- Subject Area - AEC03 (AG 2020)
- AEC05 - Building Footprints (AG 2020)
- Inaccessible Areas
- Non-Friable Asbestos Impacted Fill Soils
- Sampling Locations - Asbestos Identified (SE 2024)
- Sampling Locations - No Asbestos Identified (SE 2024)
- Approximate Sampling Locations - Asbestos Identified (AG 2020)
- Approximate Sampling Locations - Asbestos Identified (Coffey 2011)
