## Compaction & Soil Testing Services Pty Ltd

Reference: PWC4778 – AA

### ***Preliminary Site Investigation 28 & 30 Forrest Road, East Hills NSW 2213***

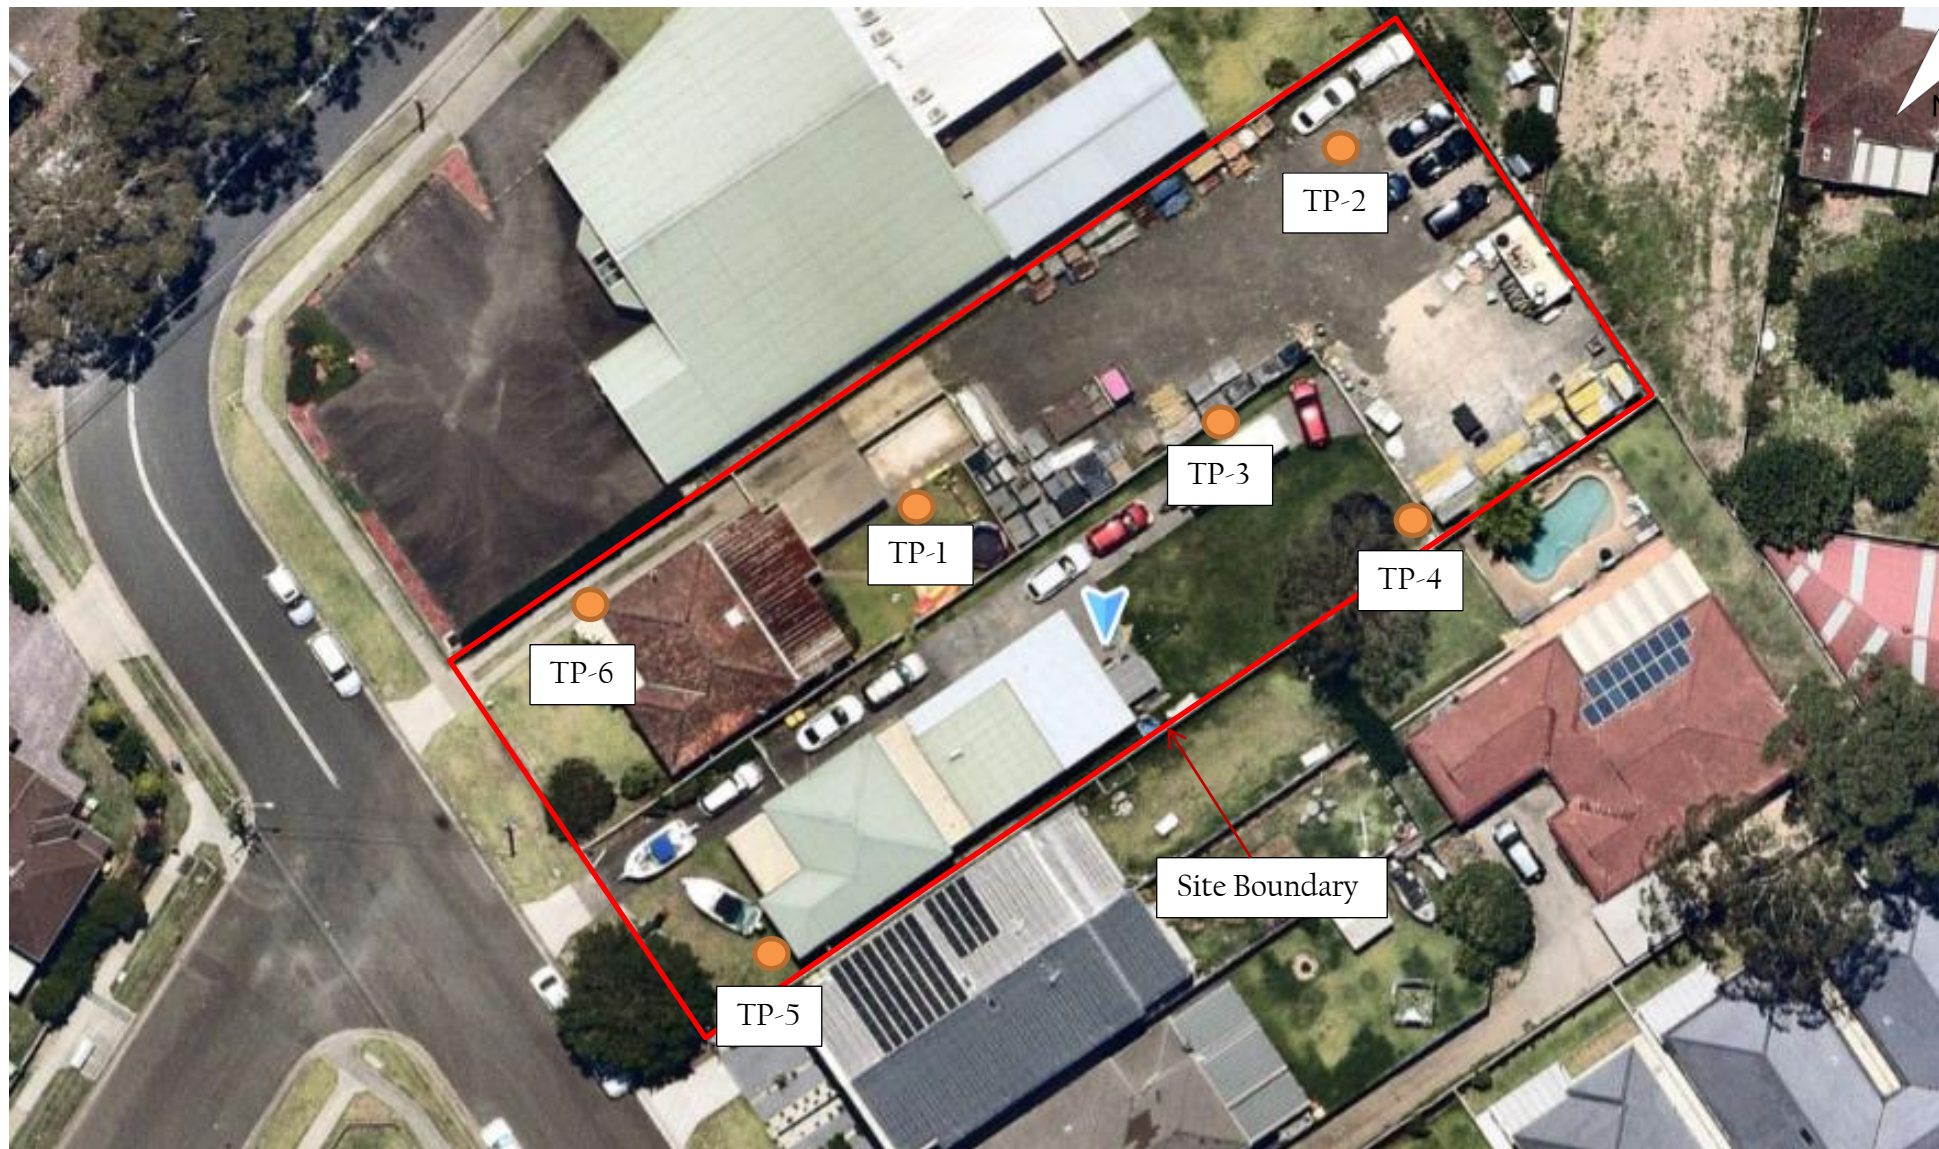
Drawn:	KD	<b>Site Drawing – Sampling Layout</b> Site drawing for 28 & 30 Forrest Street, East Hills 2213 NSW. Lot 37 and 38 of DP14650. Approximate GPS Coordinates of (GDA2020): -33.960654, 150.987223.	Drawing No:	AA 001
Approved:	PS		Project Code	
Date:	5/05/2023		PWC4778

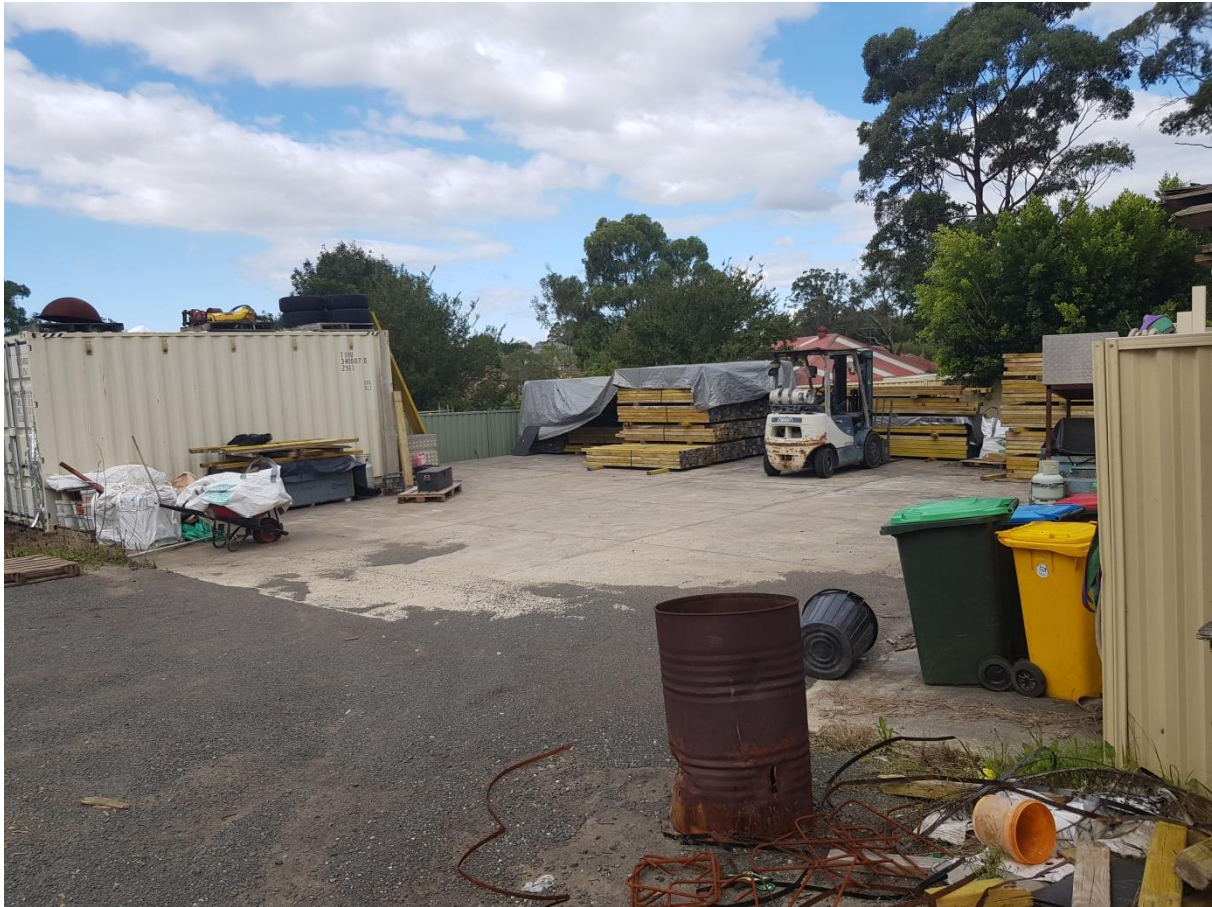
**Photograph 1, 2, 3, 4 and 5** – Rear section of Lot 38, located on the East of the site of interest, showing piles of wood, fencing and various construction materials. 30 Forrest Street, East Hills 2213 NSW. Approximate GPS Coordinates of (GDA2020): -33.960527, 150.98728.

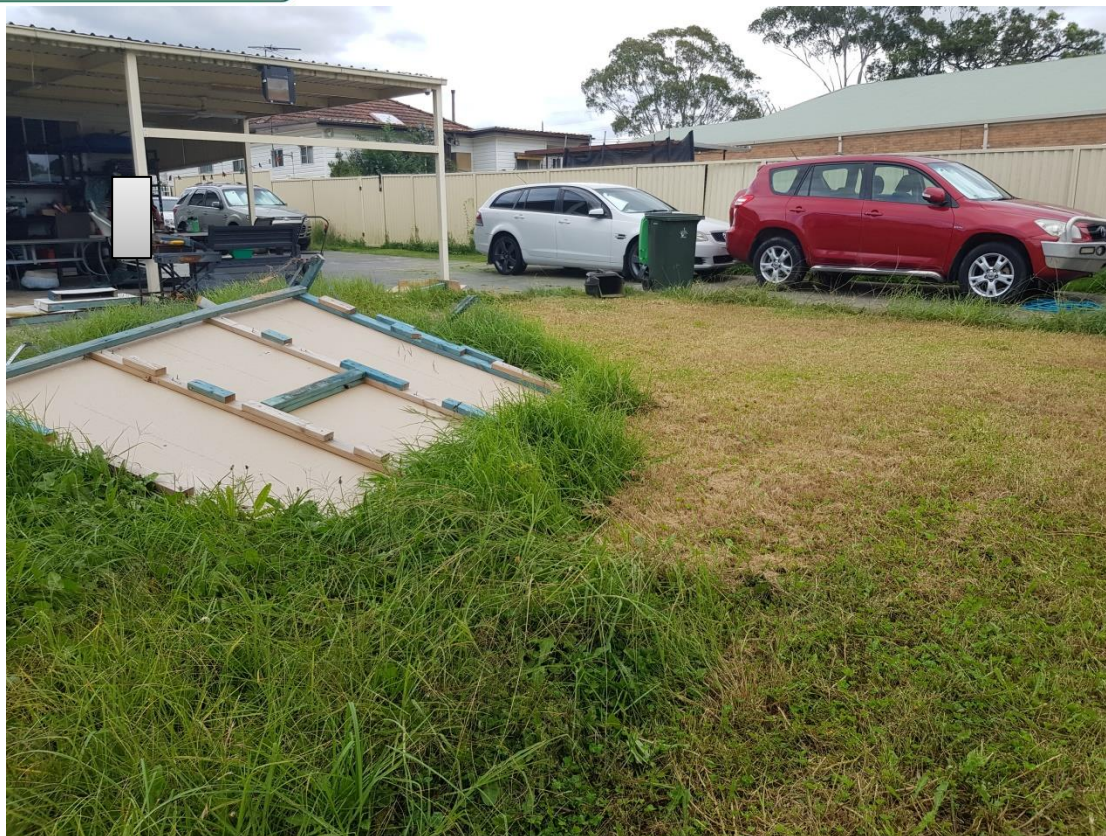
**Photograph 6, 7, 8** – Rear section of Lot 37, located on the East of the site of interest, showing several vehicles and a tree. 28 Forrest Street, East Hills 2213 NSW. Approximate GPS Coordinates of (GDA2020): -33.960653, 150.987359.

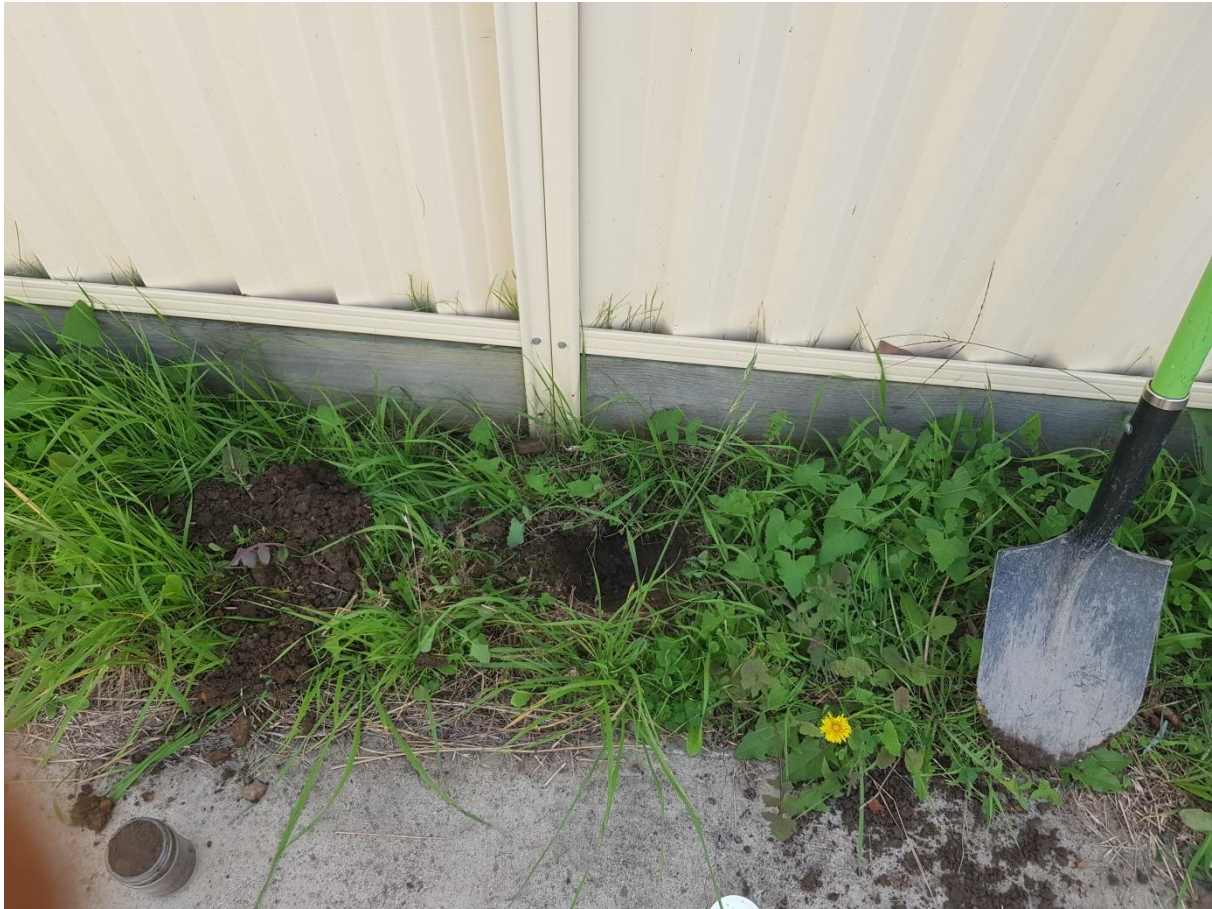
**Photograph 9** - Driveway section of Lot 38, located on the East of the site of interest, showing test-pit 1. 30 Forrest Street, East Hills 2213 NSW. Approximate GPS Coordinates of (GDA2020): -33.960602, 150.98705.

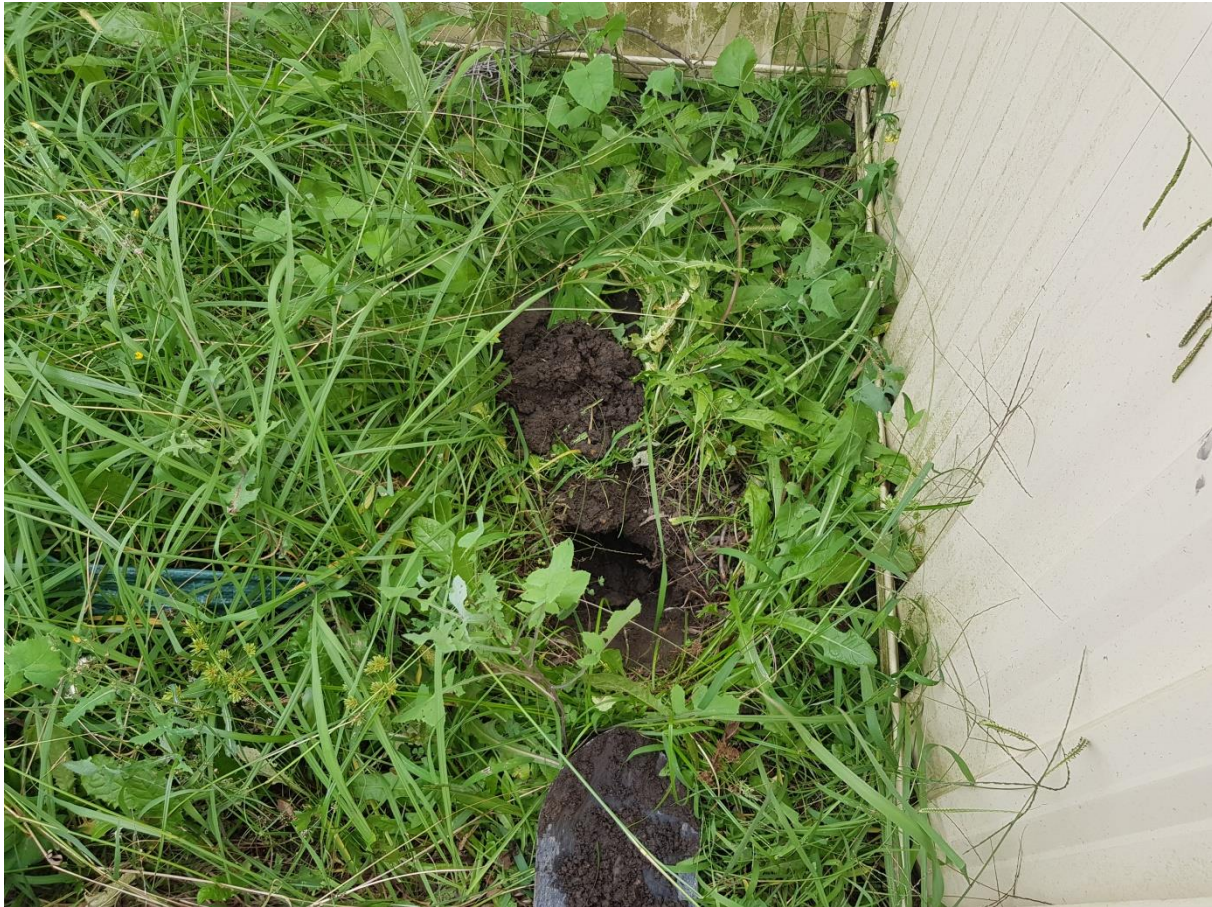
**Photograph 10** – Rear section of Lot 37, showing test-pit 3. 28 Forrest Street, East Hills 2213 NSW. Approximate GPS Coordinates of (GDA2020): -33.960555, 150.987409.

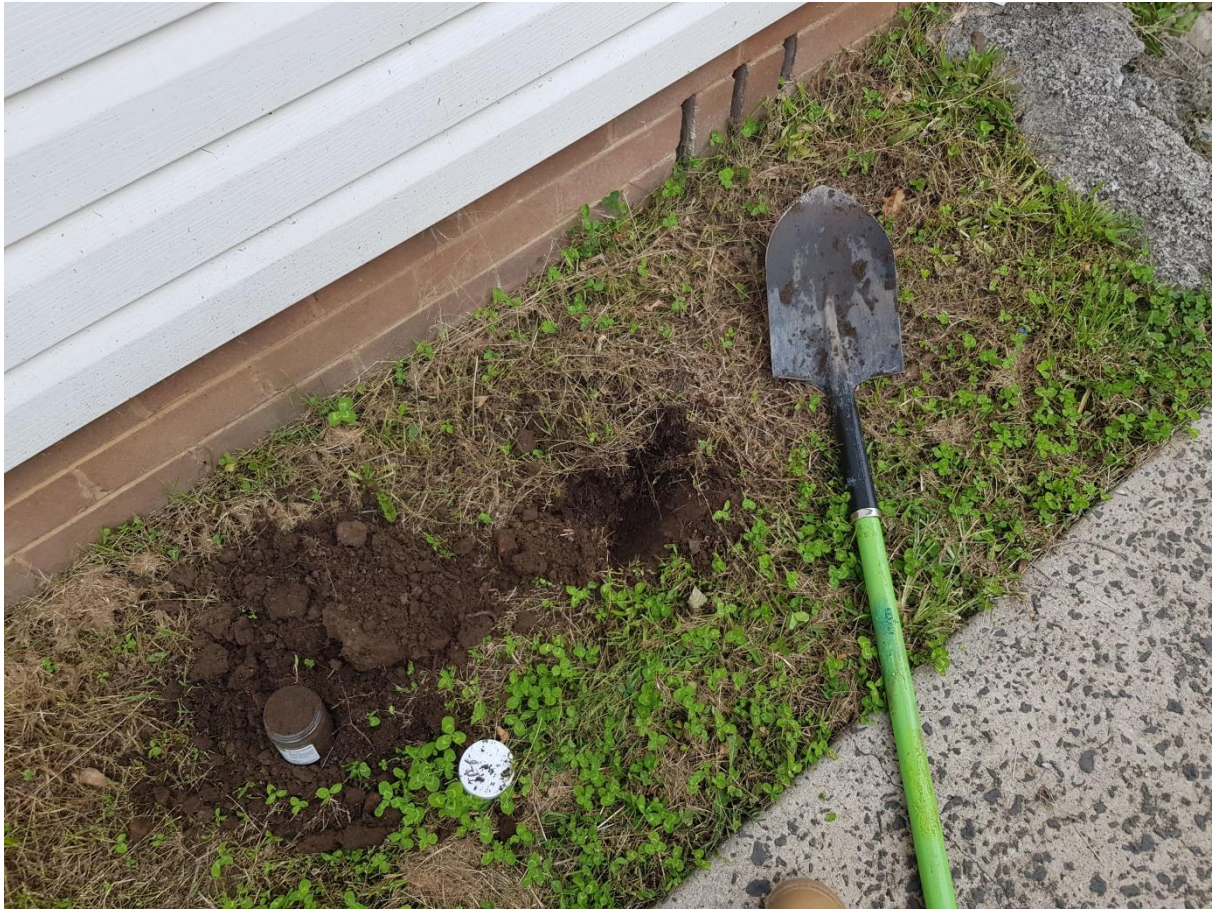
**Photograph 11** - Driveway section of Lot 38, showing test-pit 6. 30 Forrest Street, East Hills 2213 NSW. Approximate GPS Coordinates of (GDA2020): -33.960664, 150.98737.

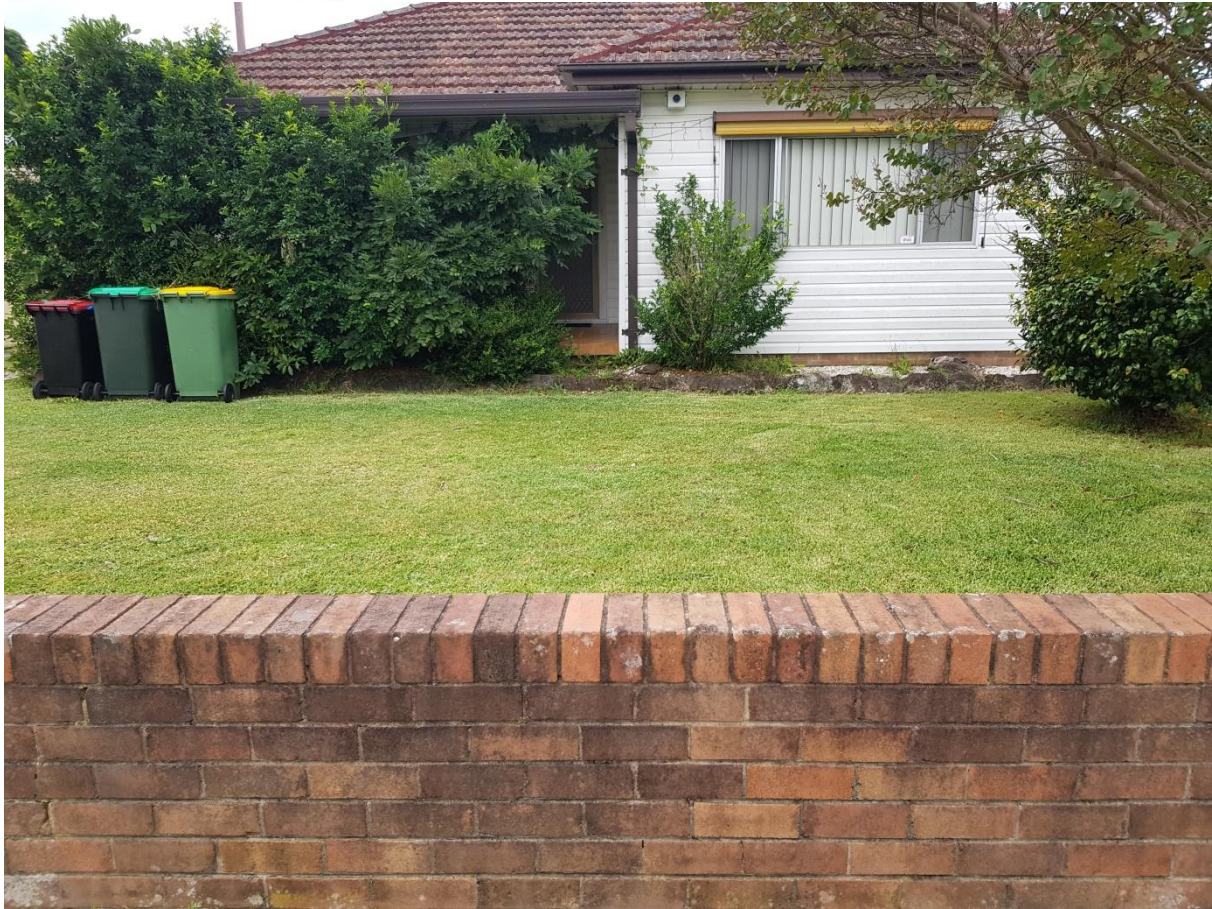
**Photograph 12** – Driveway section of Lot 37, located on the East of the site of interest, showing test-pit 1. 30 Forrest Street, East Hills 2213 NSW. Approximate GPS Coordinates of (GDA2020): -33.960778, 150.986843.
