Aboriginal Cultural Heritage Due Diligence Assessment Crackenback Ridge Water Supply Upgrade

Report Prepared for Kosciuszko Thredbo Pty Ltd

18 November 2024

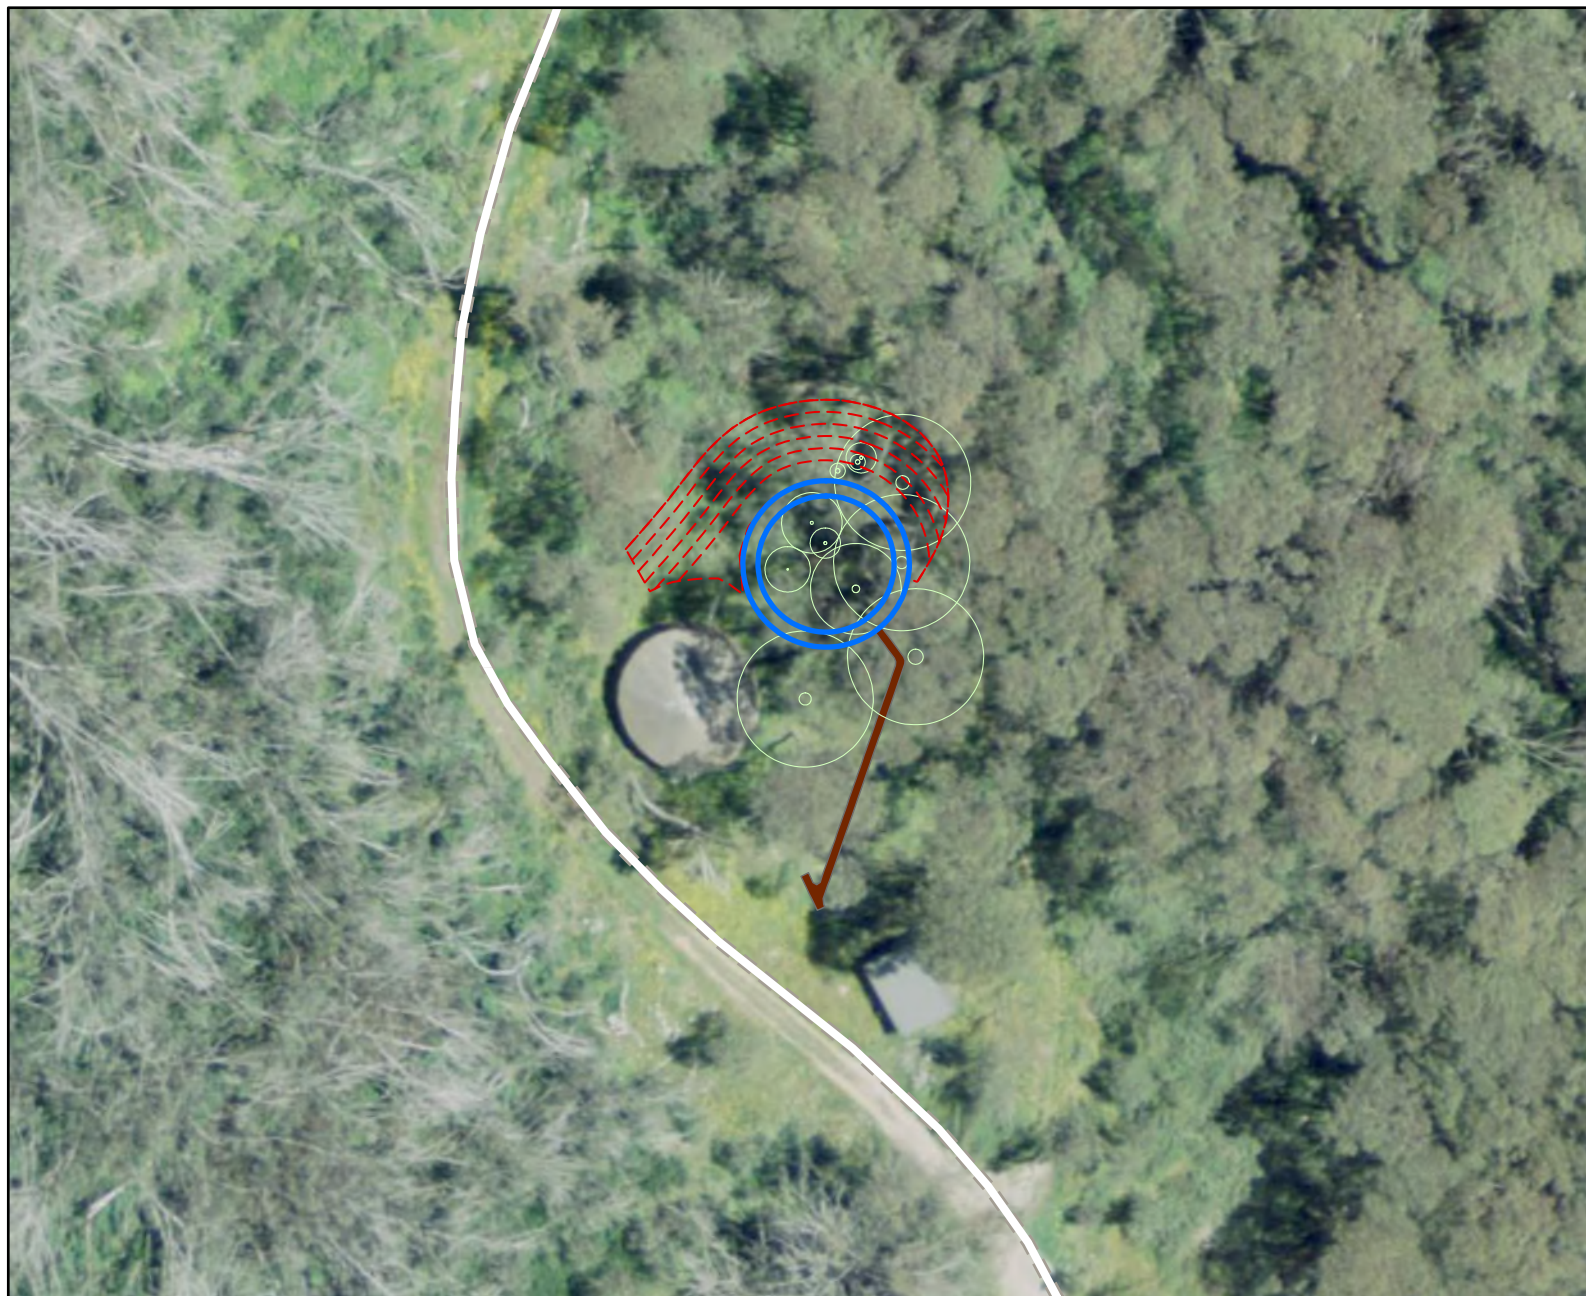
Figure 2: Project Area

-   Trees
-   New Tank & Footings
-   Earthworks
-   Trench

The proposed location of works is shown in Figure 1 in a regional context and in detail in Figure 2.

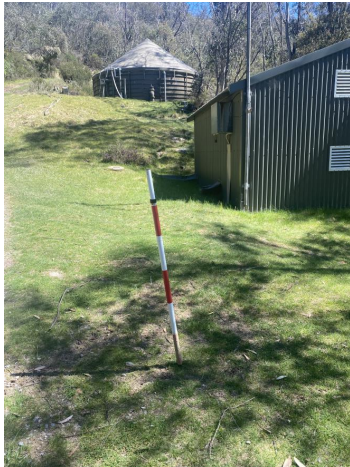
Plate 1. Current pumphouse and water tank – note benched areas for placement

The current water tank is located adjacent to the main fire trail leading from Cascade Close and ascending the middle to upper slopes. The water tank and current pump house are located within mid slopes with steep gradient slopes. Vegetation removal and soil displacement has occurred due to the previous works of tank and pipeline which is evident in mounds of displaced soils within the current footprint of the proposed additional tank (Plate 4) .

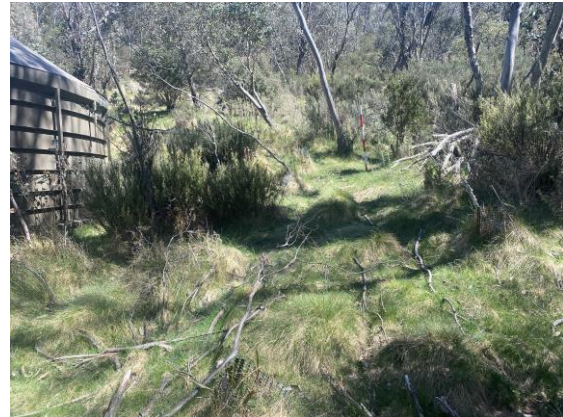
Plate 2. Proposed tank location amidst displaced soils from benching

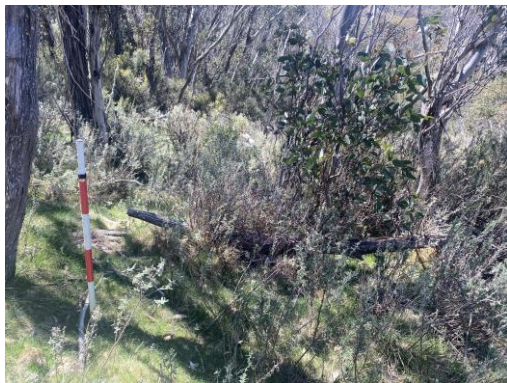
Plate 3. Vegetation coverage on slopes

As a result of the survey, no heritage sites or areas of potential were identified. Exposures are present in limited small areas of erosion and exposed soils. The general GSV in the area is considered low due to vegetation coverage at 35%.

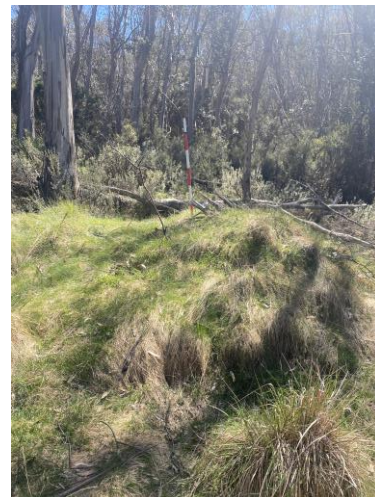
Plate 4. Example of mounded soils

As a result, the gradients on which the current water tank and proposed tank do not hold high potential and the locations of current water supply infrastructure, access points and surrounds have been highly impacted by previous works. The previous installation of the water tank, pumphouse and underground pipeline and construction of benching to allow placement (see Plate 1) and access have resulted in mounds of displaced soils in the adjacent areas (now overgrown) and level areas in each structure location (see Plate 4).

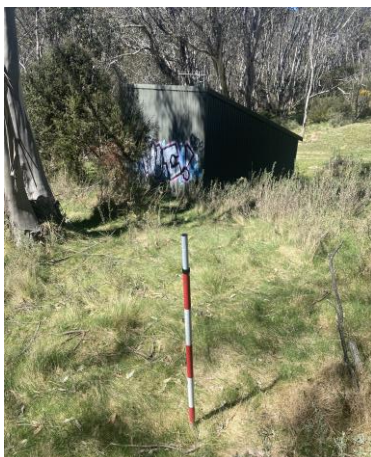
Plate 5. Pump House

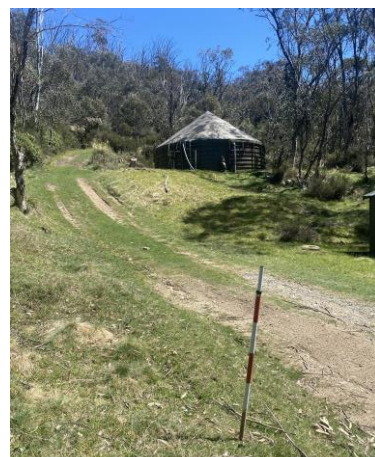
Plate 6. Current access fire trail
