Our ref: 7480-2-R1 Rev1  
20 December 2024

Kosciuszko Thredbo Pty Ltd / EVT  
1 Friday Drive  
Thredbo NSW 2625

## **Geotechnical Assessment for Crackenback Ridge Water Supply Upgrade Thredbo NSW**

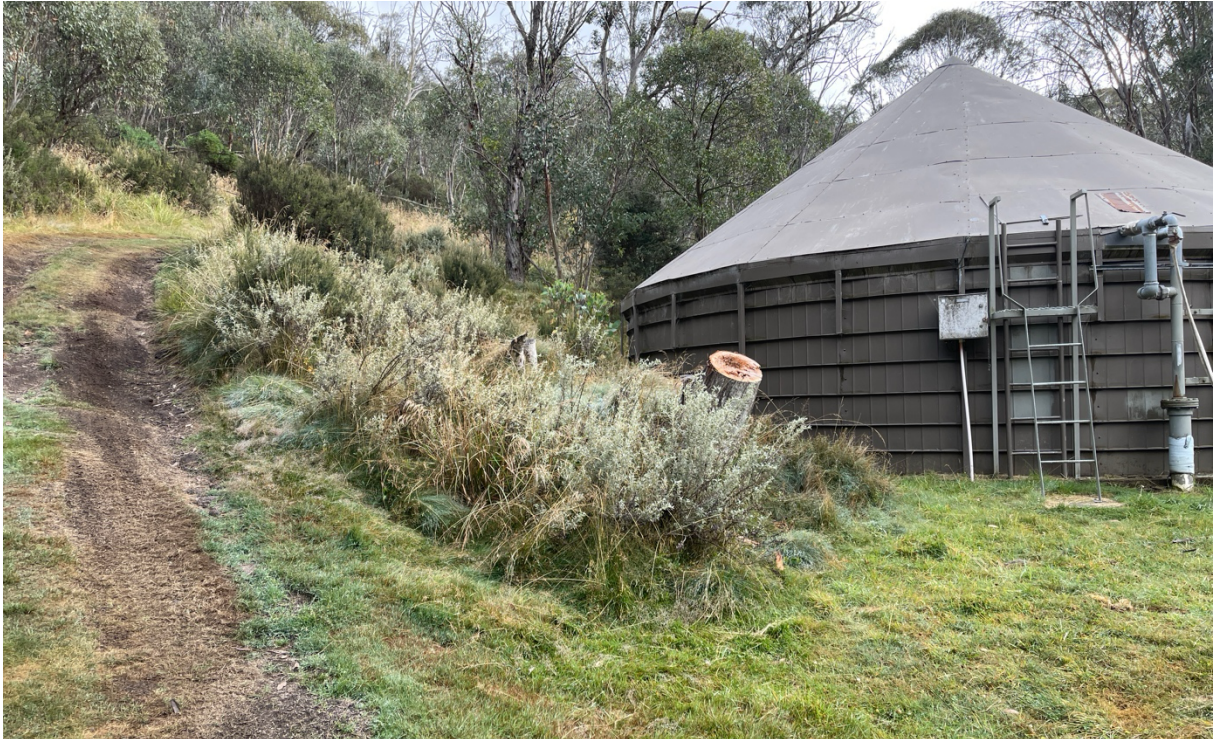
**Photo 1 – View of tank and uphill slope.**

The existing tank is situated on the eastern side of a gravel track that winds up the slope from Crackenback Drive, and on the side of a south-easterly facing slope of about 15°. The original slope has been cut up to about 2.5m depth to provide a level area for the tank construction, with the uphill part of the slope formed at about 30° to 35°. Photos 1 and 2 show the existing tank.

It is proposed to site another tank of similar dimensions adjacent to the existing tank, which will require cutting into the existing slope up to about 2.5m depth. The existing cut slope appears to be in good condition with no signs of slope movement and with good erosion protection provided by thick vegetation. Given the observed slope and good condition for the existing cut, which was formed nearly 30 years ago, it is likely that this cut is formed predominantly within weathered granite. We also note that there are no structures or services within 30m upslope of the proposed cut.

- Cuts should be limited to maximum 30° to 35° above horizontal to match the existing cut angle, and vegetated and covered to limit erosion.
- Filling is not recommended or required for the development.

- Foundations for the tank should be on the same stratum to limit differential movements. On the uphill side this is anticipated to be weathered granite which would provide an allowable bearing pressure of at least 200kPa. On the downhill side, deeper excavation may be required to reach the same stratum, which could be achieved by a strip / ring beam footing or piles beneath the ring beam.

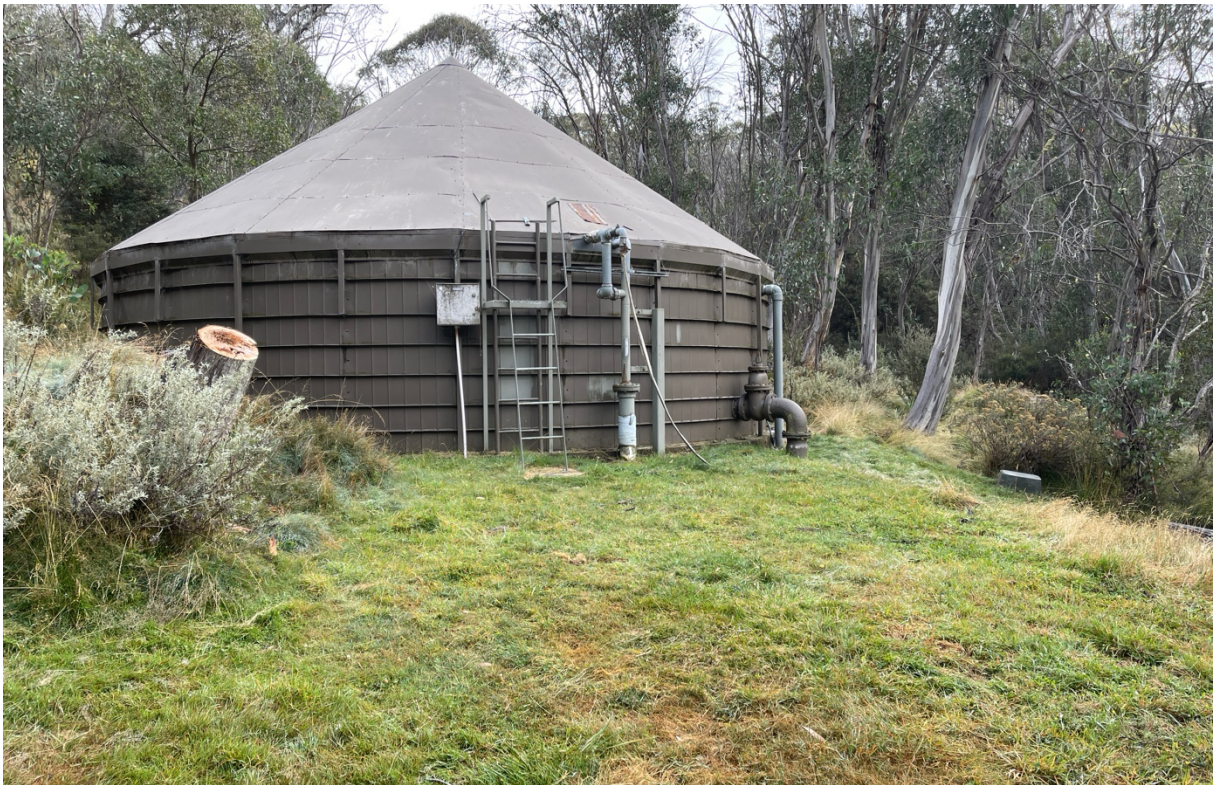
**Photo 2 – View of tank and downhill slope.**

No granite exposures were observed across the development area. Variable subsurface conditions are expected to be encountered including minor fill on the downhill part of the existing slope, clay slope-wash soils, completely decomposed granite (sands), with granite cobbles and boulders interspersed throughout the profile, and occasionally granite bedrock is anticipated.

No obvious signs of slope instability were observed during the site inspection. No signs of surface seepage were observed.

- Excavation is anticipated to be predominantly within completely weathered granite and cobbles and boulders with some overlying soils. Excavation could be achieved by suitably sized excavator, with rock-breaking or blasting required if less weathered granite is encountered.
